28 Dilworth Lane, Longridge

**Bat Survey Report – Version 1**

**Date:** 15 May, 2018

**By:** Dominic Rigby MCIEEM

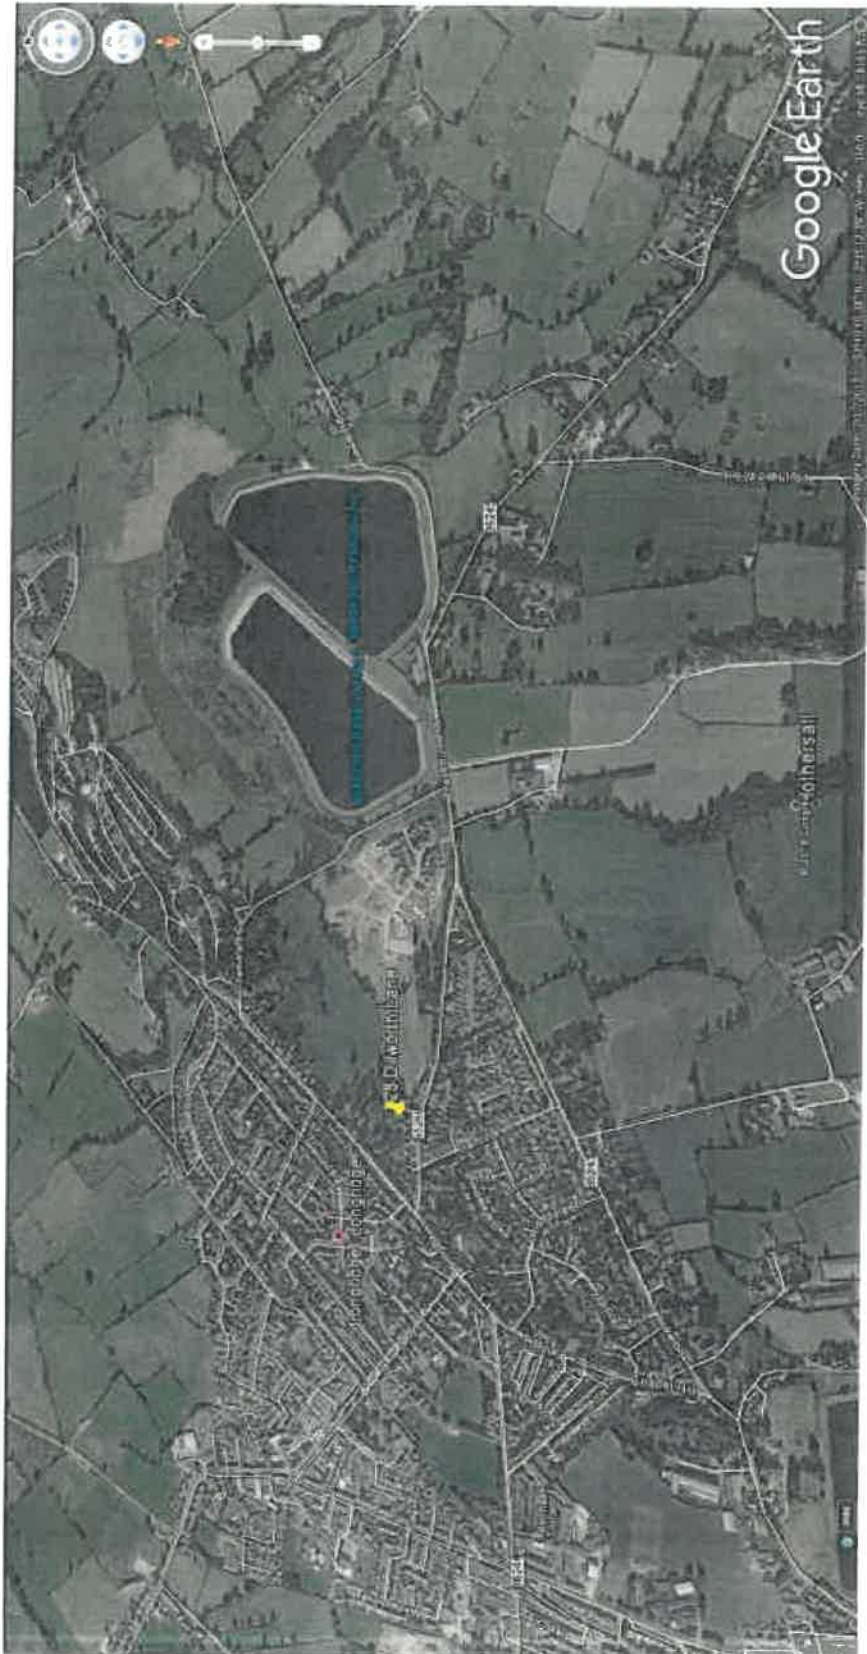
Photograph One: 28 Dilworth Lane in a landscape context

The habitat to the east of the site provides good, connected foraging opportunities for bats. The mix of modern and older buildings to the west provided opportunities for roosting for several species.

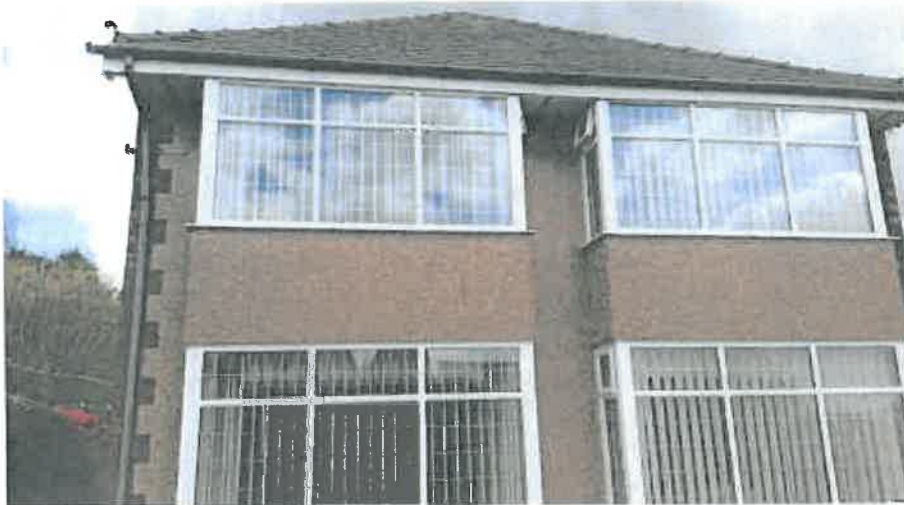
- The pebbledash exterior-wall covering was in good condition. The doors and windows and accompanying lintels were in good condition, sealed and no droppings were present. The slate roof was largely well-sealed and no ridge tiles were lifted or missing, however, there was some light penetration into the loft, with gaps enough for bats to enter.

**Photograph Two: Front view of house**

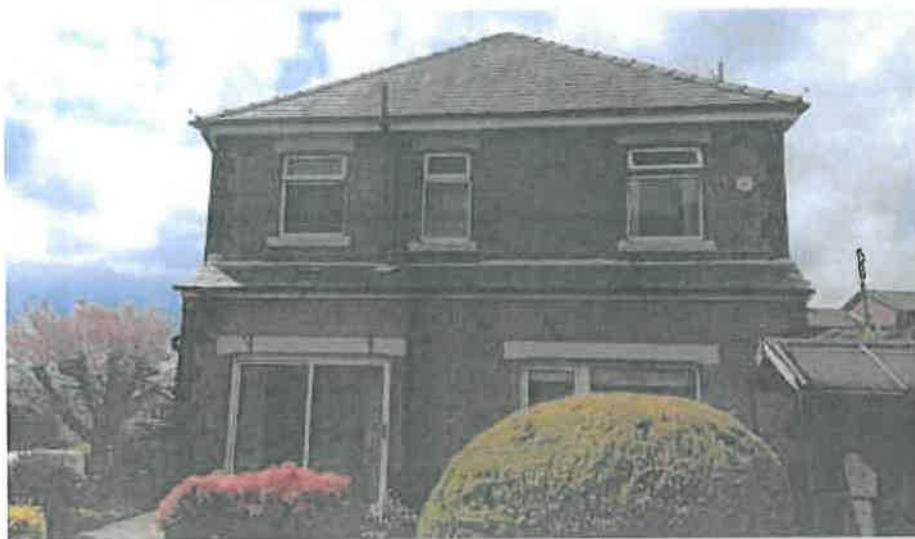
**Photograph Three: Rear View of house, showing Lean-to**

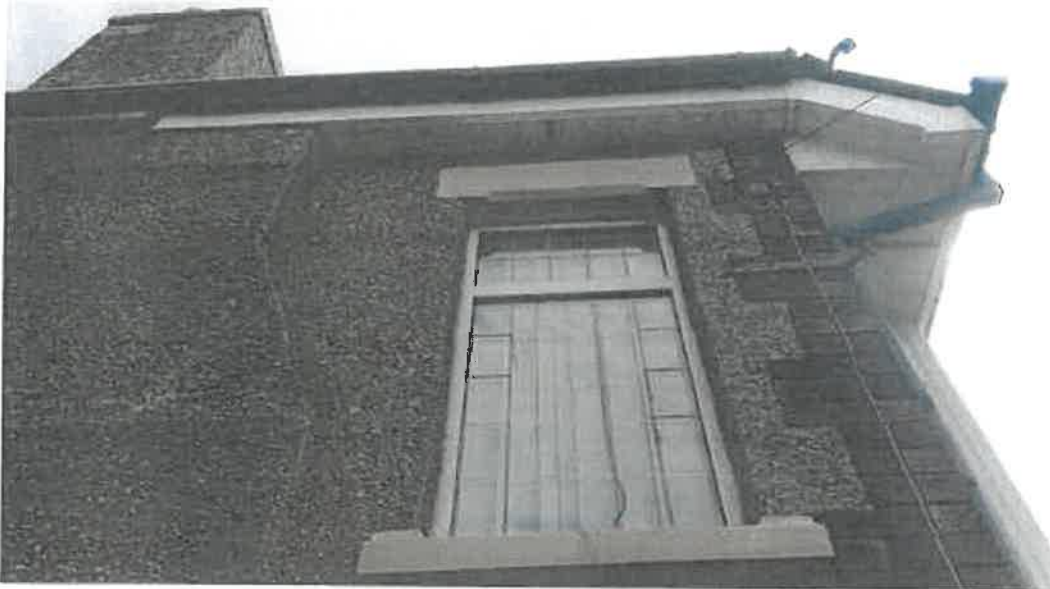
- The fascias and soffits were of wood and in good condition.

**Photograph Four: The eaves were in good condition**

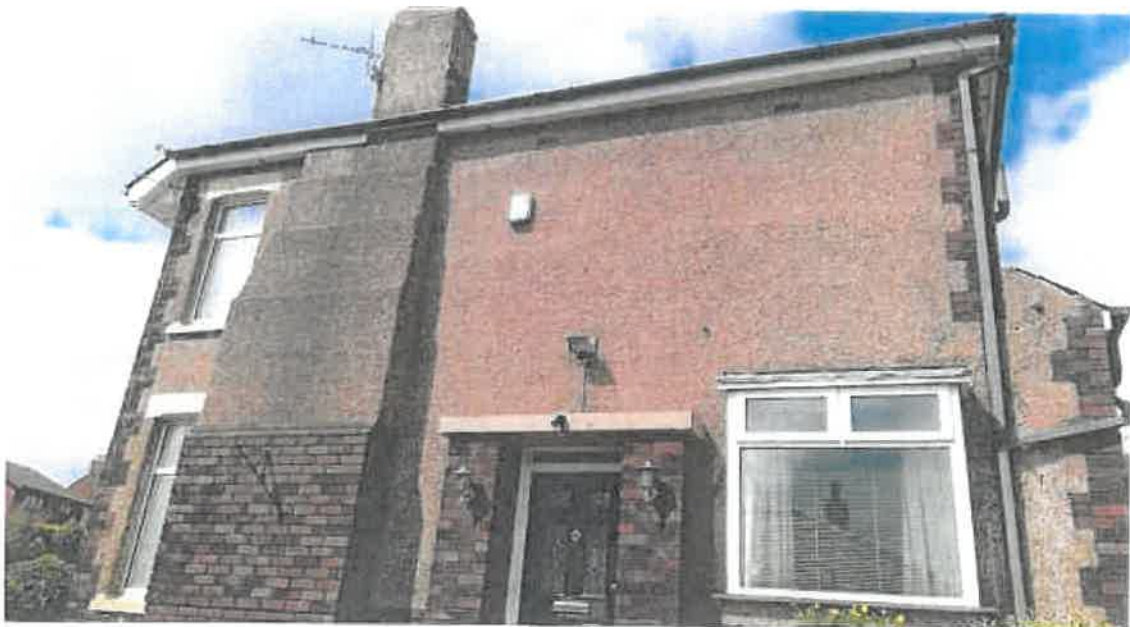
- Pebbledash was sealed around the external chimney breast and the front-door lintel and recess, it was in good condition with no obvious entry-point for crevice-dwelling bats.

**Photograph Five: Side View (east), showing door lintel and chimney breast**

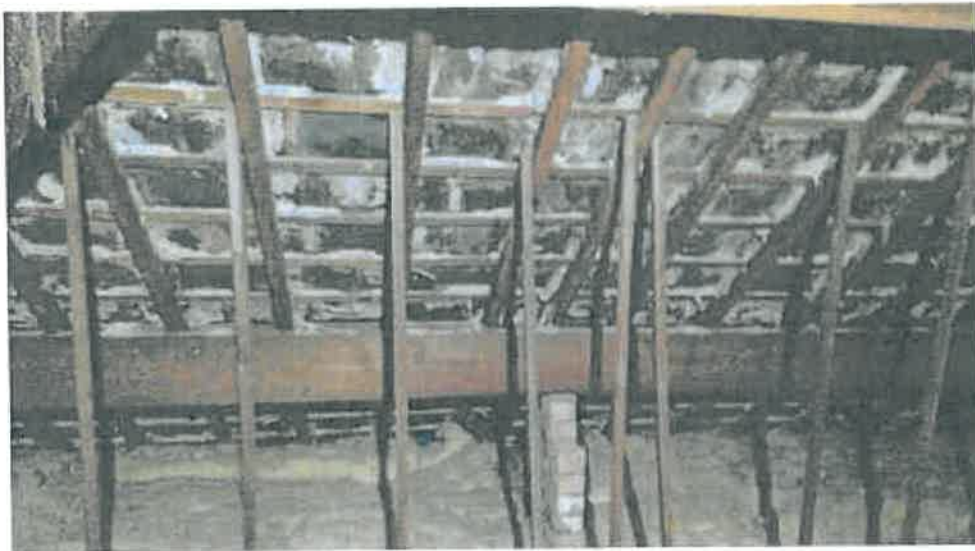
The loft was undisturbed, clear and accessible. There was some light penetration, especially at the front centre and in the NE corner. There was extensive cobwebbing and no signs of droppings. As the roof was single-skin all gaps between slates could be inspected and no bats or bat evidence was found.

**Photograph Six: Single-skinned slate roof and wooden purlin and rafters**

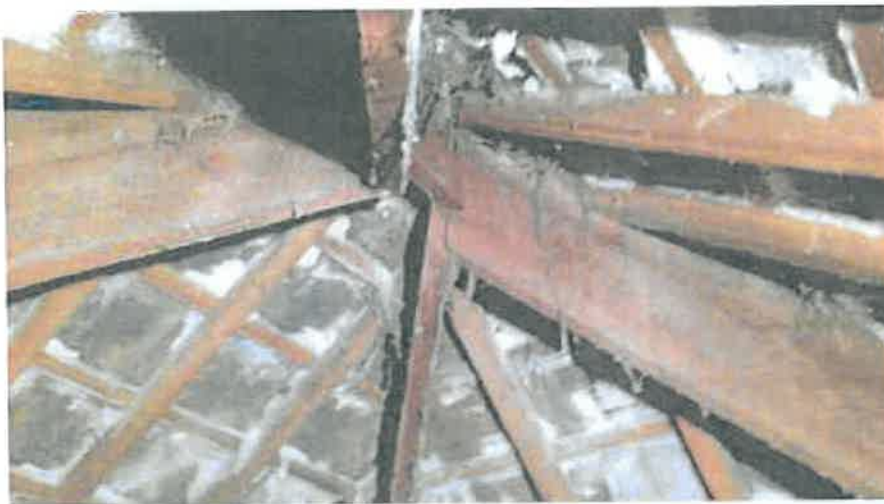
**Photographs Seven: Internal apex of hipped roof, showing extensive cobwebbing**

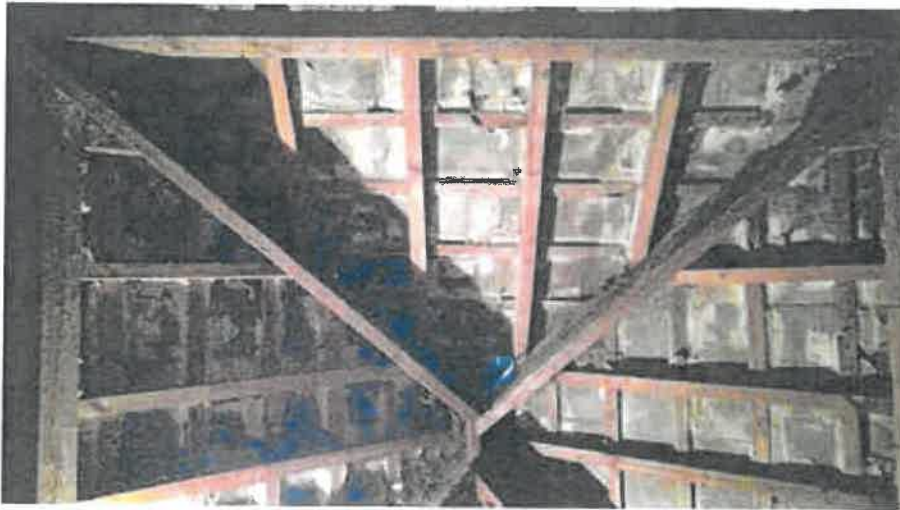
**Photographs Eight: Internal apex of hipped roof, showing wooden hip rafters**

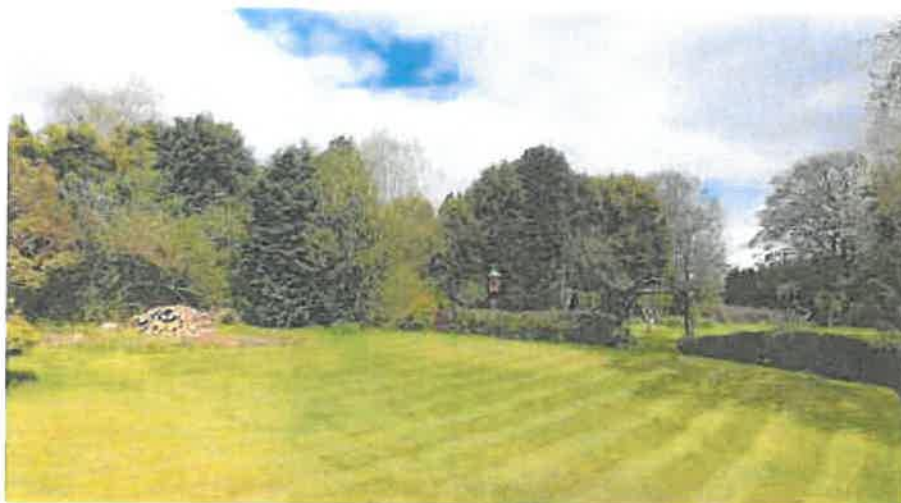
The garden was not the focus of the survey. However, the quality of habitat in and around the garden affect the desirability of potential roost sites and were part of the Bat Roost Trigger Index metric. The garden contained good quality linear habitats leading from the house into the wider pastoral landscape.

**Photograph Nine: The garden, looking NNE, showing a combination of linear and open habitat**

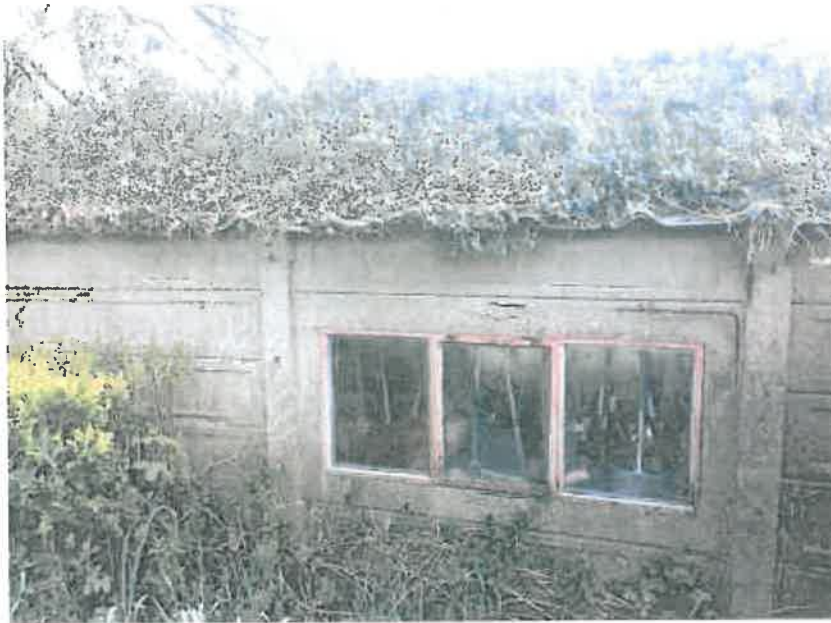
The garage is a single-leaf concrete structure with an ivy-covered corrugated concrete-asbestos roof. There were windows on the western and eastern sides and a metal up-and-over door at the front. The garage was regularly used as a garden storage area. Ivy covering the roof gappy enough to enable adequate inspection.

**Photograph Ten: Western side of garage**

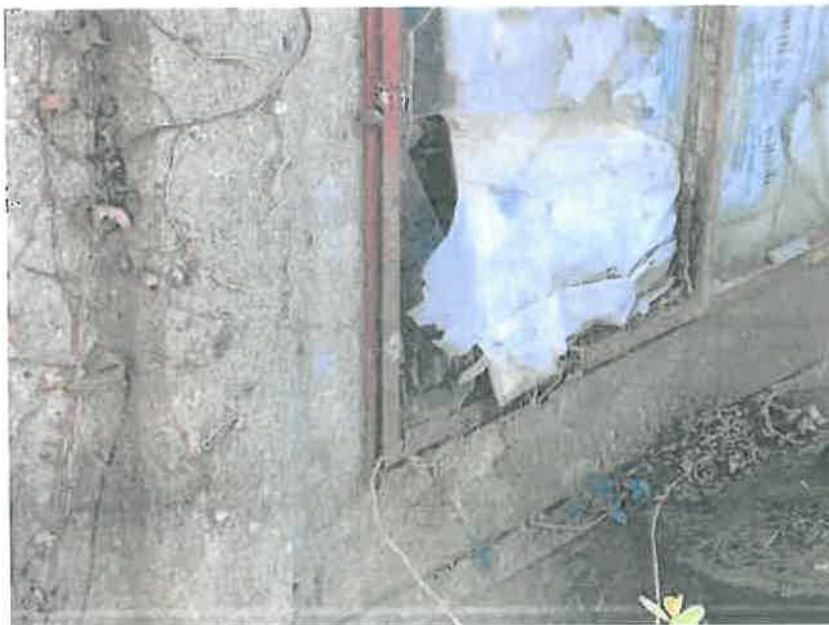
**Photograph Eleven: Eastern side of garage, with broken window**

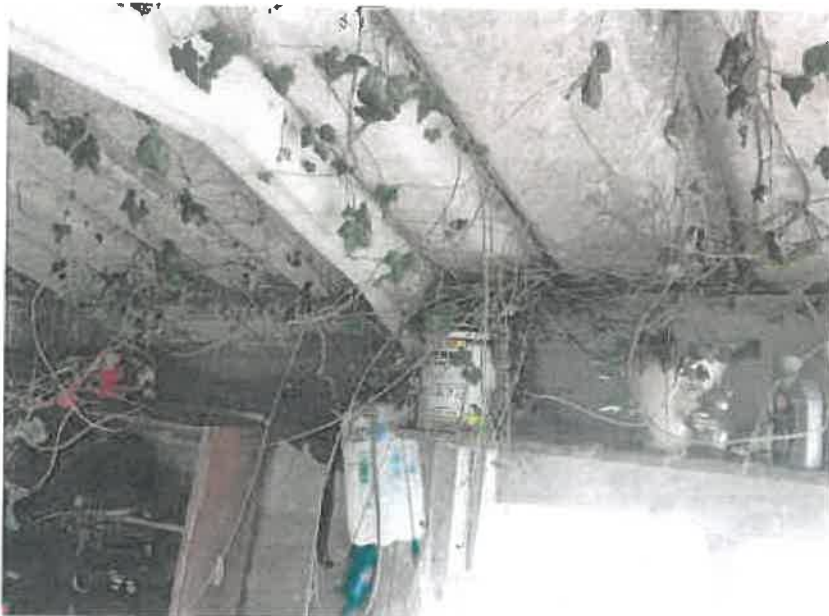
**Photograph Twelve: Internal view of garage**

**The poor thermal properties of concrete and asbestos, the high light levels enabled by windows and the regular usage from spring to autumn and occasional during winter all contributed to this being a structure of negligible use to bats and as such was scoped out of the need for emergence surveys (see Table Five, p20).**
