# Romala Design Ltd

## STRUCTURAL CONVERSION ASSESMENT AND METHOD STATEMENT MOOR BARN KNOWLE GREEN

A structural inspection of the above property was carried out on 27 July, 2009, to examine and report on the current state and safety of an existing barn for conversion purposes.

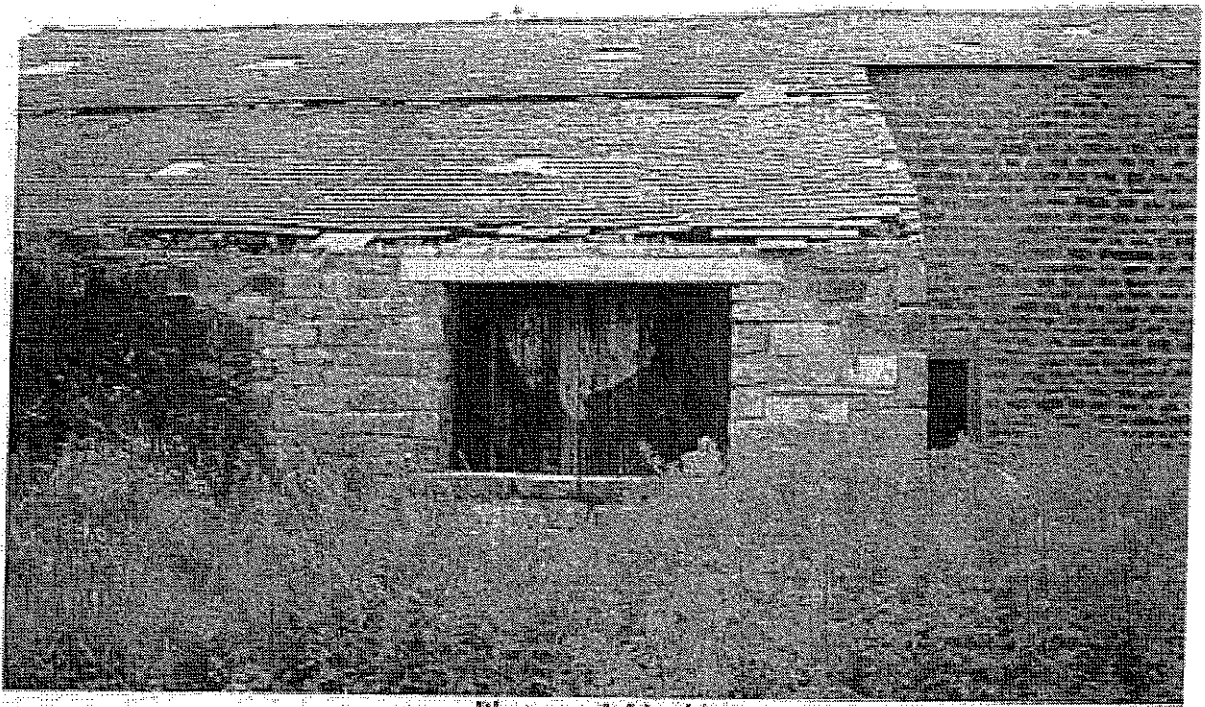
Photograph No. 11

The two external walls shown on the plans as position 11, 12 & 10 are reasonably plumb and in good condition showing no real signs of excessive movement or large cracking. All the pointing however is in poor condition.

Lintels to all openings are defective.

The two number walls shown as position 11, 12 & 10 require all the existing pointing to be removed and replaced. Any loose stonework must also be replaced as necessary once the pointing has been removed with stone work to match; this should be carried out both externally and internally.

Inspections of the existing foundations are required.

All lintels to openings to be replaced with new stone lintels to external face and Catnic lintels to internal masonry as per manufacturer's details and specifications.

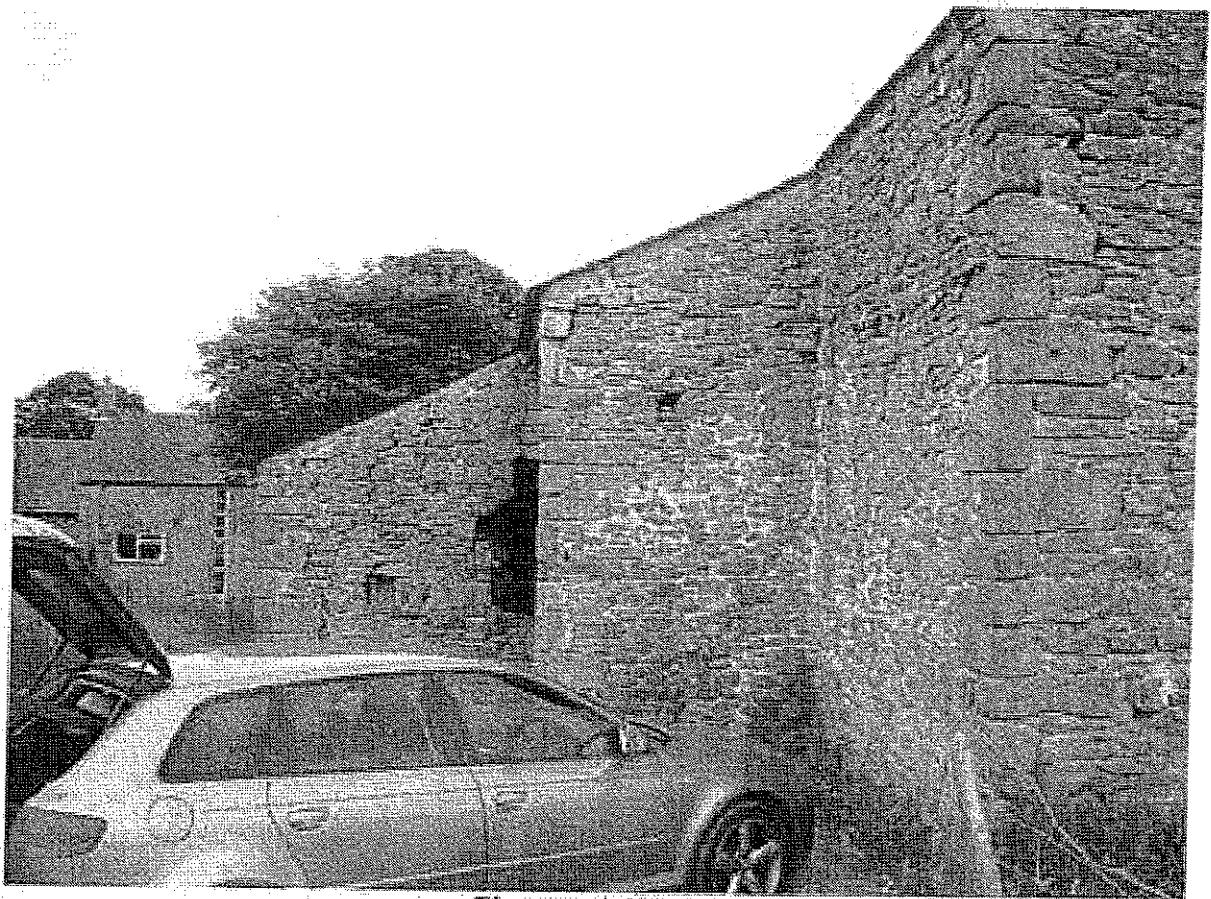
Photograph No. 15

The external wall shown on the plans as position 15 showed two areas of excessive damage. The first was the base of the right flank wall whilst facing the main entrance which did not exist and secondly the left flank wall whilst facing the front entrance had a substantial hole in the middle. All the pointing was in poor condition.

Inspections of the existing foundations are required.

All lintels to openings to be replaced with new stone lintels to external face and Castic lintels to internal masonry as per manufacturers' details and specifications.

## **METHOD STATEMENT FOR THE DEMOLITION OF THE EXTERNAL WALL AREAS TO POSITION NUMBERS 7 & 15 ON THE ATTACHED PLANS**
