**HAPPY DRAINS LTD**  
UNIT 12B CHALEX IND ESTATE, MANOR HALL ROAD

**Project Name:** 36 Painter Wood Whalley\_BB7 9JD

**Project Date:** 14/02/2022

**Inspection Standard:** MSCC5 Domestic GB (DRB Scoring)

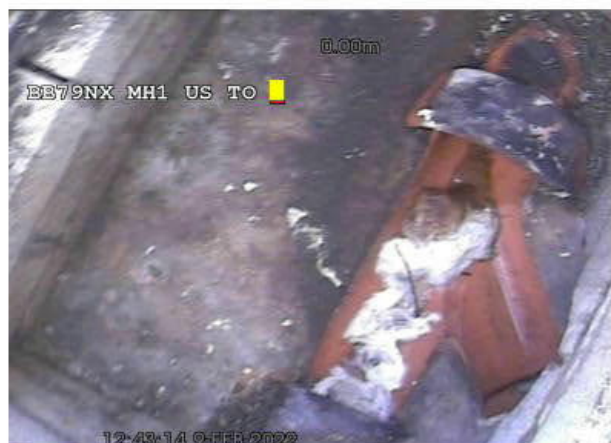
| Scale: | 1:50 | Position [m] | Code | Observation | Grade |
|---|---|---|---|---|---|
| | | 0.00 | MH | Start manhole, MH1: LARGE DEPOSITS IN MANHOLE INVERT | <br>MH - 0.00 m |

1-1-1A, 00:00:00, 0.00 m  
Start manhole, MH1, LARGE DEPOSITS IN MANHOLE  
INVERT

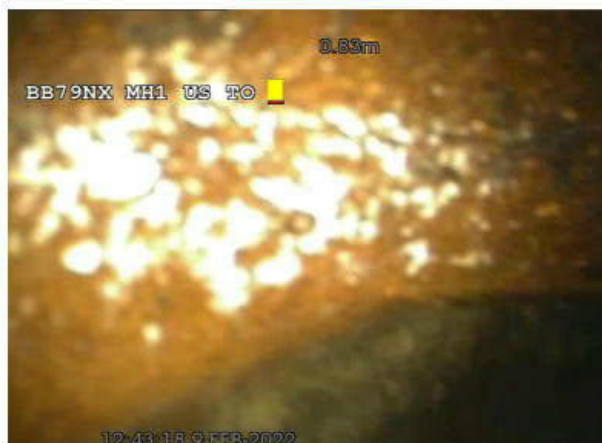
1-1-2A, 00:00:04, 0.30 m  
Finish gully, GY, the pipe is flowing fine

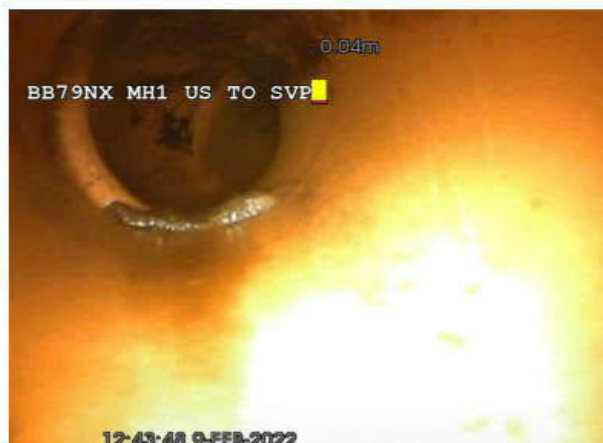
| Scale: | 1:50 | Position [m] | Code | Observation | Grade |
|---|---|---|---|---|---|
| | | 0.04 | JDL | Large displaced joint | C |

2-1-2A, 00:00:05, 0.04 m  
Large displaced joint

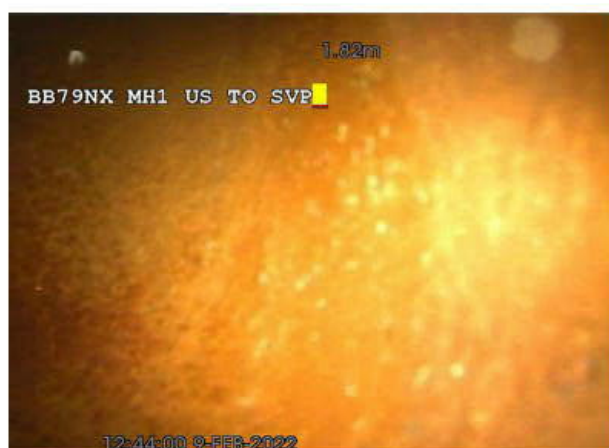
| Pipe Condition Grade: C | Service Condition: Not Serviceable |

2-1-3A, 00:00:18, 1.82 m  
Finish gully, SVP, the pipe is unserviceable

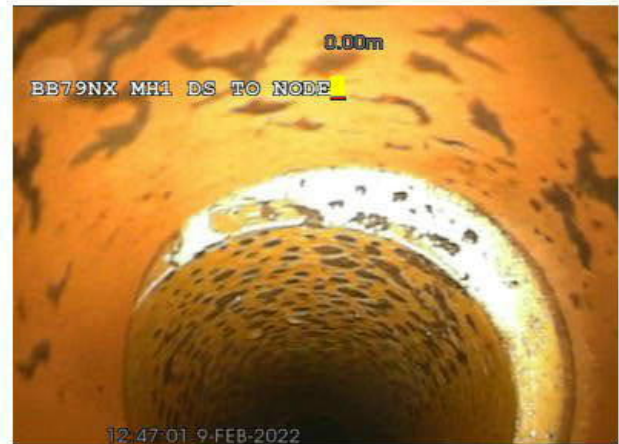
| Scale: 1:50 | Position [m] | Code | Observation | Grade |
|---|---|---|---|---|
| | 0.10 | JDL | Large displaced joint | C |

3-1-2A, 00:00:07, 0.10 m  
Large displaced joint

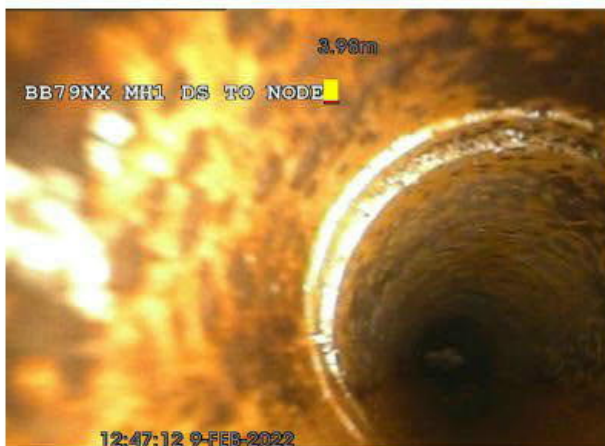
| Scale: 1:50 | Position [m] | Code | Observation | Grade |
|---|---|---|---|---|
| | 3.98 | CCJ | Circumferential crack at joint from 6 o'clock to 1 o'clock | A |

3-1-3A, 00:00:17, 3.98 m  
Circumferential crack at joint from 6 o'clock to 1 o'clock

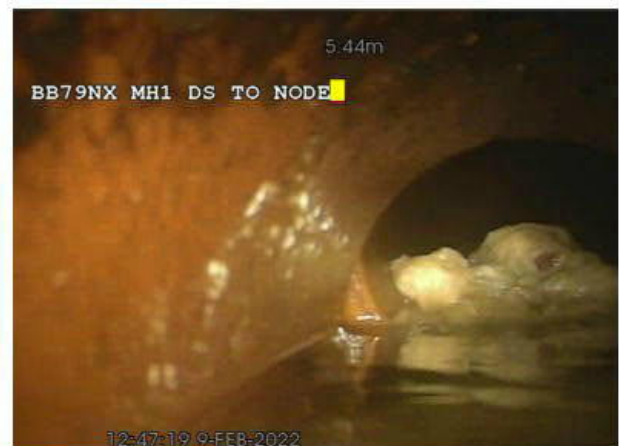
| Scale: 1:50 | Position [m] | Code | Observation | Grade |
|---|---|---|---|---|
| | 5.44 | XP | Collapsed drain or sewer, 75% area loss: REQUIRES EXCAVATION AND REPAIR | C |
| | 5.44 | SA | Survey abandoned, the pipe is unserviceable: UNABLE TO PASS | A |

3-1-4A, 00:00:24, 5.44 m  
Collapsed drain or sewer, 75% area loss, REQUIRES  
EXCAVATION AND REPAIR

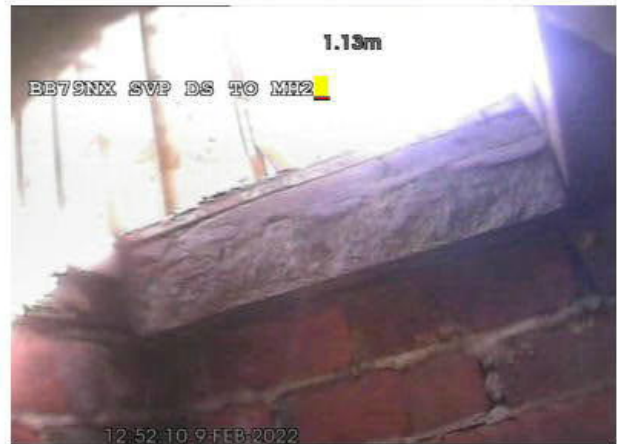
4-1-2A, 00:00:09, 1.13 m  
Finish manhole, MH2, the pipe is flowing fine

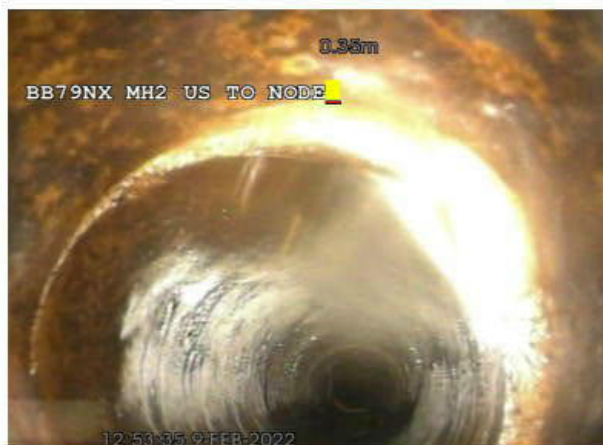
5-1-2A, 00:00:28, 0.35 m  
Large displaced joint

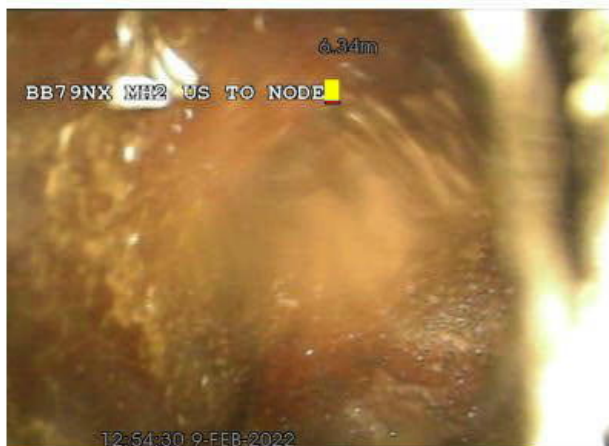
| <b>Pipe Condition Grade: C</b> | <b>Service Condition: Not Serviceable</b> |

5-1-3A, 00:01:23, 6.34 m  
Finish gully, UNKNOWN, the pipe is unserviceable

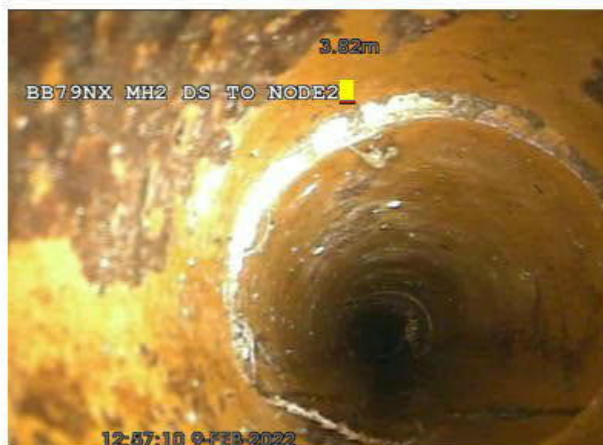
| Scale: 1:206 | Position [m] | Code | Observation | Grade |
|---|---|---|---|---|
| | 3.62 | RJ | Roots at joint | B |

6-1-2A, 00:00:19, 3.62 m  
Roots at joint

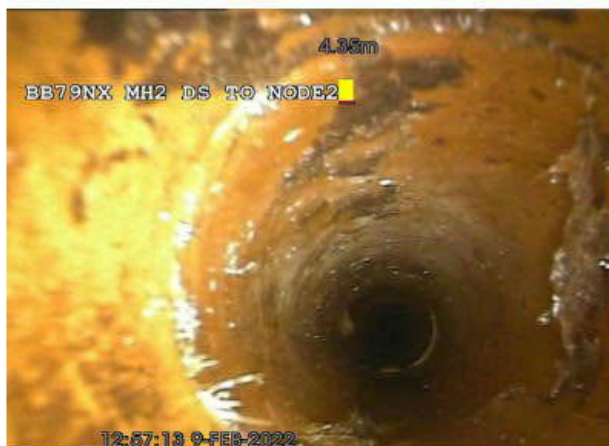
| Scale: 1:206 | Position [m] | Code | Observation | Grade |
|---|---|---|---|---|
| | 4.35 | RJ | Roots at joint | B |

6-1-3A, 00:00:21, 4.35 m  
Roots at joint

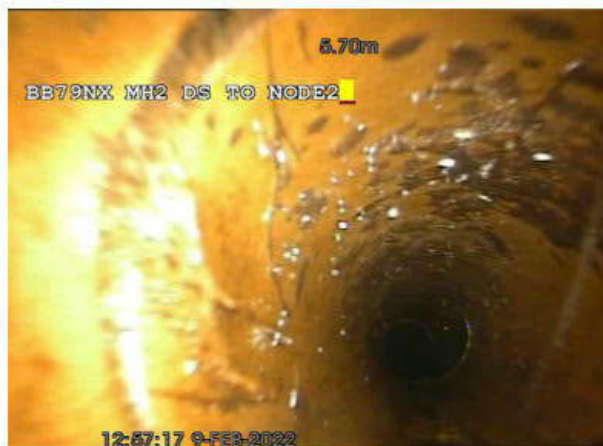
| Scale: 1:206 | Position [m] | Code | Observation | Grade |
|---|---|---|---|---|
| | 5.70 | RJ | Roots at joint | B |

6-1-4A, 00:00:28, 5.70 m  
Roots at joint

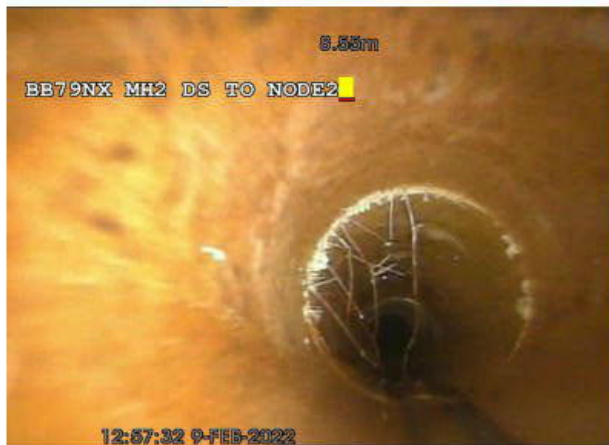
| Scale: 1:206 | Position [m] | Code | Observation | Grade |
|---|---|---|---|---|
| | 8.55 | RJ | Roots at joint | B |

6-1-5A, 00:00:41, 8.55 m  
Roots at joint

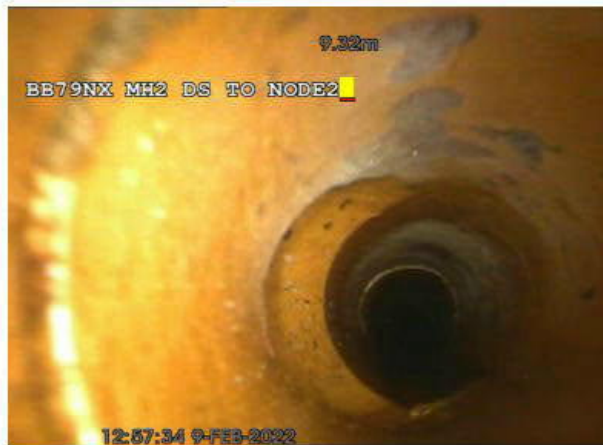
| Scale: 1:206 | Position [m] | Code | Observation | Grade |
|---|---|---|---|---|
| | 9.39 | JN | Junction at 9 o'clock, diameter: 100mm: PIPELINE FROM MH1 | A |

6-1-6A, 00:00:43, 9.39 m  
Junction at 9 o'clock, diameter: 100mm, PIPELINE FROM MH1

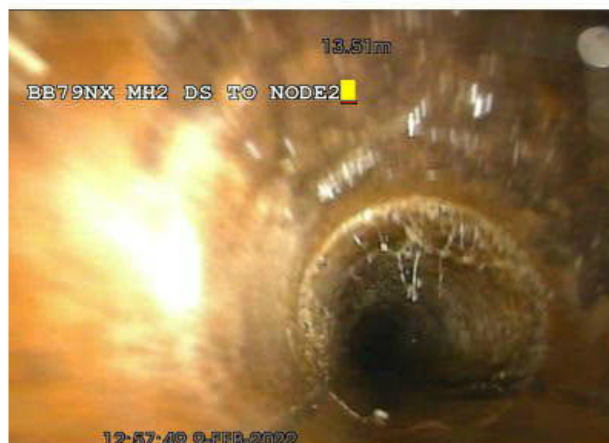
| Scale: 1:206 | Position [m] | Code | Observation | Grade |
|---|---|---|---|---|
| | 13.51 | RJ | Roots at joint | B |

6-1-7A, 00:00:58, 13.51 m  
Roots at joint

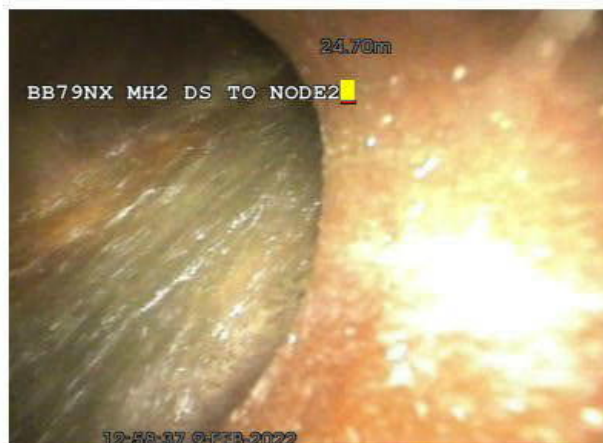
| Scale: 1:206 | Position [m] | Code | Observation | Grade |
|---|---|---|---|---|
| | 24.70 | BRF | Finish connection without manhole, OFF PROP, the pipe is unserviceable | |

6-1-8A, 00:01:46, 24.70 m  
Finish connection without manhole, OFF PROP, the pipe is  
unservicable

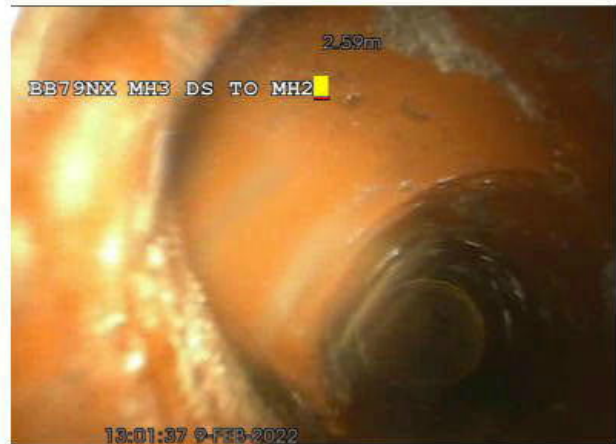
7-1-2A, 00:00:26, 2.59 m  
Junction at 10 o'clock, diameter: 100mm

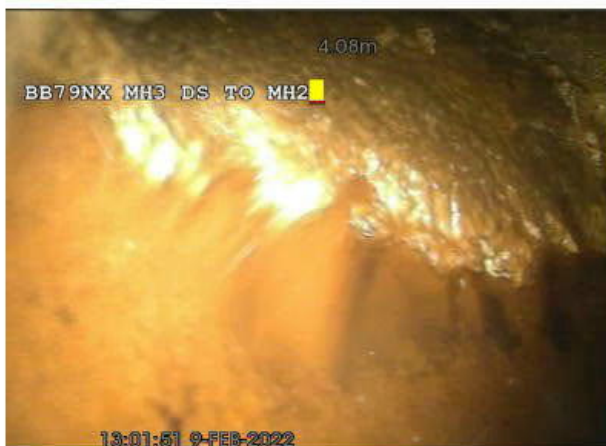
7-1-3A, 00:00:40, 4.08 m  
Finish manhole, MH2, the pipe is flowing fine

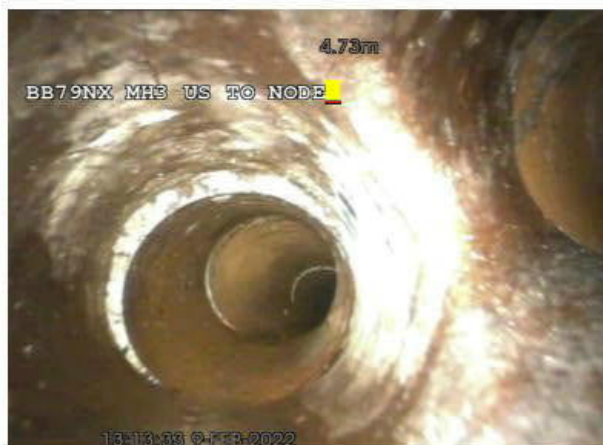
8-1-2A, 00:00:21, 4.73 m  
Junction at 2 o'clock, diameter: 100mm

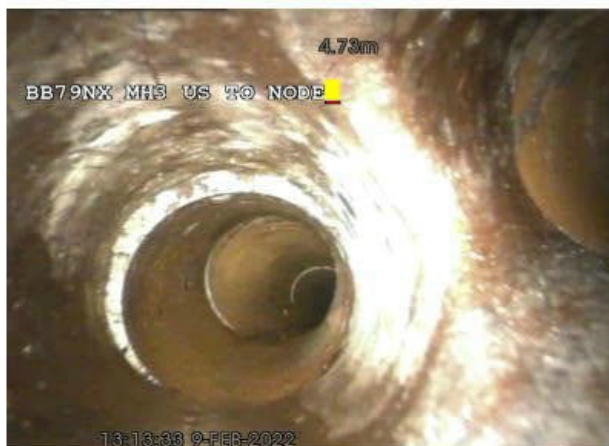
| Scale: 1:60 | Position [m] | Code | Observation | Grade |
|---|---|---|---|---|
| | 4.73 | JDL | Large displaced joint | C |

8-1-3A, 00:00:21, 4.73 m  
Large displaced joint

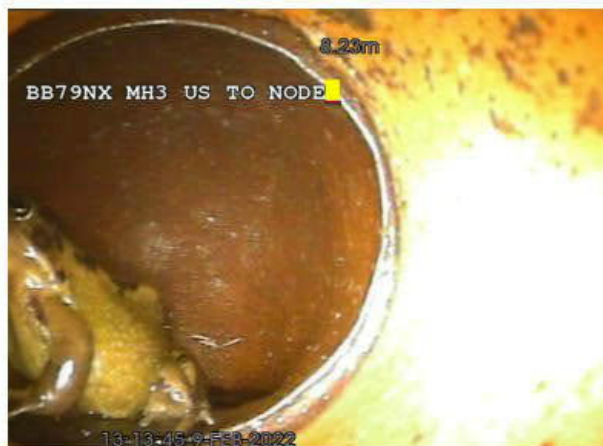
| Scale: 1:60 | Position [m] | Code | Observation | Grade |
|---|---|---|---|---|
| | 8.23 | REM | General remark: FROG IN PIPELINE | A |

8-1-5A, 00:00:33, 8.23 m  
General remark, FROG IN PIPELINE

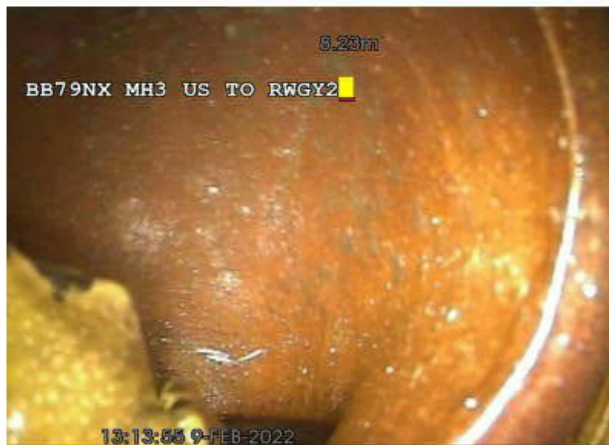
| <b>Pipe Condition Grade: C</b> | <b>Service Condition: Not Serviceable</b> |

8-1-6A, 00:00:43, 8.23 m  
Finish gully, GY, the pipe is unserviceable
