STRUCTURAL INSPECTION

**STONE BARN TO REAR OF 29 – 31 CHURCH STREET,
RIBCHESTER**

MR RUSSELL MILNES

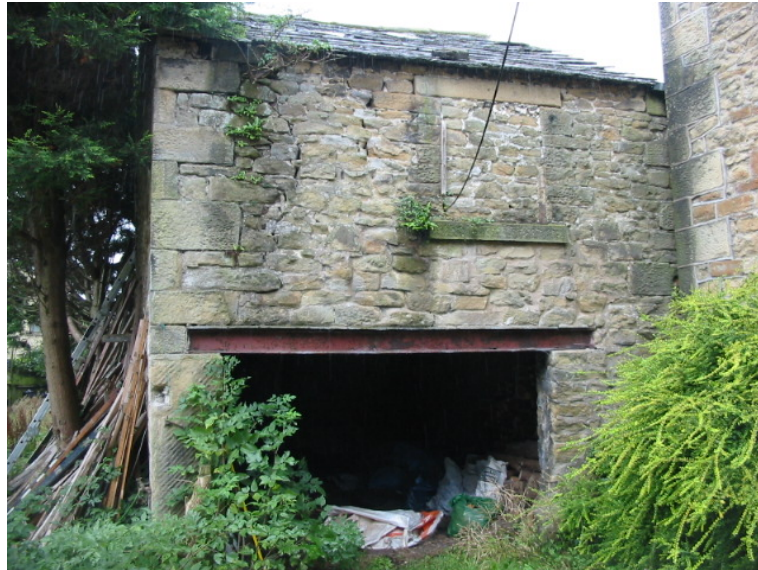
Photo 1 – View of Front of Barn

The property is a stone-built two-storey barn or storage building (**photos 1&2**), and appears to be around 200 years old.

- A door opening near the front corner has been in-filled with stone. The stone jamb at the corner leans outwards to both the north and east and there are signs of separation between the original masonry and the more recent in-filling (**photos 1&7**).
- The wall contains a central window opening at first floor. The stonework above is supported on timber lintels, which have decayed due to wet rot and insect infestation (**photo 8**).
- Some bonding timbers have been built into the inside face of the wall at ground floor. These are decaying.
- One vertical crack of up to 10mm in width was noted at ground floor on the inside face of the wall.
- A number of large conifers have been planted immediately alongside the wall.
- The stonework is in reasonable condition and the wall is generally straight and vertical.

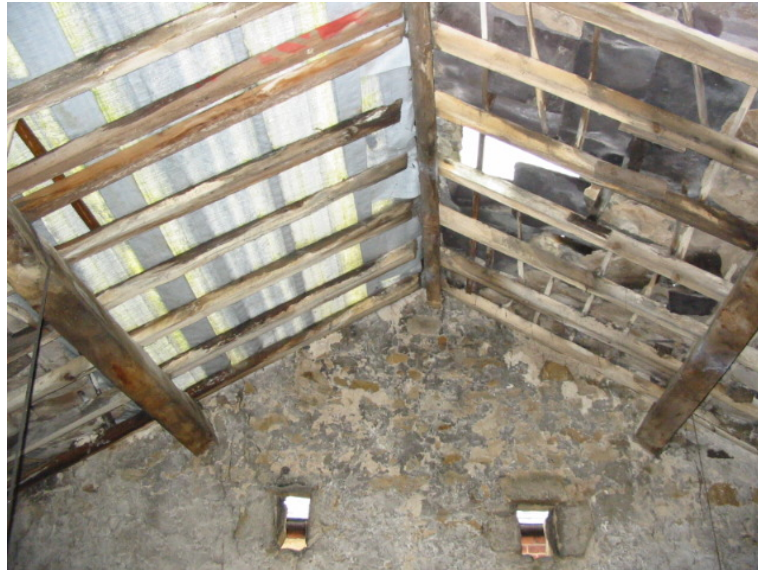
Photo 3 –Roof Structure

- Large areas of the stone flag covering are missing or have been replaced by temporary polythene sheeting (**photo 3**).
- Some timber rafters appear to be relatively new, and the remainder appear to be in reasonable condition.
- The rafters are supported on two timber purlins on each roof slope and a central ridge purlin. The purlins appear to be in reasonable condition, but with some damp staining where they bear onto the external walls (**photo 4**).
- It would appear that the roof timbers are non-original items and that the roof structure has been replaced at least once during the life of the building.

- Removal of the stone roof covering. Inspection and replacement as necessary of the roof timbers. Replacement of the stone flagged covering.

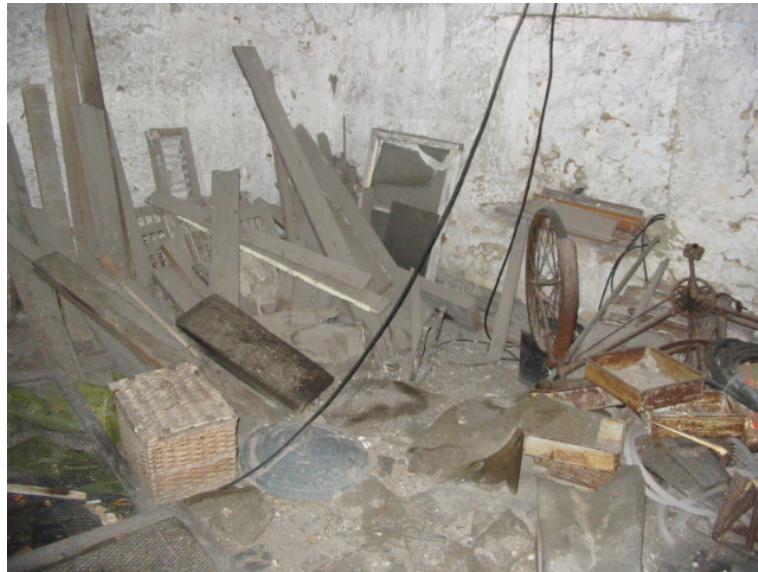
Photo 5 – First Floor Showing Stored Material

- The first floor is in very poor condition and was inspected from an opening in the east gable wall and from the ground floor below (**photo 5**).
- Parts of the floor boarding have decayed and are missing.
- Most of the timber joists are decayed to some degree due to wet-rot and insect infestation. Most have deflected excessively, some have fractured and have been propped by steel sections.

- Complete replacement of the timber first floor.
- Possible construction of a new ground floor slab, depending on its anticipated future use.
- Replacement of decayed lintels and bonding timbers built into the stone walls with stone or concrete items.
- Rebuilding the stonework in the north-east corner where the door opening has been in-filled.
- Re-pointing of the external face of the stonework.
- Detailed inspection and anti-corrosion treatment of the steel lintels over the main front door opening.
- Stitching of all vertical cracks on the inside face of the walls.
- Ensuring that the front and rear walls are restrained against further outward bulging by the provision of sufficient ties between the walls and first floor.
- Removal of the trees close to the east gable.

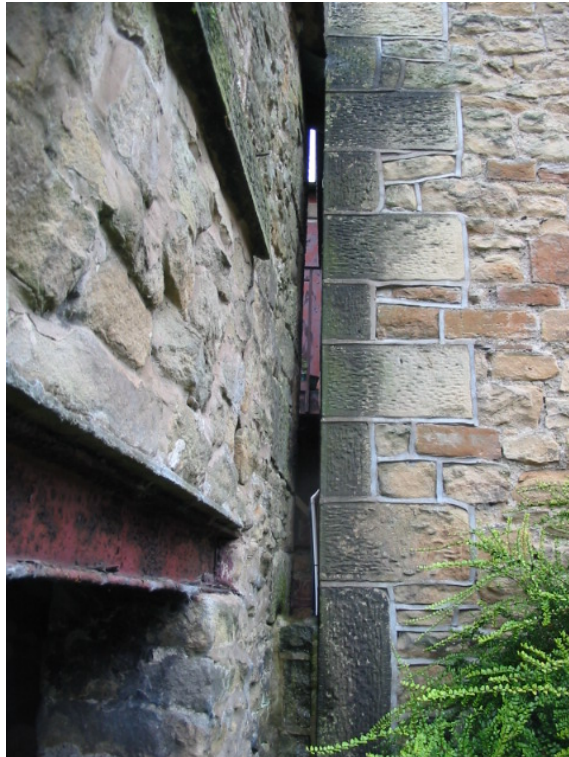
Photo 6 – Leaning Front Wall

- The wall contains the main entrance opening. The masonry above is supported on two steel channel-section beams, which seem to be in reasonable condition.
- A first floor window opening has been built up with stone masonry.
- The wall leans forward to a noticeable degree (**photo 6**).
- There is a bulge outwards between the top of the ground floor entrance door and the in-filled first floor window cill.
- The masonry joints to the east of the first floor window are badly eroded, and water ingress has encouraged vegetation growth.

Should the outward lean of the front wall be visually unacceptable, the wall would need to be taken down and re-built. It would however remain structurally stable in its present condition if the roof structure is replaced and it is tied to the new first floor as recommended above.

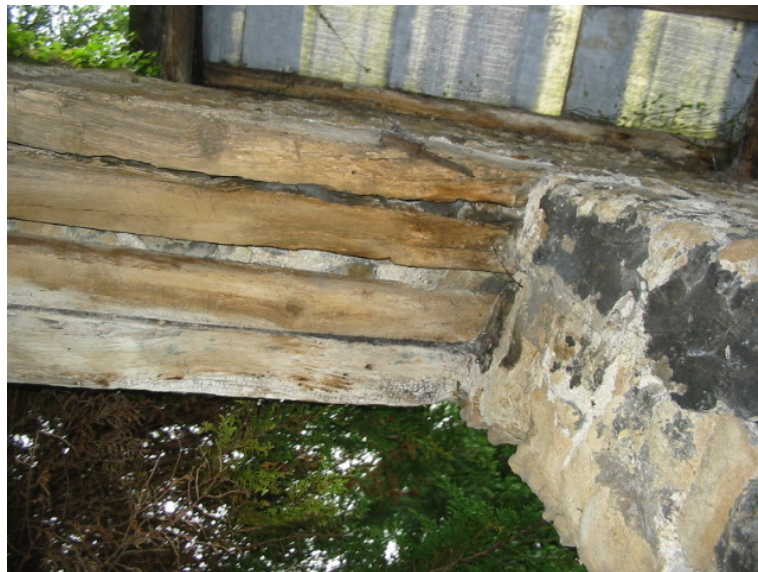
Photo 8 – Decayed Timber Lintels in Gable Wall
