CLITHEROE LIBRARY  
CHURCH STREET  
CLITHEROE

MASONRY SURVEY

Clitheroe Library Report

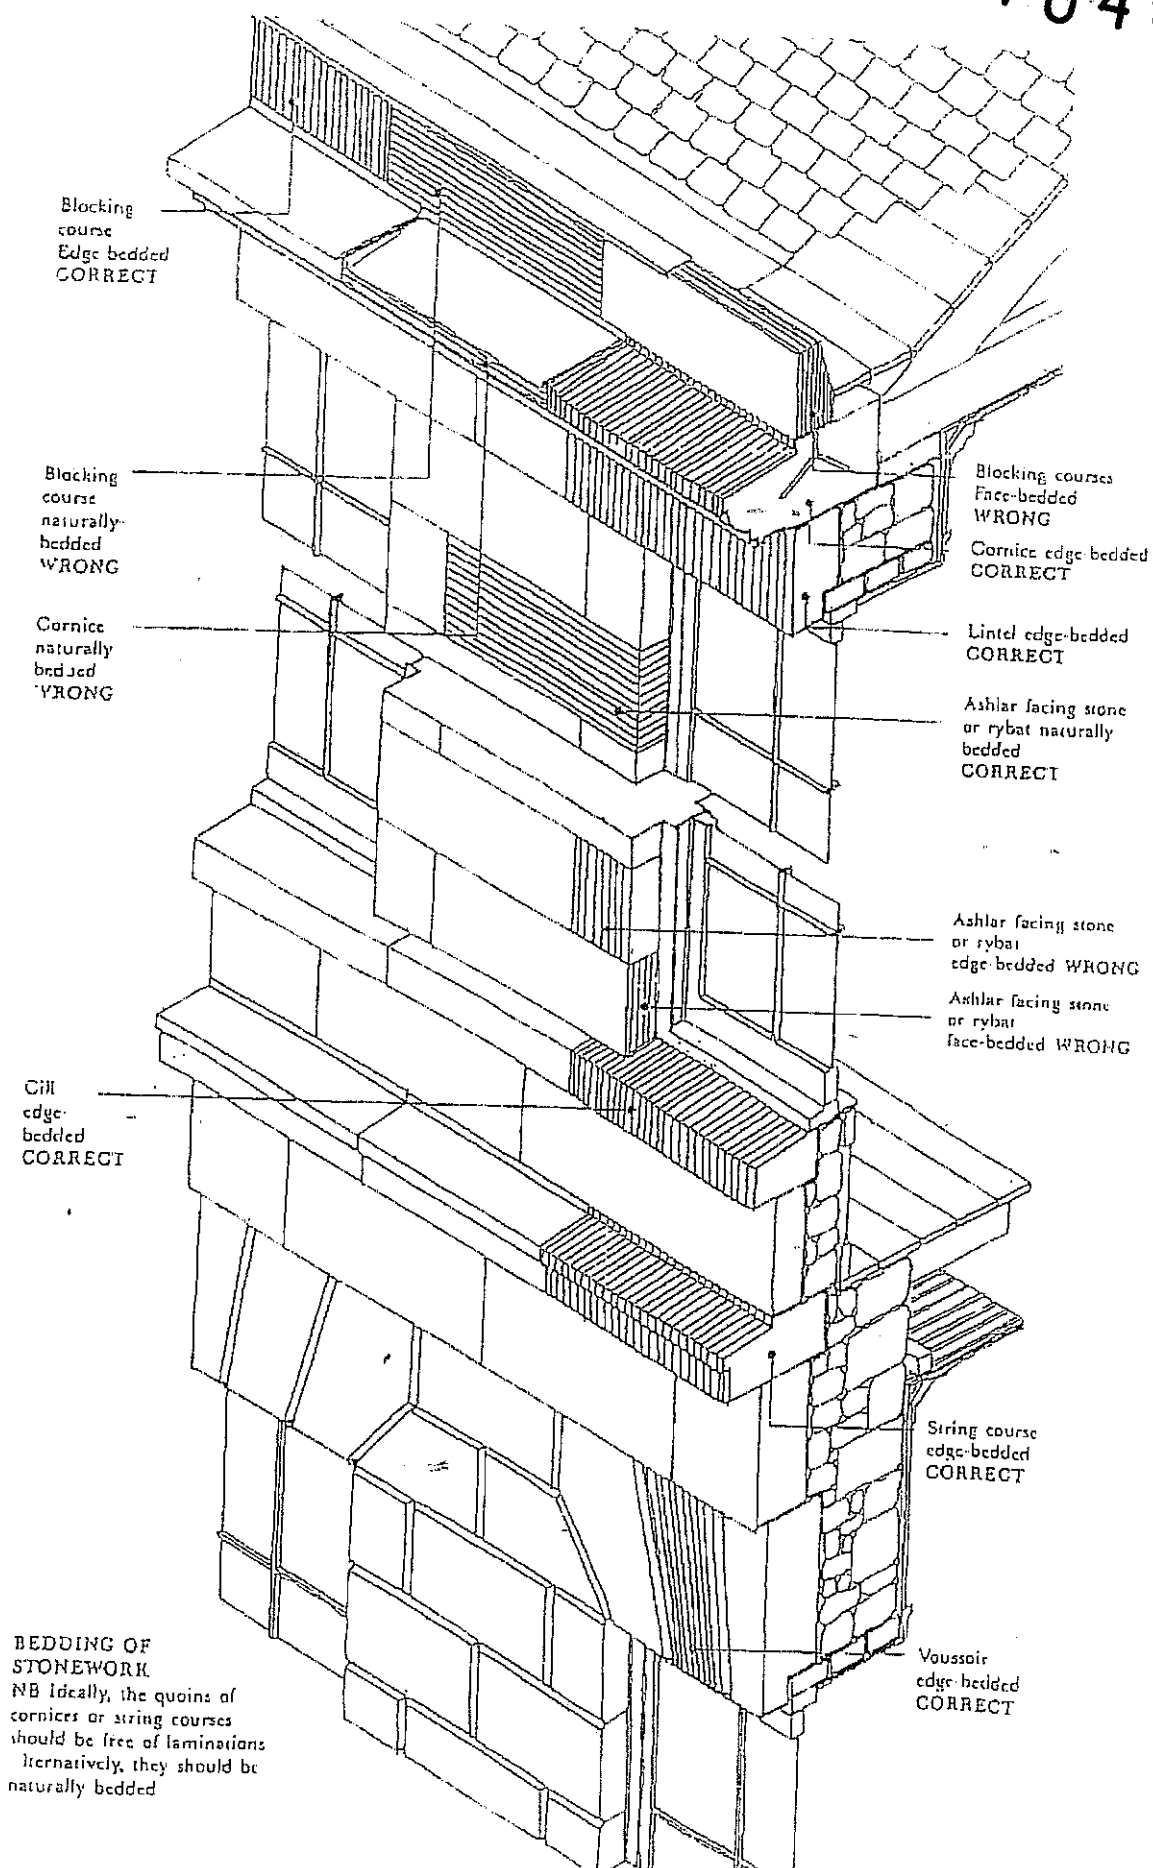
There is significant delamination of the stone to this area. Due to the stone being laid to an incorrect bed, please see appendix A for a guide to the "correct bed" of fixing sandstone. This resultant scaling and splitting requires different repair methods dependant on the extent of decay.

**BEDDING OF STONEWORK.**  
NB Ideally, the quoins of cornices or string courses should be free of laminations. Alternatively, they should be naturally bedded.

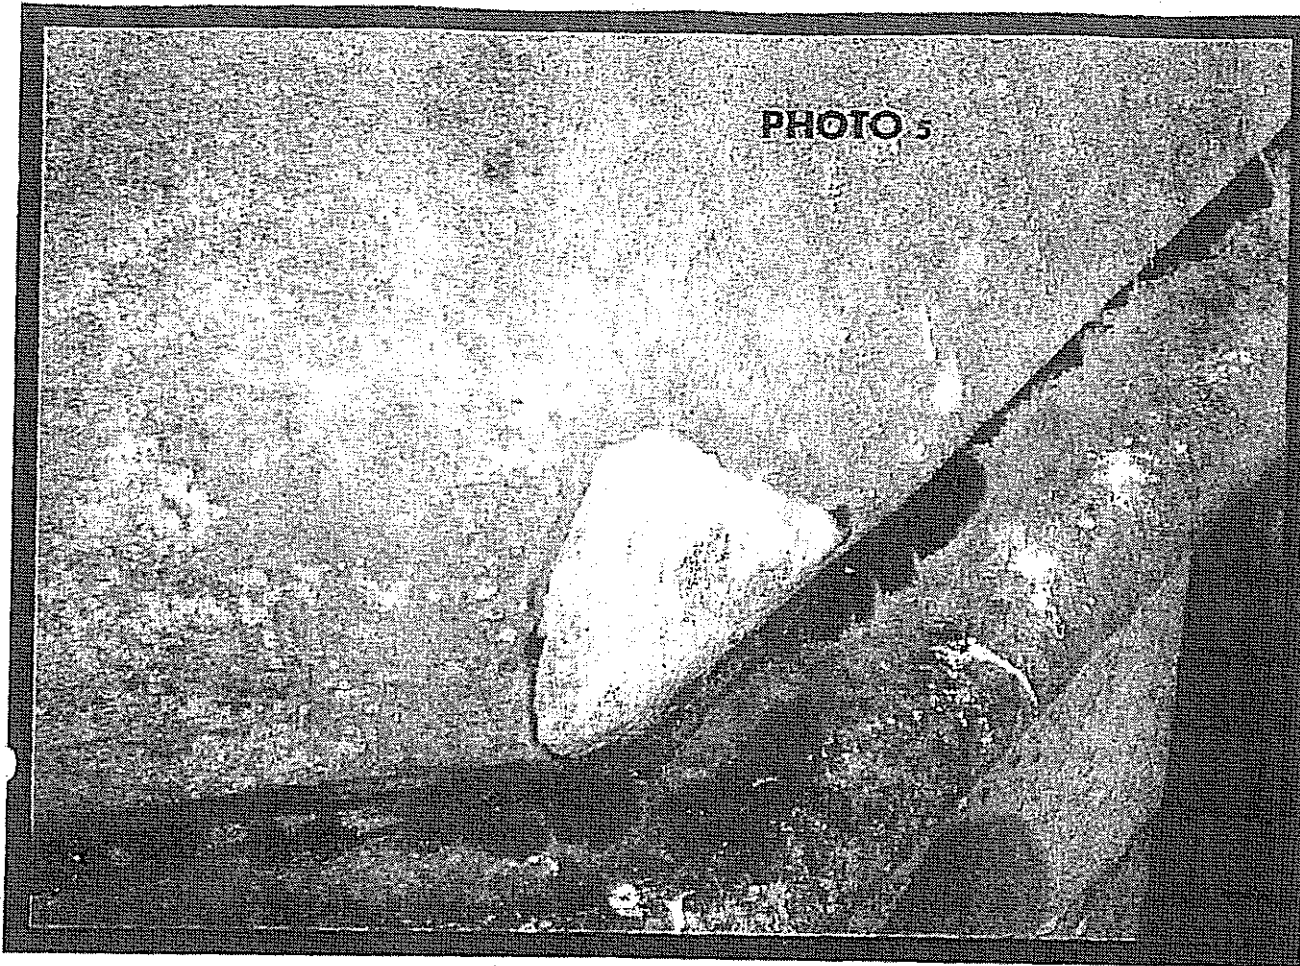
PHOTO 5

| Item | PHOTO NO | Description | REPAIR TYPE | COMMENTS | Quant | Unit |
|---|---|---|---|---|---|---|
| 6 | 5 | OLD CEMENTITIOUS REPAIR TO CORNER | INDENT | INDENT APPROX 150X150X50 | 1.00 | ITEM |

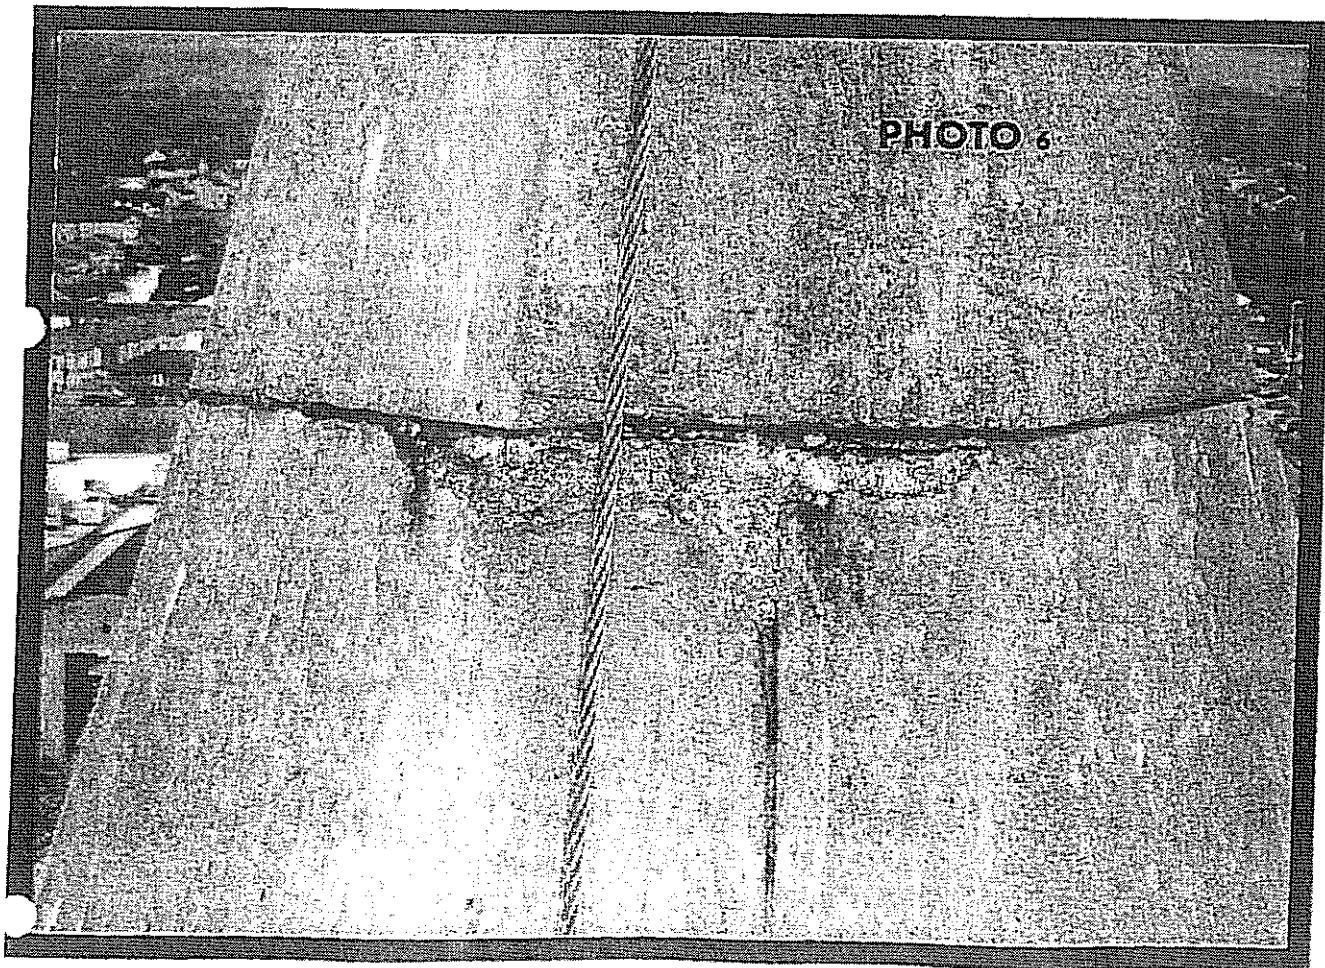
PHOTO 6

| Item | PHOTO NO | Description | REPAIR TYPE | COMMENTS | Quant | Unit |
|---|---|---|---|---|---|---|
| 7 | 6 | 2 NO OLD CEMENTITIOUS REPAIR TO CORNER | INDENT | INDENTS APPROX 200X150X50 AND 100X50X 50 A PROVISIONAL SUM SHOULD BE SET ASIDE FOR WORKS DISCOVERED ONCE ACCESS IS AVAILABLE | 1.00 | ITEM |

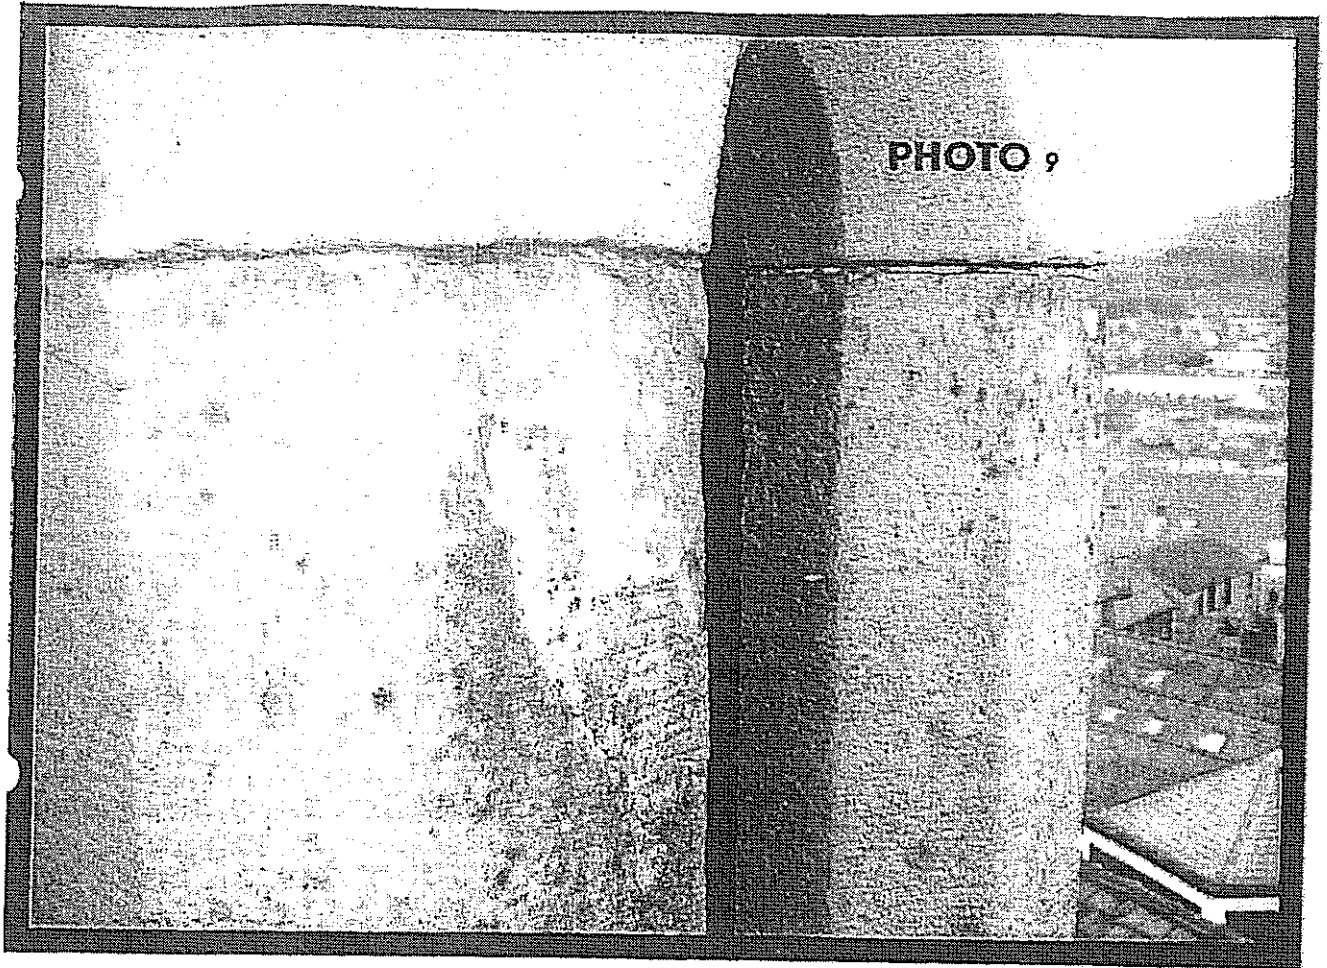
PHOTO 9

| Item | PHOTO NO | Description | REPAIR TYPE | COMMENTS | Quant | Unit |
|---|---|---|---|---|---|---|
| 12 | 9 | OLD CEMENTITIOUS REPAIR FAILING | DESCALE LOOSE | REMOVE LOOSE MATTER ONLY | 1.00 | ITEM |

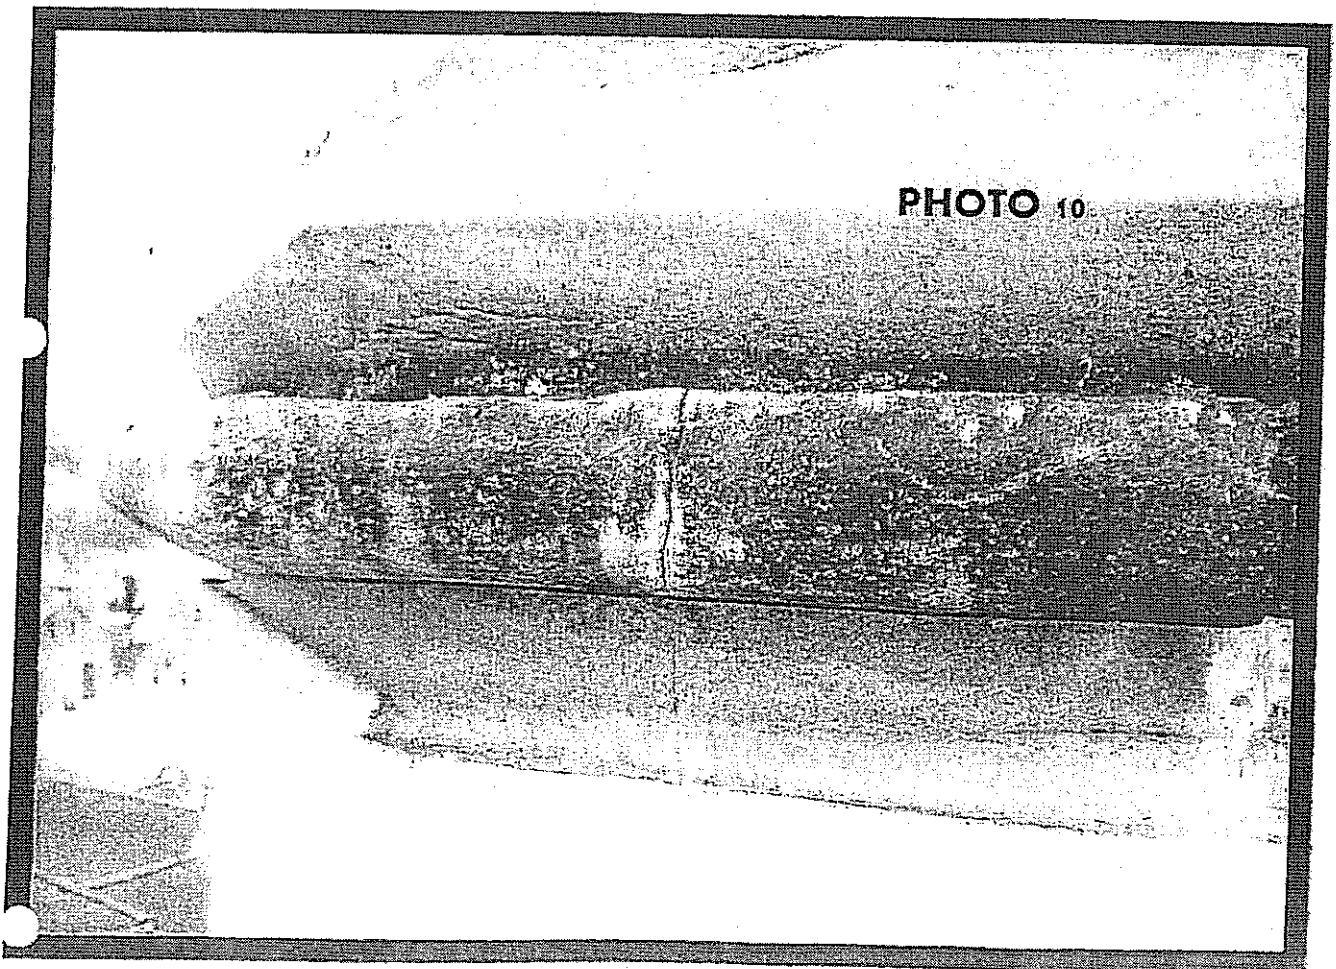
PHOTO 10

| Item | PHOTO NO | Description | REPAIR TYPE | COMMENTS | Quant | Unit |
|---|---|---|---|---|---|---|
| 13 | 10 | SMALL FRACTURE TO STRING | POINT | | 1.00 | ITEM |

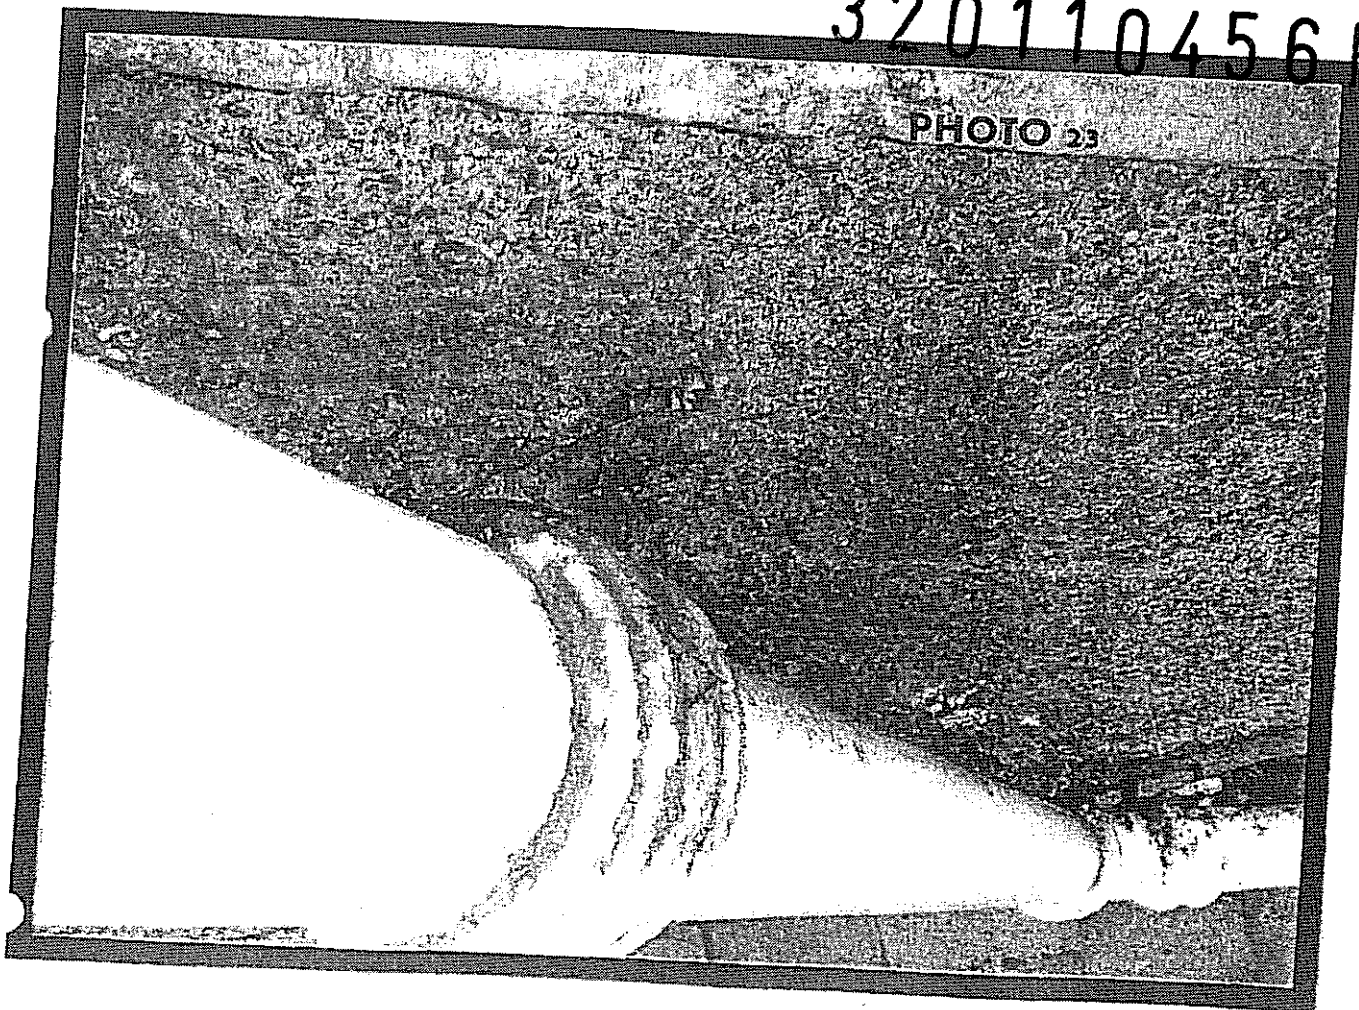
PHOTO 23

| Item | PHOTO NO | Description | REPAIR TYPE | COMMENTS | Quant | Un |
|---|---|---|---|---|---|---|
| 23 | 23 | FOUL VENT PIPE FIXINGS ARE IN POOR CONDITION | CAST IRON | REPLACE 4 NO FIXINGS | 4.00 | NO |

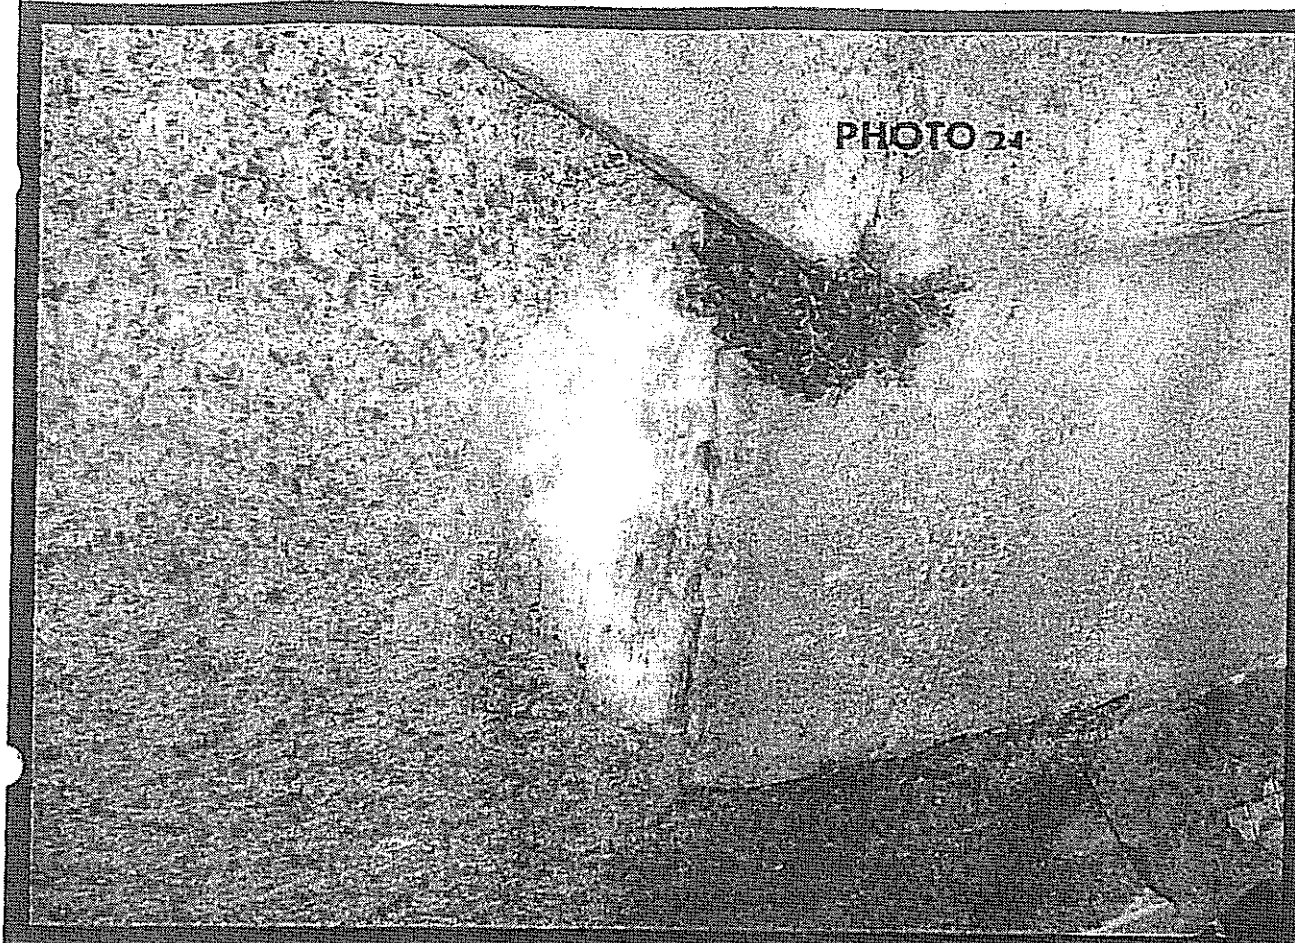
PHOTO 24

| Item | PHOTO NO | Description | REPAIR TYPE | COMMENTS | Quant | Un |
|---|---|---|---|---|---|---|
| 24 | 24 | AREA OF FAILING RENDER | RENDERING | PATCH REPAIR DEFECTIVE AREA ONLY | 1.00 | ITE |
