# **TREE CONDITION AND TREE CONSTRAINTS REPORT**

**RELATING TO POTENTIAL DEVELOPMENT SITE  
AT WHALLEY NEW ROAD AT BILLINGTON**

**Acland Bracewell Ltd via Janet Dixon Town Planners Ltd**

**December 2009**

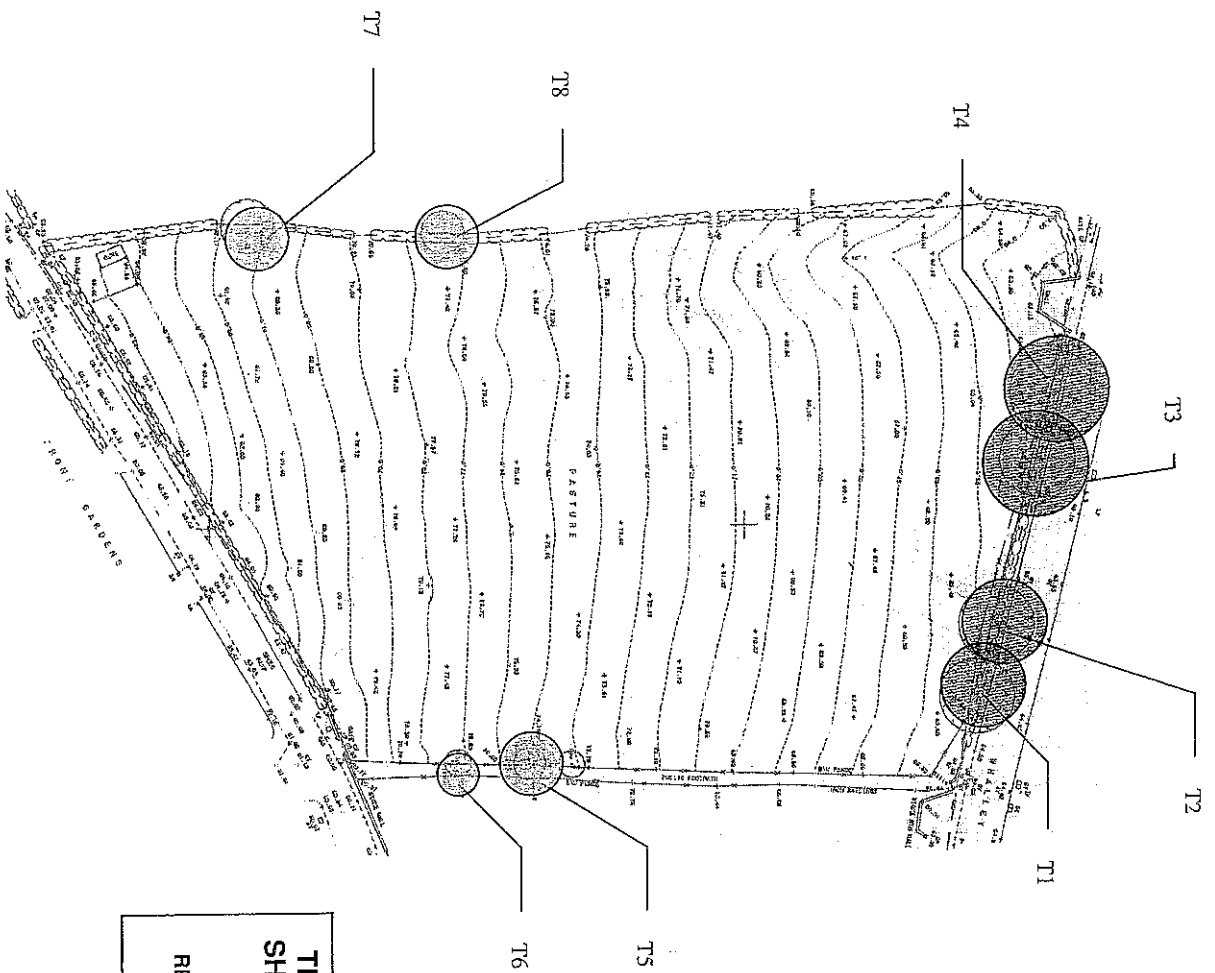
**TREE CONSTRAINTS PLAN  
SHOWING EXTENT OF ROOT  
PROTECTION AREAS**  
REFER TO RPA RADIUS DETAILS IN  
TREE CONDITION SCHEDULE

The Four trees on the northern boundary have been rated A and B and the root protection areas required are shown as partial circles within which development and ground damage should not take place. The epicormic growth on the lower stem of T3 is a block to site access visibility but this can easily be removed with no detriment to the tree.

The location of T1-4 will impose limitations on the potential road access point onto the site from the north side
