Photographic Record – Hurst Green Guild Hall Social Club

320110528P

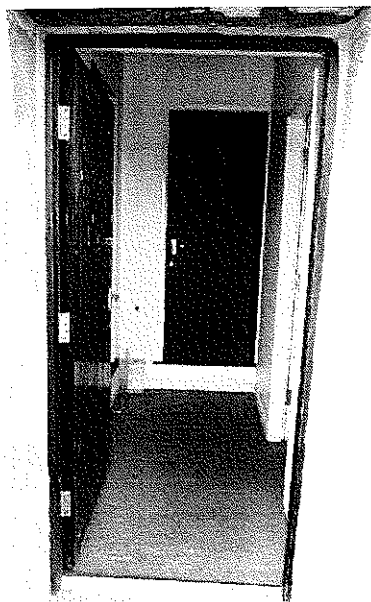
Photograph 1 – View from main entrance door looking into entrance corridor / lobby

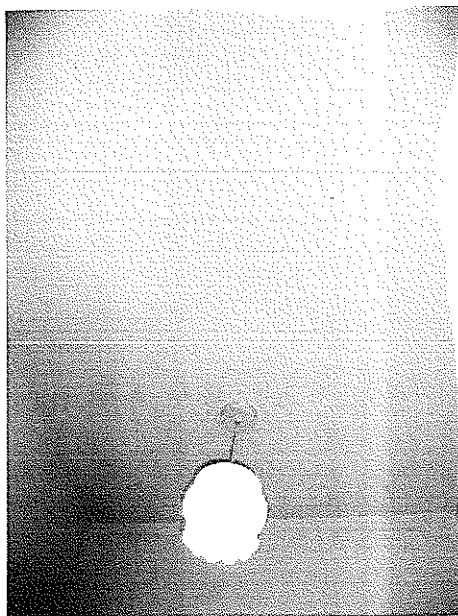
Photograph 2 –Ceiling to entrance lobby

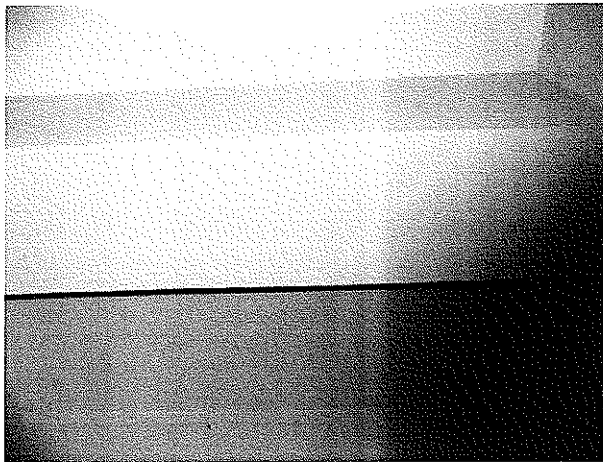
Photograph 3 – Beam at ceiling level (believed to be timber with plasterboard boxing)

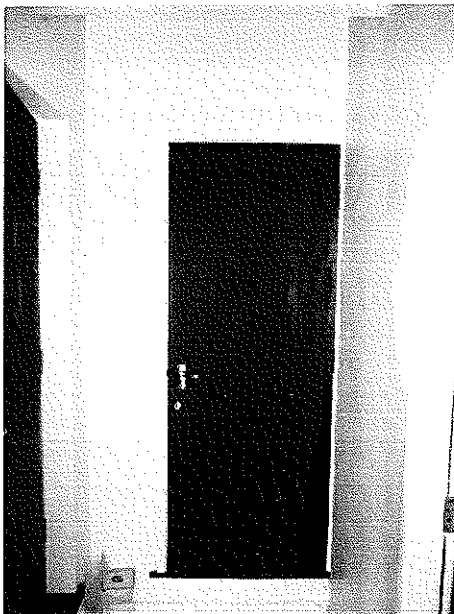
Photograph 4 – Modern timber door to cupboard

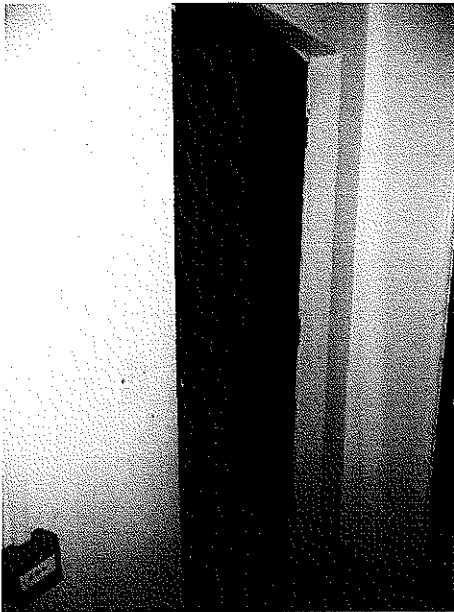
Photograph 5 – Modern timber door to meeting room

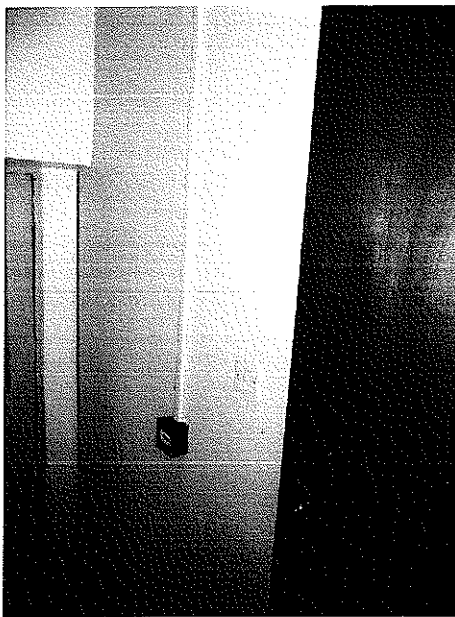
Photograph 6 – Wall between corridor and meeting room [NOTE: THIS IS THE WALL WHICH IS PROPOSED TO BE REMOVED]

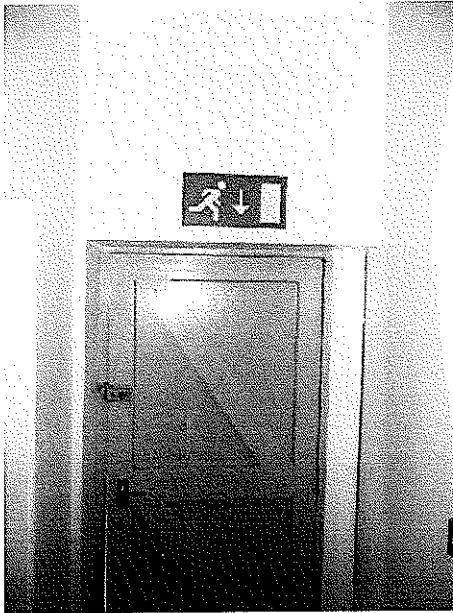
Photograph 7 – Internal face of external wall to front elevation

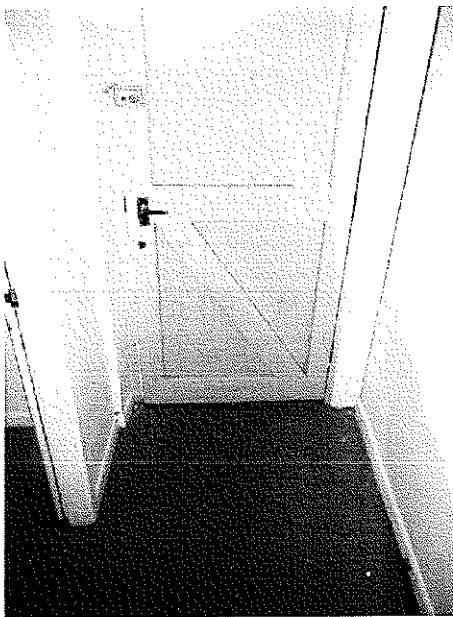
Photograph 8 – Main entrance timber door / sheet vinyl floor finish

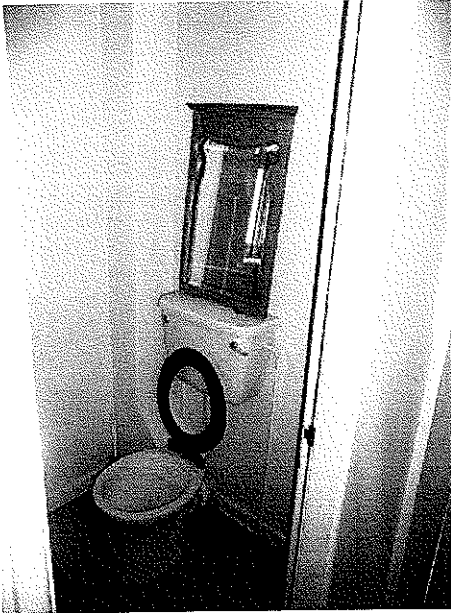
Photograph 9 – Ceramic wc, with existing foul drainage in corner behind boxing

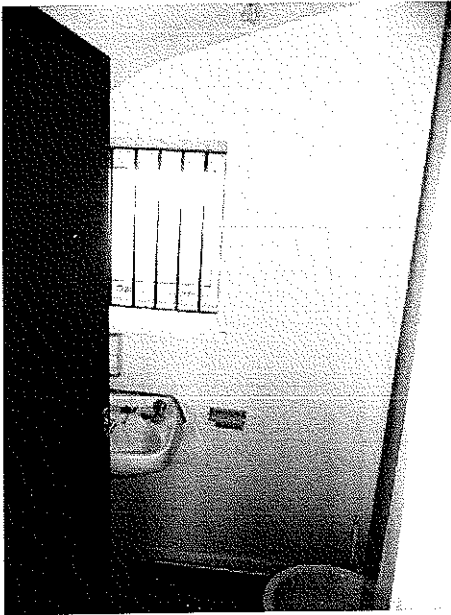
Photograph 10 – Internal face of external wall to right side elevation, uPVC double glazed window

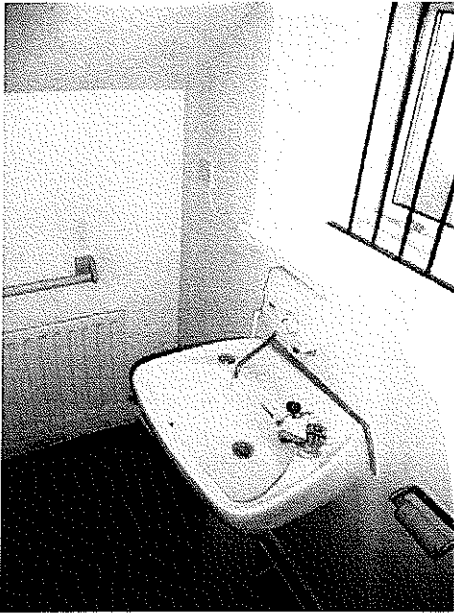
Photograph 11 – Ceramic wash hand basin

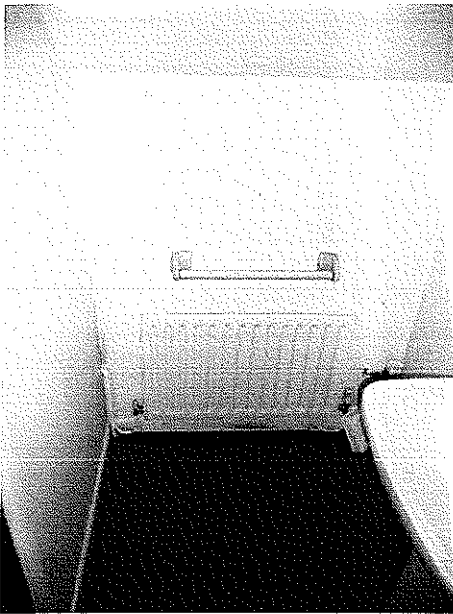
Photograph 12 – Wall beneath staircase

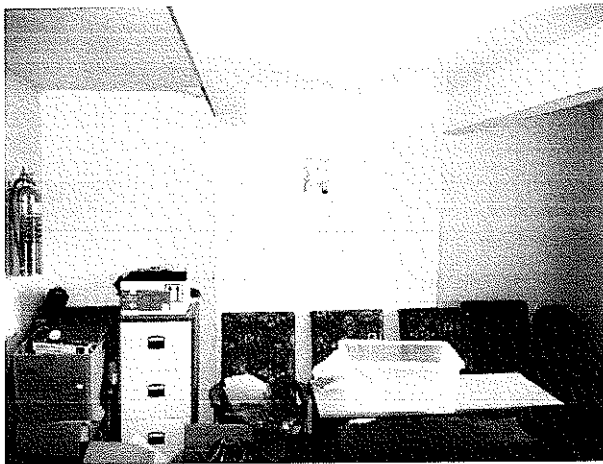
Photograph 14 – Internal face of front elevation wall, floor joists above with plasterboard boxing

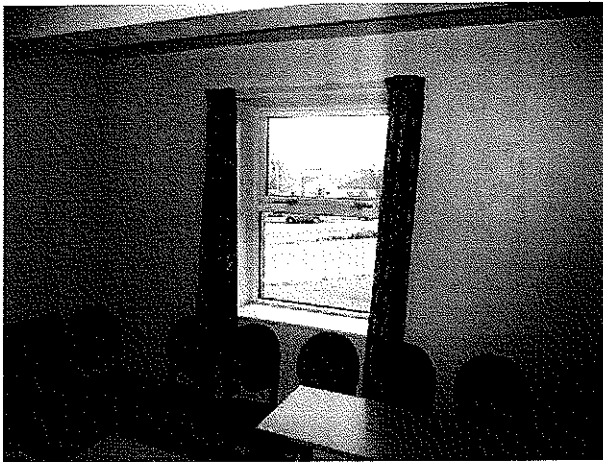
Photograph 15 – Dry-lining to internal face of external wall to left side elevation, uPVC double glazed window

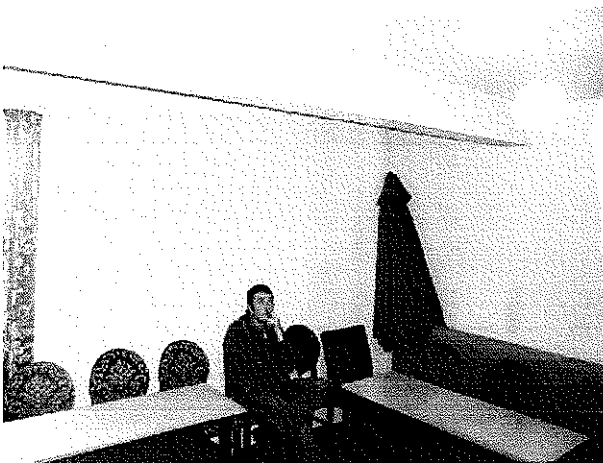
Photograph 16 – Dry-lining to internal face of external wall to left side elevation

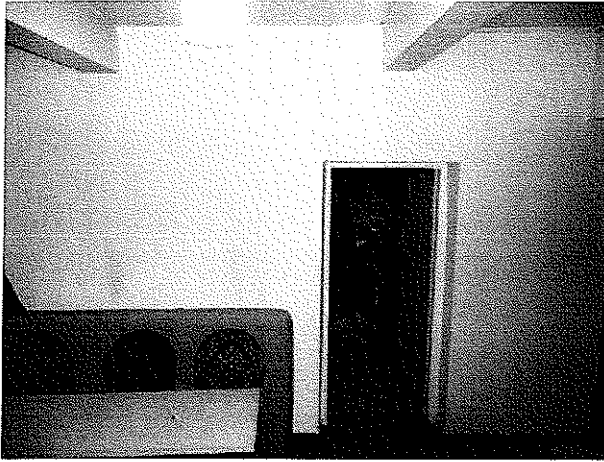
Photograph 17 - Dry lined internal wall between meeting room and store room

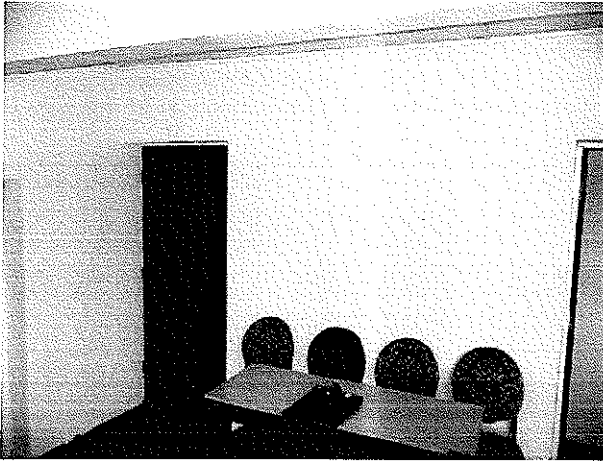
Photograph 18 -- Internal wall between staircase / cupboard / corridor [NOTE: THIS IS THE WALL WHICH IS PROPOSED TO BE REMOVED]

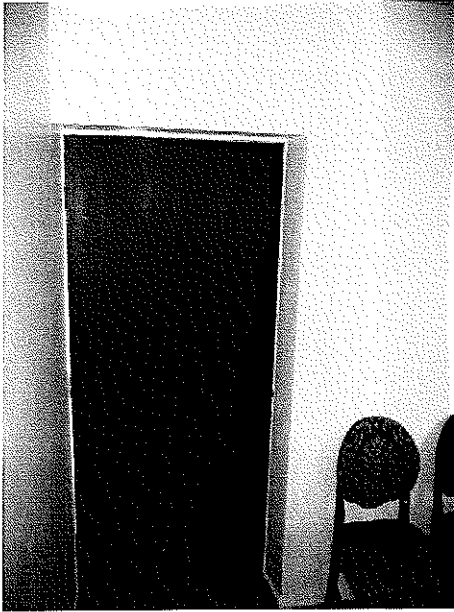
Photograph 19 - Modern timber door leading to staircase

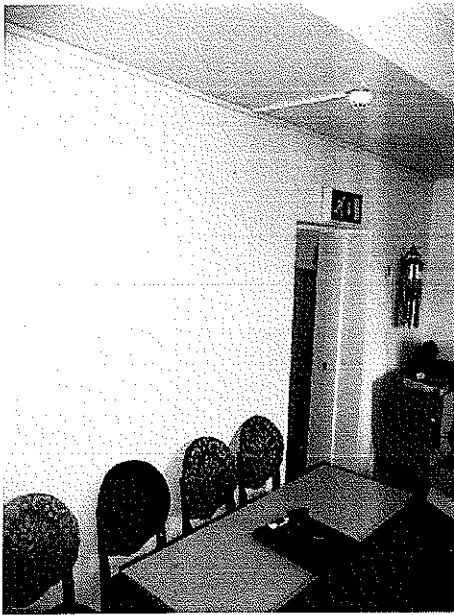
Photograph 20 – Internal wall between staircase / cupboard / corridor [NOTE: THIS IS THE WALL WHICH IS PROPOSED TO BE REMOVED]

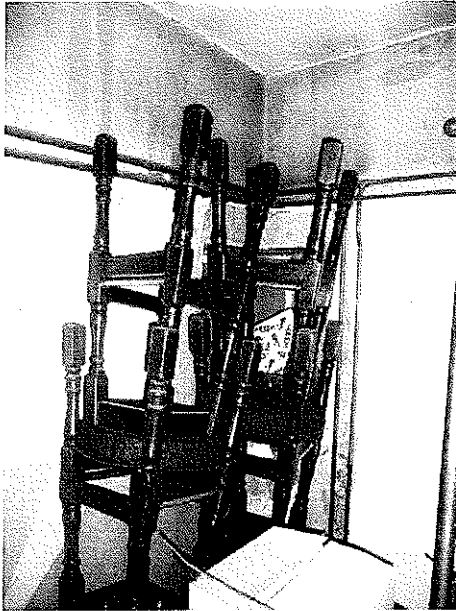
Photograph 21 – Junction of internal wall to meeting room and external wall to left side elevation where window is situated

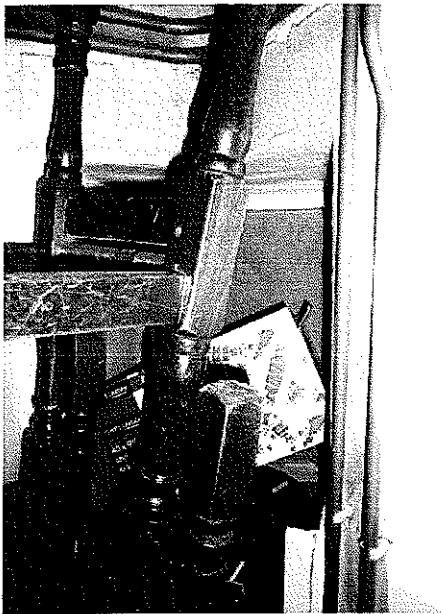
Photograph 22 – Existing uPVC window to left side elevation

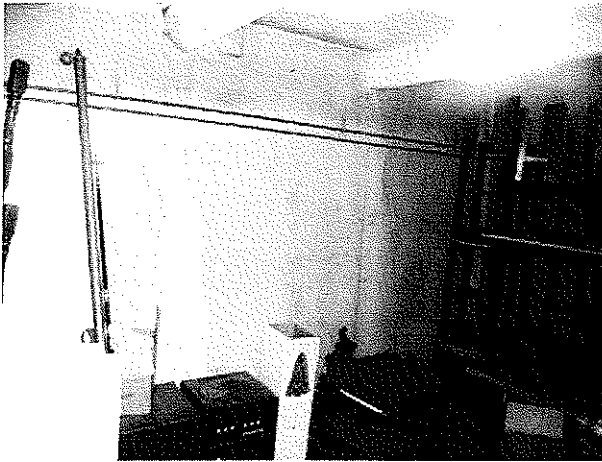
Photograph 23 – Internal wall between store room and Guild Cottage (the existing dwelling) to the left side of the storeroom

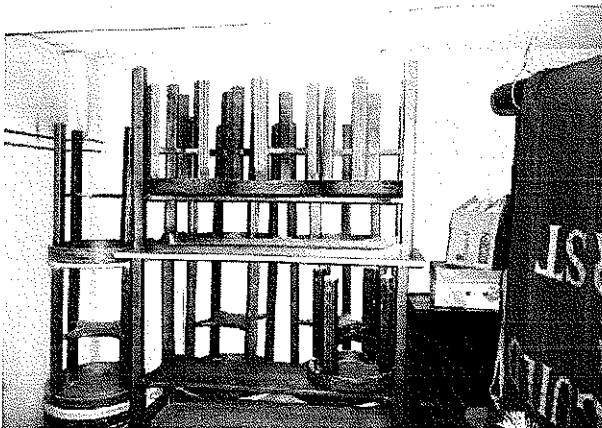
Photograph 24 – Internal wall between store room and Guild Cottage (the existing dwelling) to the rear of the storeroom

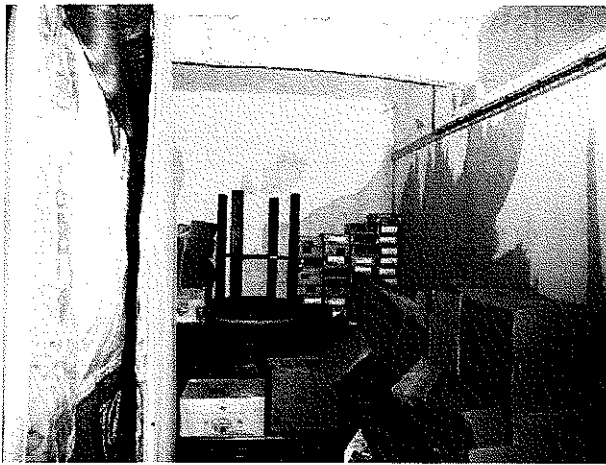
Photograph 25 – Internal wall between store room and Guild Cottage (the existing dwelling) to the rear of the storeroom

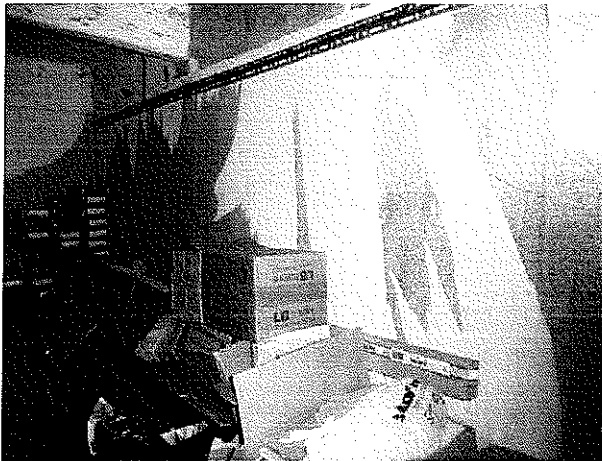
Photograph 26 - Internal wall between store room and the bottle room of the club to the right side of the storeroom

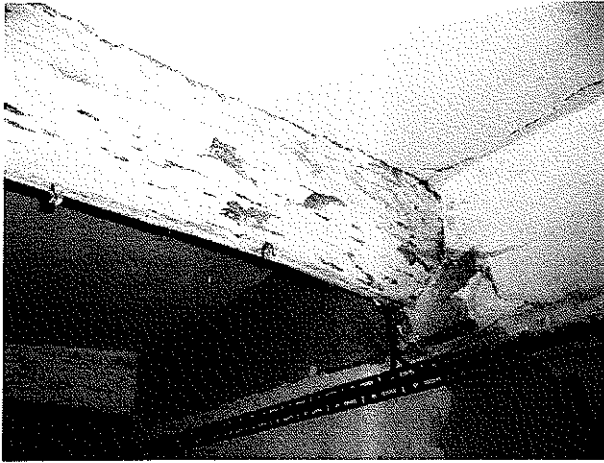
Photograph 27 – Existing original timber floor joist

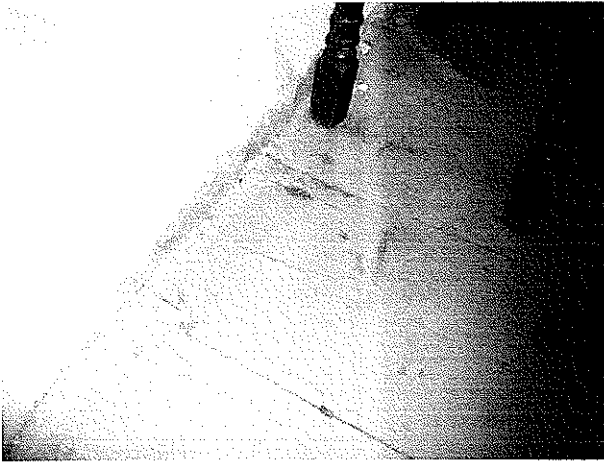
Photograph 28 – Existing timber floor boards

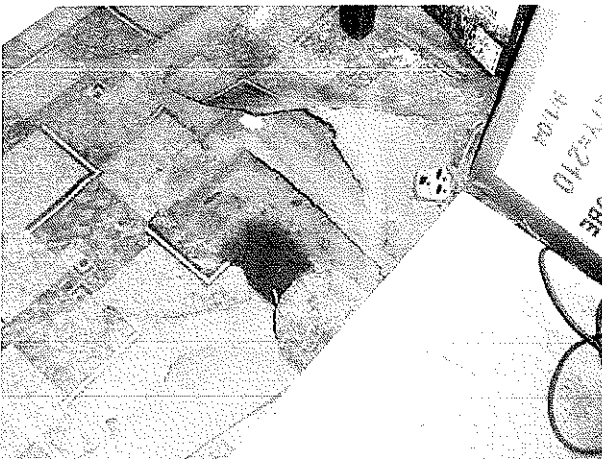
Photograph 29 – Rotten floor proposed to be repaired like for like
