Photographic Record – Hurst Green Guild Hall Social Club

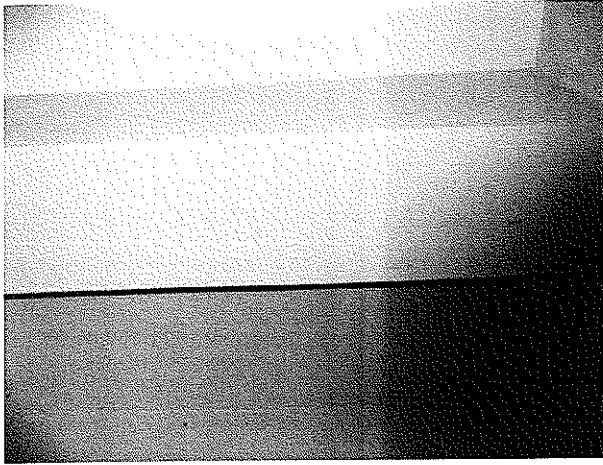
Photograph 3 – Beam at ceiling level (believed to be timber with plasterboard boxing)

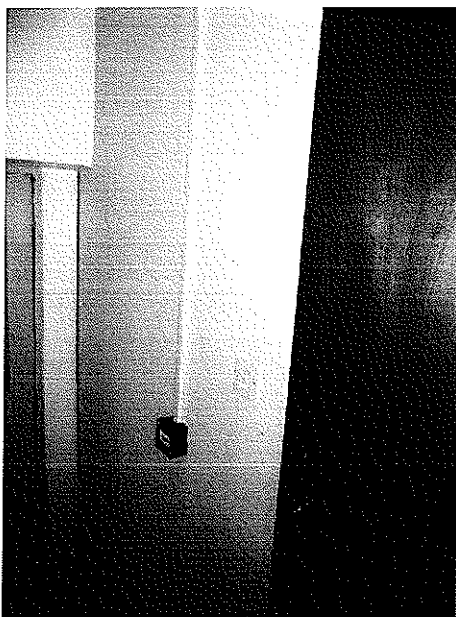
Photograph 6 – Wall between corridor and meeting room [NOTE: THIS IS THE WALL WHICH IS PROPOSED TO BE REMOVED]

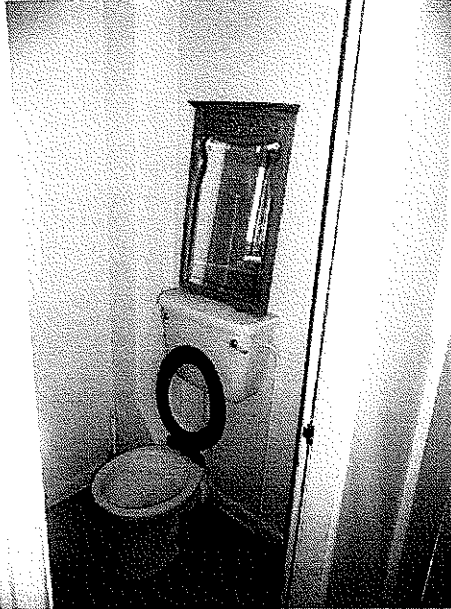
Photograph 9 – Ceramic wc, with existing foul drainage in corner behind boxing

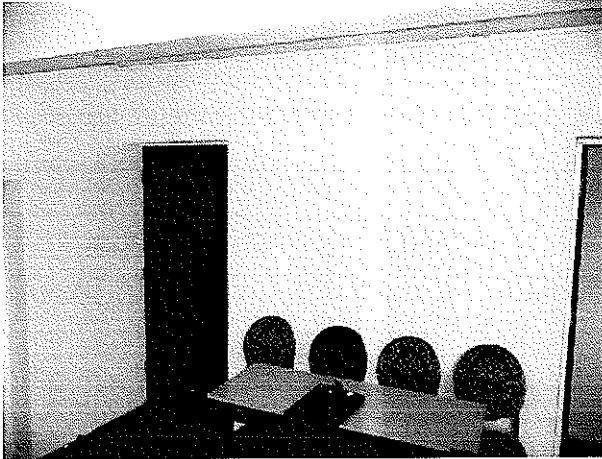
Photograph 18 – Internal wall between staircase / cupboard / corridor [NOTE: THIS IS THE WALL WHICH IS PROPOSED TO BE REMOVED]

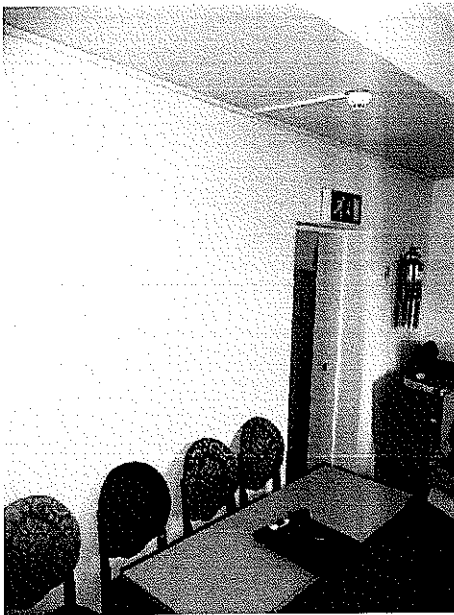
Photograph 20 – Internal wall between staircase / cupboard / corridor [NOTE: THIS IS THE WALL WHICH IS PROPOSED TO BE REMOVED]

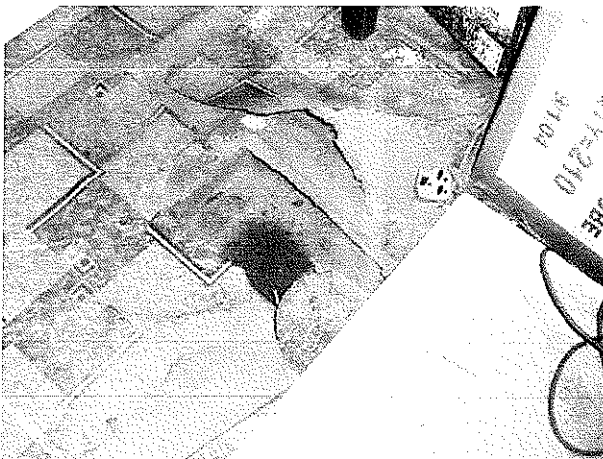
Photograph 29 – Rotten floor proposed to be repaired like for like
