*Lancashire County Council*  
*Croasdale Bridge (No: 4301) - PBI*

**4. INSPECTION PROCEDURE  
CROASDALE BRIDGE (NO: 4301/B1/B2)**

**APPENDIX A**  
**SPECIAL INSPECTION REPORT**

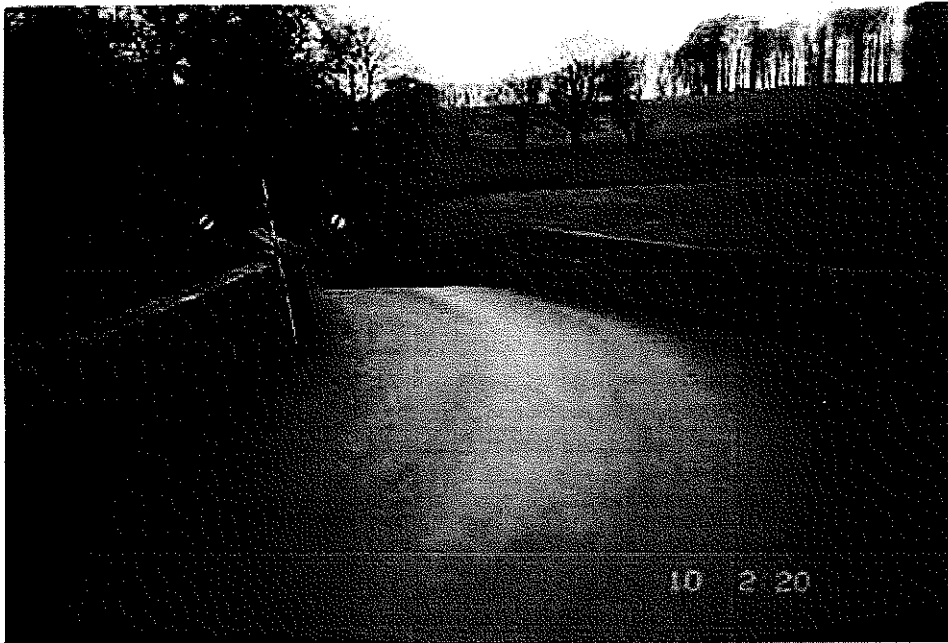
3.1 APPROACH FROM THE SOUTH

| COMPONENT | | INSPECTION RESULT | | PHOTO/<br>SKETCH | PAGE<br>No. | RECOMMENDATIONS/ACTION | TIME<br>SCALE |
|---|---|---|---|---|---|---|---|
| 21 | Surfacing | 21A | The carriageway surfacing to the structure is in fair condition, in places there are areas of poor surface texture and low skid resistance. | 3.1<br>3.2 | 15<br>5 | Monitor | L |

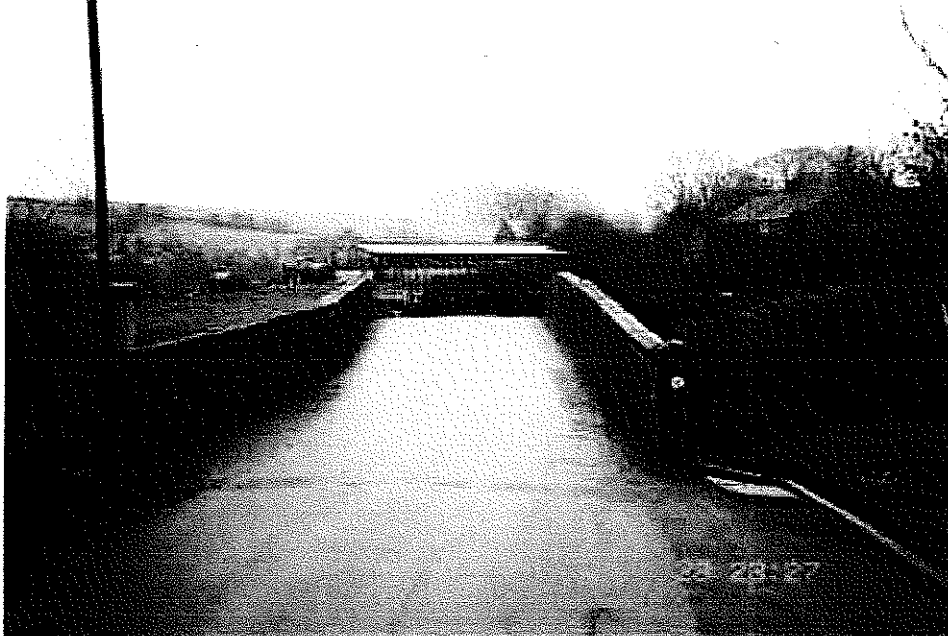
3.2 APPROACH FROM THE NORTH

| COMPONENT | | INSPECTION RESULT | | PHOTO/<br>SKETCH | PAGE<br>No. | RECOMMENDATIONS/ACTION | TIME<br>SCALE |
|---|---|---|---|---|---|---|---|
| | | 21B | Vegetation growth is present adjacent to the parapet walls, this may provide a path for the ingress of water to the structure. | 3.2 | 15 | Remove vegetation | L |

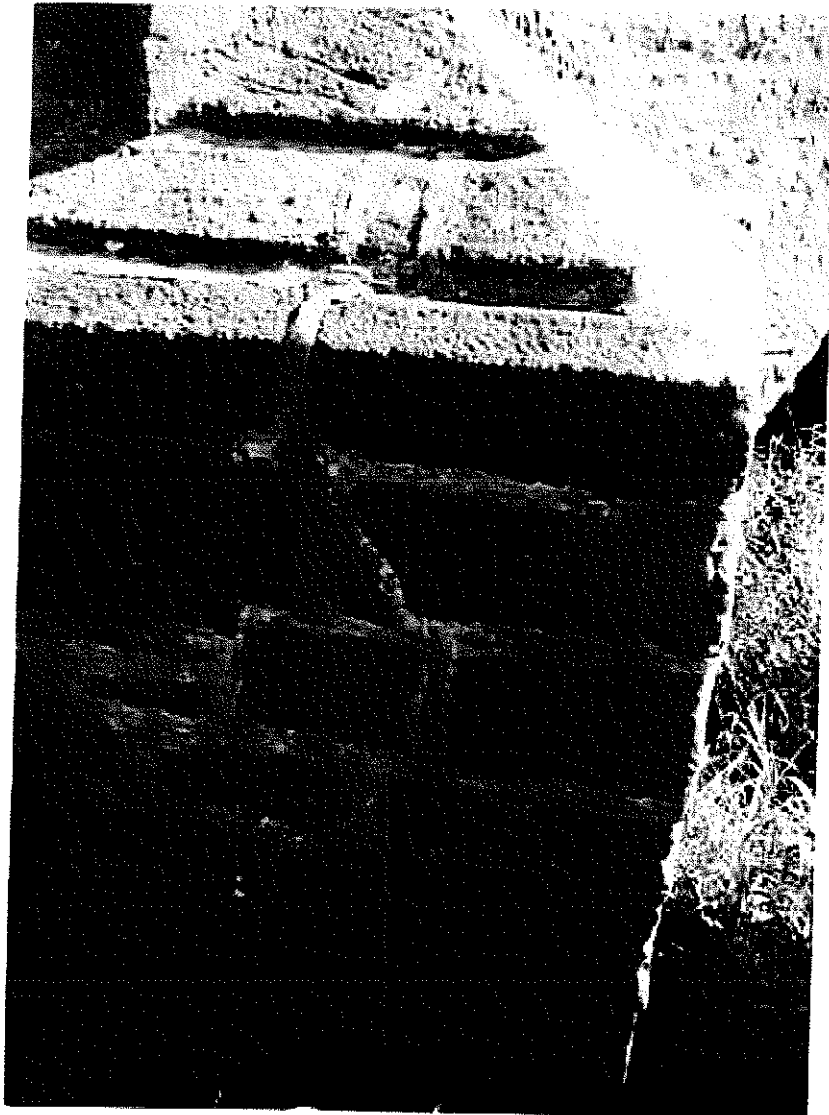
| COMPONENT | | INSPECTION RESULT | | PHOTO/<br>SKETCH | PAGE<br>No. | RECOMMENDATIONS/ACTION | TIME<br>SCALE |
|---|---|---|---|---|---|---|---|
| | | 4B | There is evidence of movement at the upstream cutwater - a vertical crack (1.0mm wide) and an area of drummy masonry. | P1<br>SK3 | | Repoint and Monitor | L |

P1 UPSTREAM CUTWATER - VERTICAL CRACK

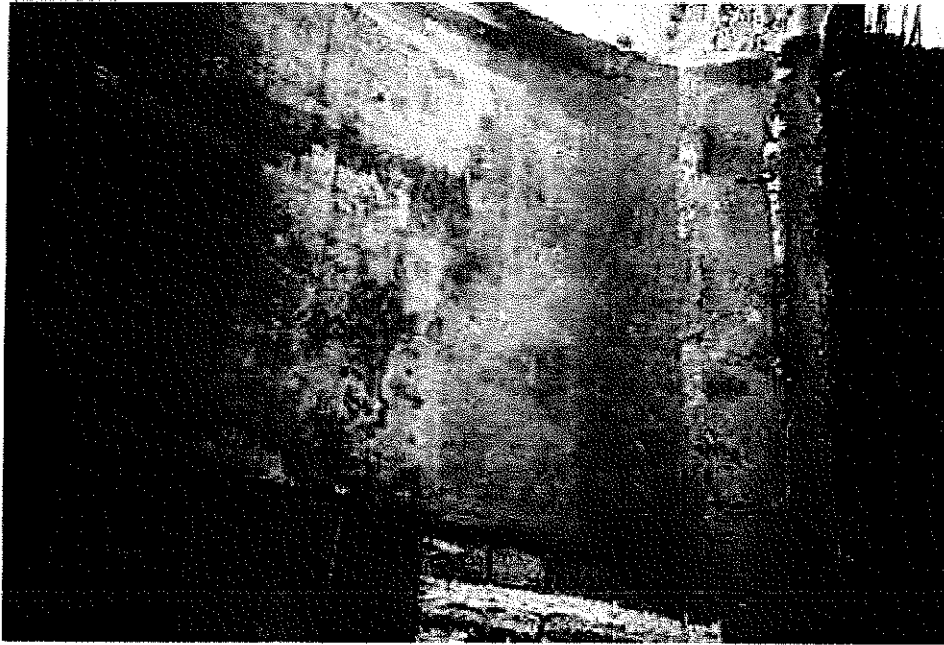
| COMPONENT | | INSPECTION RESULT | | PHOTO/<br>SKETCH | PAGE<br>No. | RECOMMENDATIONS/ACTION | TIME<br>SCALE |
|---|---|---|---|---|---|---|---|
| | | 4C | On both the South and North pier elevations there are areas of joint loss, both horizontal and vertical. Joint loss varies between 50 and 100mm in depth. | P2, P3, P4<br>SK1<br>SK2 | 17, 18<br>36<br>37 | Rake out and repoint joints | L |
| | | 4D | Both faces of the pier exhibit extensive areas of green staining from previous lichen/algae growth, with localised areas of leached deposits and efflorescence. | P2, P3, P4<br>SK1<br>SK2 | 17, 18<br>36<br>37 | No Action | |

P4 PIER DOWNSTREAM END OF SOUTH FACE 29677/2/30

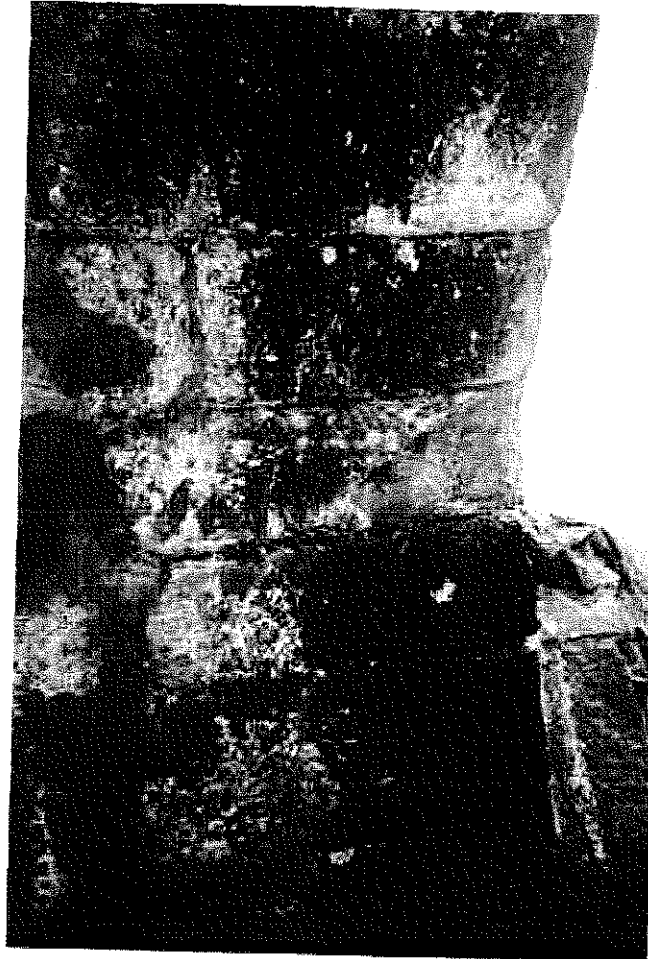
| COMPONENT | | INSPECTION RESULT | | PHOTO/<br>SKETCH | PAGE<br>No. | RECOMMENDATIONS/ACTION | TIME<br>SCALE |
|---|---|---|---|---|---|---|---|
| | | 4E | Active seepage was noted towards the upstream end of the South pier face. | P5<br>SK1 | 19<br>36 | Provide effective waterproofing membrane. | L |

P5 ACTIVE SEEPAGE - UPSTREAM END OF PIER (SOUTH FACE)

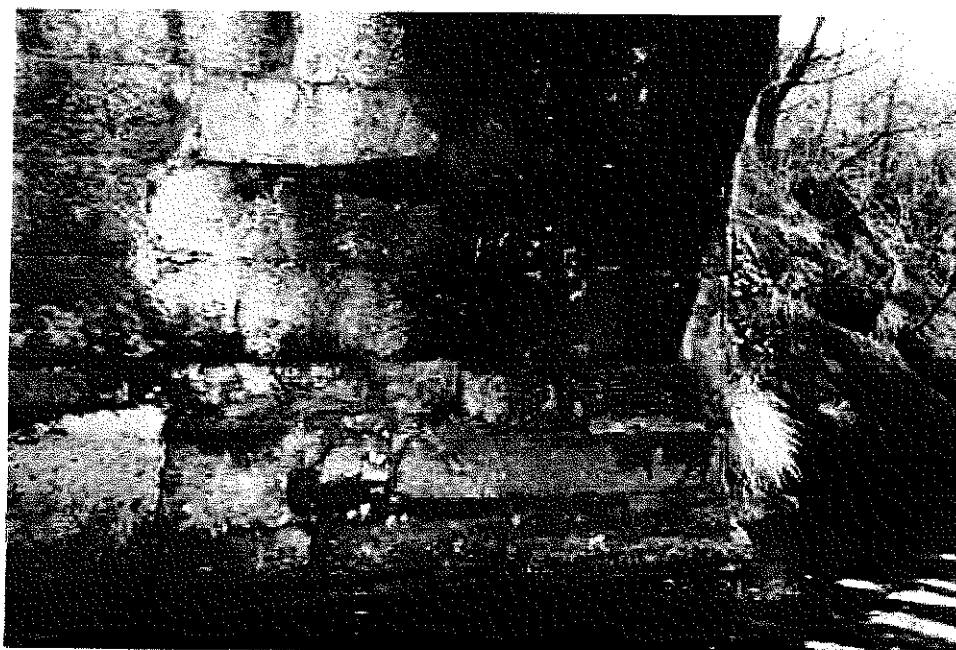
| COMPONENT | | INSPECTION RESULT | | PHOTO/<br>SKETCH | PAGE<br>No. | RECOMMENDATIONS/ACTION | TIME<br>SCALE |
|---|---|---|---|---|---|---|---|
| | | 5B | On the main arch abutment there are extensive areas of joint loss, both horizontal and vertical. Joint loss generally in the region of 50 mm deep. | P6, P7<br>SK1 | 20, 21<br>36 | Rake out and repoint joints | L |
| | | 5C | Both abutments exhibit extensive areas of green staining, from previous lichen/algae growth. In addition, localised areas of leached deposits are visible. | P6, P7<br>SK1, SK2 | 20, 21<br>36, 37 | No Action | |
| | | 5D | An area of drummy and spalling masonry is located at the downstream end of the main arch abutment. (Spalling 30 mm deep) | P6<br>SK1 | 20<br>36 | Remove and replace defective masonry. | L |

P6 GENERAL VIEW OF UPSTREAM END OF MAIN ARCH ABUTMENT

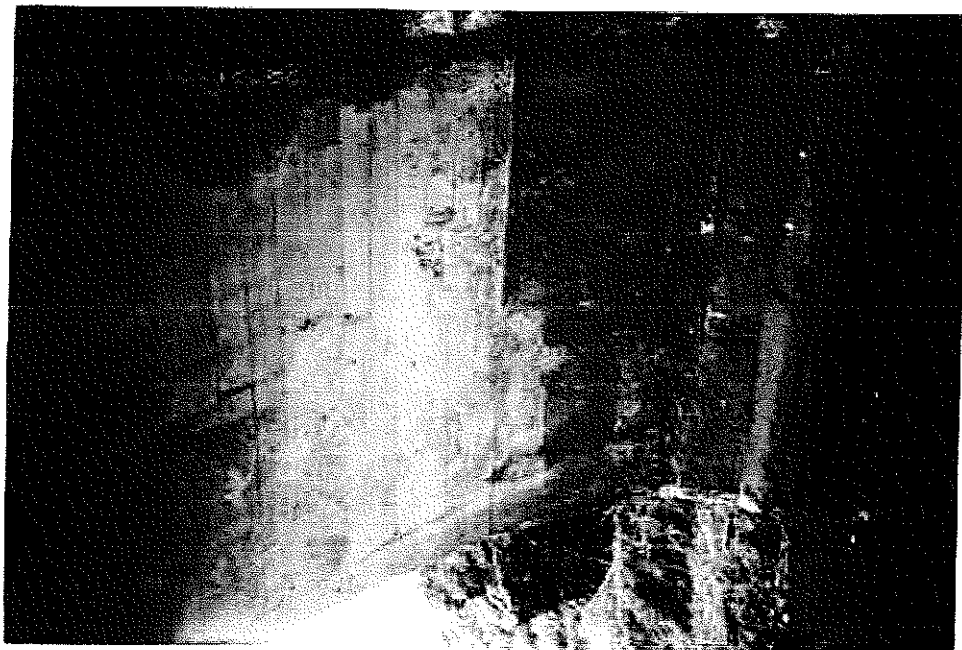
P7 DOWNSTREAM END - MAIN ARCH ABUTMENT 29677/2/29

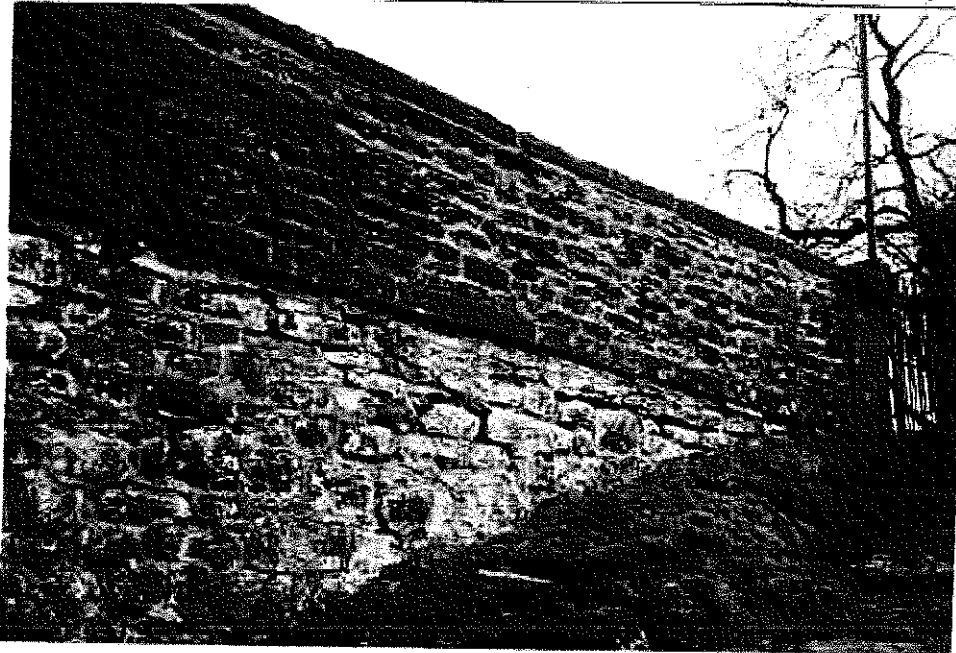
| COMPONENT | | INSPECTION RESULT | | PHOTO/<br>SKETCH | PAGE<br>No. | RECOMMENDATIONS/ACTION | TIME<br>SCALE |
|---|---|---|---|---|---|---|---|
| | | 6B | Throughout the North East wingwall there is extensive joint loss. The mortar is generally loose and friable with loss up to 40 mm deep. | P9<br>SK3 | 22<br>38 | Repoint joints | L |

P9 GENERAL VIEW OF JOINT LOSS TO NORTH EAST WINGWALL

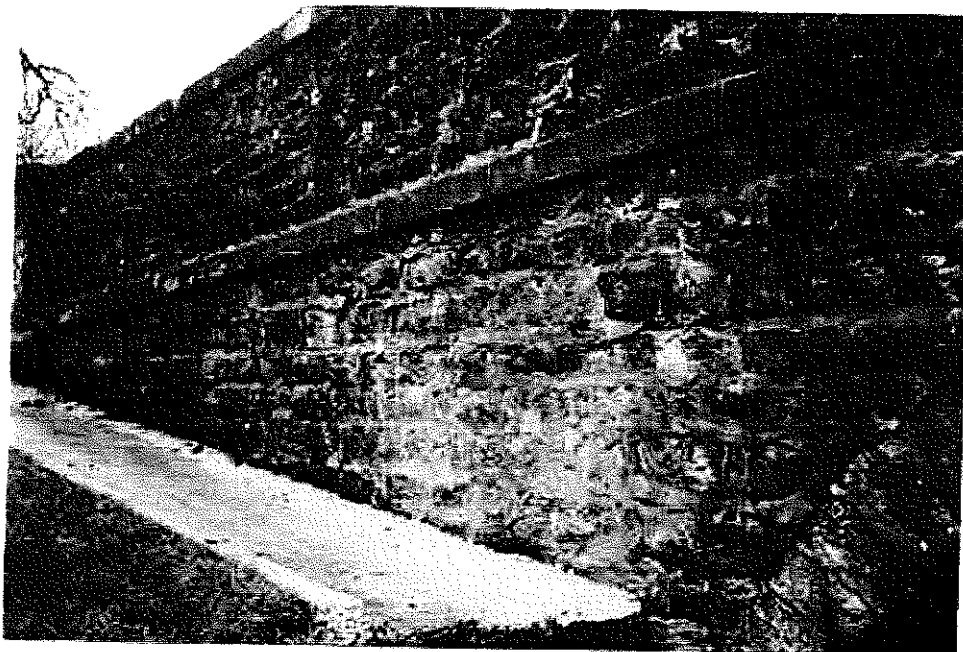
| COMPONENT | | INSPECTION RESULT | | PHOTO/<br>SKETCH | PAGE<br>No. | RECOMMENDATIONS/ACTION | TIME<br>SCALE |
|---|---|---|---|---|---|---|---|
| | | 6C | The North West wingwall exhibits signs of structural movement - in the form of diagonal cracking with steps (up to 20 mm) between adjacent masonry faces. These defects are currently being monitored by Lancashire County Council (monitoring commenced 1993). | P10<br>P11<br>P12<br>SK3 | 22<br>23<br>24<br>38 | Monitor | |

P10 GENERAL VIEW OF NORTH WEST WINGWALL

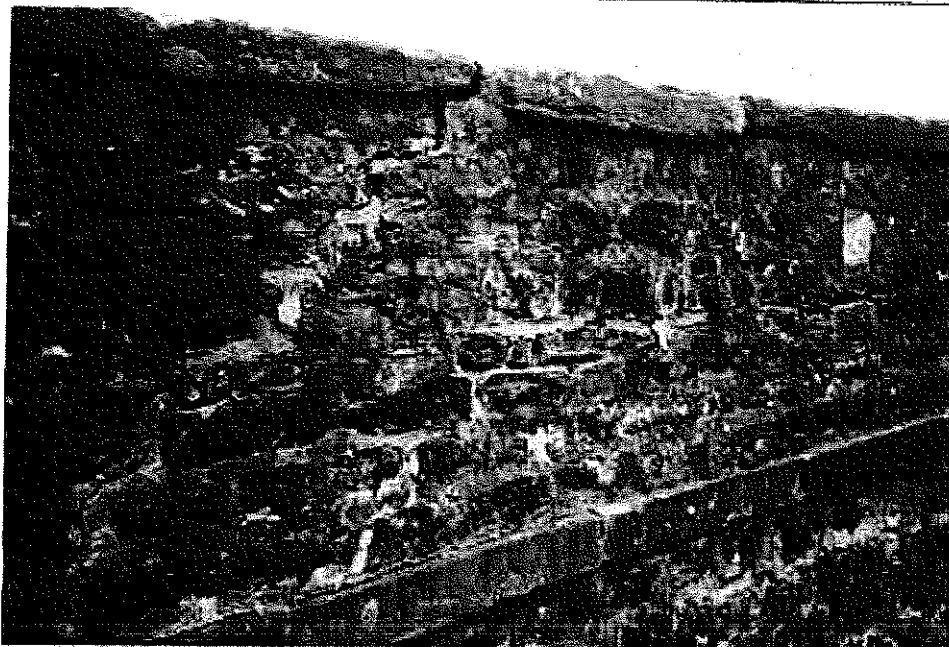
P11 DIAGONAL CRACKING TO OUTER FACE OF NORTH WEST WINGWALL - CRACK ALIGNS WITH THAT IN PHOTO P12 20677 332

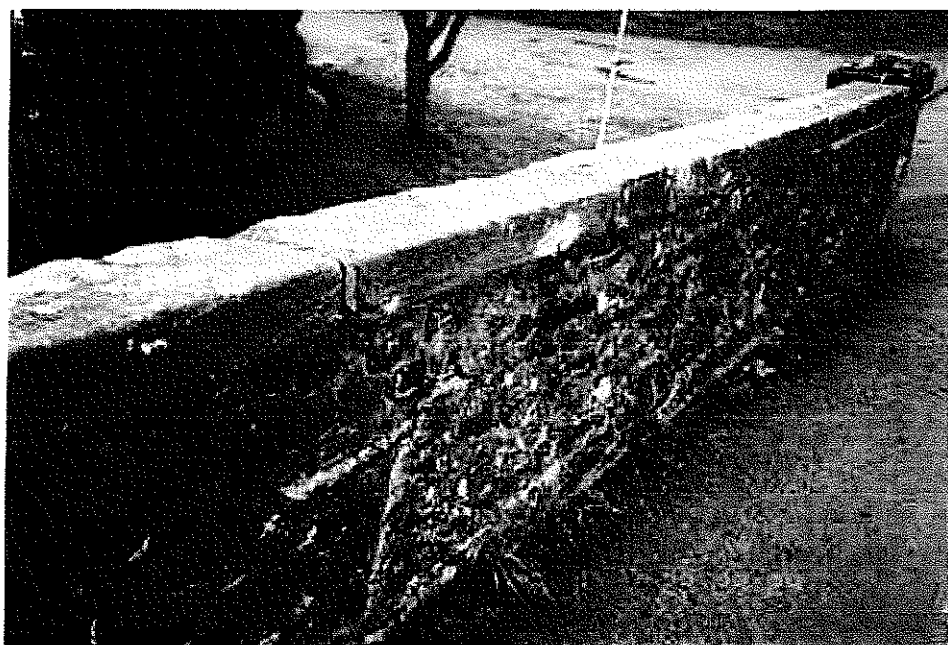
P12 DIAGONAL CRACKING IN INNER FACE OF NORTH WEST WINGWALL - CRACK ALIGNS WITH THAT IN PHOTO P11 20677 336

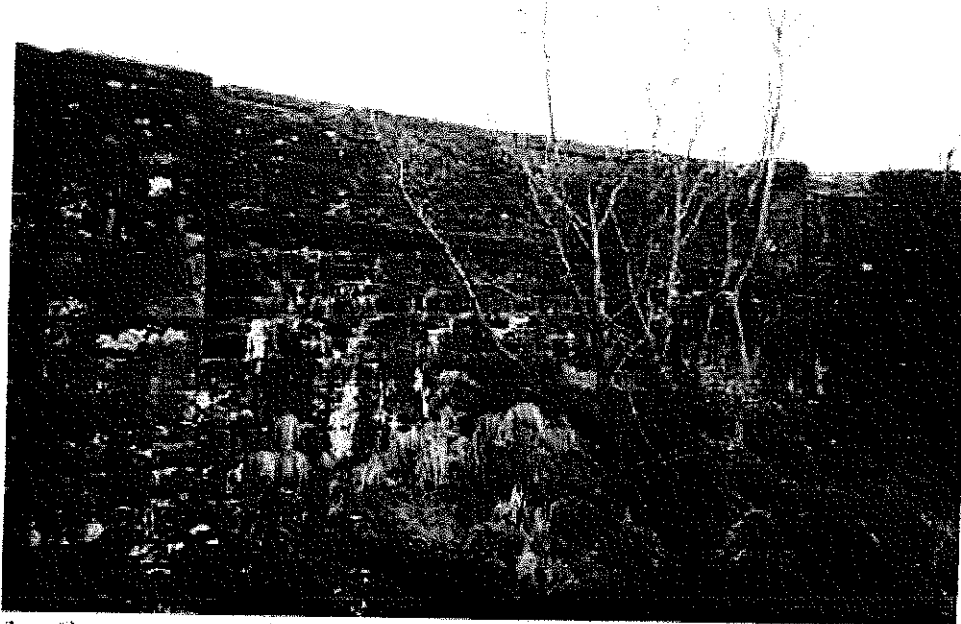
| COMPONENT | | INSPECTION RESULT | | PHOTO/<br>SKETCH | PAGE<br>No. | RECOMMENDATIONS/ACTION | TIME<br>SCALE |
|---|---|---|---|---|---|---|---|
| | | 6D | There are several areas of joint loss and open joints, up to 230 mm in depth, on the South West wingwall. Teltails have been installed by Lancashire County Council to monitor movement. The teltails are dated December 1993 and only one exhibits any defect (i.e. a hairline crack). | P13<br>P14<br>P15<br>SK3 | 25<br>25<br>26<br>38 | Rake out and repoint joints, Monitor | L |

P13 GENERAL VIEW OF SOUTH WEST WINGWALL

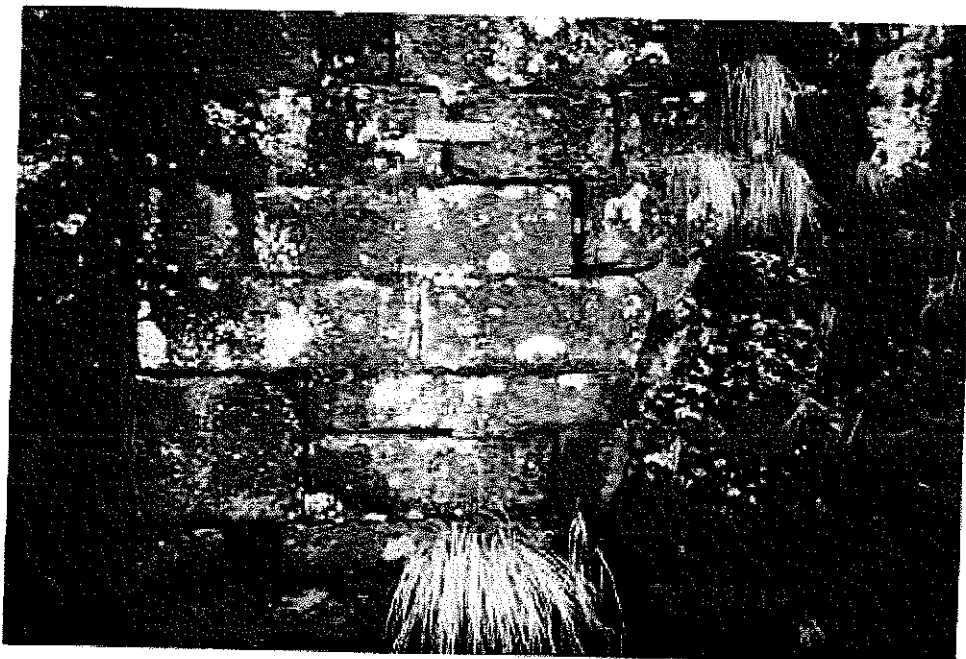
P14 OPEN JOINTS TO SOUTH WEST WINGWALL

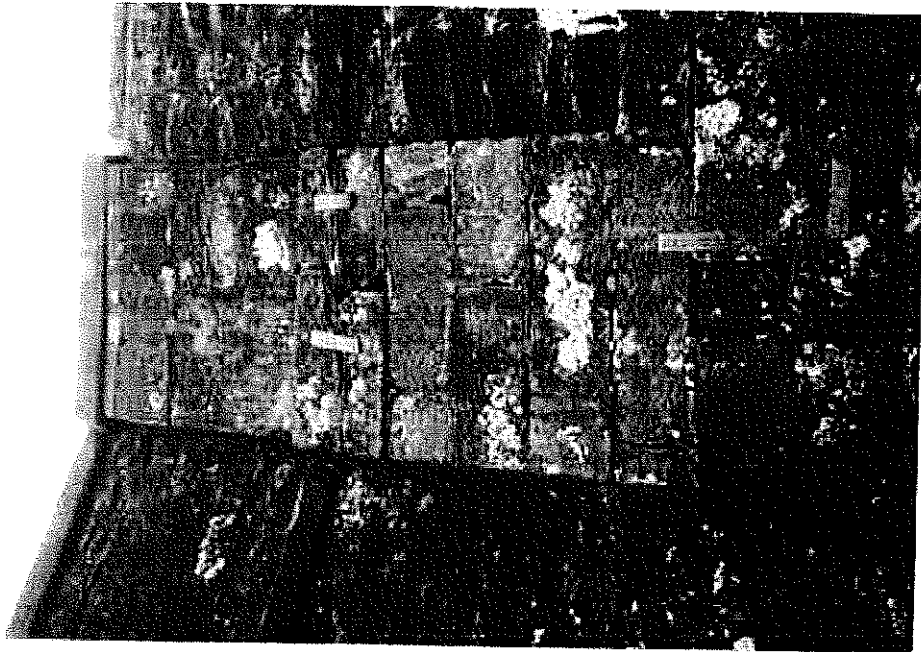
P15 OPEN JOINTS/TEL.TAILS ON S.W. WINGWALL 29677/3/30  
29677/3/5

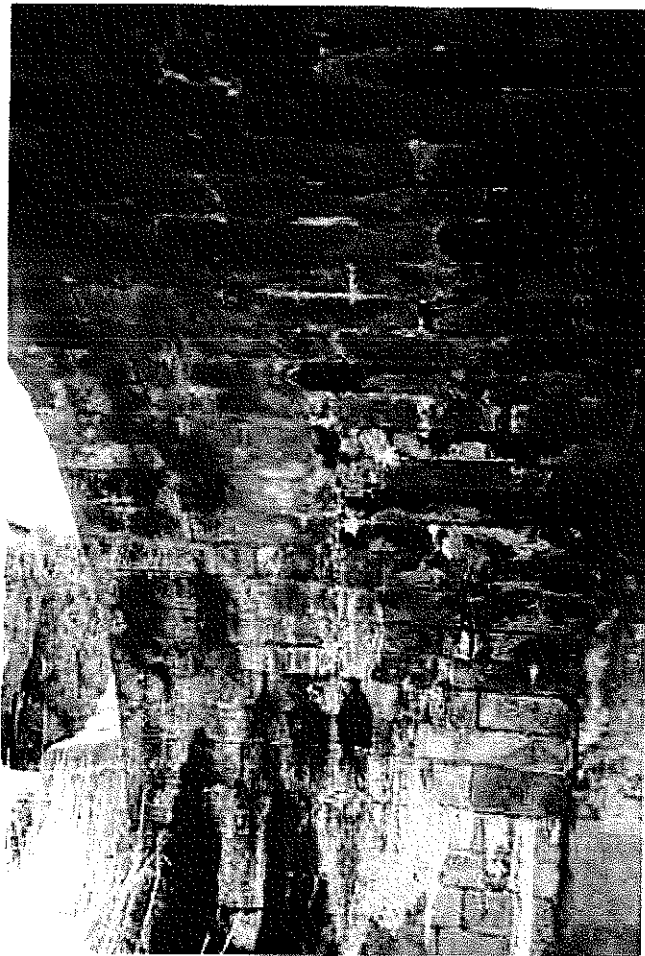
| COMPONENT | | INSPECTION RESULT | | PHOTO/<br>SKETCH | PAGE<br>No. | RECOMMENDATIONS/ACTION | TIME<br>SCALE |
|---|---|---|---|---|---|---|---|
| | | 16B | Extensive staining is present to the arch rings. This includes black type deposits, white leached deposits, and green deposits resulting from lichen/algae growth. | P17, P18<br>SK1 | 26, 27<br>36 | Provide effective waterproofing membrane. | L |
| | | 16C | At the upstream end of the arch ring active seepage was noted from the quarter points to the springings at both the North and South sides of the barrel. | P17<br>SK1 | 26<br>36 | Provide effective waterproofing membrane. | L |
| | | 16D | There is joint loss to the rear of 50% of the voussoirs, up to 120 mm in depth. Other localised areas of joint loss were noted. | P17<br>SK1 | 26<br>36 | Rake out and repoint | L |

P17 GENERAL VIEW OF MAIN ARCH RING - TOWARDS NORTH

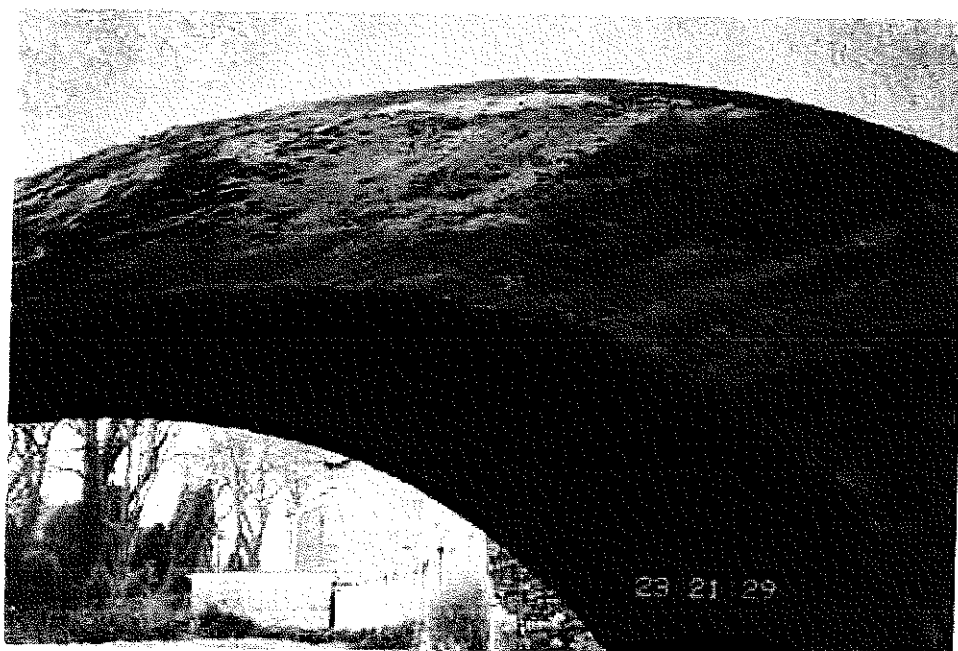
| COMPONENT | | INSPECTION RESULT | | PHOTO/<br>SKETCH | PAGE<br>No. | RECOMMENDATIONS/ACTION | TIME<br>SCALE |
|---|---|---|---|---|---|---|---|
| | | 16E | The East section of the main arch is reinforced concrete. This is generally in good condition with the only defects including a small number of hairline cracks and spalling concrete/exposed rebar. | P18, P19<br>SK1 | 27, 28<br>36 | Break out spalled concrete, expose and clean rebar, make good with repair mortar/concrete | L |

P18 GENERAL VIEW OF MAIN ARCH RING - TOWARDS WEST

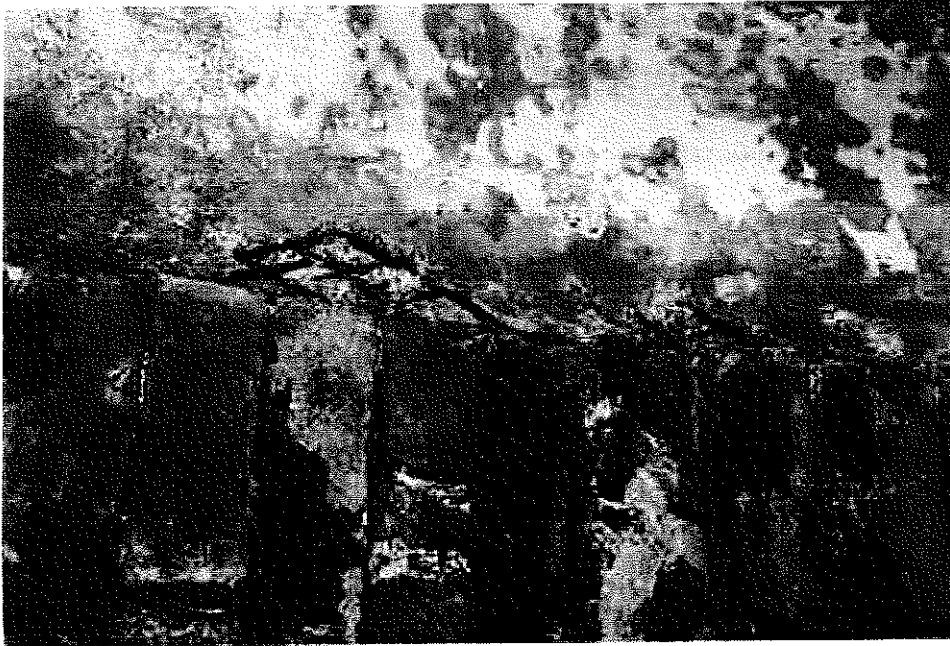
P19 MAIN ARCH BARREL - EXPOSED REBAR 29677/2/31

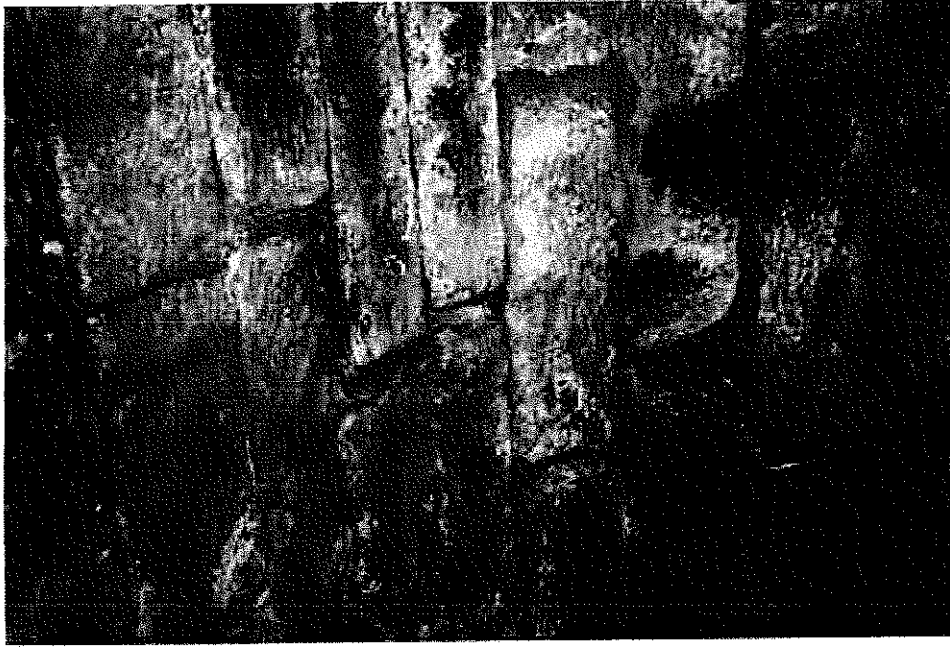
| COMPONENT | | INSPECTION RESULT | | PHOTO/<br>SKETCH | PAGE<br>No. | RECOMMENDATIONS/ACTION | TIME<br>SCALE |
|---|---|---|---|---|---|---|---|
| | | 16G | Open joints/joint loss to the rear of the voussoirs are present to the downstream end of the arch ring. (up to 260mm deep and between 50-60mm wide) | P20, P21<br>SK2 | 28, 29<br>37 | Rake out and repoint. Monitor | L |

P20 RELIEF ARCH - OPEN JOINTS 29677/3/16

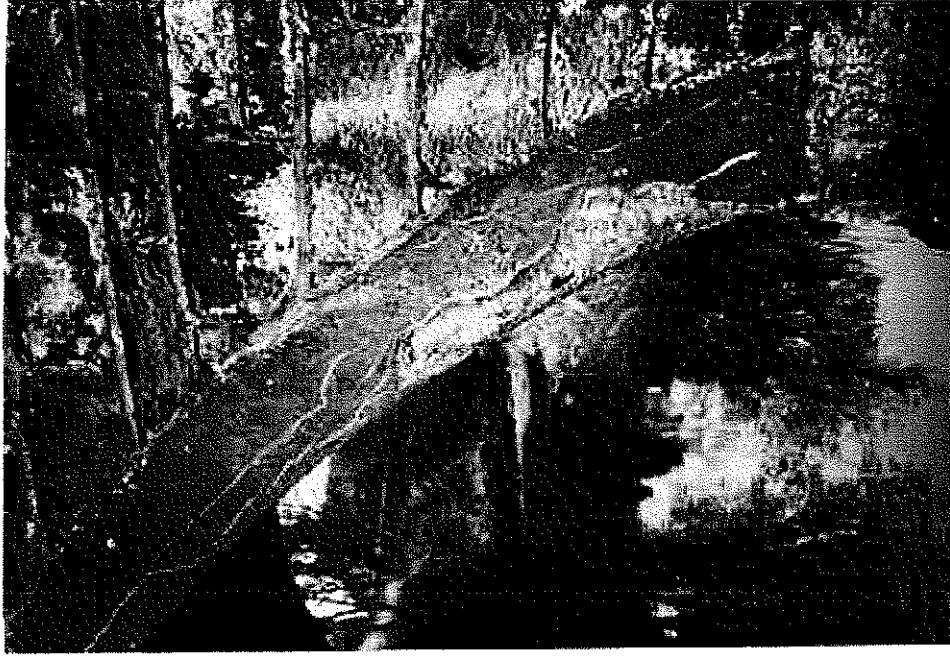
| COMPONENT | | INSPECTION RESULT | | PHOTO/<br>SKETCH | PAGE<br>No. | RECOMMENDATIONS/ACTION | TIME<br>SCALE |
|---|---|---|---|---|---|---|---|
| | | 17C | Nominal joint loss, leaching and spalling concrete is present on the east elevation, in the vicinity of the main arch springings. | P22, P29<br>SK3 | 29, 33<br>38 | Repoint and repair areas of spalling concrete | L |

P22 SPALLING CONCRETE - NORTH SPRINGING 29/6/77/10

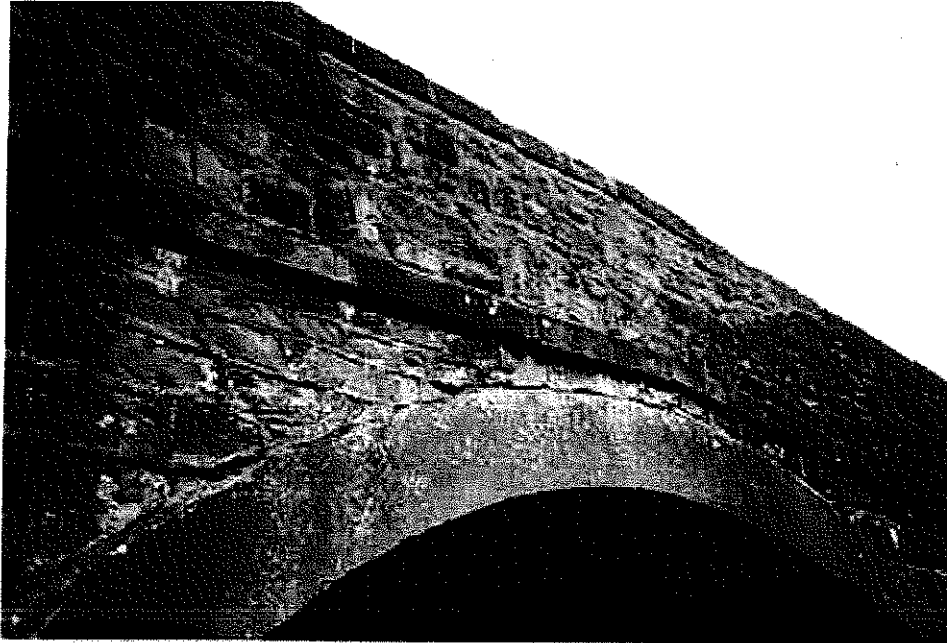
| COMPONENT | | INSPECTION RESULT | | PHOTO/<br>SKETCH | PAGE<br>No. | RECOMMENDATIONS/ACTION | TIME<br>SCALE |
|---|---|---|---|---|---|---|---|
| | | 17B | Extensive friable mortar and joint loss, up to 40 mm deep, was noted to the northern end of the East Elevation and to the rear of the main arch concrete ring. | P23, P24<br>SK3 | 30<br>38 | Rake out and repair | L |

P23 CRACKED MORTAR - EAST ELEVATION MAIN SPAN

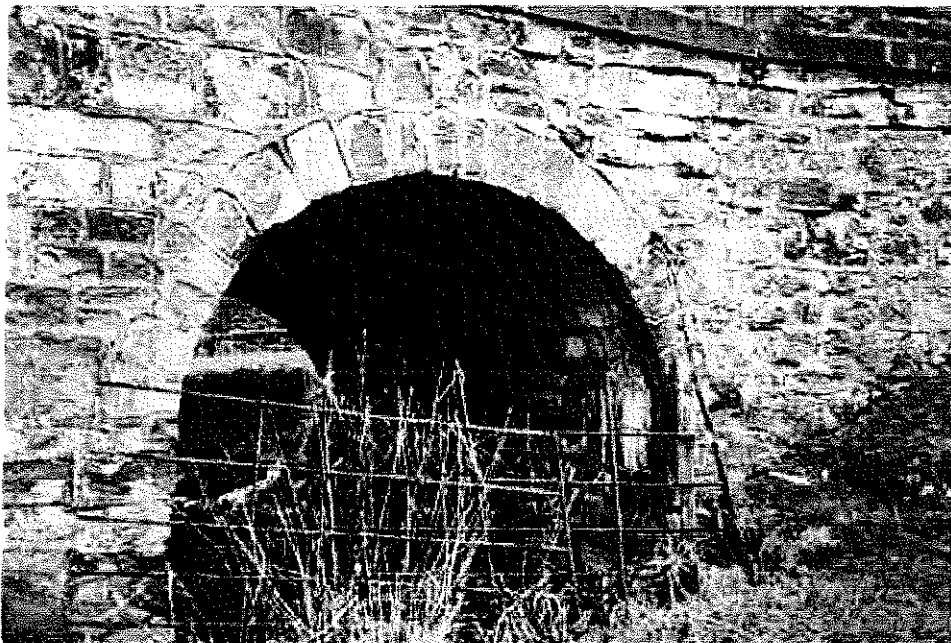
P24 EAST ELEVATION OF RELIEF ARCH

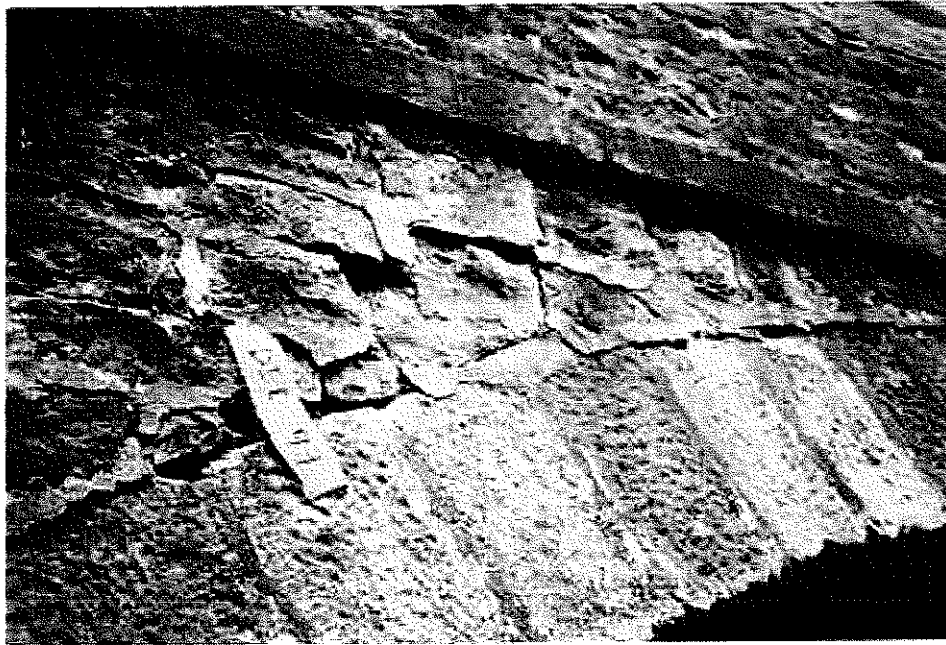
| COMPONENT | | INSPECTION RESULT | | PHOTO/<br>SKETCH | PAGE<br>No. | RECOMMENDATIONS/ACTION | TIME<br>SCALE |
|---|---|---|---|---|---|---|---|
| | | 17E | On the west elevation localised areas of joint loss and open joints were noted particularly at the rear of both the main and relief arch rings (step of up to 30 mm) - the former having mortar telltails dated December 1993. | P25, P26,<br>P27<br>SK3 | 31<br>32<br>38 | Rake out and repoint - Monitor | L |

P25 CRACKING/MOVEMENT - WEST ELEVATION OF MAIN ARCH (TELL TAIL NO 1) 29677.3/24

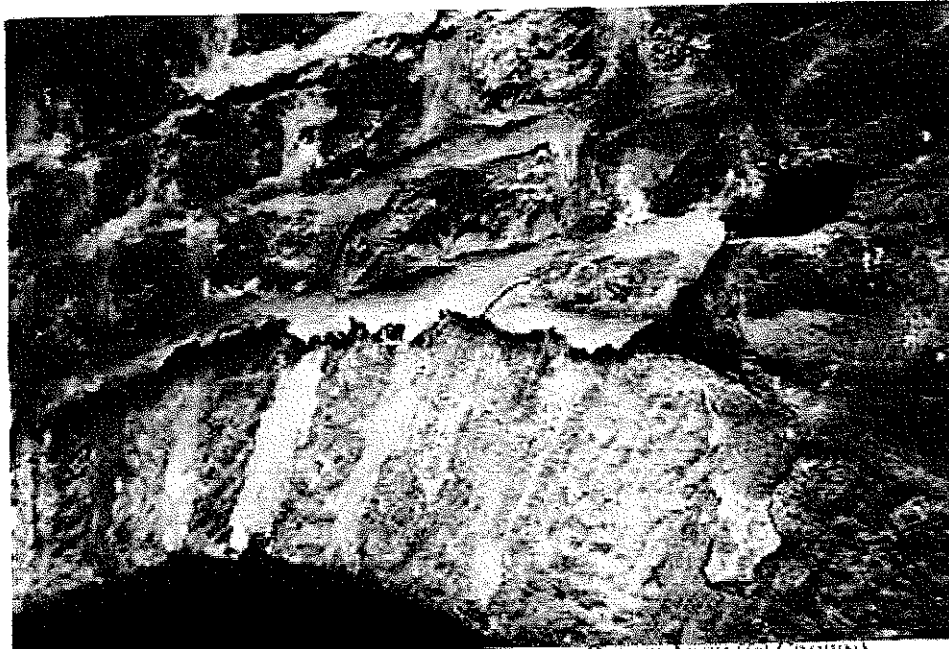
P26 CRACKING/MOVEMENT - WEST ELEVATION OF RELIEF ARCH (@ CROWN) 29677.3/10

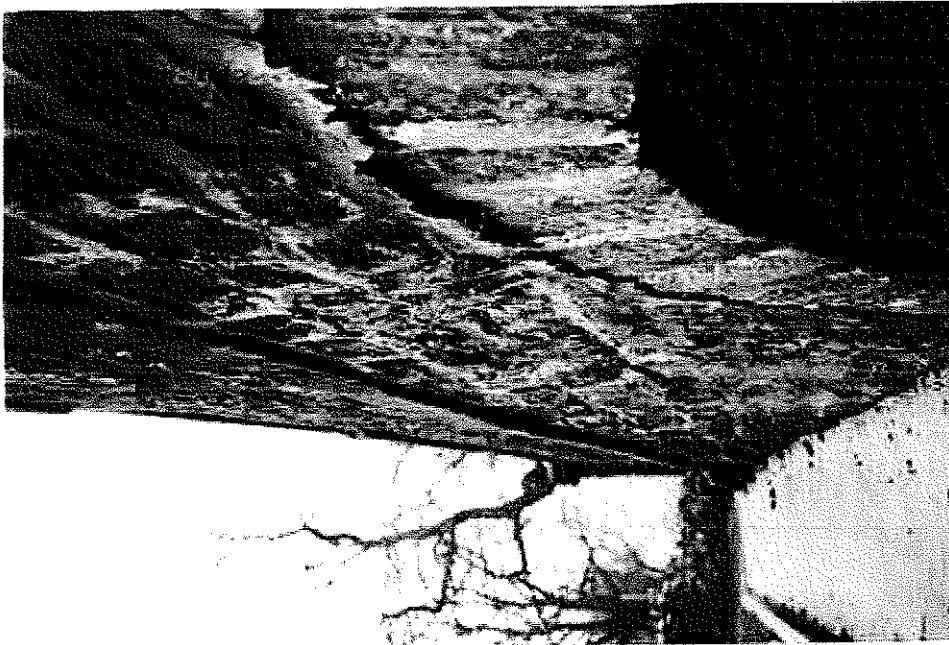
P27 MOVEMENT AT UPSTREAM END OF RELIEF ARCH 29/07/20

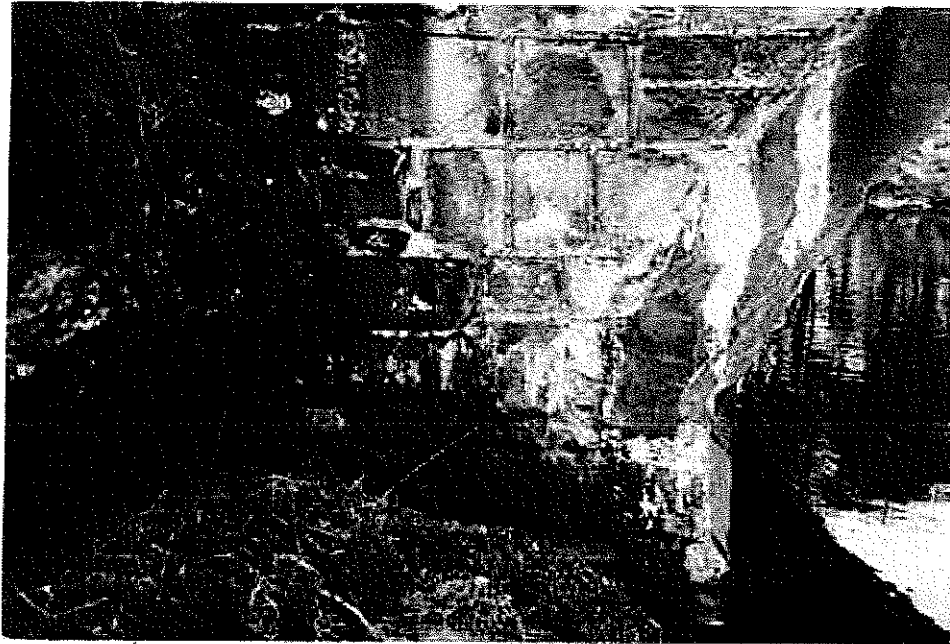
| COMPONENT | | INSPECTION RESULT | | PHOTO/<br>SKETCH | PAGE<br>No. | RECOMMENDATIONS/ACTION | TIME<br>SCALE |
|---|---|---|---|---|---|---|---|
| | | 17D | Active seepage to the south end of main arch spandrel - East elevation | P29<br>SK3 | 33<br>38 | Provide effective waterproofing membrane | L |

P29 JOINT LOSS AND STAINING - DOWNSTREAM END OF MAIN ARCH

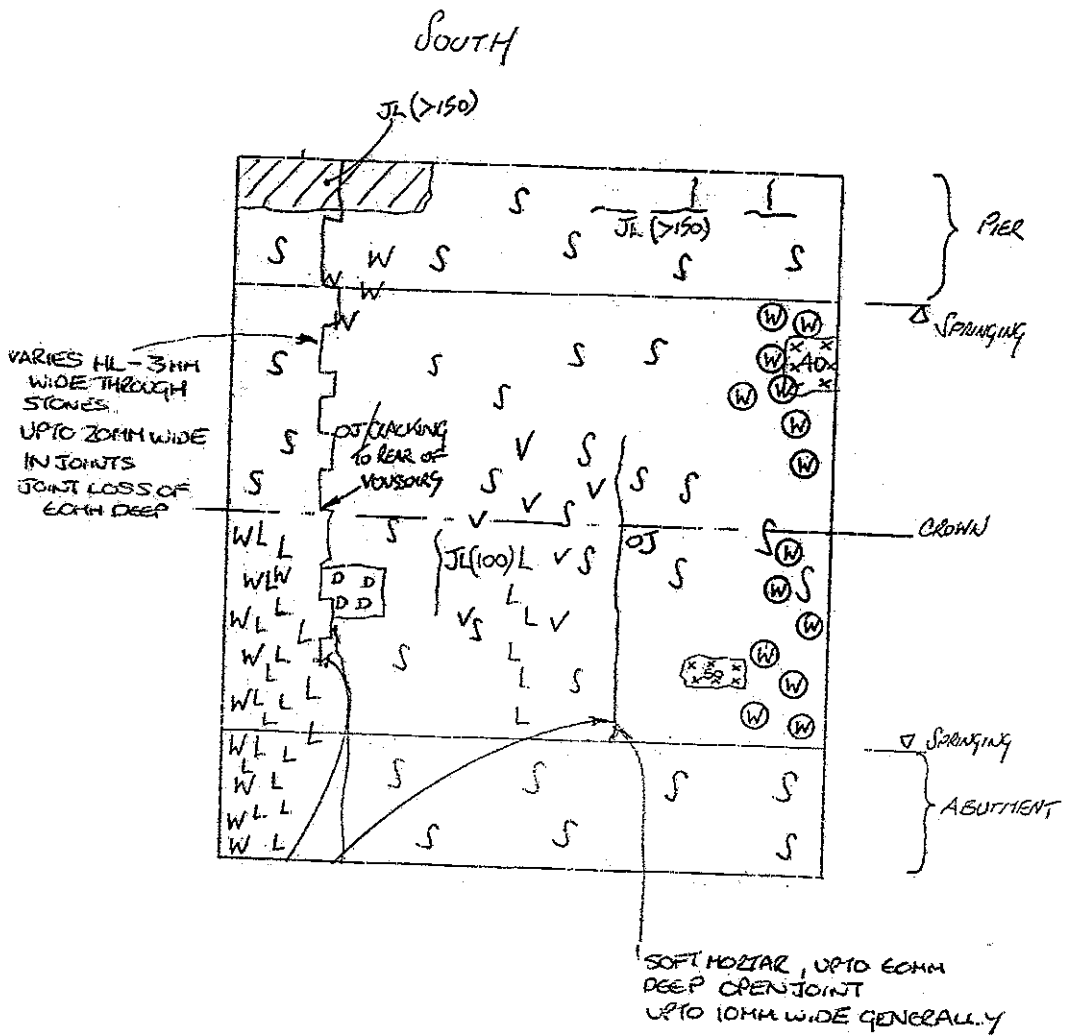
SK2 RELIEF ARCH

| COMPONENT | | INSPECTION RESULT | | PHOTO/<br>SKETCH | PAGE<br>No. | RECOMMENDATIONS/ACTION | TIME<br>SCALE |
|---|---|---|---|---|---|---|---|
| | | 16H | Extensive staining is present to the arch ring, including block deposits, which leached deposits and green deposits from algae/lichen growth. | P21<br>SK2 | 29<br>37 | Provide effective Waterproofing membrane. | L |
| | | 16I | Localised area of spalling/eroded masonry, 40 to 50 mm deep, towards the upstream elevation. | SK2 | 37 | Remove and replace defective masonry | L |
