**BAT RISK ASSESSMENT**

**AT  
SALESBURY HALL FARM  
SALESBURY HALL ROAD  
RIBCHESTER**

**DATE AND TIME OF VISIT  
3<sup>RD</sup> JUNE 2011 1.00 PM**

**REFERENCE NO. 3955**

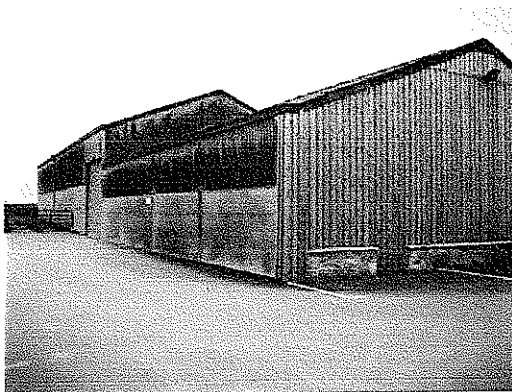
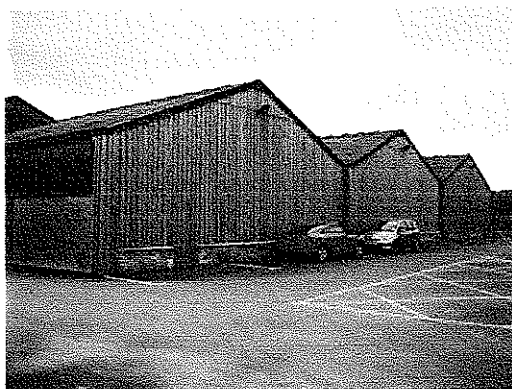
Elevations illustrating new boarding and existing sheeting.

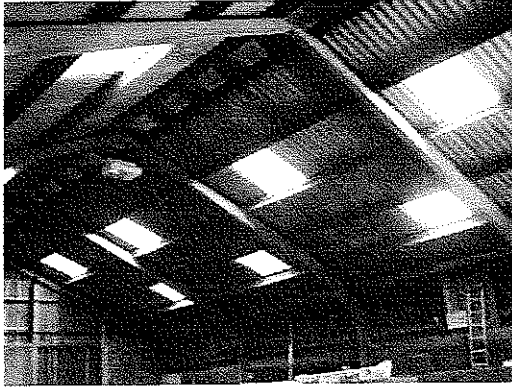
Internal roof.

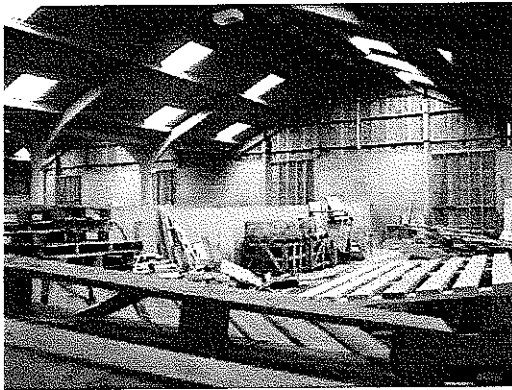
Internal view of building.

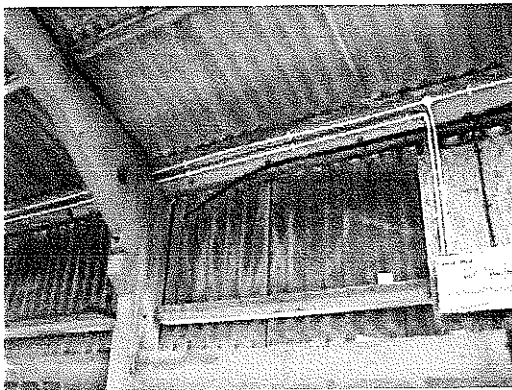
COMMENTS: It would be possible for bats to access the building via the eaves.

Internal eaves.

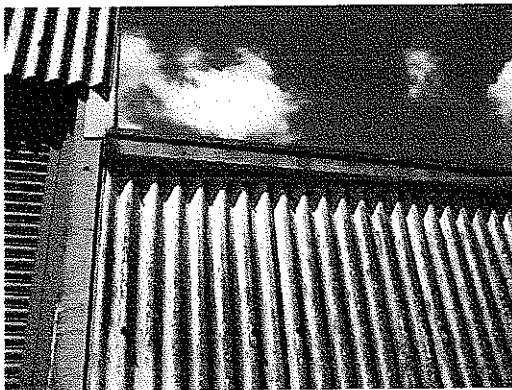
External eaves showing corrugated sheeting.
