## STRUCTURAL APPRAISAL REPORT

Hubbersty Fold Farm, Commons Lane, Balderstone,  
Blackburn, BB2 7LL

IN RELATION TO A PROPOSED PLANNING APPLICATION  
FOR THE CONVERSION OF A TRADITIONAL FARM  
BUILDING, INTO A FIVE BEDROOMED RESIDENTIAL  
DWELLING.

Prepared by: Andrew Mitchell for and on behalf of Gary Hoerty Associates  
Our Ref: Tho/509/1307/AJM  
Date: July 2011  
Client: Mr & Mrs A. Thompson

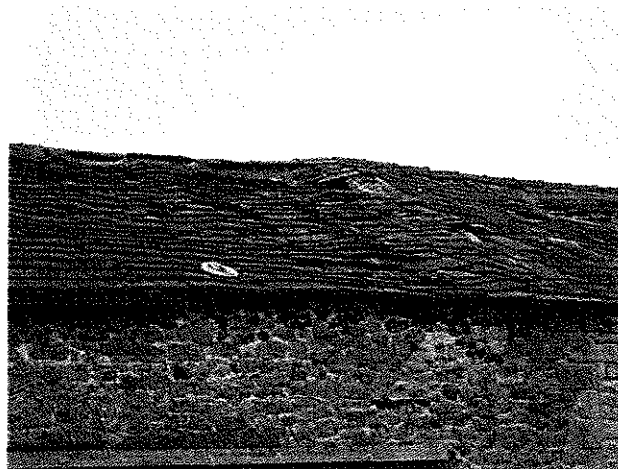
- 5.1 The roof over the barns is in a poor condition, with several significant undulations across the pitch line of the roof. The roof looks to be in a dangerous condition and should be demolished and re-built as part of the scheme. The roof covering is also in a poor condition with a number of slates missing and the remnants of a timber gutter are visible which is in a poor condition. The condition of the gutter has led to damp staining on the external wall surface and increased the potential for penetrating damp. There are also some localised areas of vegetation growth at gutter level. This along with the gutter will need to be removed as part of the conversion scheme, and a new gutter system introduced.

**3. Poor condition of roof**

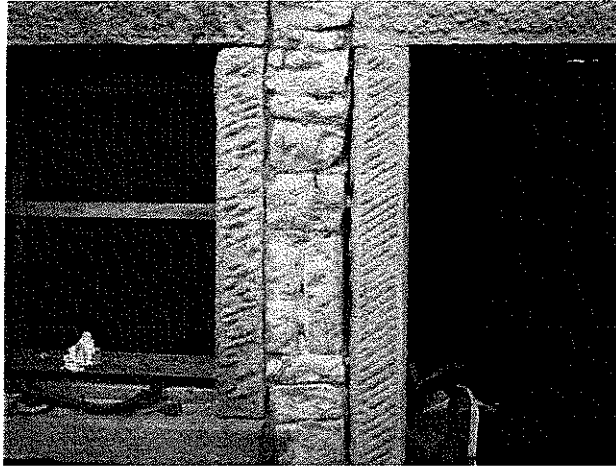
- 5.2 The main external wall to the principal elevation appears to be in a reasonable structural condition with little evidence of any significant structural cracking or signs of ill alignment. The pointing to the external walls also appears to be in a reasonable condition, however there are localised areas that require touching up, in particular to the sides of each window and door. There is also little evidence of any significant structural movement around the window and doors, as the stone lintels across each of the openings is reasonably level, with little evidence of any cracking around the openings. There is also little evidence of any significant movement around the large cart opening; however it was noted that there is evidence of insect infestation within the timber lintels, as shown by the telltale flight holes. As part of the conversion scheme it would be prudent to treat the timber with an appropriate chemical treatment should the lintels be retained.

4. Existing openings on easterly face. Localised re-pointing required around openings

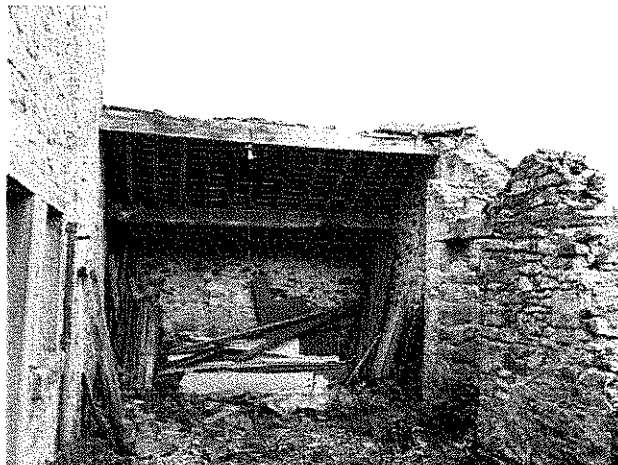
- 5.3 The open sided storage building that abuts the barn on this elevation is in a reasonable condition however it has been subject to some alterations and structural movement. 50% of the original roof has been removed with the remaining section intact and open to the underside of the roof. Whilst the remaining section of is in a fair condition structurally, the proposed scheme indicates the demolition of this structure as a new linked garage construction is proposed.

5. Open sided storage building and adjoined dilapidated structure

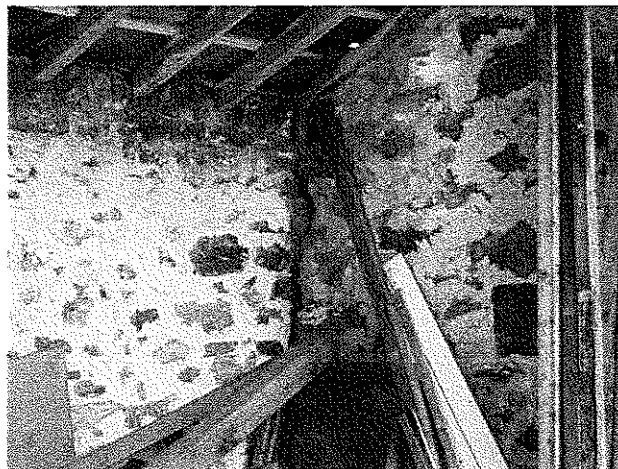
- 5.4 The external walls to this structure are of solid stone masonry. It was noted that in a number of locations the external walls to this structure have suffered some structural movement. There is a vertical crack and gap which corresponds on both internal and external faces of the wall, at the outside corner to the structure. The rear wall of the structure also shows some signs of ill alignment and diagonal cracking at the base of the wall. With the level of structural damage shown in the remaining walls it would be prudent to demolish the structure as part of the scheme for conversion.

6. Structural crack at outside corner of open sided store building

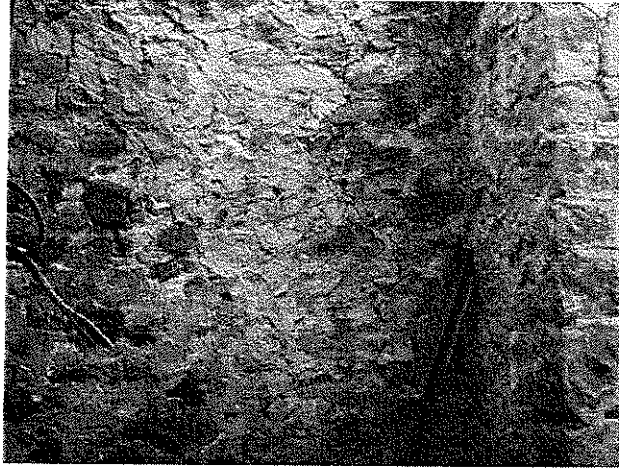
7. Southerly elevation of main barn. Adjoining brick building to be demolished

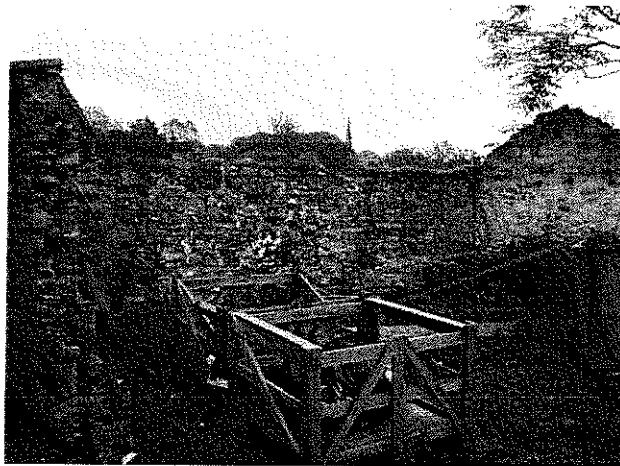
- 5.5 The smaller out-building used formerly as a pig sty, is in a poor condition with nor roof and approximately 50% of the external walls missing. The remaining walls of this structure show signs of a large amount of structural movement. With the level of structural damage shown in the remaining walls it would be prudent to demolish the structure as part of the scheme for conversion.

8. Dilapidated building to easterly face of main barn

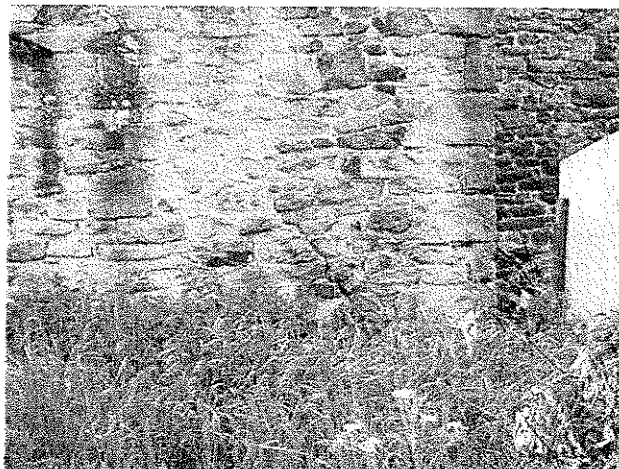
9. Cracking noted on rear northerly facing wall of open sided store

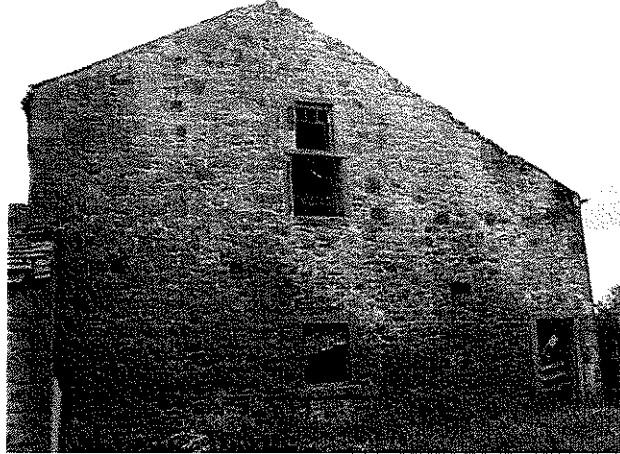
**10. Northerly gable wall**

- 5.6 Externally the stone gable wall shows little evidence of any ill-alignment and there is little evidence of any significant structural cracking. It was noted however that the section of wall close to the corner adjacent the rear wall of the building, requires re-pointing which will give added structural stability and help repel water. There is also little evidence of any significant structural movement around the windows and doors as the heads of the openings look reasonably level.

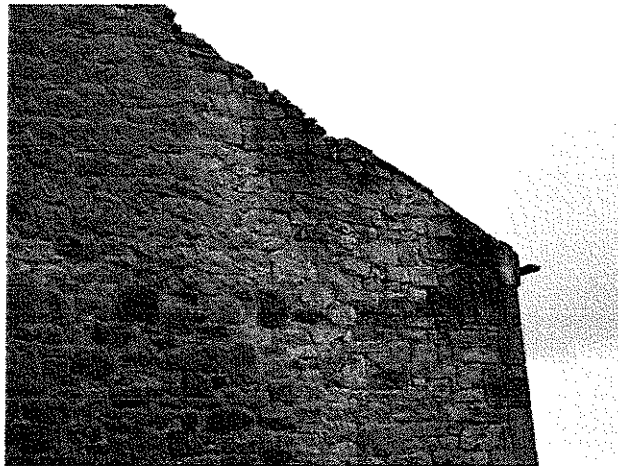
**11. Section of northerly gable wall requiring re-pointing**

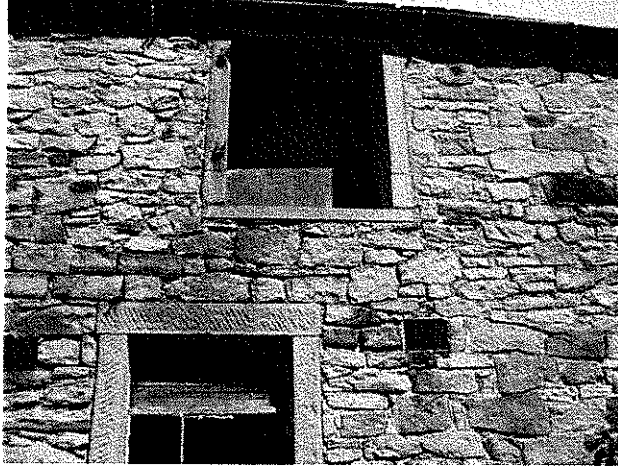
- 5.8 The main external wall of the barn shows little evidence of any ill alignment. The pointing to the rear wall is in a poor condition and will require raking out and re-pointing as part of the scheme, which will help the structure repel water and give added structural stability. There is evidence of cracking within the external walls, however it is considered that any ongoing movement will be restrained by the construction of an internal concrete block lining wall. There is also little evidence of any significant structural movement around the windows and doors as the heads of the openings look reasonably level. It was noted that the stone jamb to a window at first floor level is damaged as the result of a metal hinge being inserted into the stonework. The hinge has also started to rust further damaging the stone.

13. Window openings on westerly face. Localised areas of wall requiring re-pointing

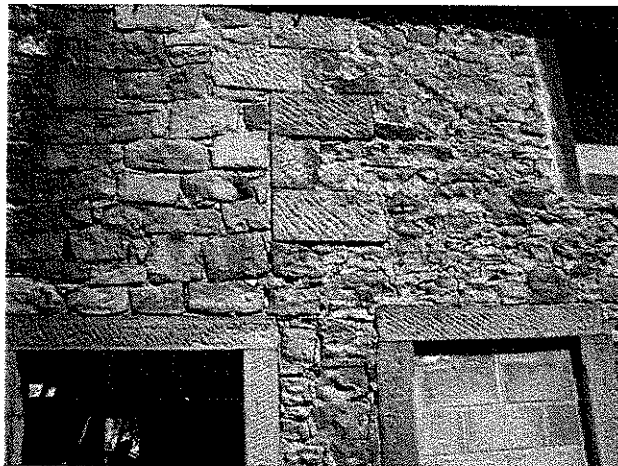
- 4.6 The pitched roof of the barn is clad with a mixture of natural blue and grey slate, with similar ridge tiles bedded in mortar. The rear wall of the barn is constructed with natural solid stone masonry with stone quoins at the external corners. Stone quoins sighted part way along the rear wall, as noted on the front elevation, can also be seen to the rear elevation, further evidence that the original barn has been extended. It is considered that the original/principal barn has been further extended over time, with the construction of a mono-pitch/lean-to, with the wall constructed in line with that of the adjoined barn extension.

14. Stone quoins to westerly elevation indicating extension to original barn

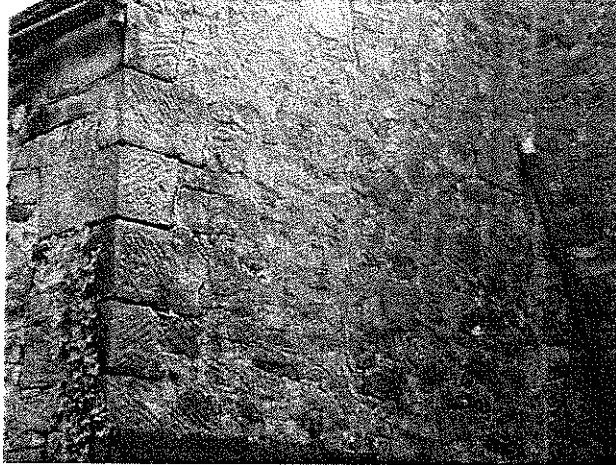
**16. Cracking within mortar to rear wall**

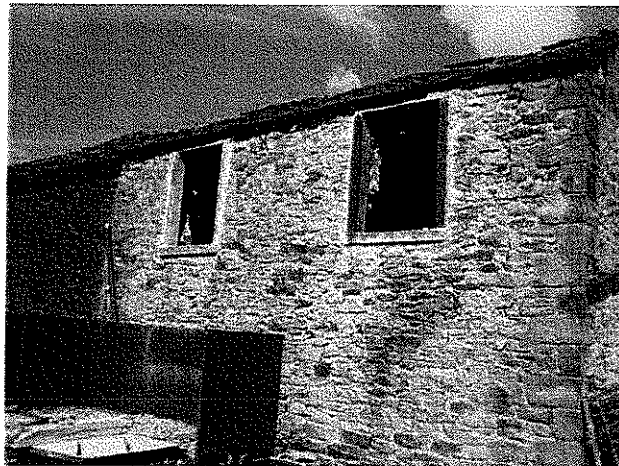
- 5.11 The internal face of the external walls show little evidence of any ill alignment, however there are a number of locations where the walls are cracked, in particular to the corner of the rear westerly and southerly gable wall, and adjacent to the large windows on the rear wall of the main barn. The internal face of the external walls would benefit from being re-pointed and any on going structural movement would be restrained by the construction of an internal leaf of lining blockwork, with the existing stone walls tied to the lining blockwork. The internal brick wall is in a poor condition and is cracked in a number of locations, in particular adjacent to the front easterly wall of the barn. It would be prudent to demolish the brick wall and build a replacement wall of concrete blockwork. The internal face the external walls is also damp in a number of locations in particular at the eaves where defective gutter details allow rain water to penetrate into the structure. As part of the scheme it will be necessary to introduce a new gutter system which will alleviate this problem.

**17. Cracking in rear wall adjacent to corner of southerly gable wall**

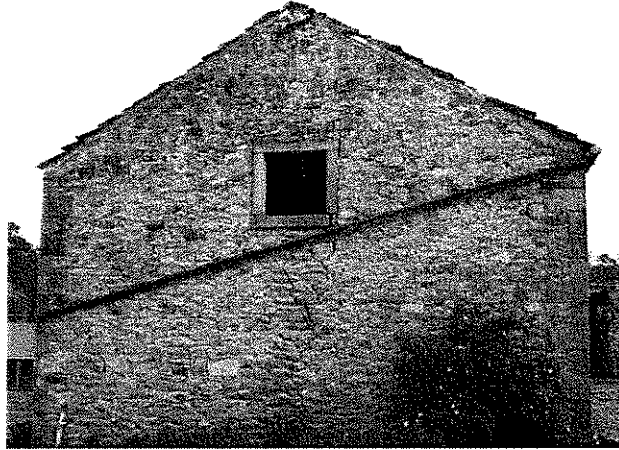
**19. Southerly gable wall**

- 5.9 Whilst there is little evidence of any ill alignment within the wall, there are a number of cracks running from the ground level, to the verge of the wall and roof and continue around the sides of the window opening. The wall would also benefit from re-pointing to help the structure repel water and give added structural stability. There is little evidence of any ill alignment within the wall. The stone surrounds to the window opening have also suffered from movement, as the surrounds are out of square. The stone sill to the window has a crack within it to the left hand side. As part of the scheme it would be expected that the surrounds would be re-set to form a square opening and the sill to be replaced.

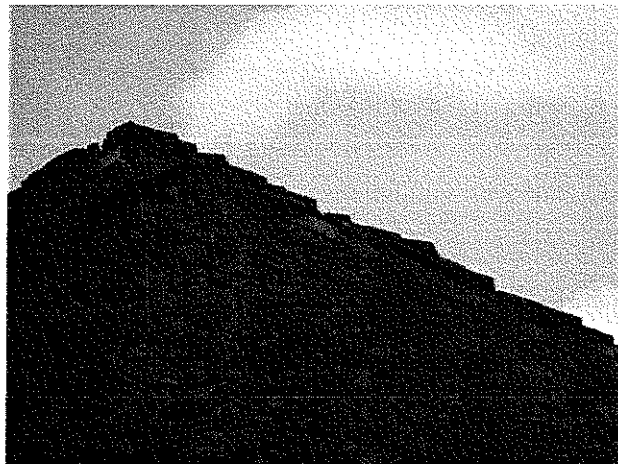
**20. Verge detail on southerly gable wall, requiring repair as part of scheme**

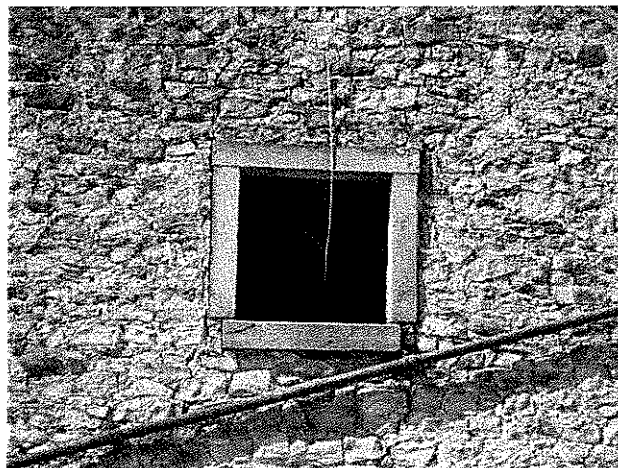
**21. Window on southerly gable showing signs of structural movement. Cracking around opening**

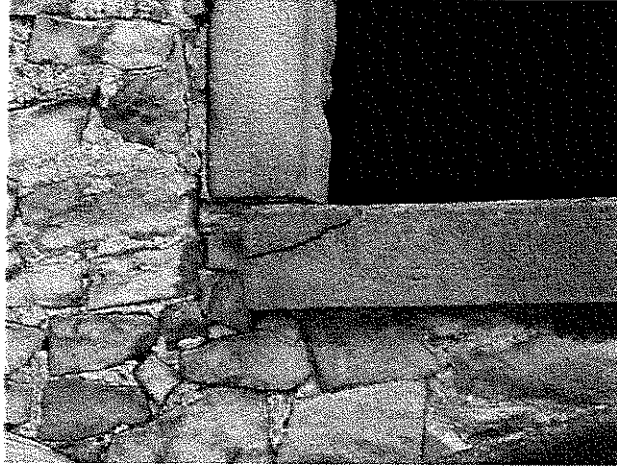
**22. Cracked window sill to window on southerly gable**

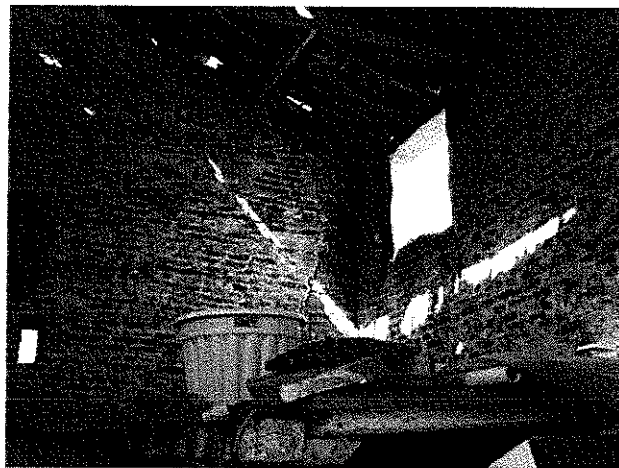
**23. Cracking to internal brick wall**

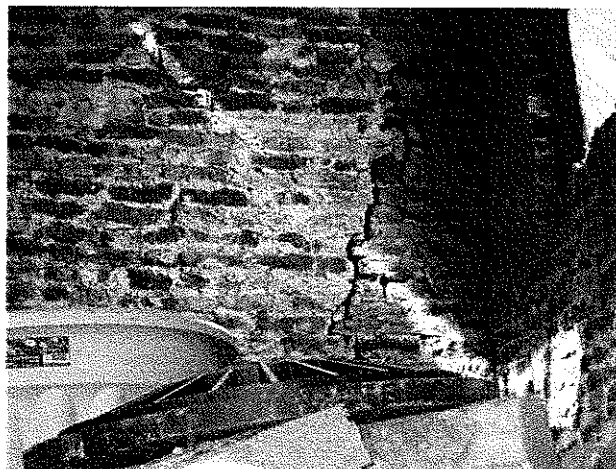
**24. Cracking to internal brick wall**

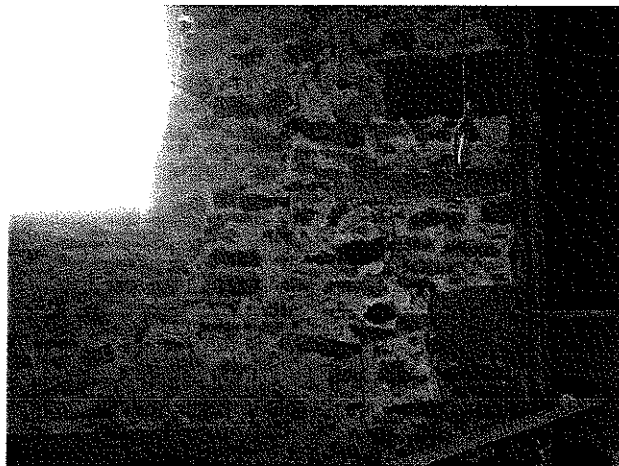
**26. Cracking to internal face of westerly rear wall within main barn**

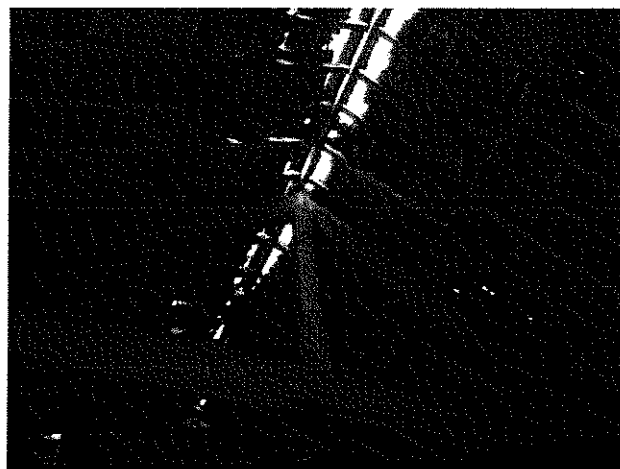
- 5.10 As noted externally the roofs over the barns are in an extremely poor condition and are considered to be in a dangerous condition. The roof timbers over the barn currently used for general storage are in a poor condition with many showing signs of bowing. A number of the timbers have suffered through an insect infestation as noted by tell tale flight holes of the insect which has reduced the structural size of a number of the timbers. There will also be a large loading placed onto the roof timbers from the heavy stone slate roof covering, which will further add to the structural problems. It is evident that

there have been remedial works undertaken as a steel purlin has been inserted. The roof over the extended barn is in a worse condition and has a large section of the roof collapsed. Given the current condition of the roofs, it would be necessary to remove the remaining sections of roof and construct a new cut timber roof, incorporating ventilation and insulation. The current traditional roof trusses appear to be in a reasonable condition and could be accommodated as part of the scheme. It would be necessary however to treat the timbers.

**30. Poor condition of roof structure, with steel purlin showing**

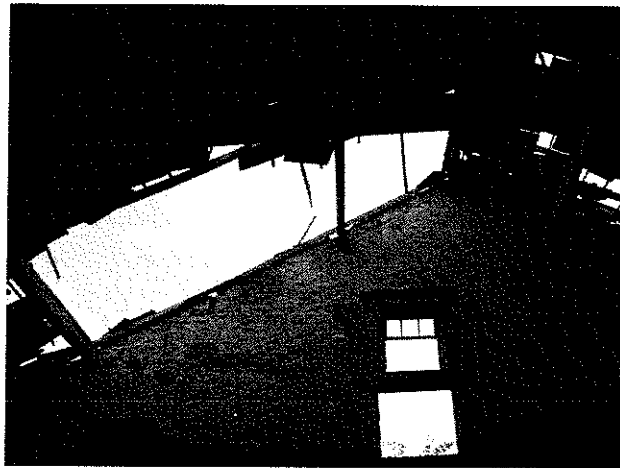
- 5.7 The roof to the rear portion of the barn is in a poor and dangerous condition. There are a number of undulations within the pitch line of the roof and a large section where the roof has collapsed. As mentioned it would be necessary to remove the existing roof and replace it as part of the scheme. The rear portion of roof is served with a black PVCu gutter, which is in a poor condition with a number of undulations within the line of the gutter. The gutter is also not connected to a downpipe. This has led to some damp staining on the external surface which will have increased the likelihood of penetrating damp on the internal surfaces of the walls. As part of the scheme it would be necessary to remove the existing defective gutters and replace it with new.

32. Collapsed section of roof

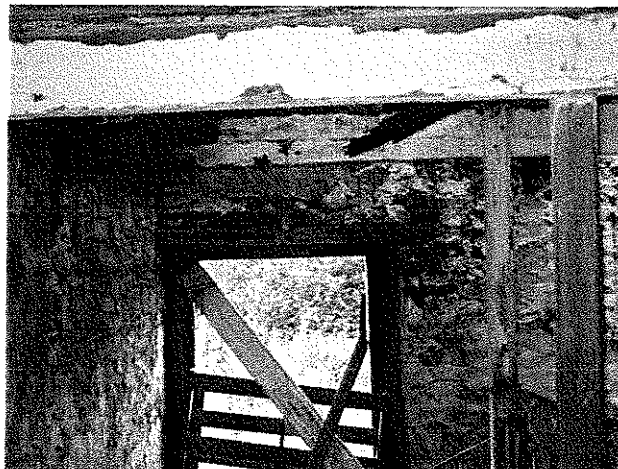
33. Timber lintel to opening on external wall

- 5.14 Internally the window and door openings are supported by timber lintels which will need to be replaced with appropriately sized reinforced concrete lintels as part of the scheme.

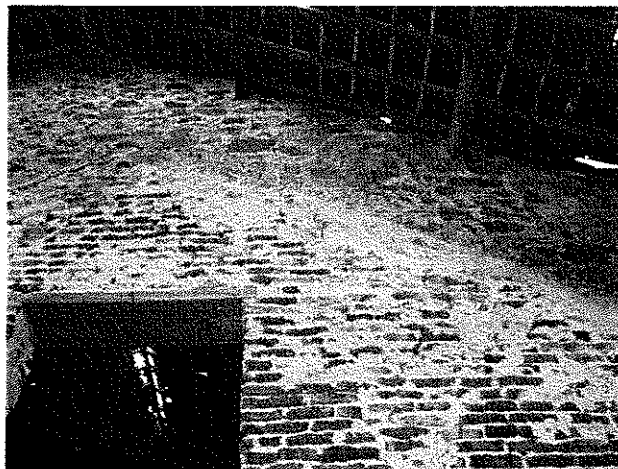
- 4.4 Adjacent to the northerly corner of the front elevation is an open sided storage area formed with solid stone walls and a mono-pitch roof structure clad in grey slate. It is clear that the roof has been altered and was previously arranged with a dual pitched roof, as noted by the cement fillet remaining on the wall surface of the main barn. The roof structure remaining is of a traditional cut timber form with timber rafters and purlins. Adjacent to this storage building are the remains of a dilapidated single storey structure, formerly used as a pig sty, with the roof missing and approximately 50% of the external walls missing.

**36. Evidence of former structure noted by the outline of pitched roof**

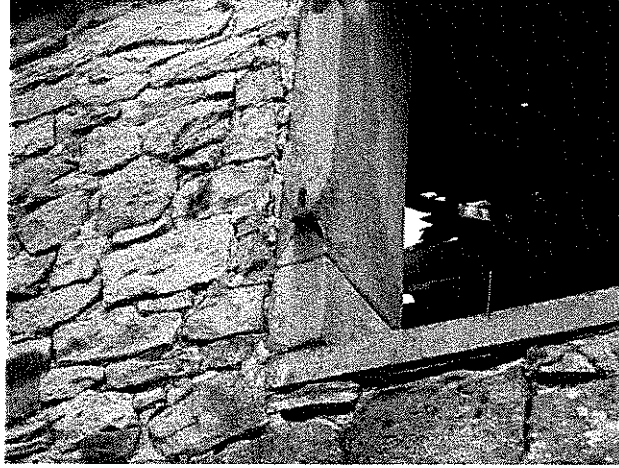
**37. Cracked and damaged stone jamb to window on rear westerly wall**
