**BUILDING INSPECTION REPORT**  
**CONVERSION ASSESMENT**

**North East Barn**  
**Wycongill Farm**  
**Holden Road**  
**Bolton-by-Bowland**  
**Lancashire**  
**BB7 4LZ**

Our Ref : LEE/01

Date July 2011

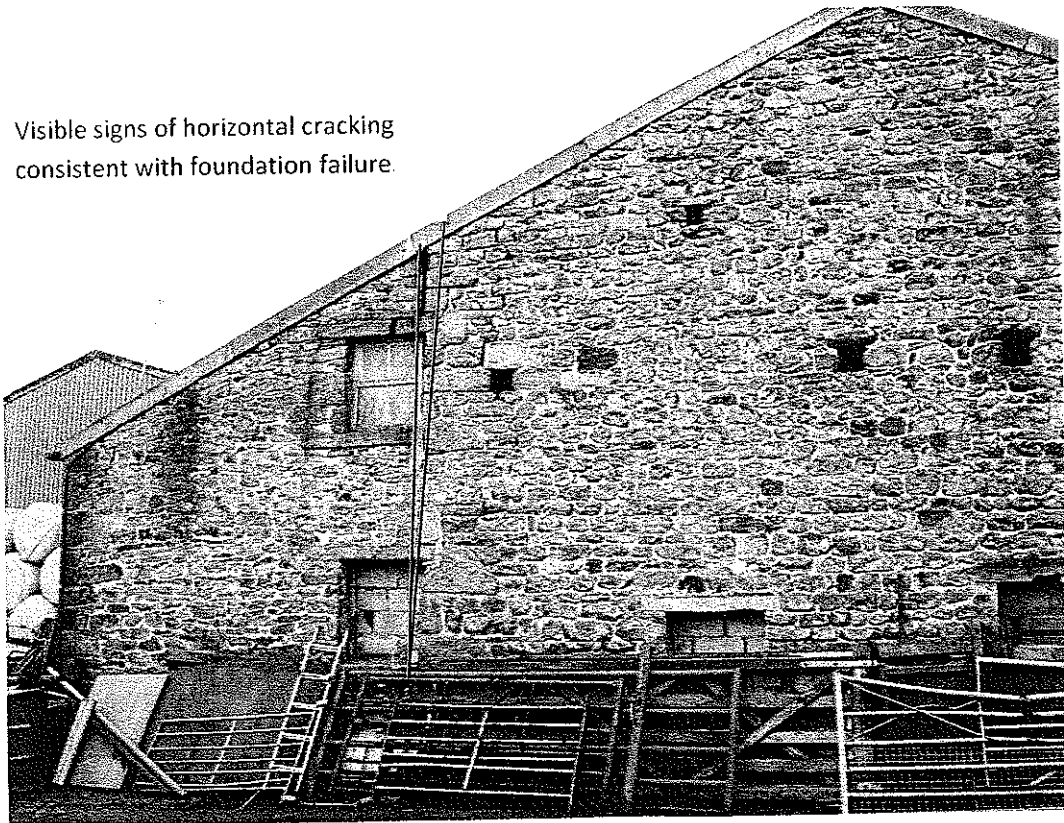
Visible signs of horizontal cracking  
consistent with foundation failure.

Photo 1 : Signs of differential ground movement

There is evidence of foundation movement to the North East corner of the property which has in turn created defects to sections of the North and East walls. The evidence of this defect is clearly visible and can be seen in Photo 1. The nature of the movement and the widening of the horizontal joints is consistent with that of vertical settlement implies foundation failure. The cracked lintel is thought to be due to the excessive movement and not lintel failure from overloading. It is also evident that the walls converging in the North East corner are leaning outwards by over 25mm which is seen as dangerous. This is seen to be in connection with the foundation failure and based on structural grounds alone it would be recommended that this section of wall is rebuilt with a new suitable foundation.

In the area that is showing signs of foundation failure it is proposed that the most suitable course of action would be partial demolition and rebuild of the area as indicated in Figure B. The rebuilt section is to be constructed on a new strip foundation tied into the proposed reinforced raft as shown in Figure C. This treatment in combination with the future prevention of heavy plant movement around the side of the property will restore structural integrity and reduce the likelihood of future defects arising from foundation defects

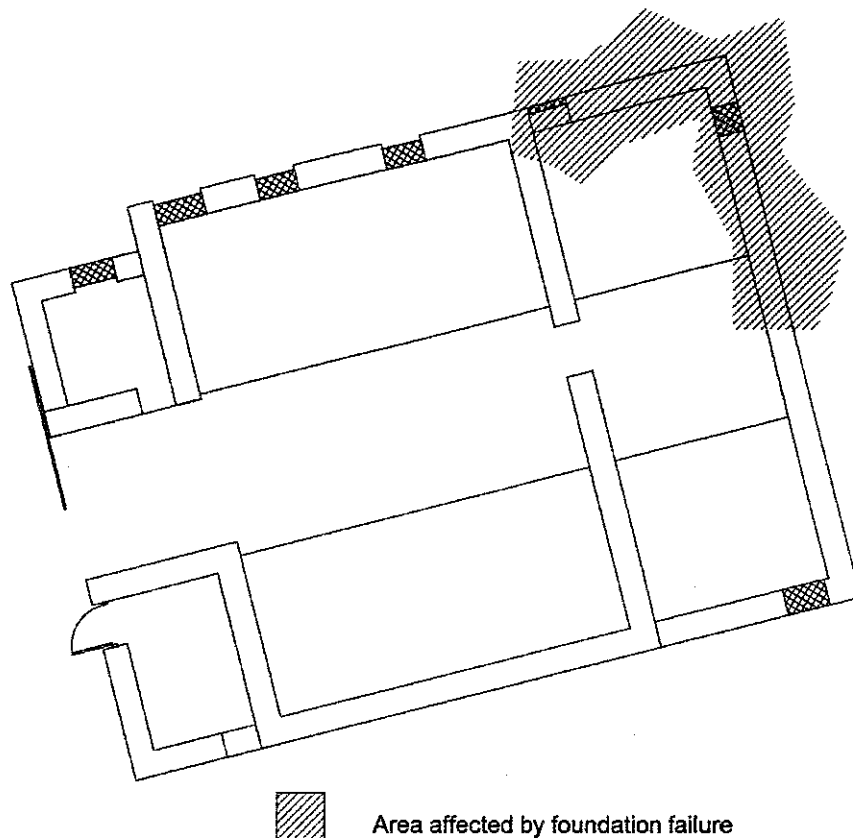
Figure B : Area of foundation failure

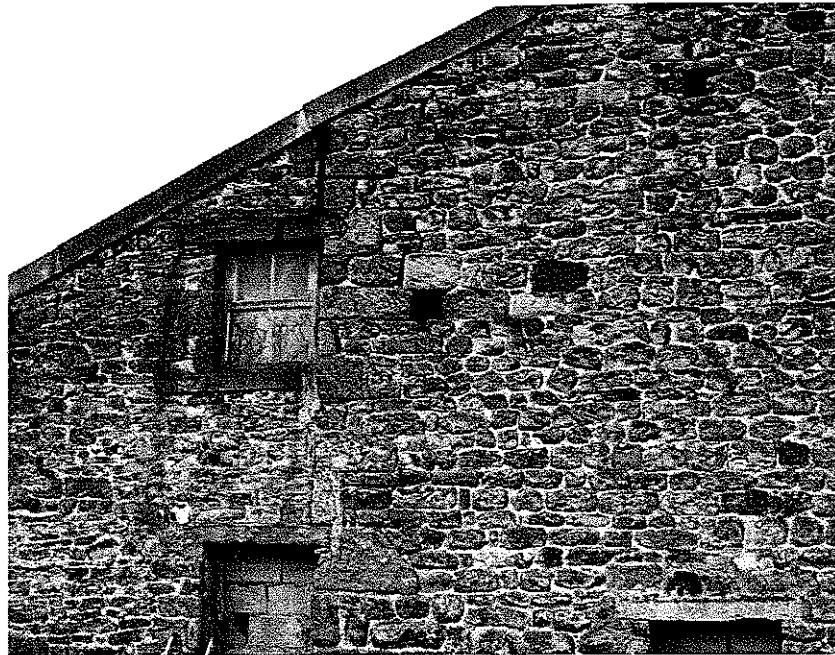
Photo 2 : Signs of differential ground movement / lintel failure

**New Wall** - The proposed design requires the rebuilding of a section of the East and North wall new wall. This new wall it to be faced with the stone from the previous wall tied to backing blockwork, to comply with the current building regulations the wall will also be constructed with a 120mm partially insulated cavity and inner leaf of blockwork (Figure 3)

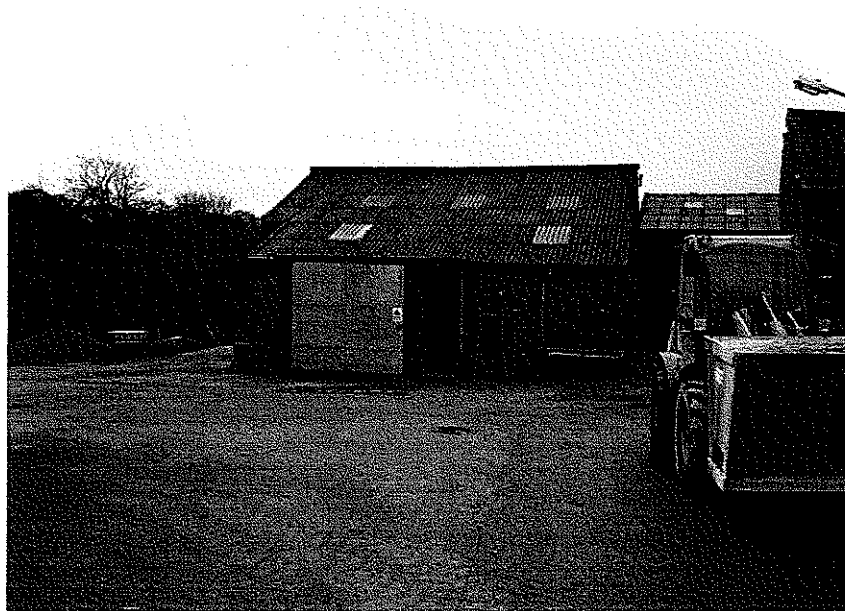
The front (West) elevation consists of one central barn opening with a timber lintel. The traditional doors have previously been removed and replaced with a galvanized steel sliding door which while

practical and maintenance free it does detract from the aesthetic appearance of the traditional structure. To the right hand side is a timber pedestrian door which is in a poor state of repair and shows signs of advanced decay to the lower sections. It is our opinion that the openings appear to be structurally sound and cause no concern.

Photo 3 – Existing West Elevation

The structural works to the front (West) elevation will require the insertion of three new windows providing natural light to the lounge, bedroom 3 and bedroom 4. The design of the openings are such as to create the minimal impact on the building and its setting and improve the aesthetics of the property. The barn and pedestrian openings are to remain as existing and be fitted out with timber framed glazing system.

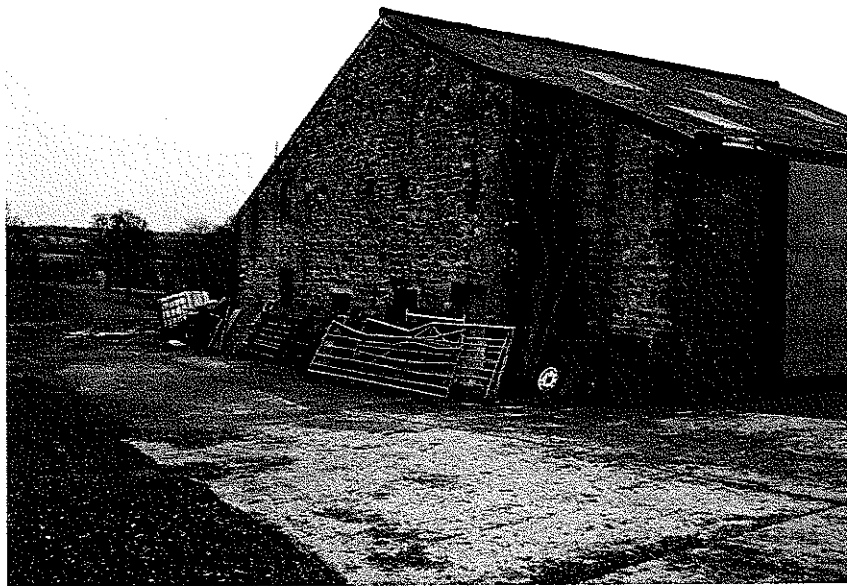
The side (North) elevation has two windows and a pedestrian door opening to the ground floor of the main building, all of which are blocked and two smaller windows in the lean-to towards the rear of the property. The pedestrian opening to the barn is thought to be original to the property and is formed with natural stone heads and jamb stones and of which are in good condition, the windows however are a more modern addition or are enlargements of previous openings. The windows have been formed using crude cast in-situ heads, jambs and sills and are out of keeping with the style of the property it is also dubious as to their structural ability as the heads appear to have limited end bearing capacity. It is our opinion that however the building is intended to be used these windows required reforming to provide adequate structural support to the built elements above. The windows within the lean-to vertically aligned over each other with the lower of the two being at ground floor level and being blocked up. The second window opening is showing signs for concern due to the foundation failure as previously described in 3.1.1. Due to this movement the lintel above the window has cracked and what little support there is, is provided by the rotten timber window frame below.

Photo 4 – Existing North Elevation

**\*\* It is recommended that remedial work is undertaken immediately to prevent danger to the occupants and visitors of the surrounding properties \*\***

To the side (North) elevation of the main building it is proposed that the existing window openings at ground floor level are to be broken out with jamb stones to form the returns to the sides. The concrete heads and cills are also to be replaced with stone alternatives to be in keeping with the rest of the property. At first floor level it is proposed that a new window be formed to the master bedroom, the detailing of which is to be the same as the windows at ground floor level. As the North wall of the lean-to requires rebuilding it is proposed the two new windows are to be formed to mimic the ones which they replace in size, style and location.

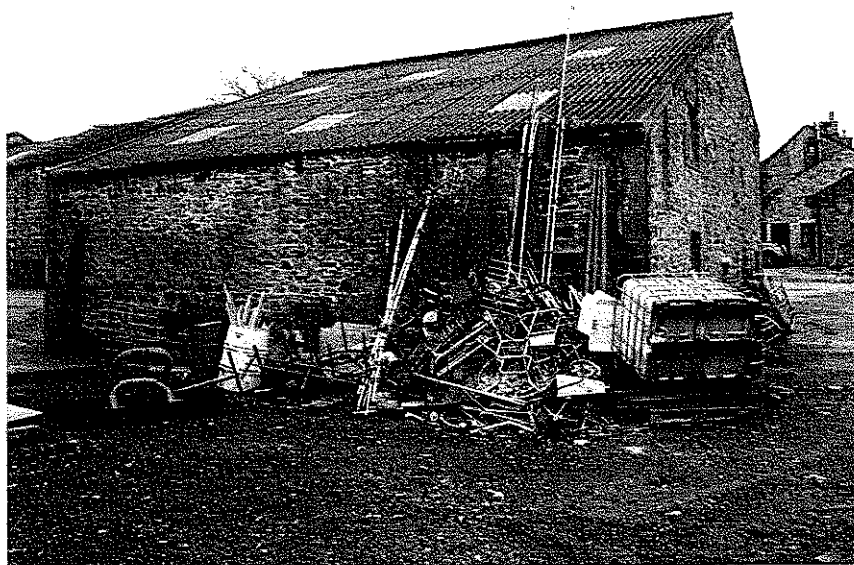
The East elevation of the lean-to has seen little adaptation from its historic form. There is only one opening in this elevation which is at a low level toward the North East corner, as like many of the other openings in the building this has been blocked up internally.

Photo 5 – Existing East Elevation (Lean-to)

The East elevation of the lean-to is to be rebuilt under this scheme due to subsidence, it is intended that when the elevation is rebuilt that a pedestrian door to the utility room and a window serving the dining room are formed. The style, size and materials used are to be the same as those on the North elevation to provide consistency.

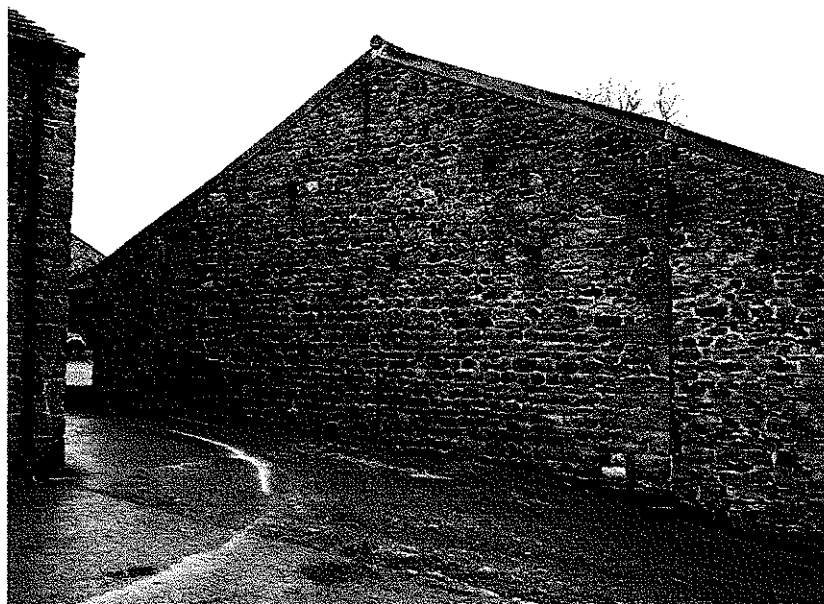
The south elevation of the property has few openings with a pedestrian door (blocked up) to the South East corner of the lean-to and a single high level window to South West of the main building which is temporally boarded over internally.

Photo 6 – Existing South Elevation

The works to the South elevation include the removal of the high window from the southerly side of the building and the raising of the head to the existing doorway from the northerly side. The proposal also includes the formation of three new windows (two at ground floor / one at first floor). All windows are to be formed with stonework to jambs and natural stone heads and cills.

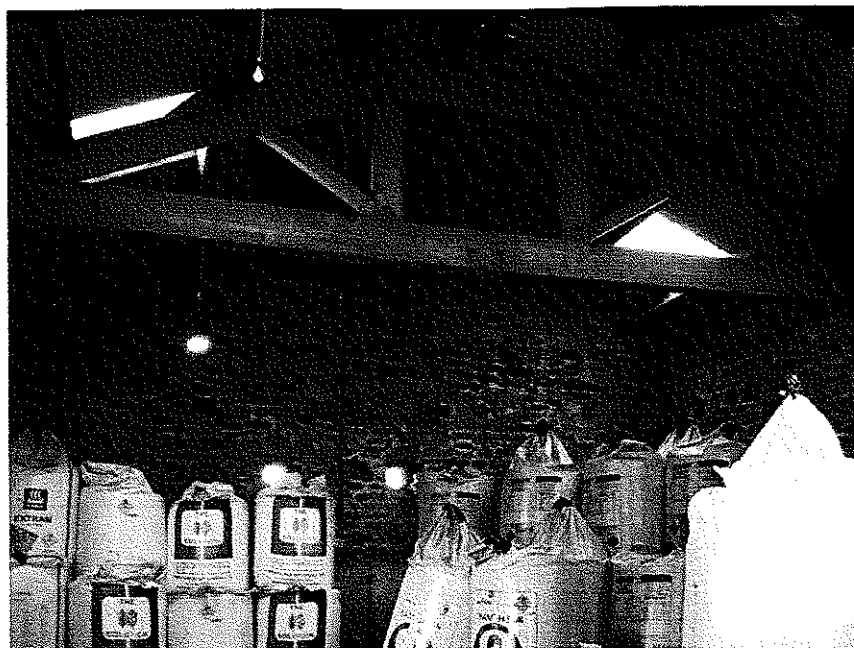
With regard to the condition of the covering over the property, it is our view that the general condition is poor and requires an overhaul. Upon an internal inspection it appears the roof covering is performing its duty and keeping the internals dry as there are no signs of water penetration visible. We also noted that the majority of the traditional roof structure has been replaced with only one of the original trusses remaining.

Photo 8 – Traditional roof truss

Due to the structure of the roof and its inability to be modified to cope with the structural loadings of an in keeping roof covering the roof structure is to be replaced with softwood trusses at 600ctrs. This is them to have a breathable membrane applied with battens and counter battens above The roof covering is to be in blue slate to match adjacent properties. In order to comply with the requirements set out in Part L1b of the Building Regulation 2010 it is propose that the roof is to be insulated at ceiling level with 400mm Knauf loft Insulation. (See Figure E)

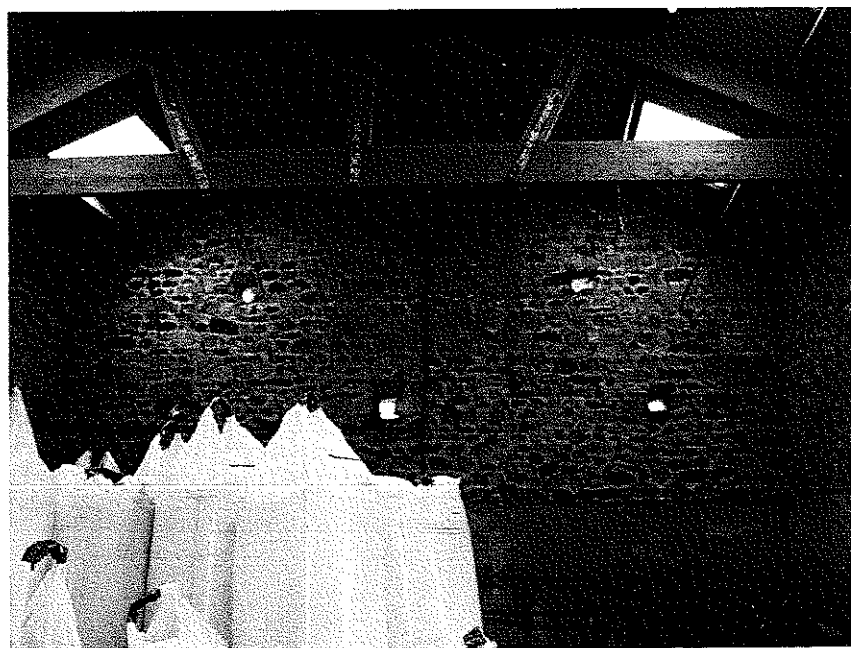
Photo 9 – Replacement Truss
