*Hazard Report*

**Hazard Survey - Mr D. Norris 41, Dilworth Lane, Longridge.**

This report describes the inspection and hazard assessment of six trees situated along the boundary fence parallel to

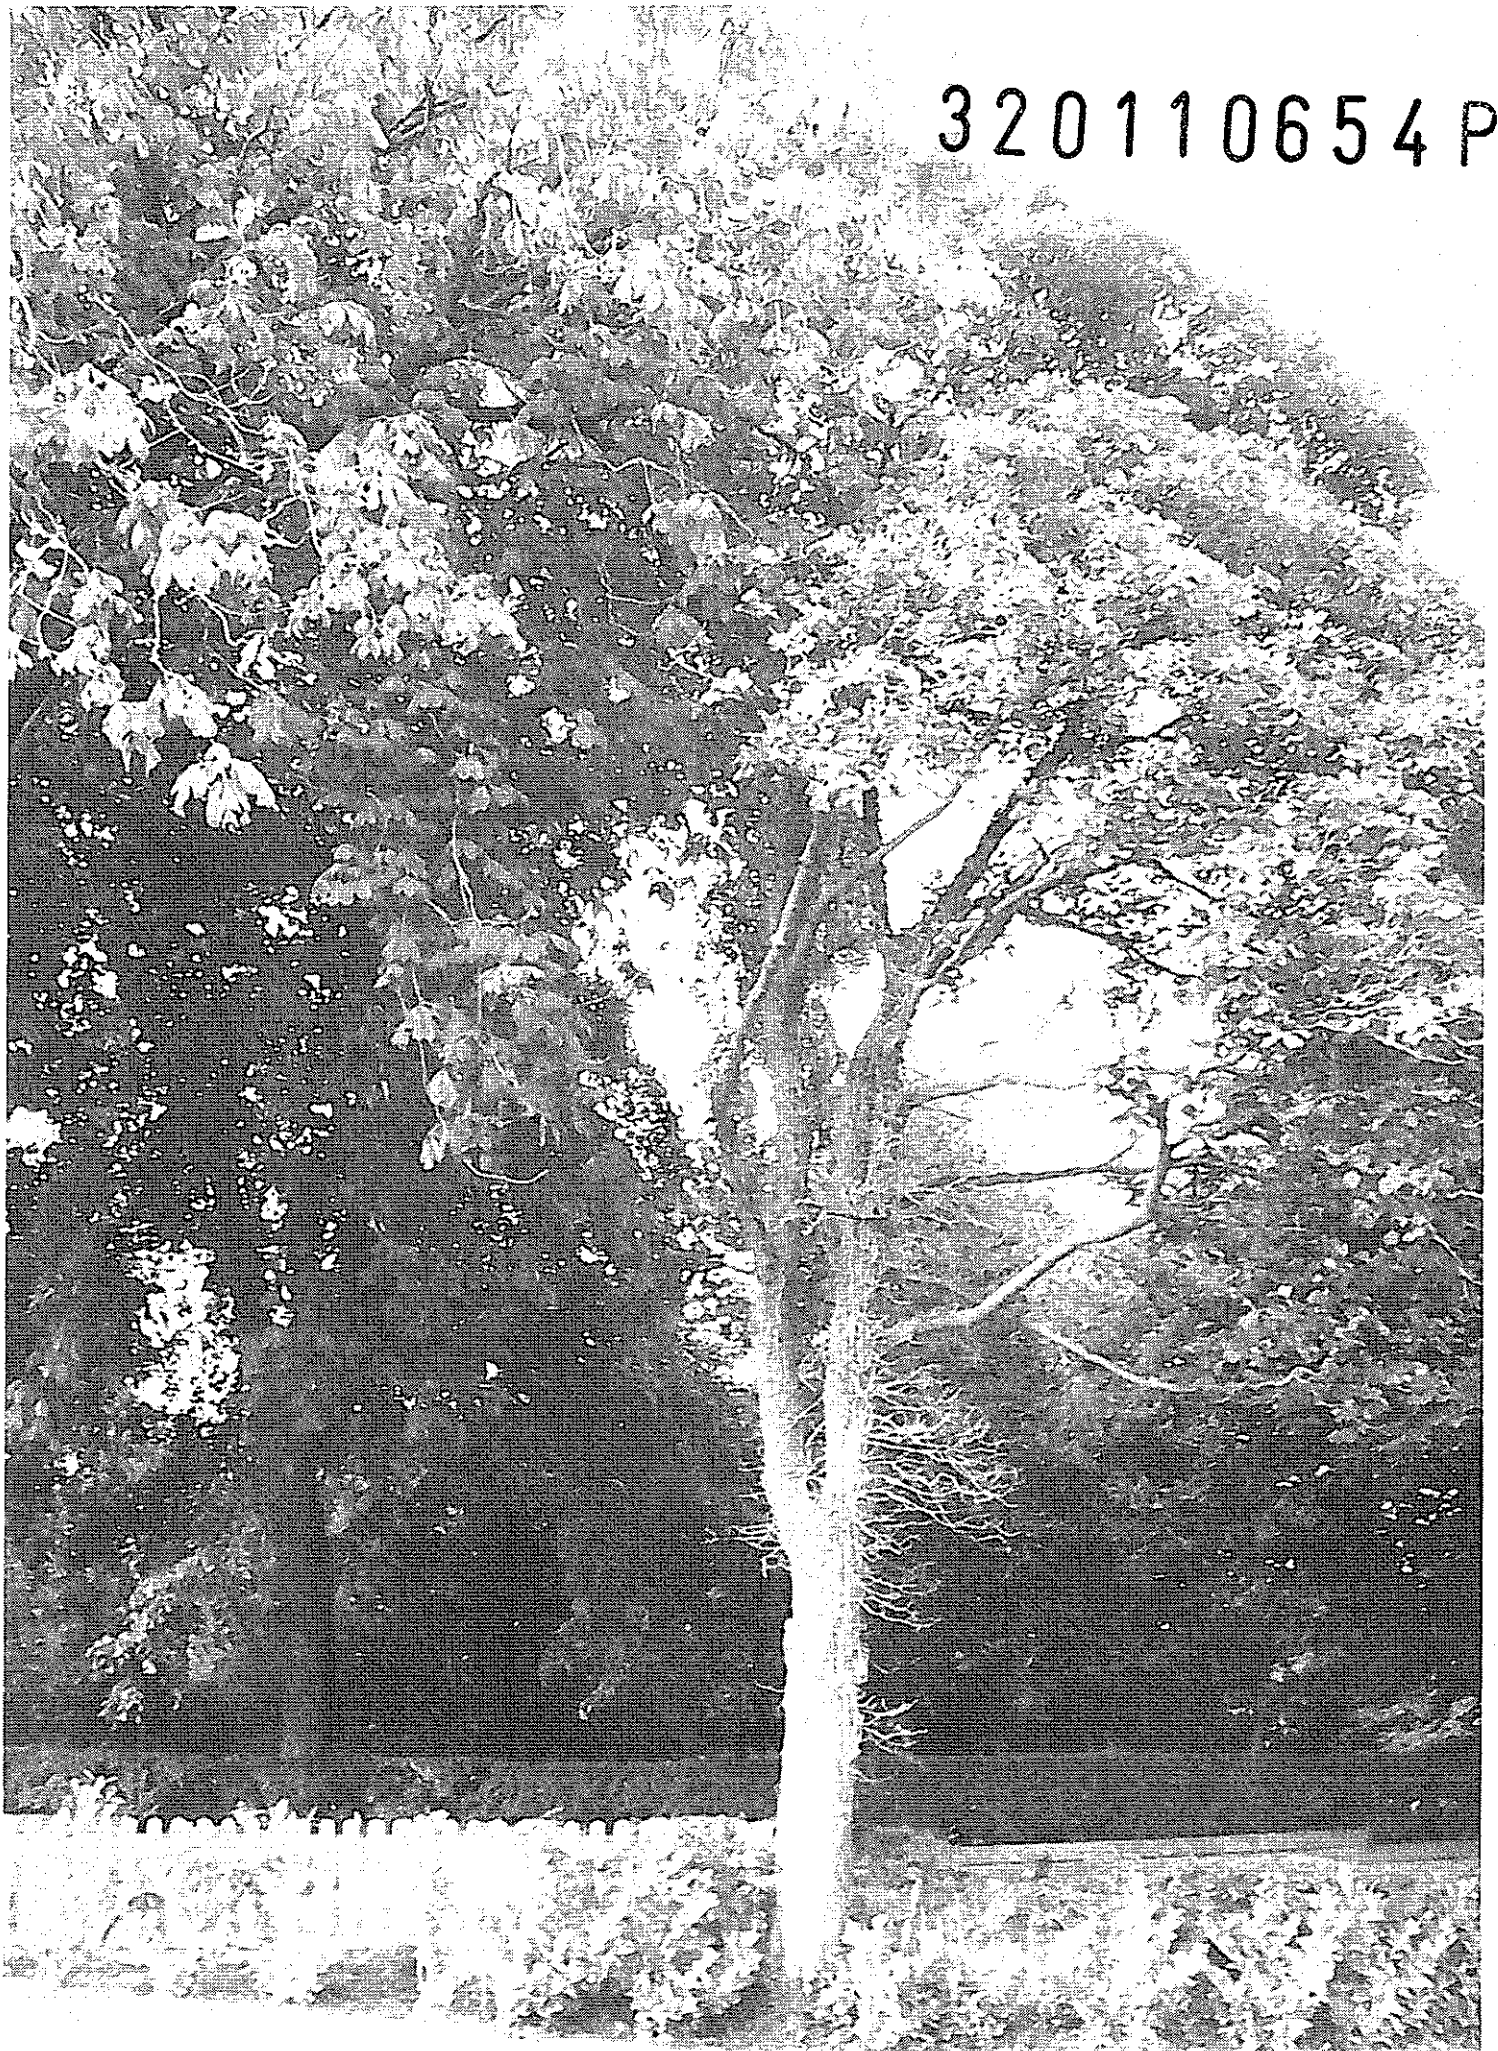
TI HORSE CHESTNUT

- Leaves - West side of the crown showing signs of Phytophthora , wilting, early leaf fall
- Buds – n/a
- Deadwood – Large amount of deadwood present in the west side of the canopy up to 150mm
- Weak or Crossing Branches – Canopy has some crossing branches. Considered to pose slight risk
- Unbalanced Crown – Slight due to position of neighbouring tree
- Dense Crown – Visibly dense crown to the east side of the crown.

- Leaning Tree – Slight southward lean
- Single stem
- Pruning Cuts – Two present on lower main stem
- Stem Formations – No visible swellings, depressions, cracks, ribs or bulges are visible
- Cavities – None visible
- Fungi – Black weeping fungal spots present in the east side of the crown.

Tree has a large widespread crown with major limb extension. Closer inspection has determined the cause for concern in the form of weeping black fungal spores visible on the main branches in one area.

Trees canopy is holding major limb structures over a public road and footpath.

This particular fungus will, eventually envelope the whole tree in time resulting in the trees death.

Therefore taking all these facts into considerations I would strongly recommend that the tree should be removed.

- T1 H/Chestnut, section fell to ground level due to the presence of Phytophthora.
- T2 Sycamore, Suppressed tree, unbalanced crown poor specimen. Replace if applicable
- T4, Crown raise and deadwood
- T6 crown raise and crown clean and monitor the angle of the main stem

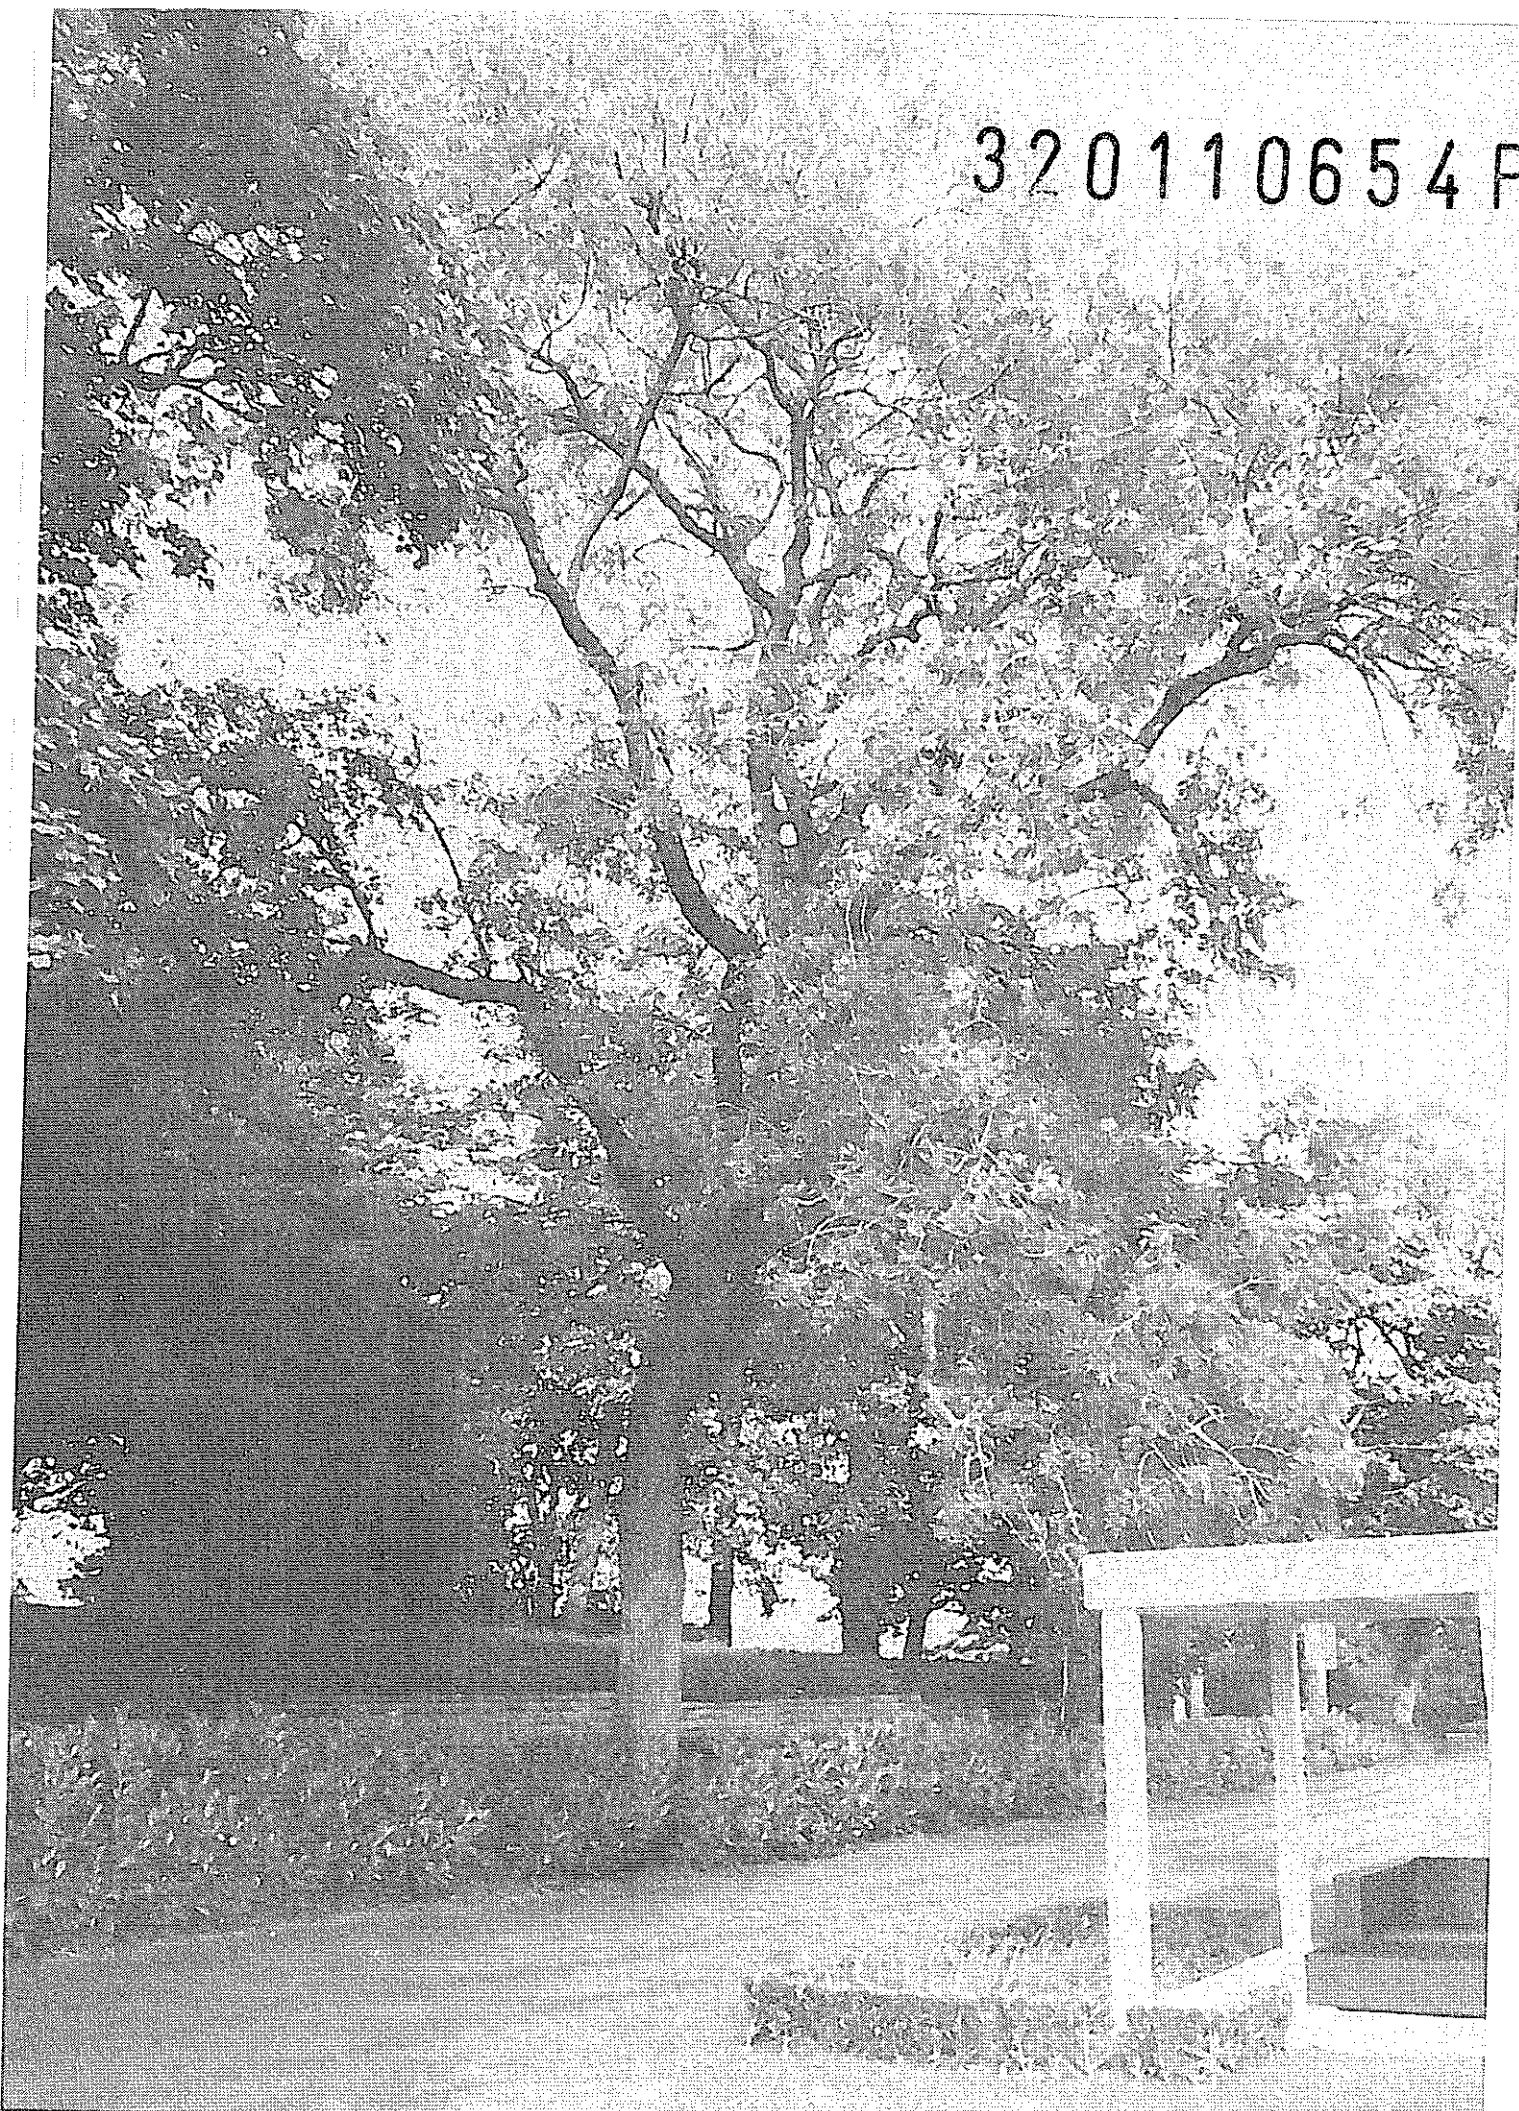
T-2. Sycamore

- Leaves – average size and condition
- Buds – n/a
- Deadwood- small amount of deadwood visible in the upper crown (25mm)
- Weak or crossing branches – no visible signs could be seen from ground level.
- Unbalanced crown – west side of crown suppressed due to the close proximity of T1.
- Dense crown – east side only.
- Weak branch formation. Non visible.

- Leaning tree – slight eastward lean
- Co- dominant stems –co dominant main stem (x2) with v shape union at approximately 4m.
- Bark wounds – no visible barks wounds present.
- Pruning cuts – four present on lower stem.
- Stem formation – no visible swellings, depressions, cracks, ribs or bulges are visible
- Cavities – non visible at the present time.
- Fungi – non visible

- Climbing plants – Ivy has been removed from the lower stem leaving the upper crown foliage to die back.
- Surrounding hazards – Structures situated to the north of the tree fence and main road.

Once tree 1 is removed the full extent of the crown will be revealed showing the unbalanced crown of the tree

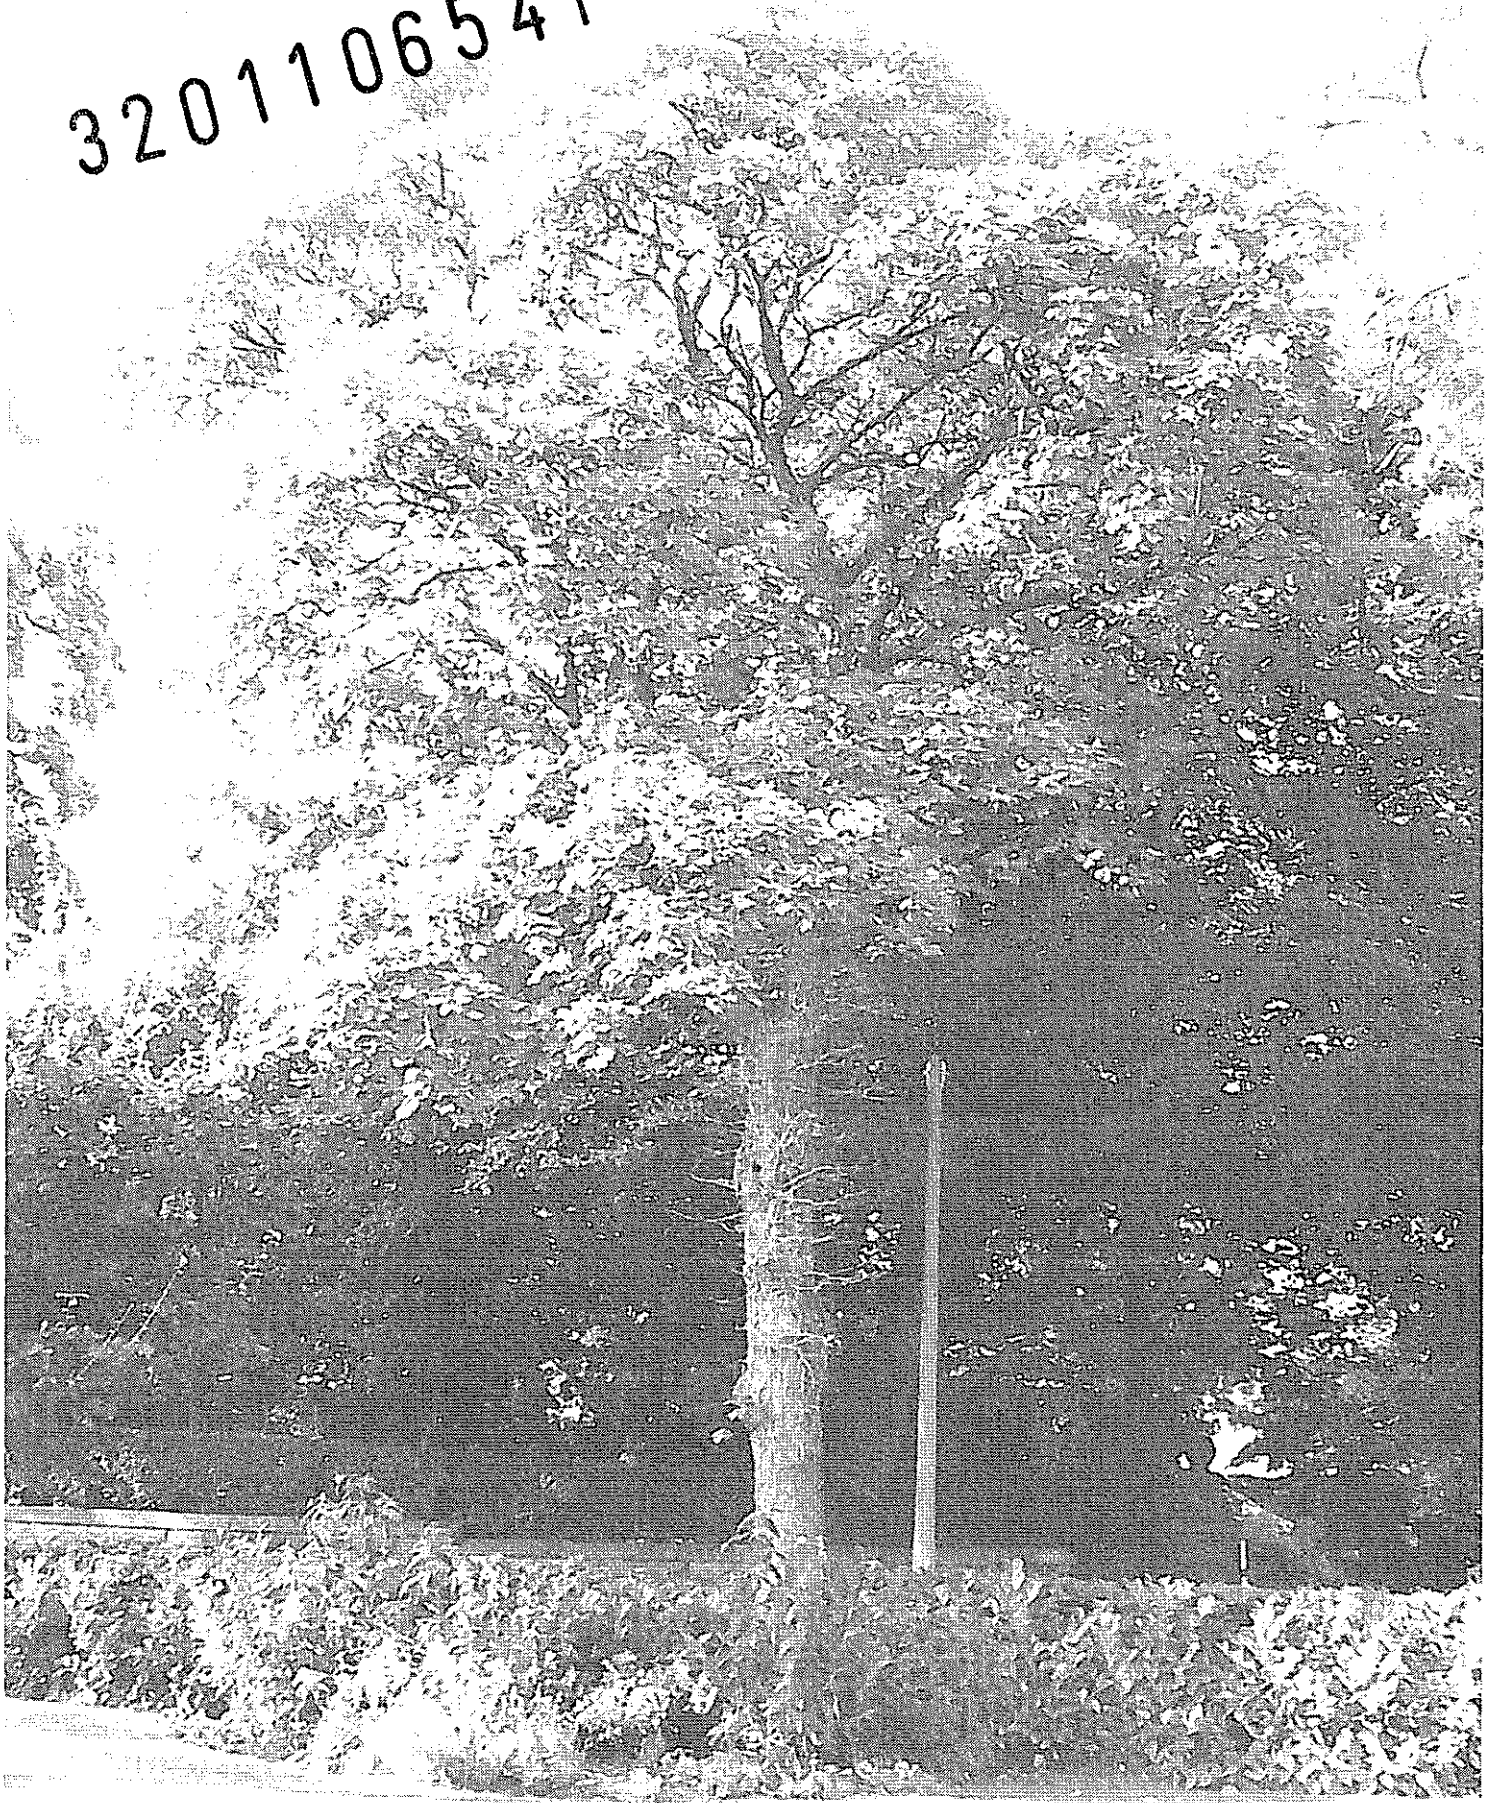
← T3 Sycamore T4 Ash

- Leaning tree – n/v
- Co- dominant stems – n/a
- Bark wounds – n/v
- Pruning cuts – crown raised to clear lamp and telephone wires
- Stem formation – no visible swellings, depressions, cracks, ribs or bulges visible
- Cavities – small cavity could be seen at approximately four metres from ground level
- Fungi – non visible

- Leaves – Average size and condition
- Buds – n/a
- Deadwood – small amount of deadwood present in the upper crown
- Weak or crossing branches – no visible signs could be seen
- Unbalanced crown slight due to neighbouring tree
- Dense crown – typical Ash, open crown with good leaf ratio
- Weak branch formation – possible weak formation in the lower crown

- Leaning tree – slight lean towards the east due to neighbouring tree
- Co dominant – co dominant main stem (x2) with v shape union at approximately four metres
- Bark wounds – n/v
- Pruning cuts – no pruning cuts visible.
- Stem formation – no visible swellings, depressions, cracks, ribs, or bulges are visible
- Cavities – n/v
- Fungi – n/v

Potential work is recognised in the form of crown raising to give clearance to high sided vehicles ( north side) and ground clearance to the south side.

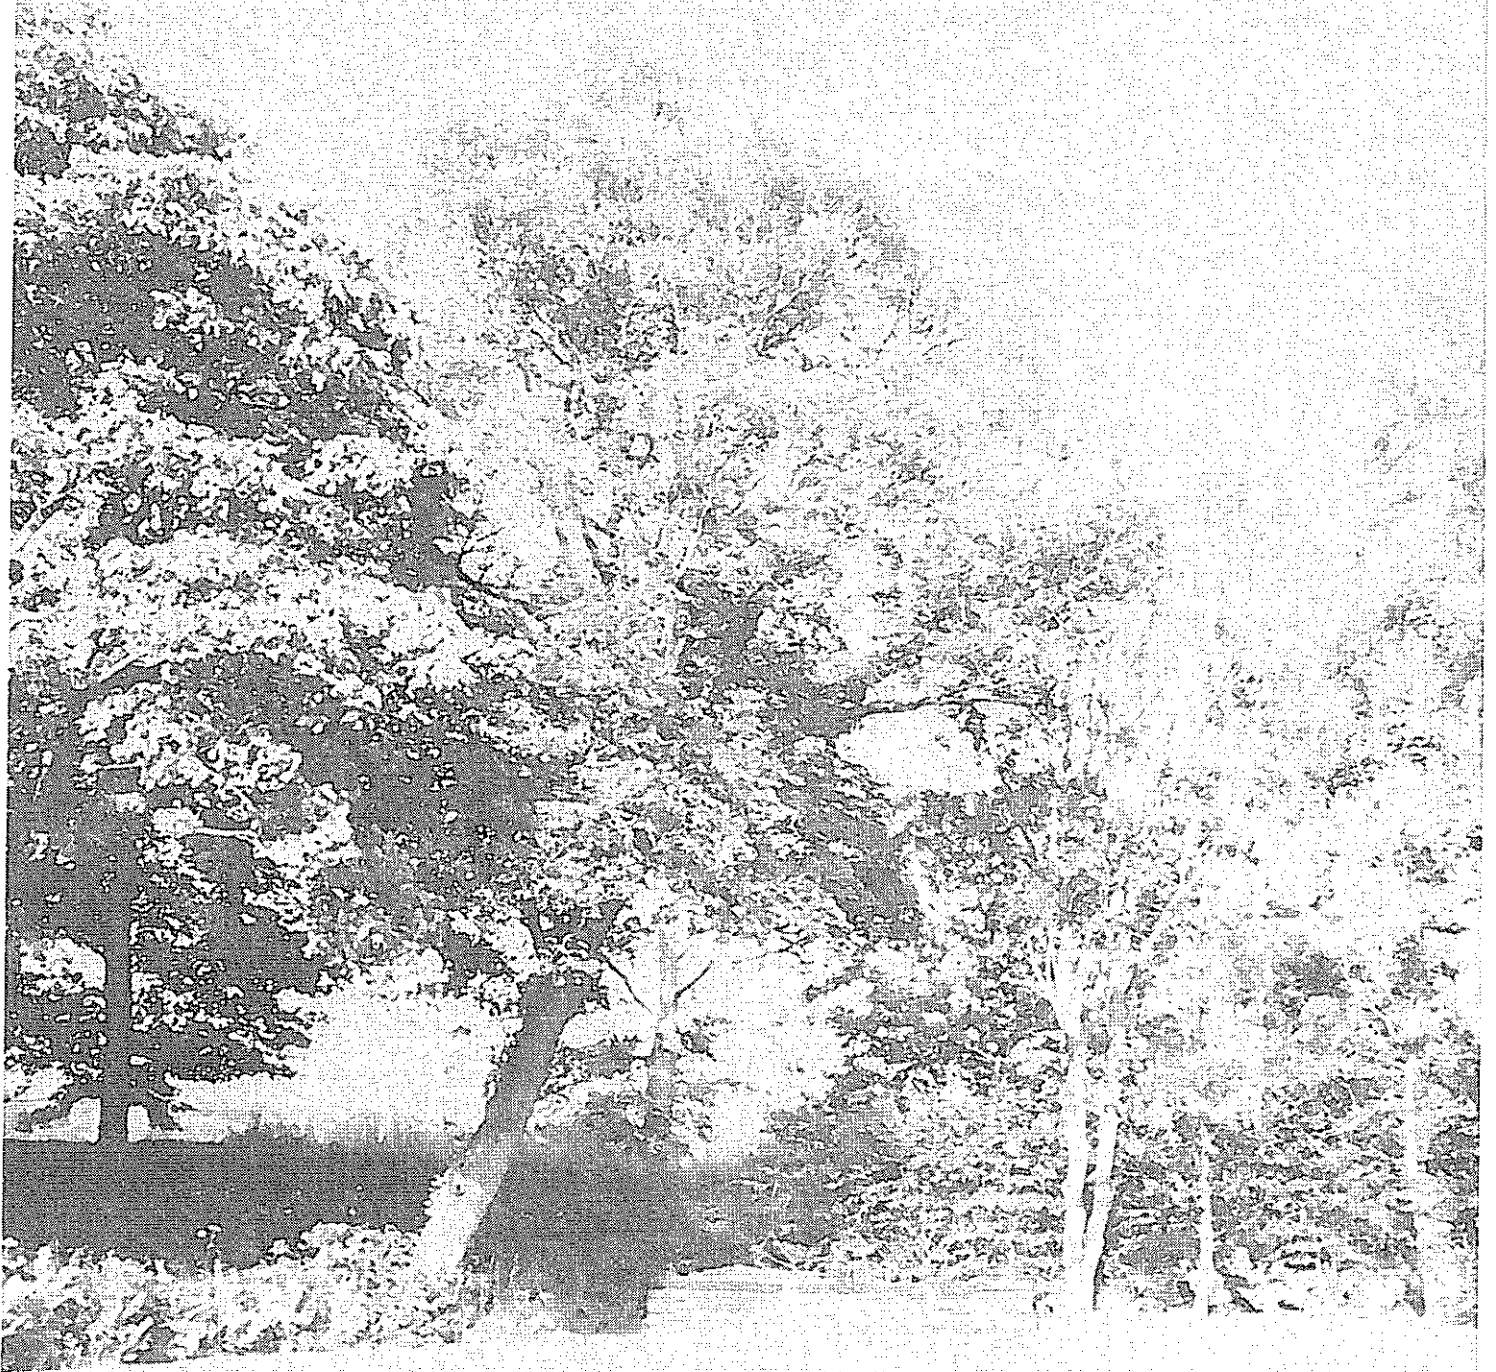
TS Sycamore

- Leaves – Average size and condition
- Buds – n/a
- Deadwood - n/v
- Weak or crossing branches – n/v
- Unbalanced crown – small but even crown
- Dense crown – visibly dense crown
- Weak branch formation – n/v

- Leaning tree – n/v
- Co dominant stems – n/v
- Bark wounds – n/v
- Pruning cuts – n/v
- Stem formation – no visible swellings, depressions, cracks, ribs, or bulges are visible
- Cavities – n/v
- Fungi – non visible at this time

**Discussion.** Tree four has been subject to a QTRA detailed tree inspection. Hazard assessment

Has been implemented and has recognised no potential hazard
