**Walker's**

**PROFESSIONAL ARBORISTS  
CONSULTANCY**

*Hazard Report*

**Hazard Survey - Mr D. Norris 41, Dilworth Lane, Longridge.**

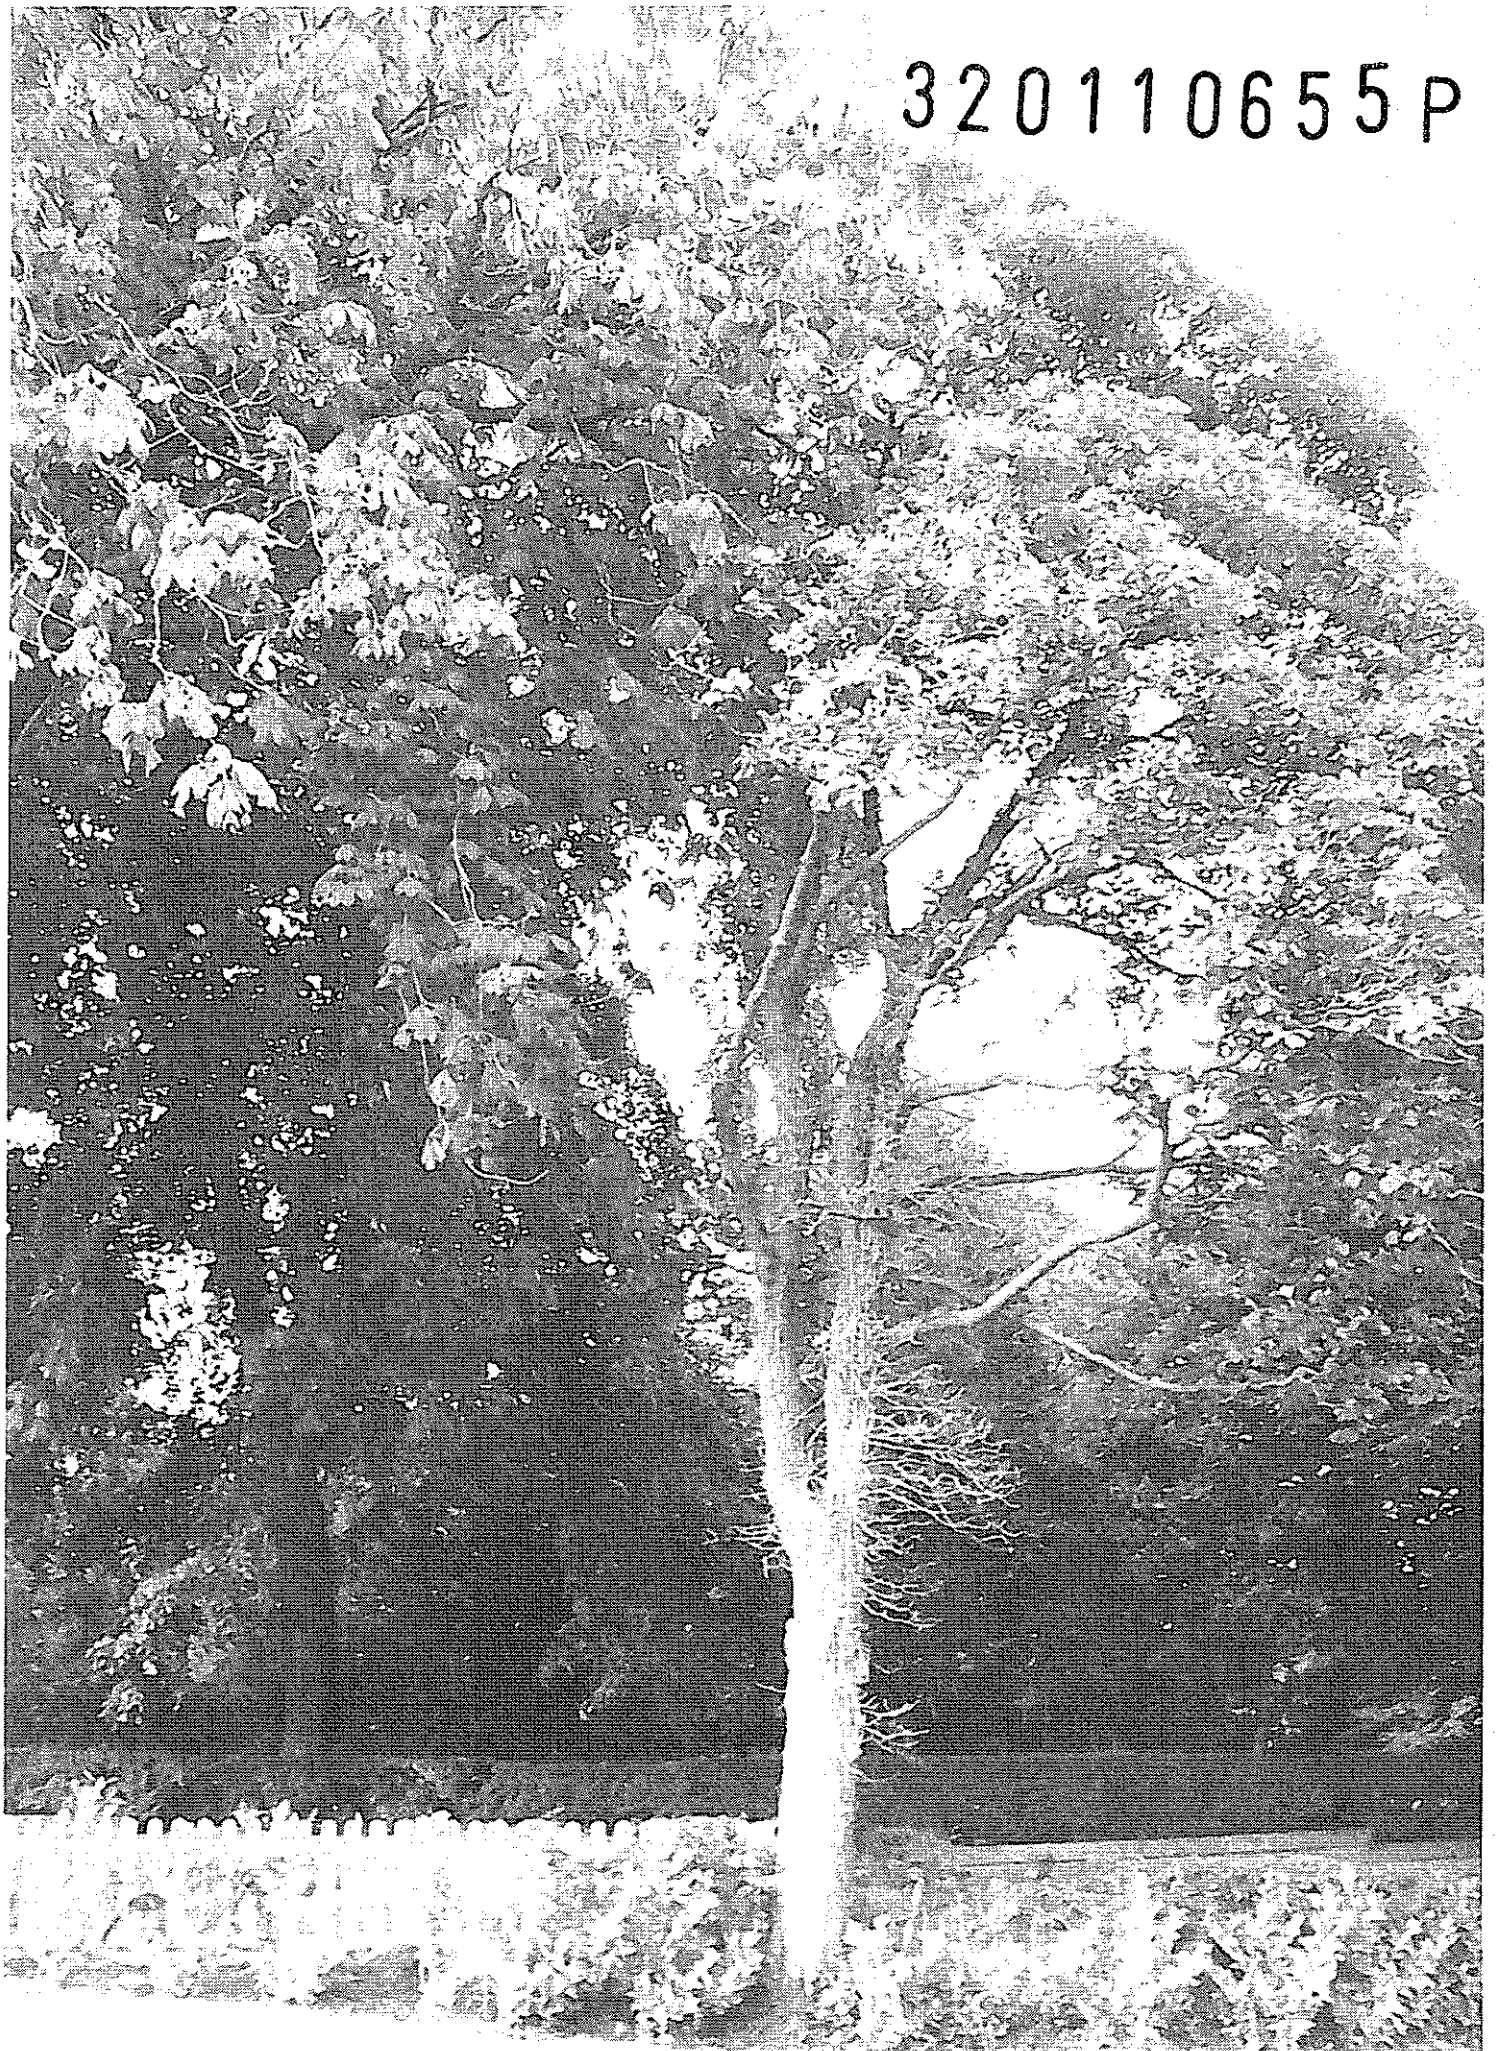
T-2. Sycamore

- Leaves – average size and condition
- Buds – n/a
- Deadwood- small amount of deadwood visible in the upper crown (25mm)
- Weak or crossing branches – no visible signs could be seen from ground level.
- Unbalanced crown – west side of crown suppressed due to the close proximity of T1
- Dense crown – east side only
- Weak branch formation. Non visible.

- Leaning tree – slight eastward lean
- Co- dominant stems –co dominant main stem (x2) with v shape union at approximately 4m.
- Bark wounds – no visible barks wounds present
- Pruning cuts – four present on lower stem.
- Stem formation – no visible swellings, depressions, cracks, ribs or bulges are visible.
- Cavities – non visible at the present time
- Fungi – non visible

Once tree 1 is removed the full extent of the crown will be revealed showing the unbalanced crown of the tree

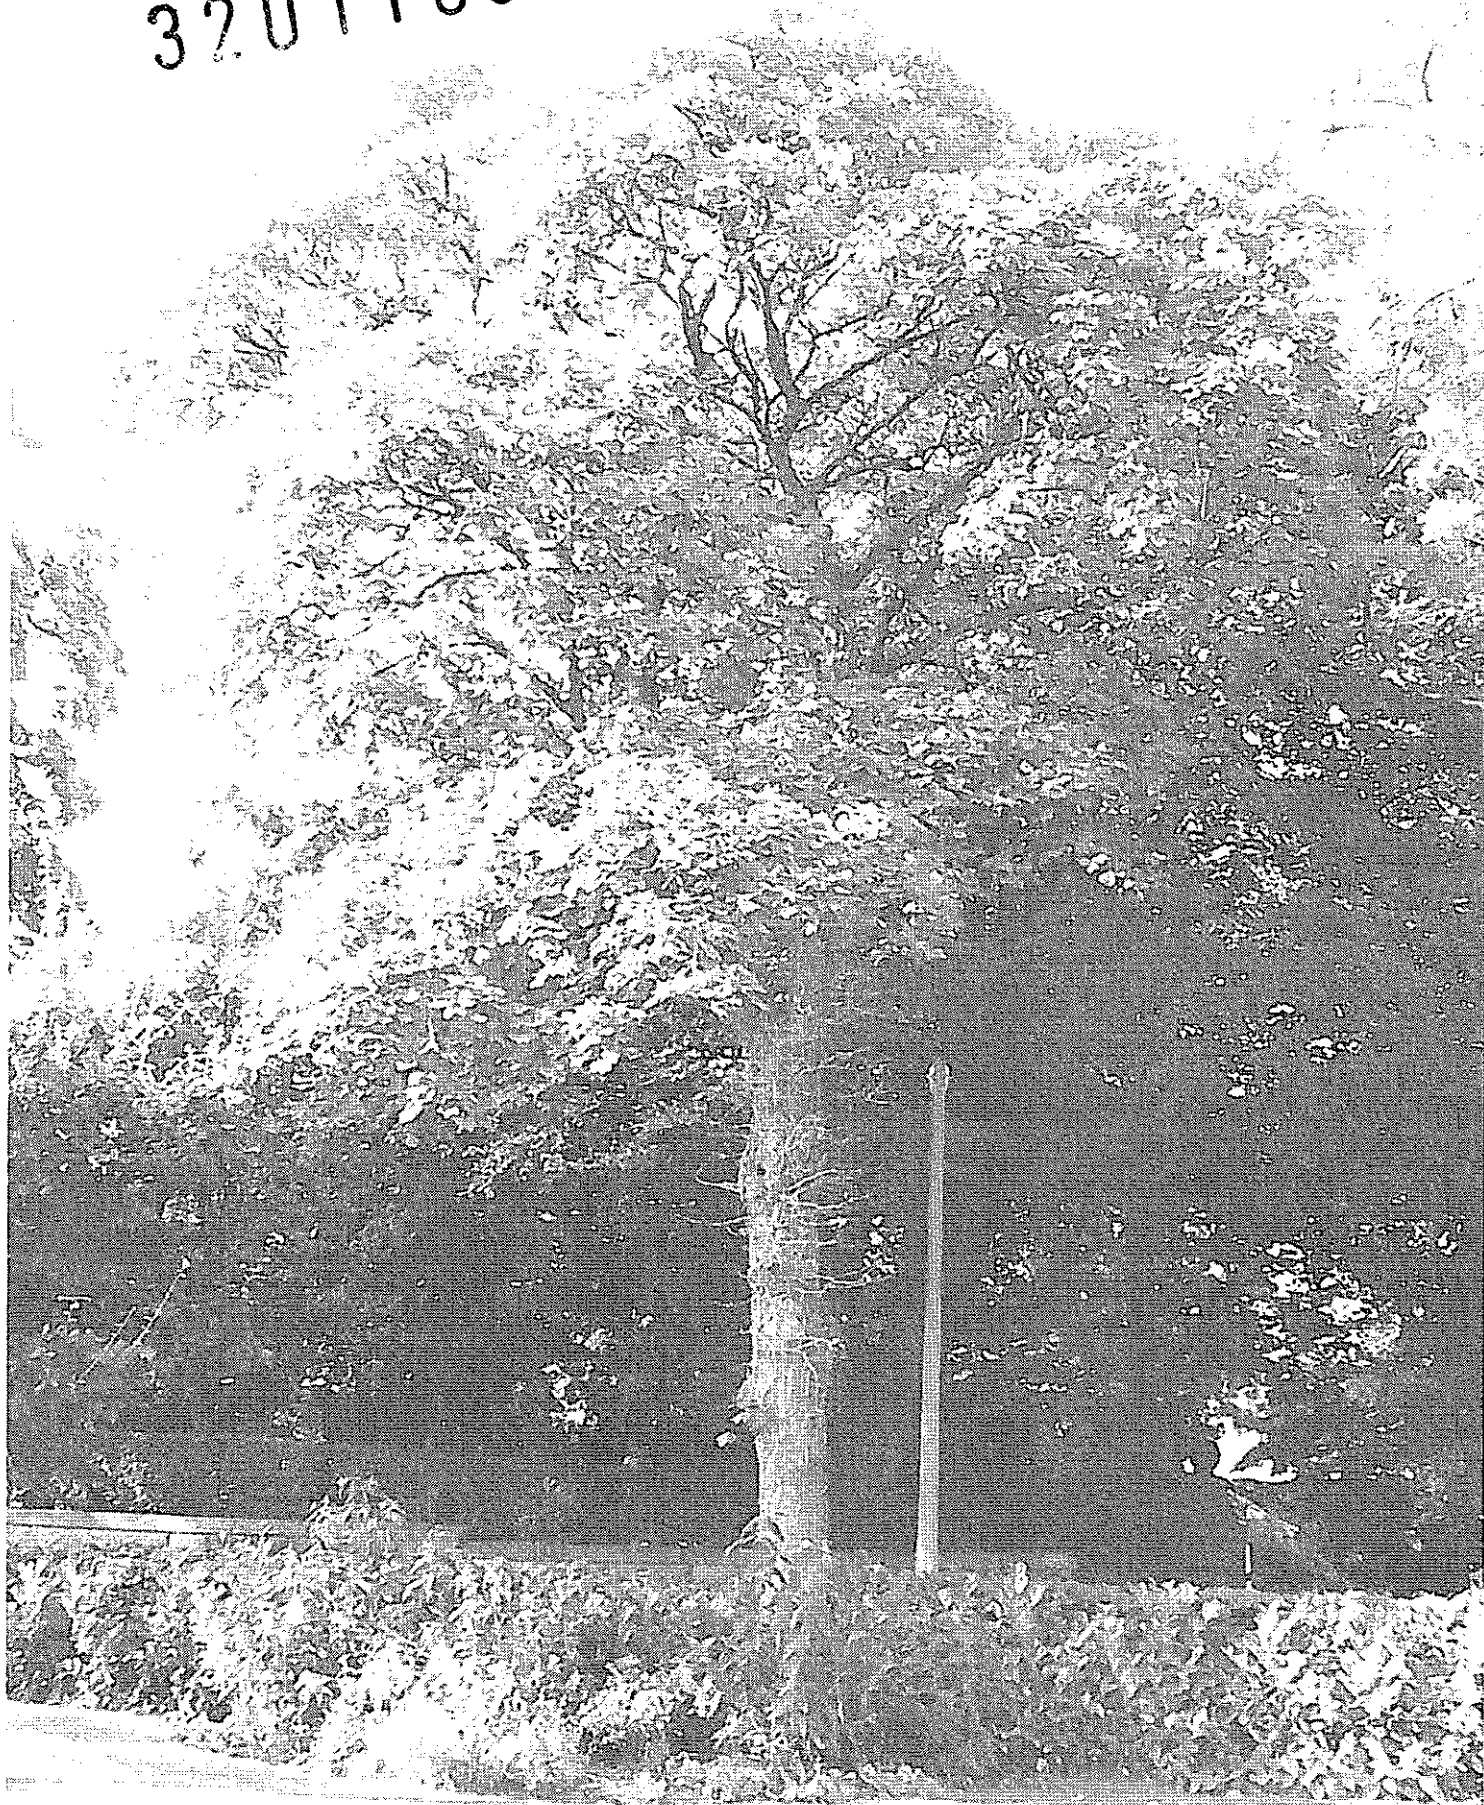
TS Sycamore

- Leaves – Average size and condition
- Buds – n/a
- Deadwood - n/v
- Weak or crossing branches – n/v
- Unbalanced crown – small but even crown
- Dense crown – visibly dense crown
- Weak branch formation – n/v

- Leaning tree - n/v
- Co dominant stems – n/v
- Bark wounds – n/v
- Pruning cuts – n/v
- Stem formation – no visible swellings, depressions, cracks, ribs, or bulges are visible
- Cavities – n/v
- Fungi – non visible at this time

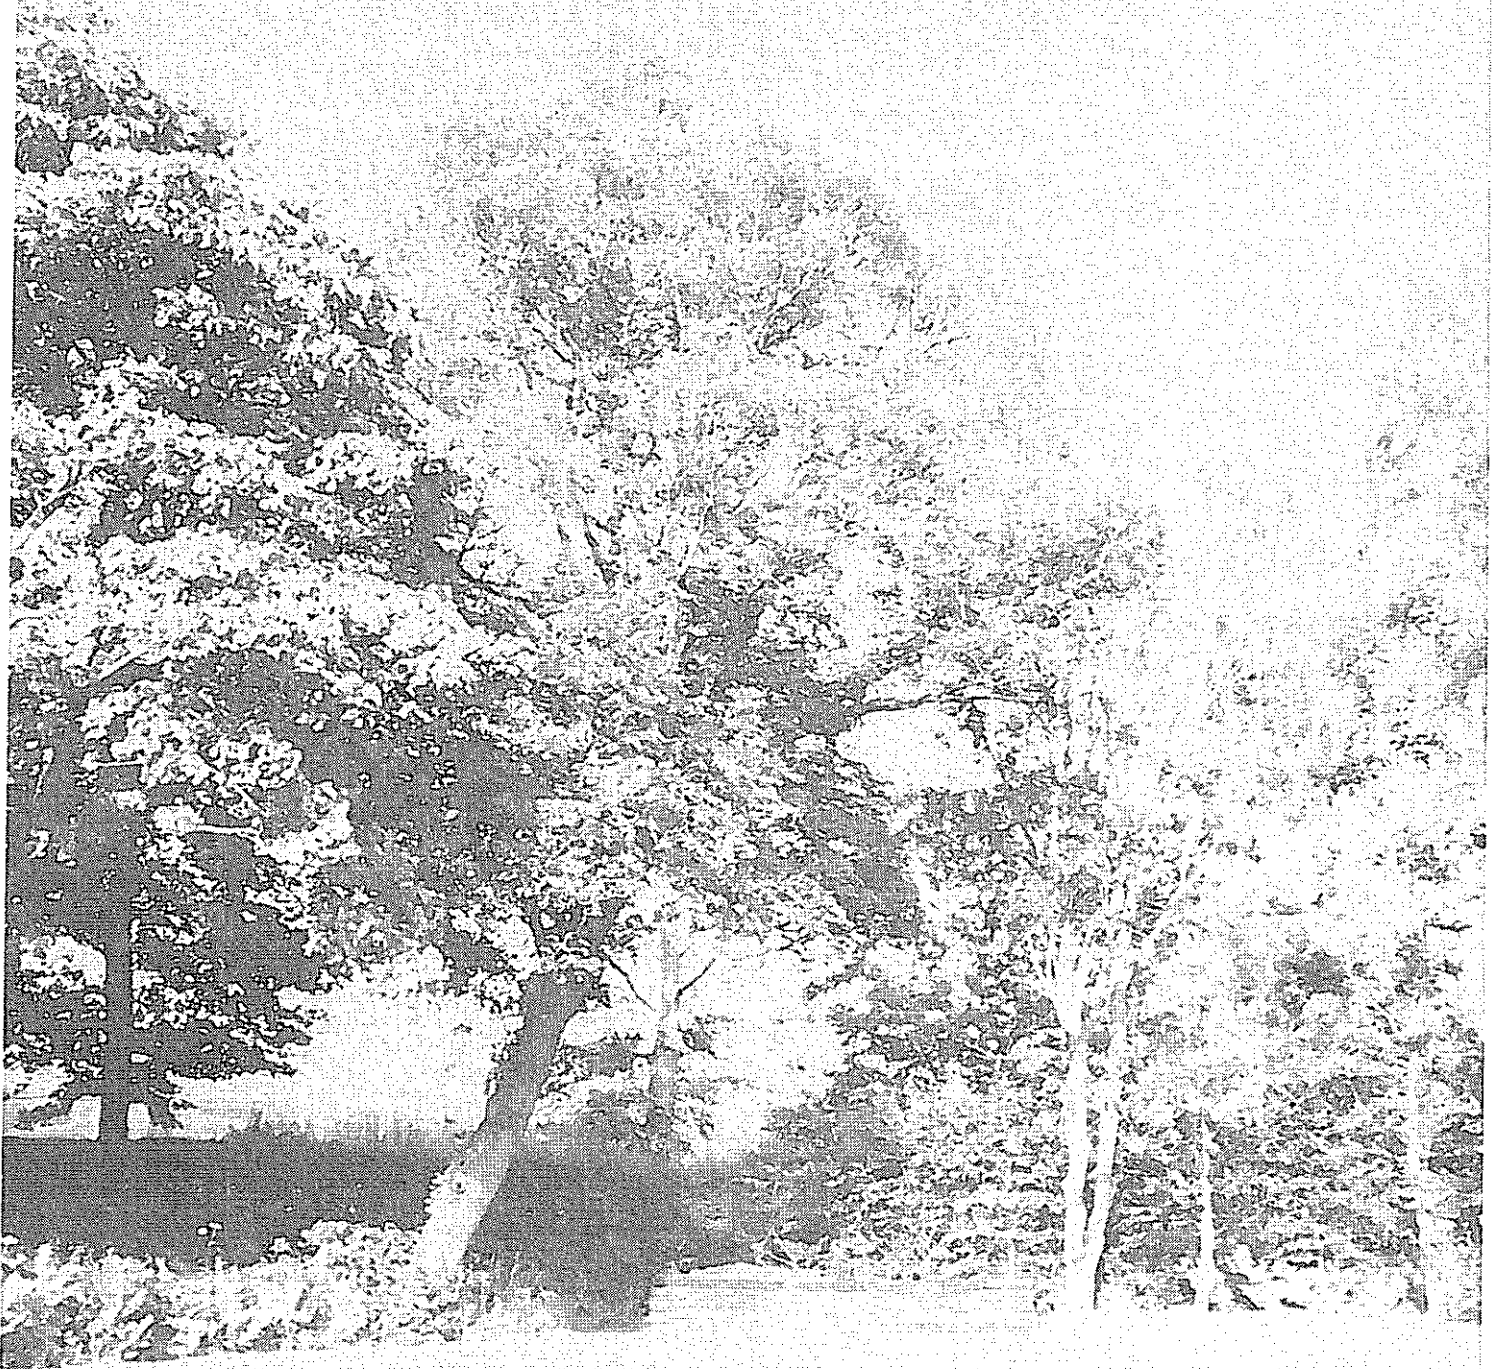
T6 Line

- Leaning tree -- thirty five degree lean to the east
- Co dominant stem n/a
- Bark wounds – n/a
- Pruning cuts – n/a
- Stem formation – no visible swellings, depressions, cracks, rib or bulges visible
- Cavities – small cavity could be seen on the main trunk at a height of approximately
- Four metres with the callusing of the old wound almost complete
- Fungi – none visible at this time

**Discussion** – Tree 6 has been subject to a QTRA detailed tree inspection. Hazard assessment has been implemented and has recognised potential parts of failure in time due to the angle of the main trunk.
