**PROFESSIONAL ARBORISTS  
CONSULTANCY**

## *Hazard Report*

**Hazard Survey - Mr D. Norris 41, Dilworth Lane, Longridge.**

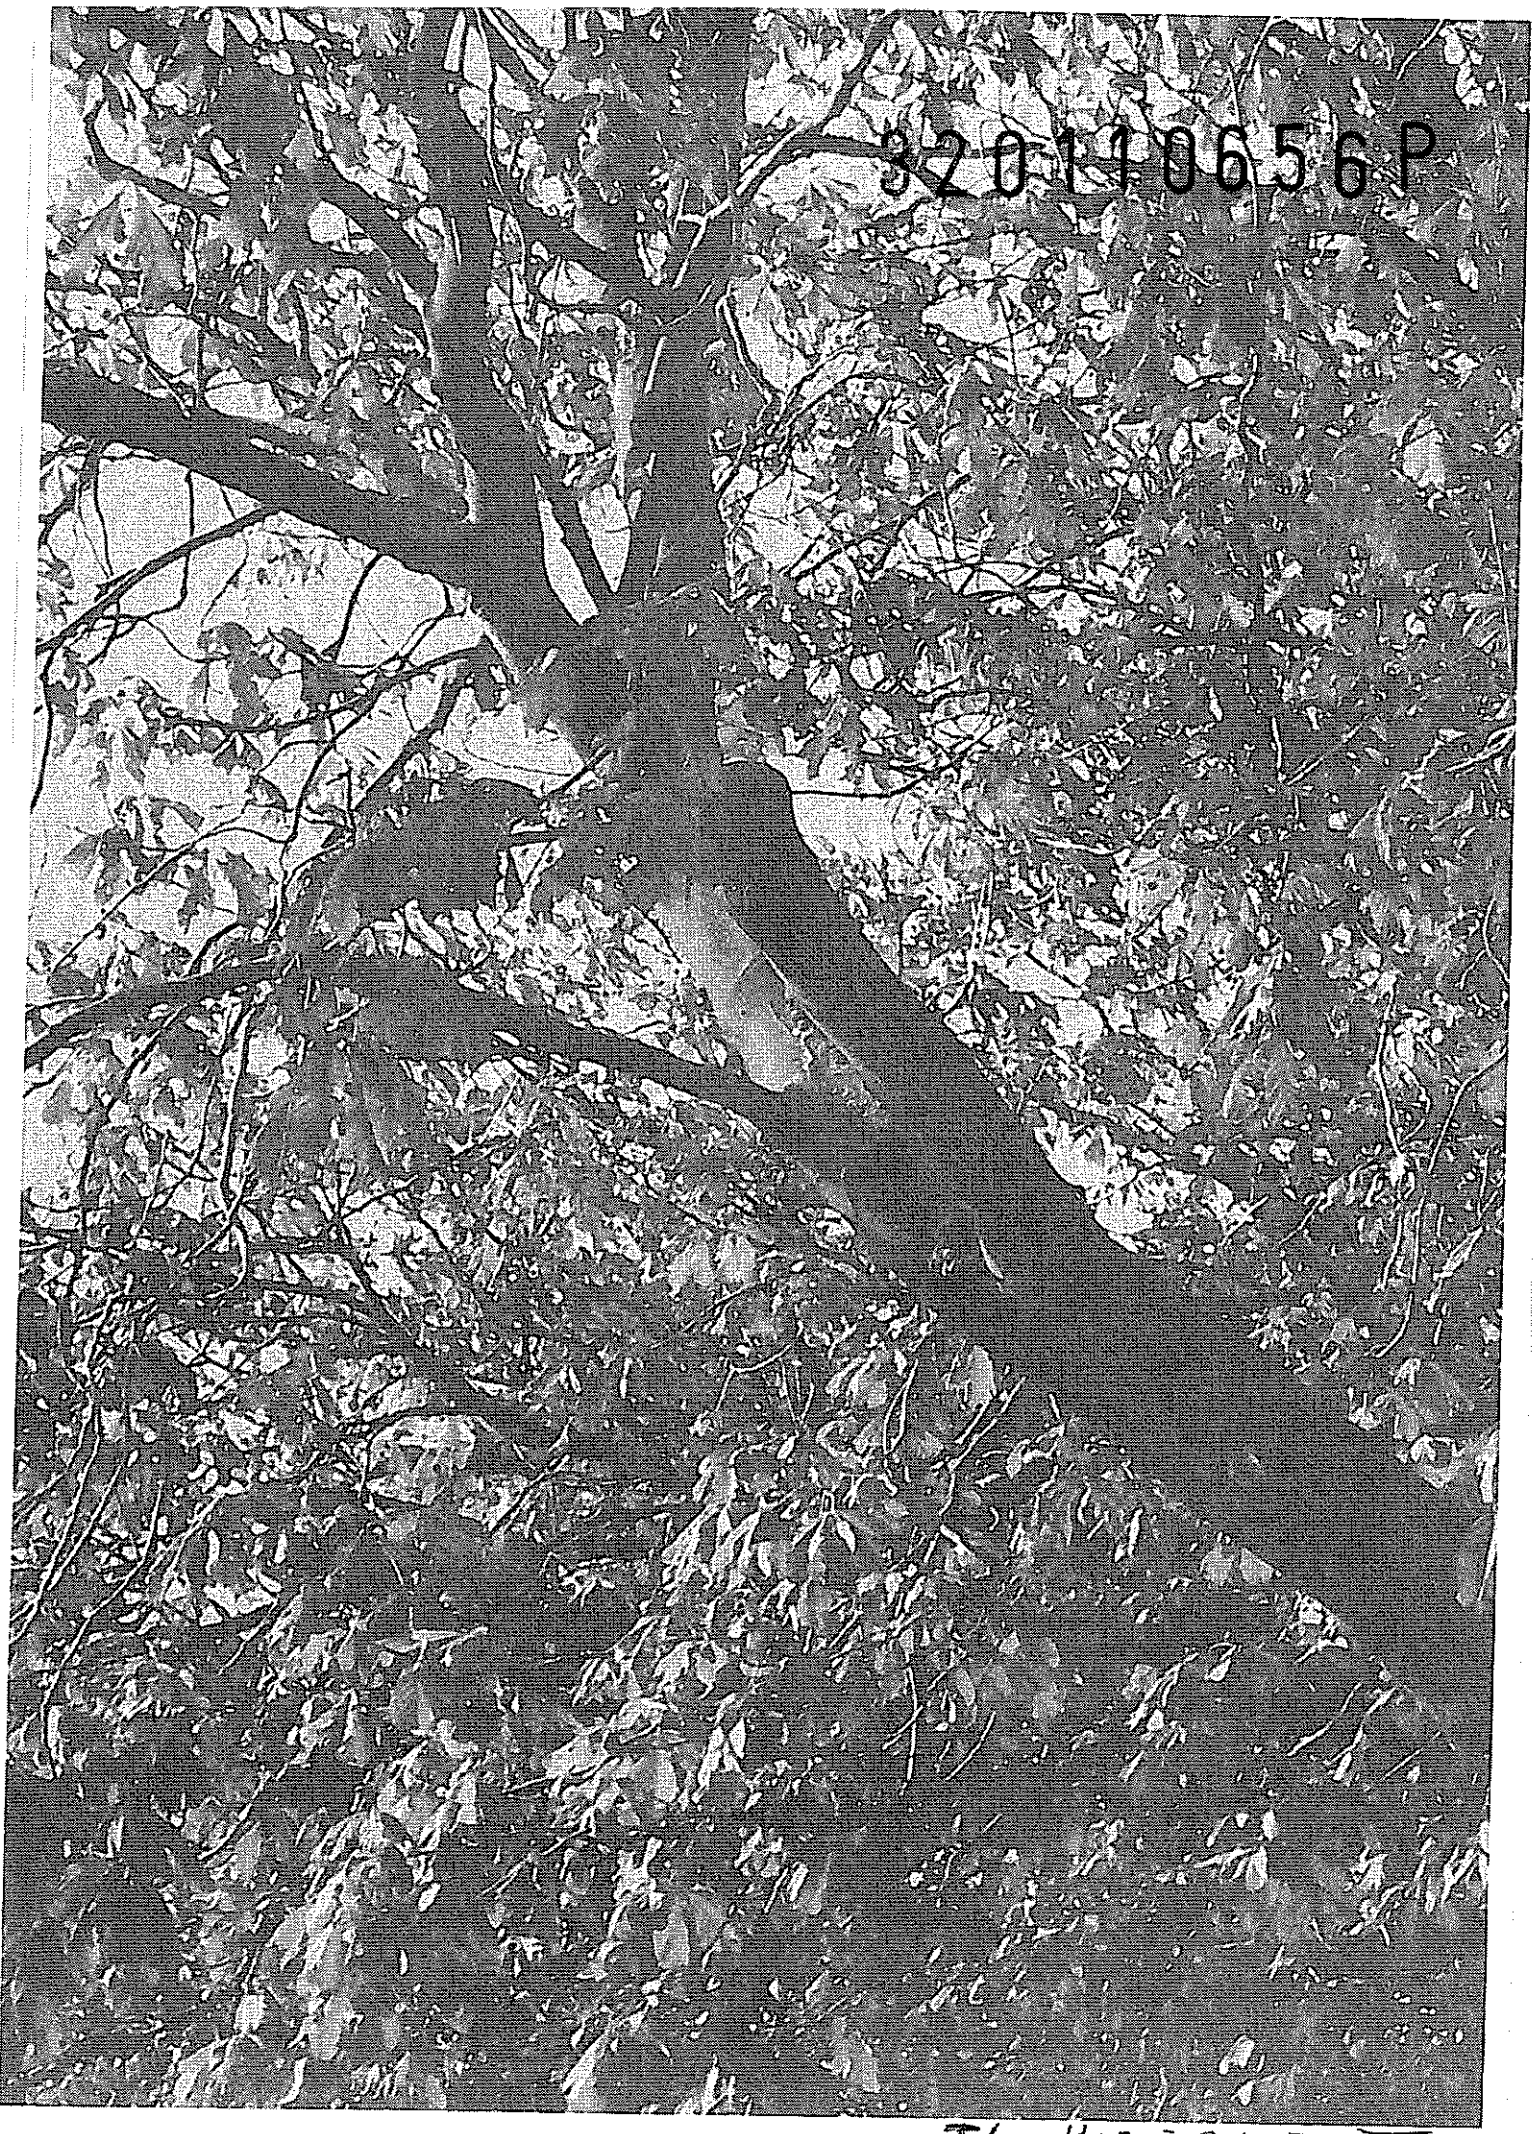
T1 HORSE CHESTNUT

- Leaves - West side of the crown showing signs of Phytophthora , wilting, early leaf fall
- Buds – n/a
- Deadwood – Large amount of deadwood present in the west side of the canopy up to 1.50m
- Weak or Crossing Branches – Canopy has some crossing branches. Considered to pose slight risk
- Unbalanced Crown -- Slight due to position of neighbouring tree
- Dense Crown – Visibly dense crown to the east side of the crown.

- Leaning Tree – Slight southward lean
- Single stem
- Pruning Cuts – Two present on lower main stem
- Stem Formations – No visible swellings, depressions, cracks, ribs or bulges are visible
- Cavities – None visible
- Fungi – Black weeping fungal spots present in the east side of the crown.

Tree has a large widespread crown with major limb extension. Closer inspection has determined the cause for concern in the form of weeping black fungal spores visible on the main branches in one area.

Trees canopy is holding major limb structures over a public road and footpath.

The large limb structures have been the basis of QTRA hazard analysis used in this report. The tree hazard rating is below the, (1; 72,000) what is considered as 'acceptable risk by the HSE',

This particular fungus will, eventually envelope the whole tree in time resulting in the trees death.

Therefor taking all these facts into considerations I would strongly recommend that the tree should be removed.

| Tree No. & Species | H | Cir | Branch Spread | H C.C | Age | P.C | Condition | Recommendations | ERC | Cat Grade | RPA Radius | RPA M |
|---|---|---|---|---|---|---|---|---|---|---|---|---|
| <b>T1. H/Chestnut</b><br><b>Aesculus hippocastanum</b> | 16.60m | 3.2m | EW.23m<br>NS.15m | 5.5m | M | P | Suffering from Phytophthora | Section fell to ground level | Less than 10 | | | |

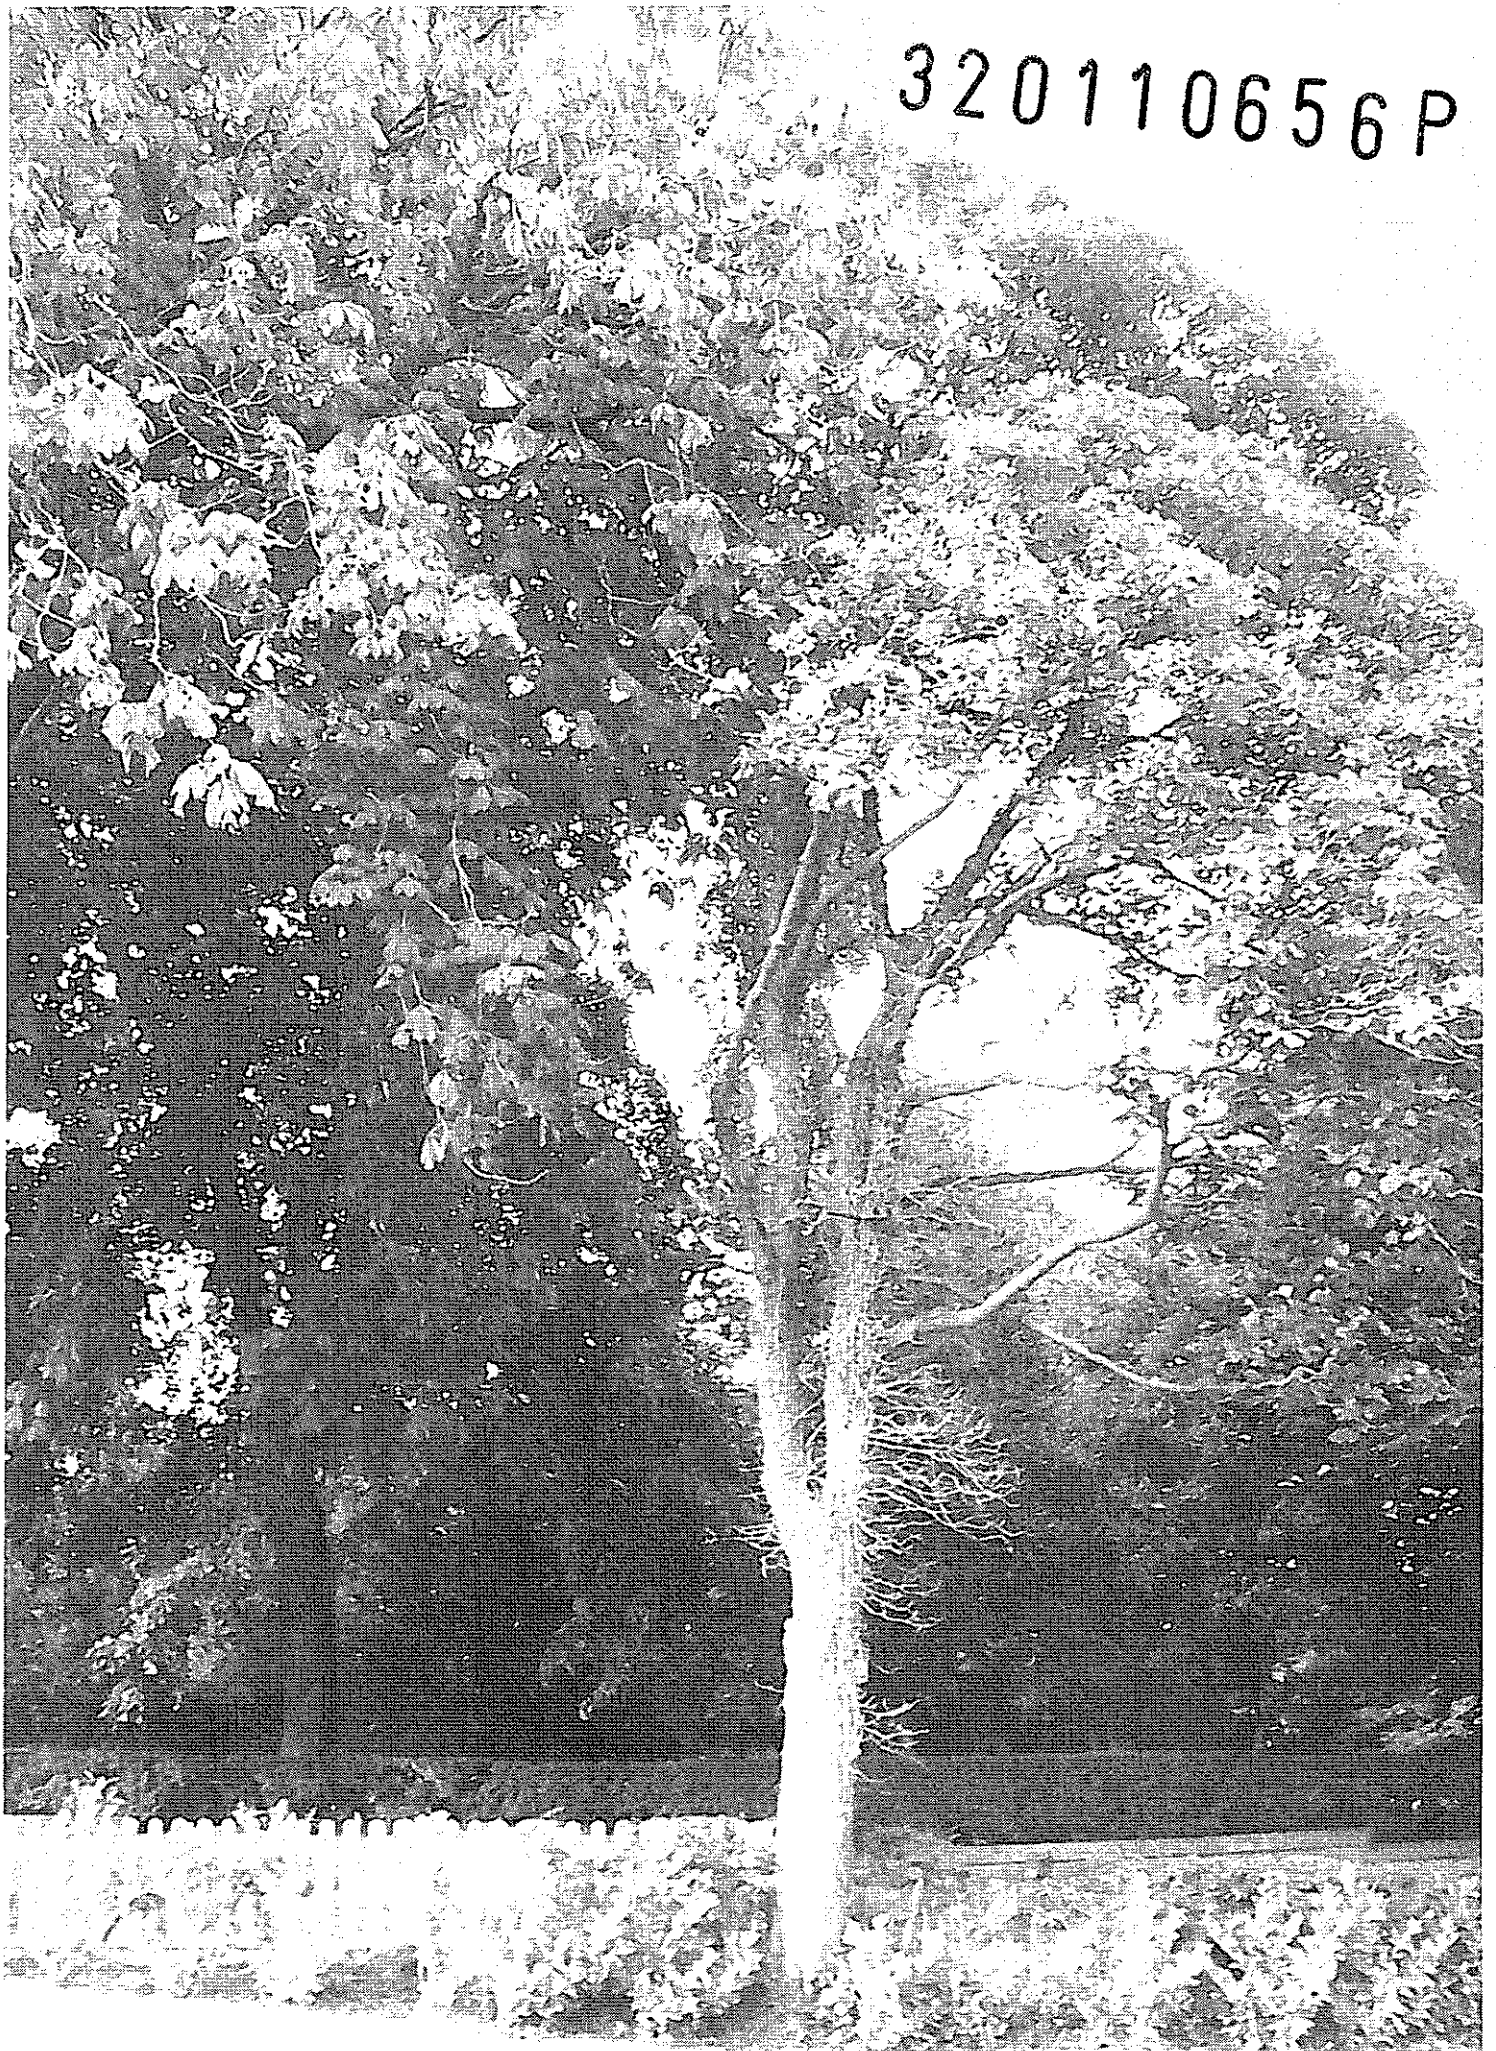
T.2. Sycamore

- Leaves – average size and condition
- Buds – n/a
- Deadwood- small amount of deadwood visible in the upper crown (25mm)
- Weak or crossing branches – no visible signs could be seen from ground level
- Unbalanced crown – west side of crown suppressed due to the close proximity of T1
- Dense crown – east side only
- Weak branch formation Non visible

- Leaning tree – slight eastward lean
- Co- dominant stems –co dominant main stem (x2) with v shape union at approximately 4m.
- Bark wounds – no visible barks wounds present.
- Pruning cuts – four present on lower stem
- Stem formation – no visible swellings, depressions, cracks, ribs or bulges are visible.
- Cavities – non visible at the present time.
- Fungi – non visible.

- Climbing plants – Ivy has been removed from the lower stem leaving the upper crown foliage to die back.
- Surrounding hazards – Structures situated to the north of the tree fence and main road.

Once tree 1 is removed the full extent of the crown will be revealed showing the unbalanced crown of the tree

| Tree No. & Species | H | Cir | Branch Spread | H C.C | Age | P.C | Condition | Recommendations | ERC | Cat Grade | RPA Radius | RPA M |
|---|---|---|---|---|---|---|---|---|---|---|---|---|
| <b>T2. Sycamore</b><br><b>Acer psuedoplatanus</b> | 13.83m | 1.68m | EW.7.8m<br>NS.8.28m | 4.6m | EM | P | Suppressed tree | Section fell to ground level | 40 | | | |

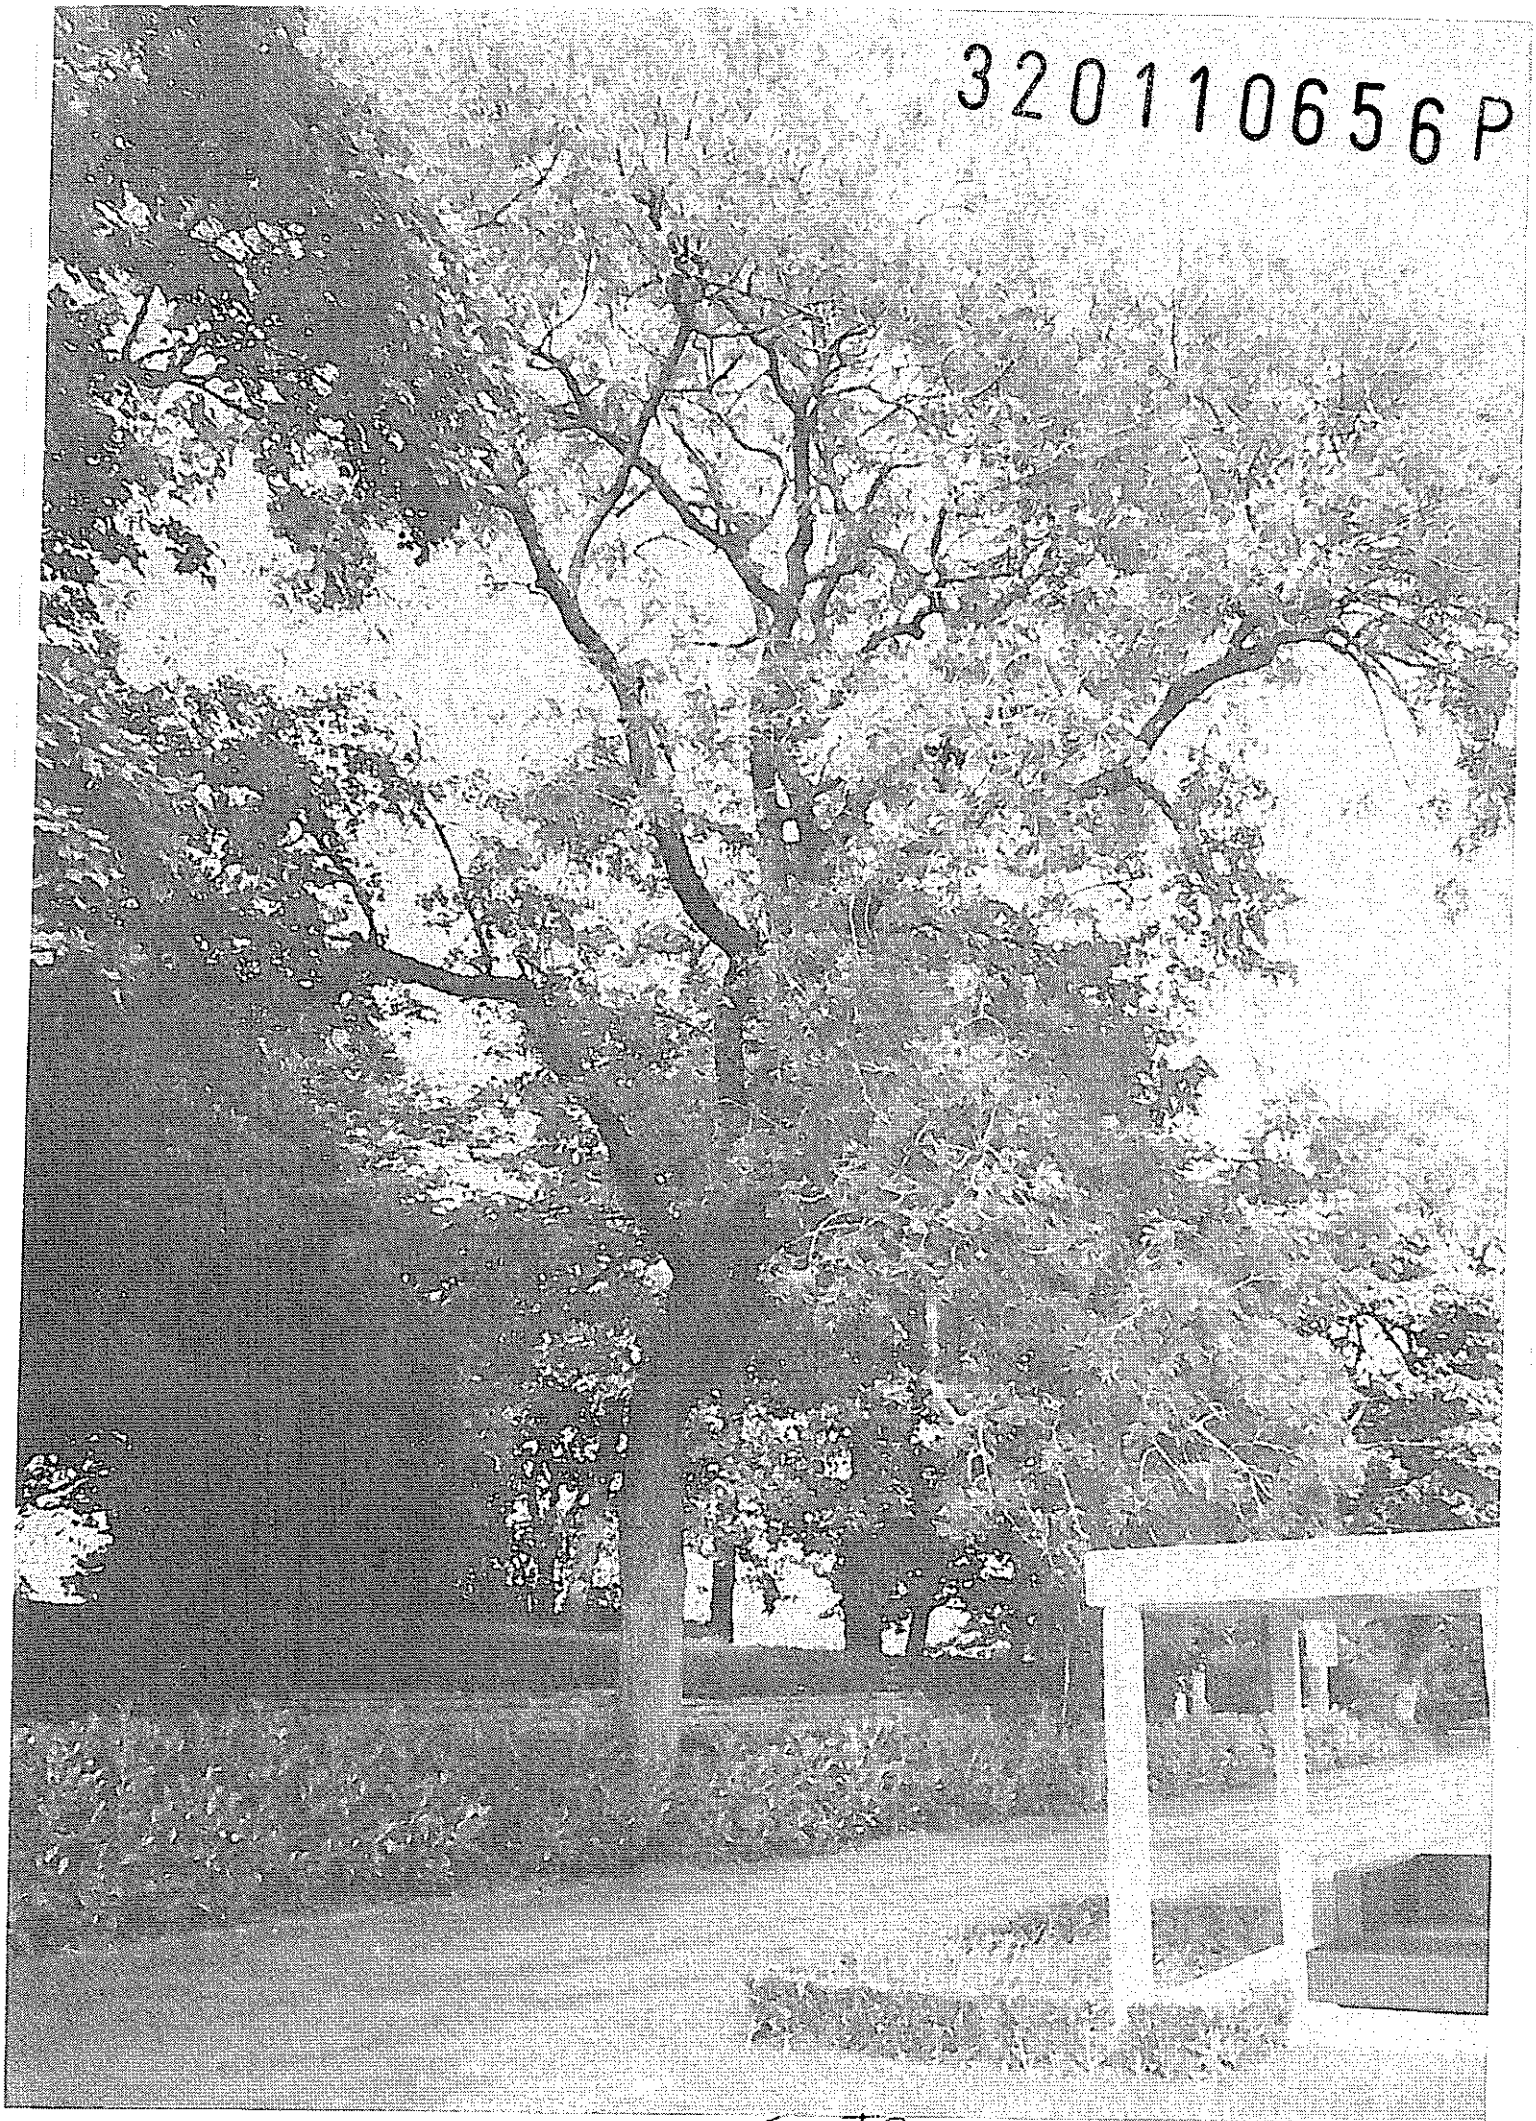
← T3 Sycamore T4 Ash

- Leaning tree – n/v
- Co- dominant stems – n/a
- Bark wounds – n/v
- Pruning cuts – crown raised to clear lamp and telephone wires
- Stem formation – no visible swellings, depressions, cracks, ribs or bulges visible
- Cavities – small cavity could be seen at approximately four metres from ground level
- Fungi – non visible

- Leaves – Average size and condition
- Buds – n/a
- Deadwood – small amount of deadwood present in the upper crown
- Weak or crossing branches – no visible signs could be seen
- Unbalanced crown slight due to neighbouring tree
- Dense crown – typical Ash, open crown with good leaf ratio
- Weak branch formation – possible weak formation in the lower crown

- Leaning tree – slight lean towards the east due to neighbouring tree
- Co dominant – co dominant main stem (x2) with v shape union at approximately four metres
- Bark wounds – n/v
- Pruning cuts – no pruning cuts visible
- Stem formation – no visible swellings, depressions, cracks, ribs, or bulges are visible
- Cavities – n/v
- Fungi – n/v

Potential work is recognised in the form of crown raising to give clearance to high sided vehicles ( north side) and ground clearance to the south side.

| Tree No. & Species | H | Cir | Branch Spread | H C.C | Age | P.C | Condition | Recommendations | ERC | Cat Grade | RPA Radius | RPA M |
|---|---|---|---|---|---|---|---|---|---|---|---|---|
| <b>T4. Ash</b><br><b>Fraxinus excelsior</b> | 15.6m | 2.3m | EW. 21.6<br>NS.12.8m | 5.5m | M | M | Moderate condition | Crown raise and crown clean | 40 | | | |

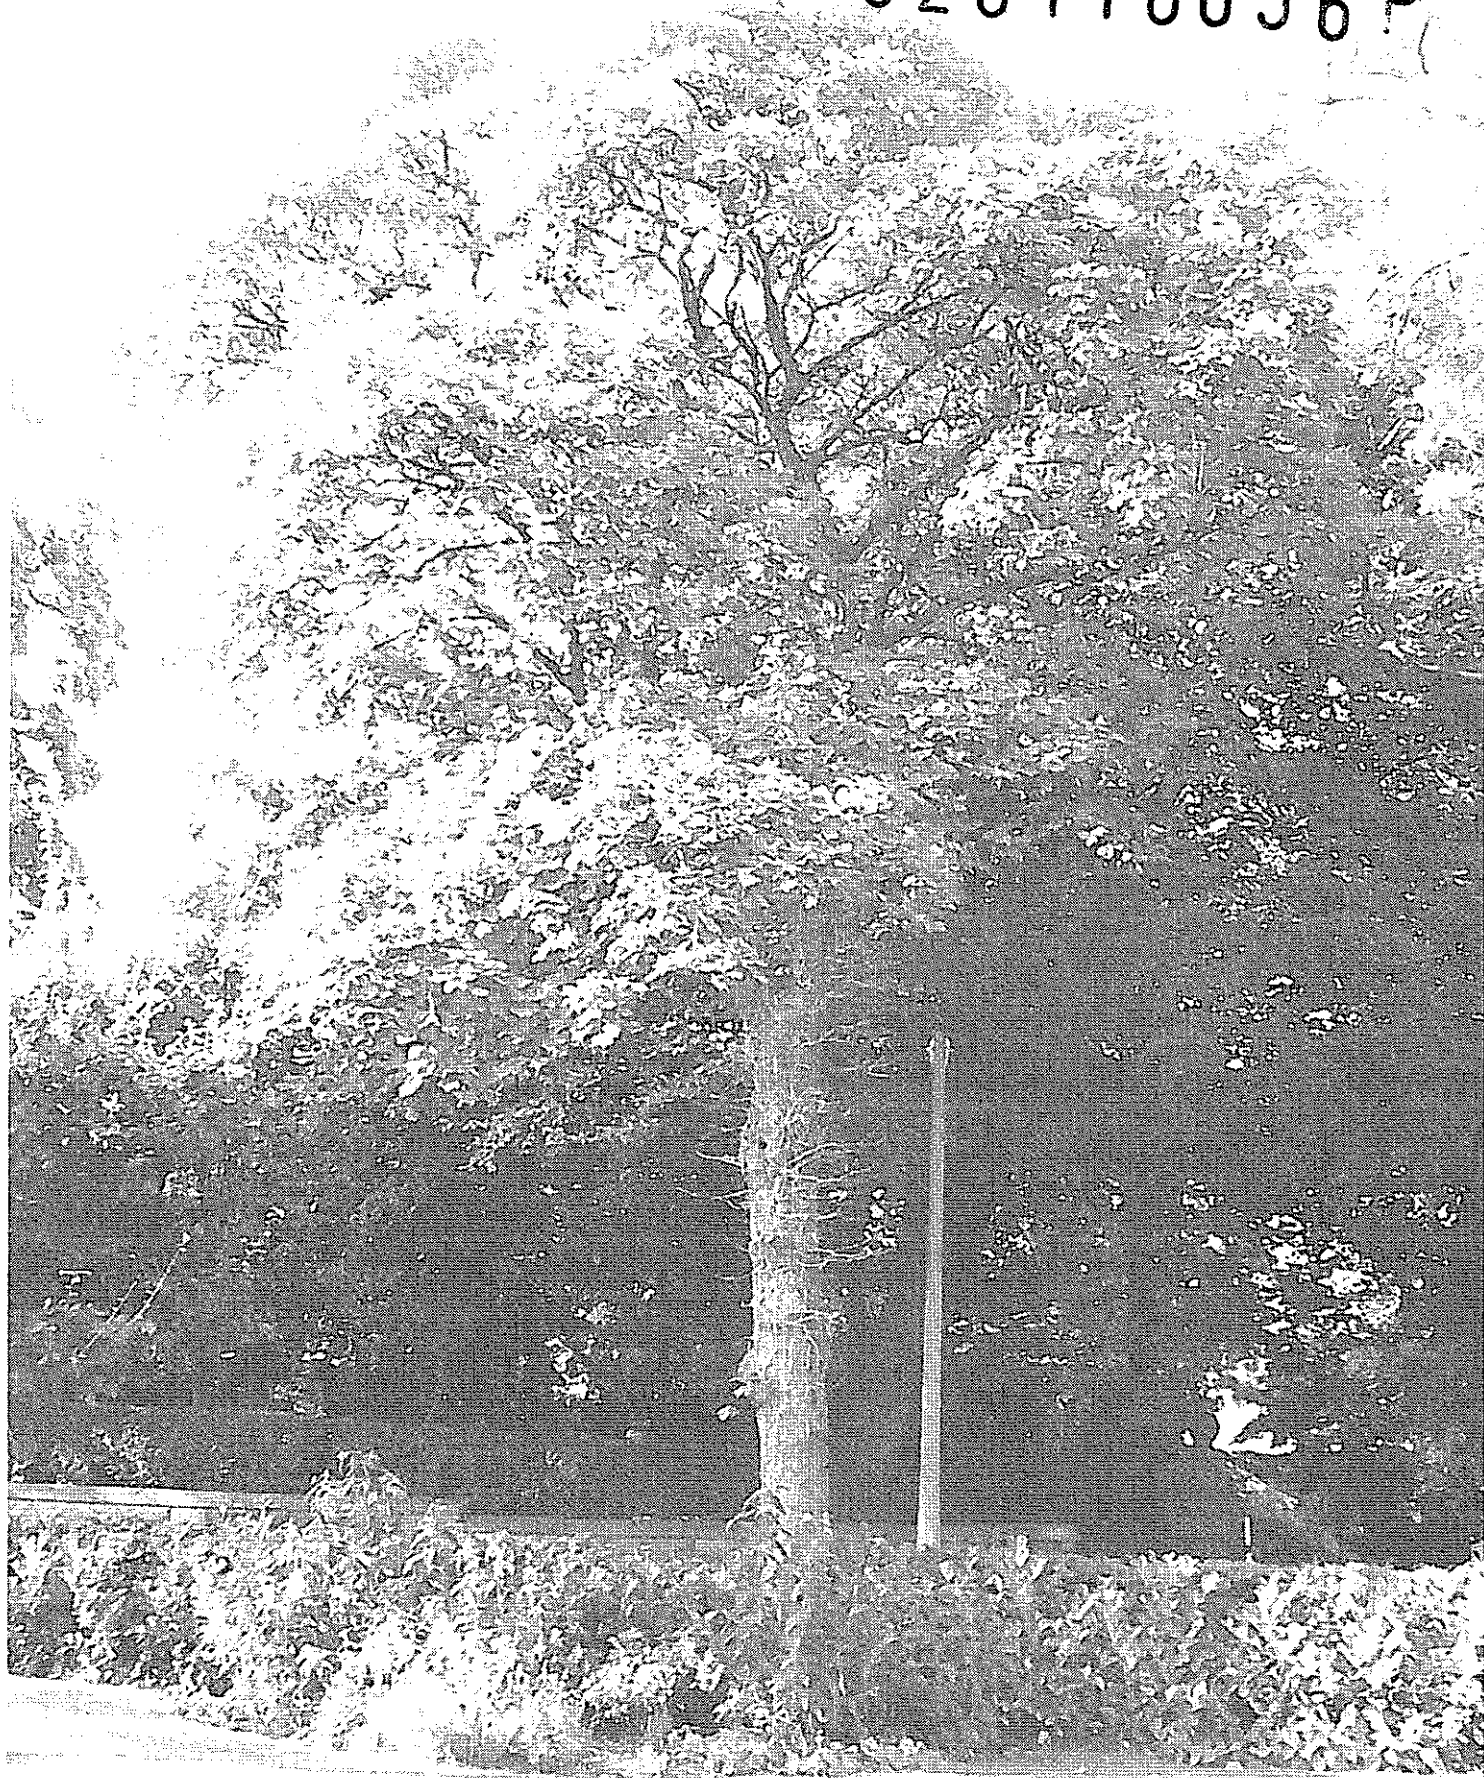
TS Sycamore

**Discussion.** Tree four has been subject to a QTRA detailed tree inspection. Hazard assessment

Has been implemented and has recognised no potential hazard

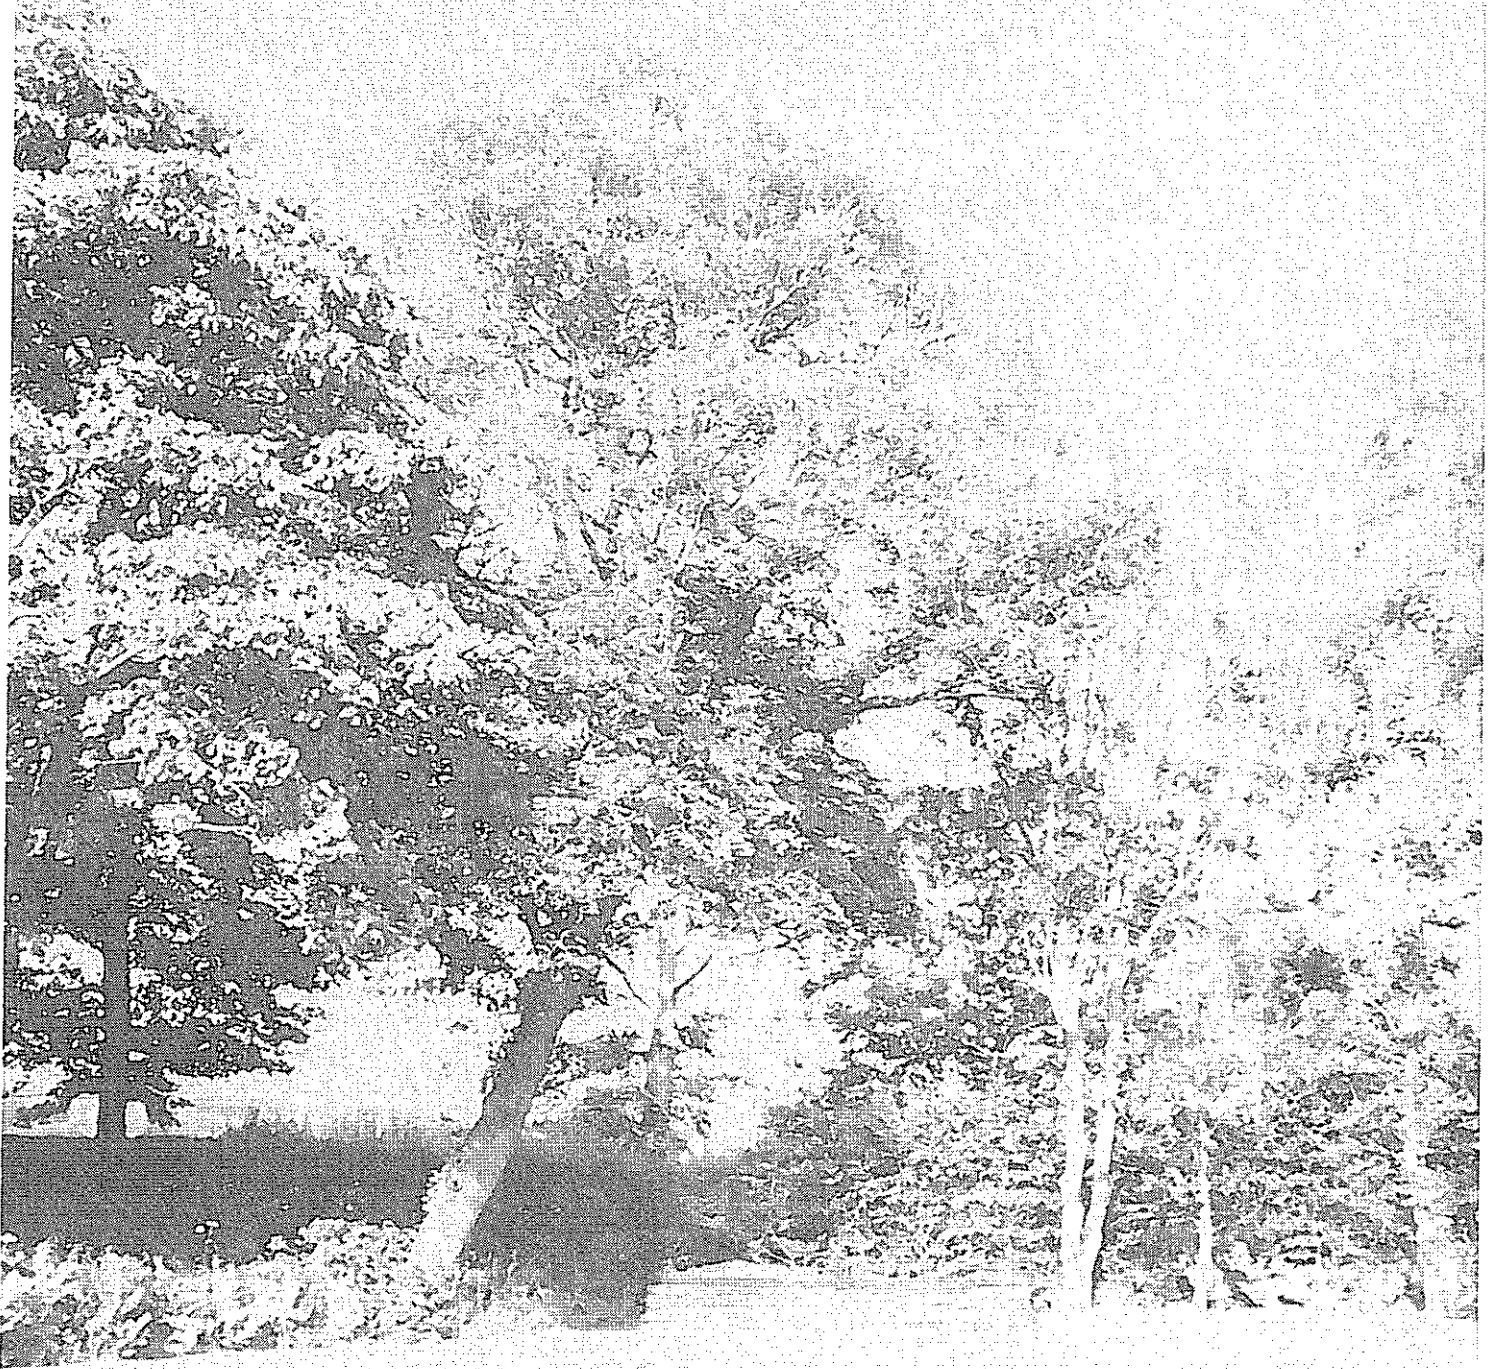
T6 Line

- Leaves – average size and condition
- Buds – n/a
- Deadwood - small amount of deadwood could be seen in the upper crown
- Weak or crossing branches – canopy has some crossing branches considered to pose slight risk
- Unbalanced crown – n/v
- Dense crown - visibly dense crown
- Weak branch formation – possible weak formation in mid crown

- Leaning tree -- thirty five degree lean to the east
- Co dominant stem. n/a
- Bark wounds – n/a
- Pruning cuts – n/a
- Stem formation – no visible swellings, depressions, cracks, rib or bulges visible
- Cavities – small cavity could be seen on the main trunk at a height of approximately
- Four metres with the callusing of the old wound almost complete
- Fungi -- none visible at this time

**Discussion** – Tree 6 has been subject to a QTRA detailed tree inspection. Hazard assessment has been implemented and has recognised potential parts of failure in time due to the angle of the main trunk

| Tree No. & Species | H | Cir | Branch Spread | H C.C | Age | P.C | Condition | Recommendations | ERC | Cat Grade | RPA Radius | RPA M |
|---|---|---|---|---|---|---|---|---|---|---|---|---|
| <b>T6. Lime</b><br><b>Tilia europaea</b> | 13.5m | 1.9m | EW.13.9m<br>NS. 11m | 4.2m | M | M | Moderate condition | Crown raise crown clean and monitor the angle of lean (stem) | 40 | | | |
