## STRUCTURAL APPRAISAL REPORT

Aspinalls Farm, Kenyon Lane, Dinckley, Blackburn, BB6 8AN.

IN RELATION TO A PROPOSED RE-SUBMISSION PLANNING  
APPLICATION FOR THE CONVERSION OF TWO  
TRADITIONAL FARM BUILDINGS, INTO TWO FOUR  
BEDROOMED RESIDENTIAL DWELLINGS.

Prepared by: Andrew Mitchell for and on behalf of Gary Hoerty Associates  
Our Ref: Sim/477/1208/AJM  
Date: August 2011  
Client: Messrs Simpson

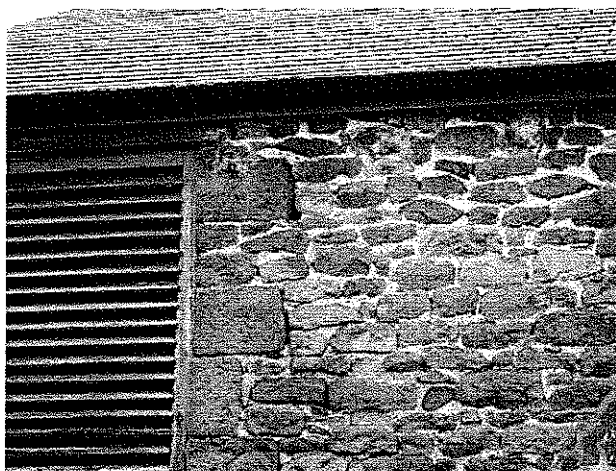
- 5.2 The external wall to barn 1 is in a reasonable condition with little evidence of any significant structural cracking or any signs of outward deflection. There are some localised areas of re-pointing required, where mortar has blown and come out of the joint. The window and door openings also appear to be in a reasonable condition with little evidence of any significant structural cracking around the openings or any signs of dropped lintels & sills. It was noted that there is some minor cracking within the mortar around the openings which would need to be re-pointed as part of the scheme.

**4. Areas requiring re-pointing to front wall of barn 1**

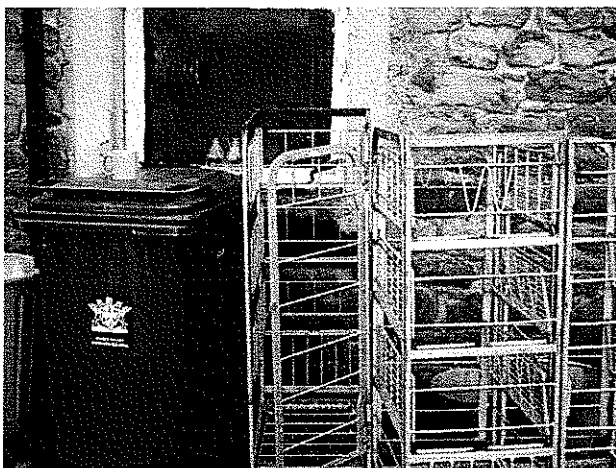
**5. Altered opening to front wall of barn 1**

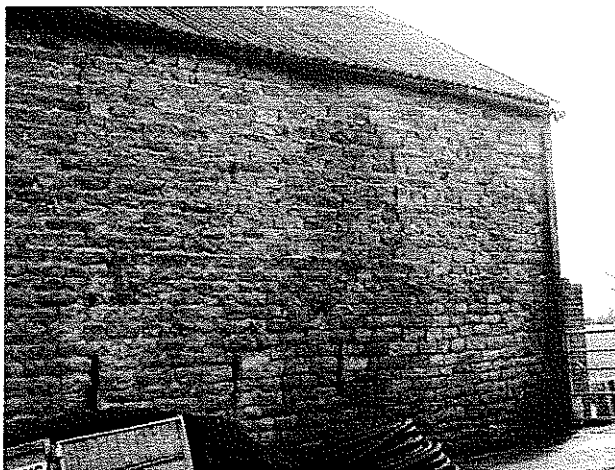
**6. Front wall of barn 2**

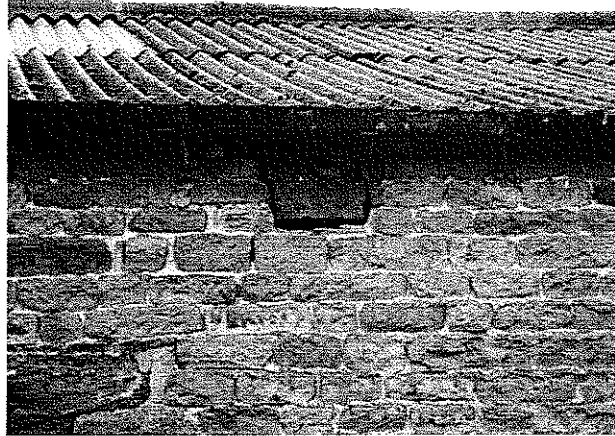
**7. Re-pointing required to sections of front wall to barn 2**

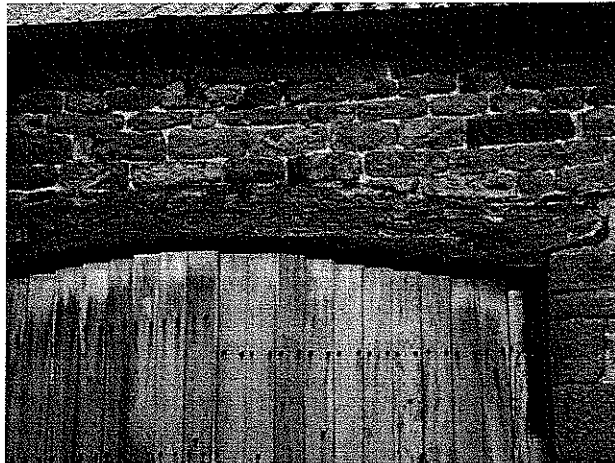
**8. Arched timber lintel above cart opening to barn 2**

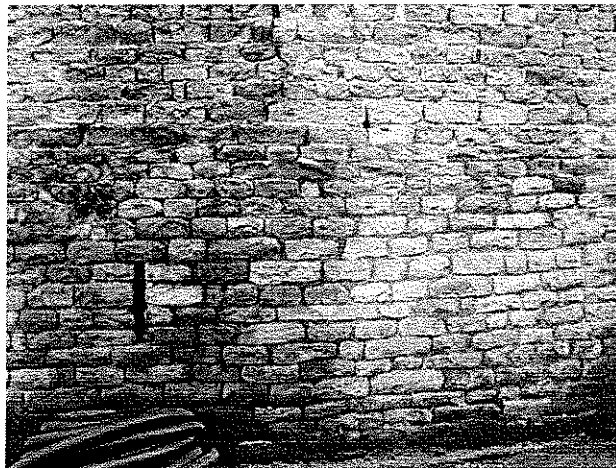
- 5.3 The front wall to barn 2 shows signs of structural movement to the westerly end of the wall, with a section of the wall bowing outward. The stonework to the effected area of wall appears to have been re-pointed with a vertical crack running to the eaves also having been re-pointed. It was noted that in some localised areas the mortar between stone blocks had blown and come away from the wall, which requires re-pointing. The large cart opening appears to be in a reasonable condition with little evidence of any significant structural movement; however the arched timber lintel is showing signs of decay and some insect infestation. It would be worthwhile to either treat this lintel or replace it with a new timber or stone lintel.

**9. Re-pointed section of wall to front wall of barn 2, that has suffered structural movement**

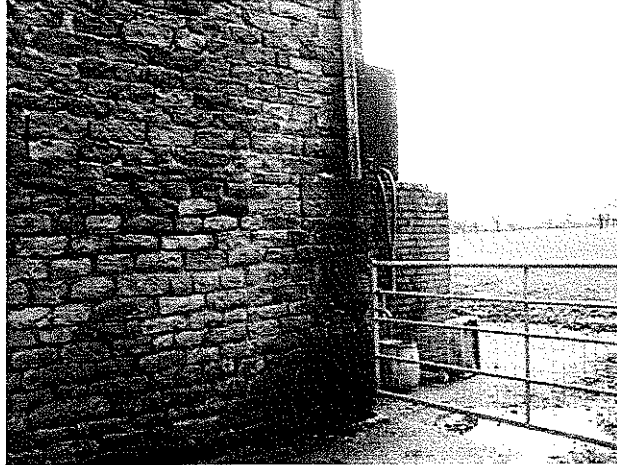
- 5.1 Externally the roofs over both barns are in a reasonable condition with little evidence of any changes within the roof or ridge lines. The roof coverings above both barns are also in a reasonable condition, with little evidence of any slipped or missing slates or any disintegration to the profiled roof sheeting. The rain water goods to barn 1 appear to be in a reasonable condition with no missing sections of guttering or downpipe. The guttering also appears to have adequate cross falls to the black PVCu downpipe. Whilst the guttering to barn 2 is in place, it is in a tired condition and would need to be replaced as part of the scheme. The downpipe to which the guttering is connected is in a poor condition with a large section missing, which is causing damp staining and splash back onto the adjacent wall surface.

**10. Missing down pipe section with damp staining to wall surface**

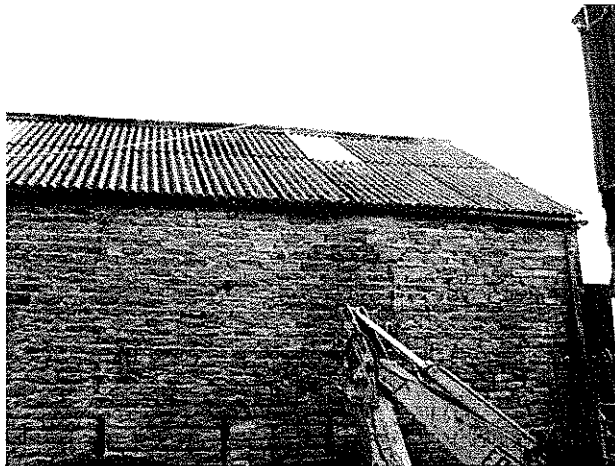
**11. Front wall of barn 2. Re-pointing noted to crack running to eaves level**

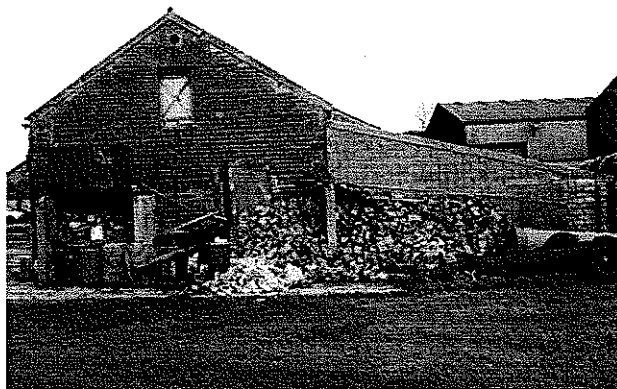
**12. Westerly gable wall of barn 2 and side wall of lean-to**

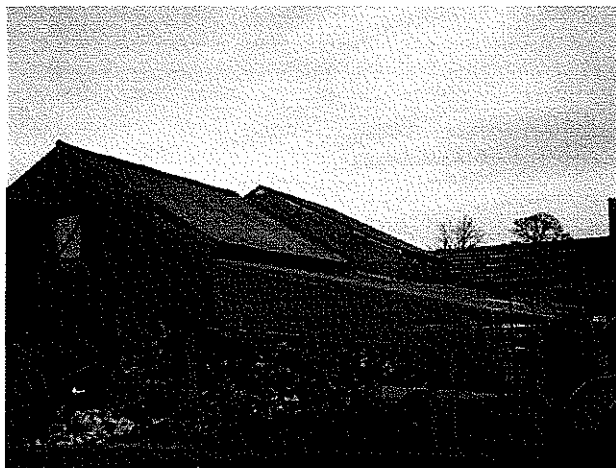
13. Westerly gable wall and rear southerly elevation. Barn 2 to the left & barn 1 to the right

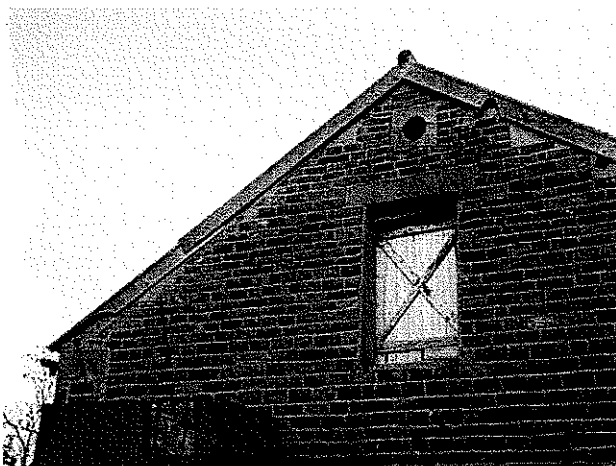
- 5.5 The verge detail between the roof and wall is in a poor condition with numerous sections missing and damaged which if left would allow water ingress into the structure however it is likely that this will be rectified as part of the scheme.

14. Verge detail to barn 2 westerly gable wall

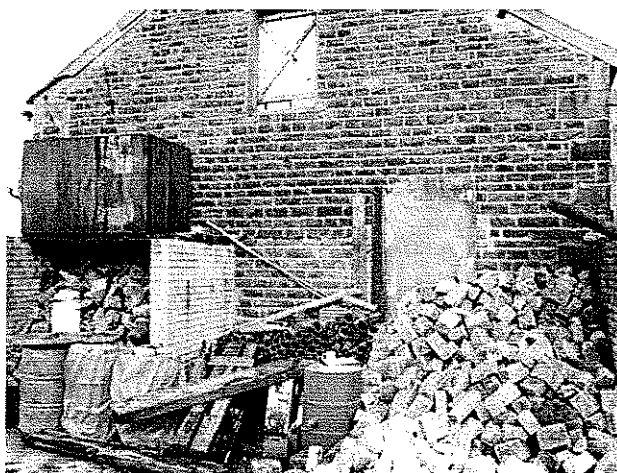
- 5.4 The main gable wall is in a reasonable condition with little evidence of any structural cracking or outward deflection. At the time of our inspection, a large amount of stone was stored against the wall, preventing a full inspection of these areas. An indicator of the effect of this though, is shown by the difference in colour of the stone, as shown in photographs 12 and 15 in this reports appendix. A section of the pointing to the wall in this area requires repair to prevent water ingress into the structure.

15. Stone stored against wall

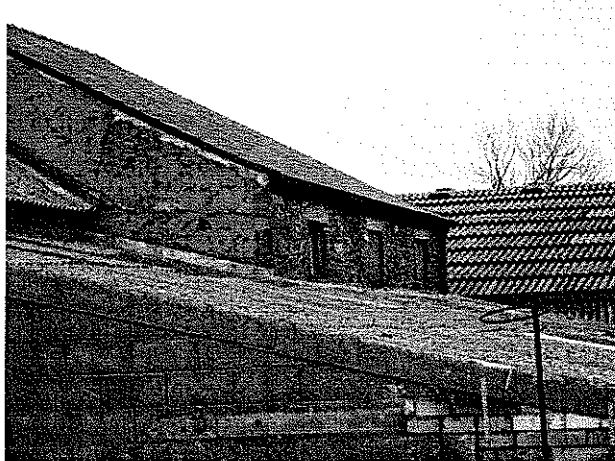
**16. Defective/blown render to separating wall. Rear wall of barn 1 & lean-to abutment detail**

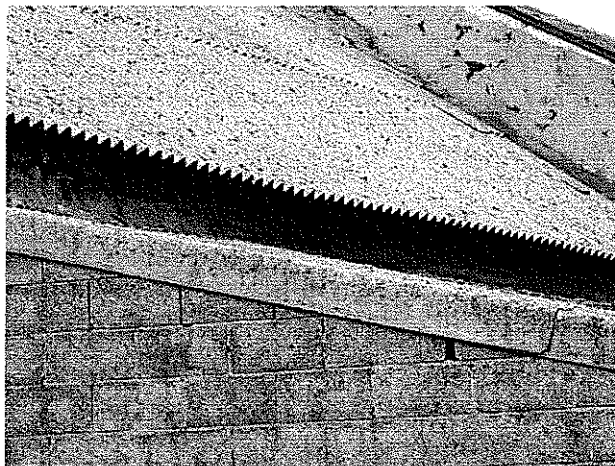
- 5.6 The render to the separating wall between the two barns is in a poor condition with crazed cracking throughout indicating that the mortar has blown and is coming away from the wall surface. It would be prudent to re-render this section of wall as part of the scheme. The abutment between the wall and roof of barn 2 and the lean-to structure is also in a poor condition and would require upgrading/replacement with an appropriate sized lead flashing strip and cavity tray.

**17. Poor flashing detail of barn 2 roof to separating wall. Defective render to wall of barn 1**

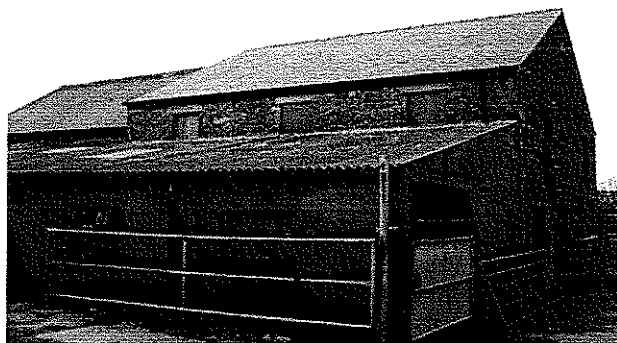
**18. Southerly & easterly elevations of barn 1 and lean-to**

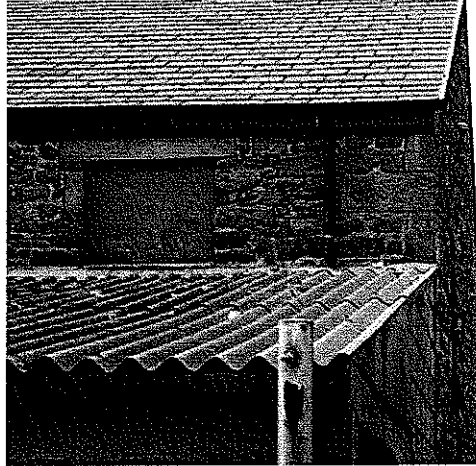
**19. Rear elevation of barn 1 & lean-to. Area of wall requiring re-pointing**

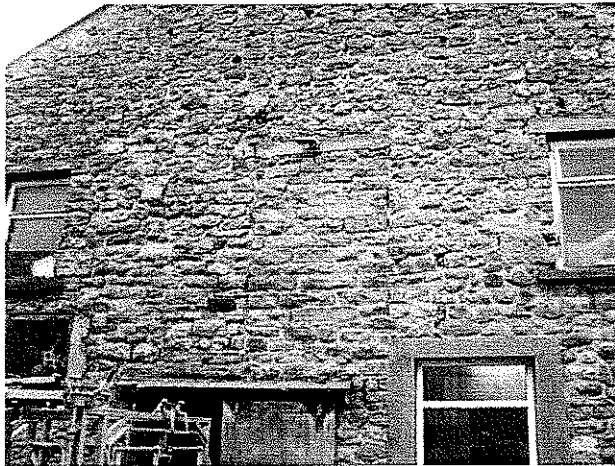
**20. Gable of barn 1. Evidence of blocked up door/window at first floor level**

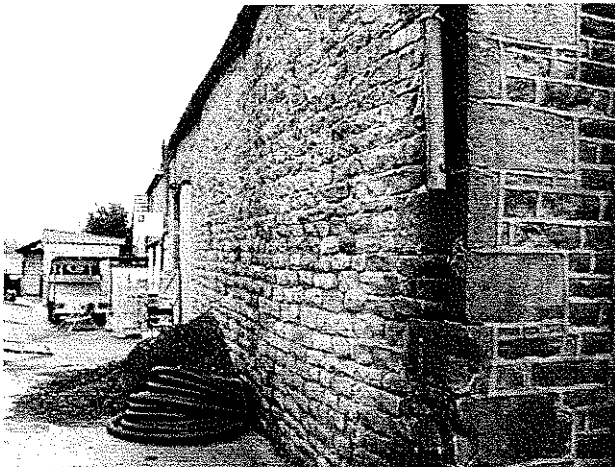
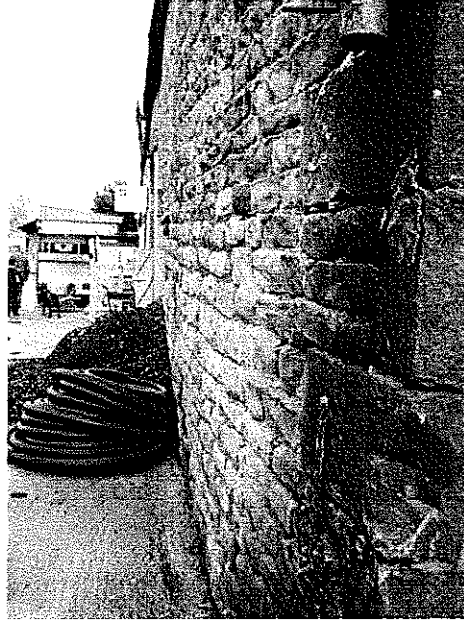
**21. Mis-alignment of section of front wall to barn 2**

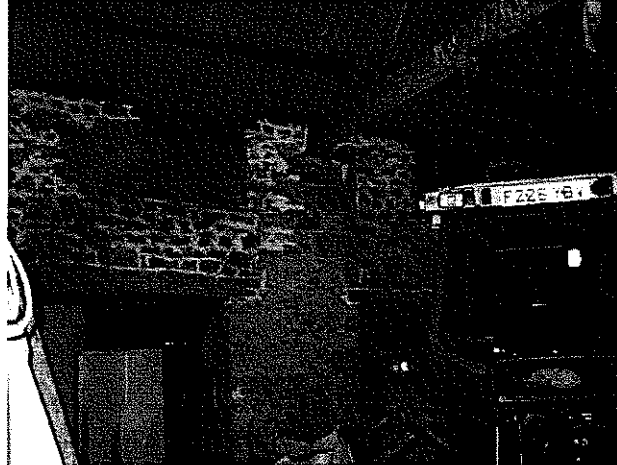
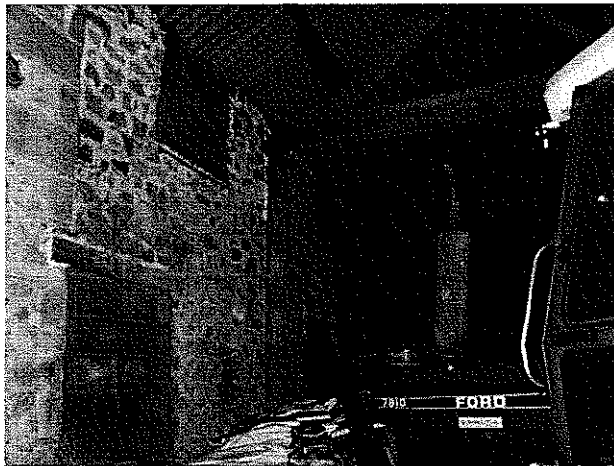
**24. Blocked up openings to internal face of rear wall in barn 2**

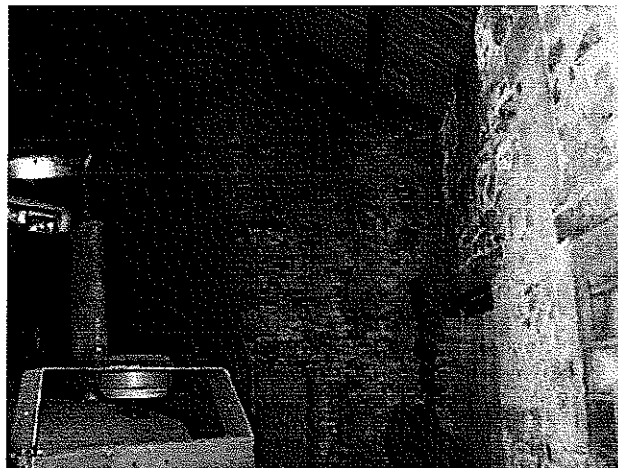
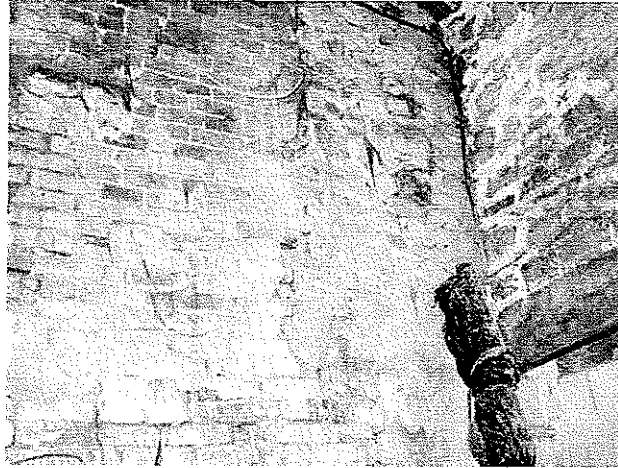
**29. Cracking at join between stone and brick work sections of separating wall**

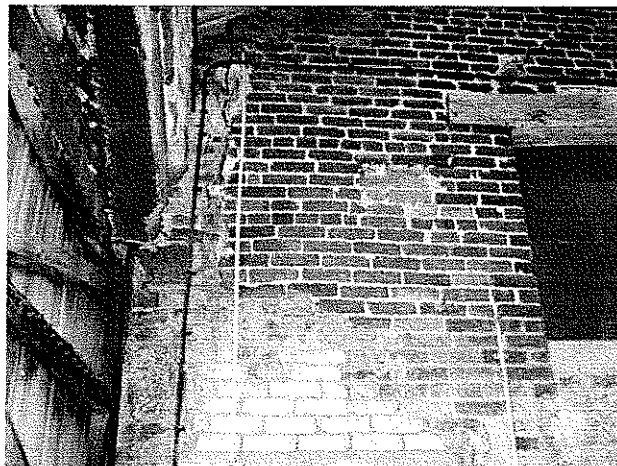
**31. Structural movement and cracking noted within separating wall adjacent to front wall**

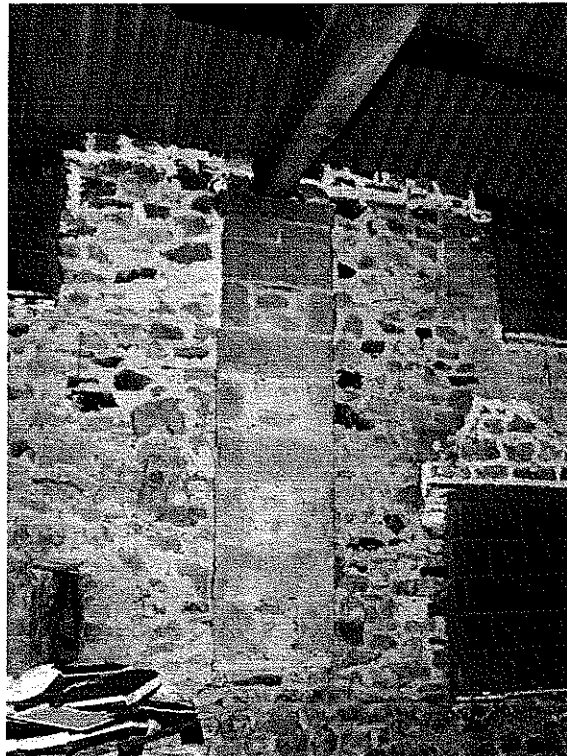
**34. Roof trusses sat on stone piers to rear wall within barn 2**

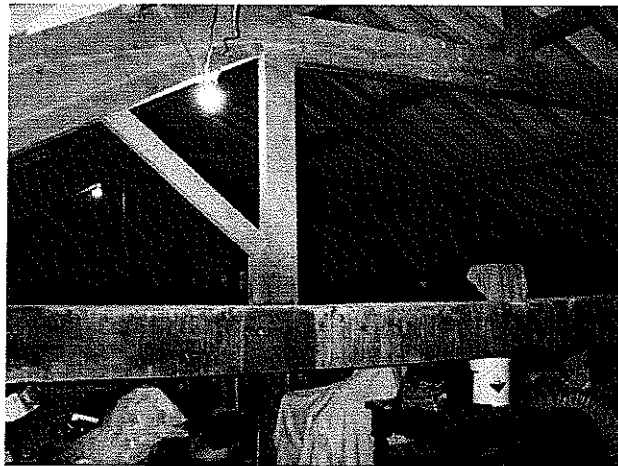
- 5.17 The roof to the barn is in a reasonable structural condition and it would appear that the roof has been replaced relatively recently. The existing roof timbers are in place together with a breathable membrane; however the roof would require upgrading in order for it to satisfy the building regulations for its intended use.

**36. Loft and roof area within barn 1**

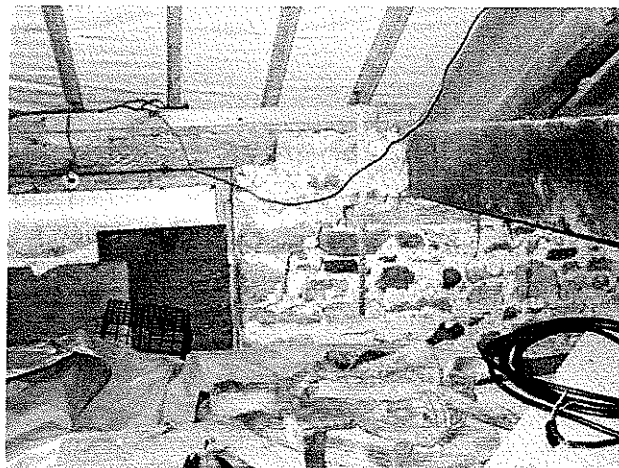
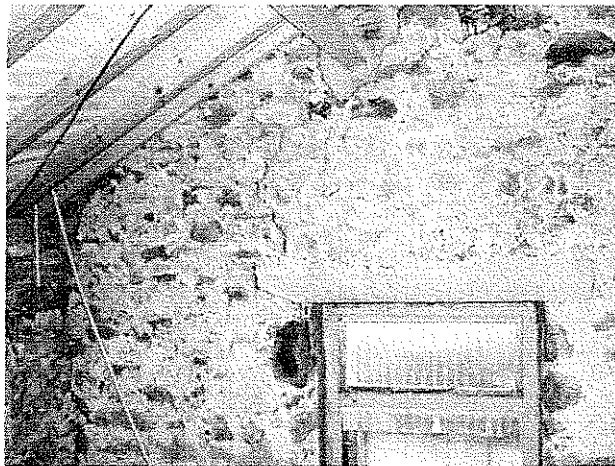
- 5.18 The walls within this area are also in a reasonable condition with little evidence of any significant structural movement. There was cracking noted in various locations, however this maybe as a result of the settlement of the roof structure after the re-roofing works. The cracking noted within the brick separating wall is also noticeable from the loft area of barn 1. The wall does not show signs of any outward movement. It would be advisable to re-build sections of the wall as a consequence of the cracking.

**37. Cracking to internal face of external wall to barn 1 noted within loft area**

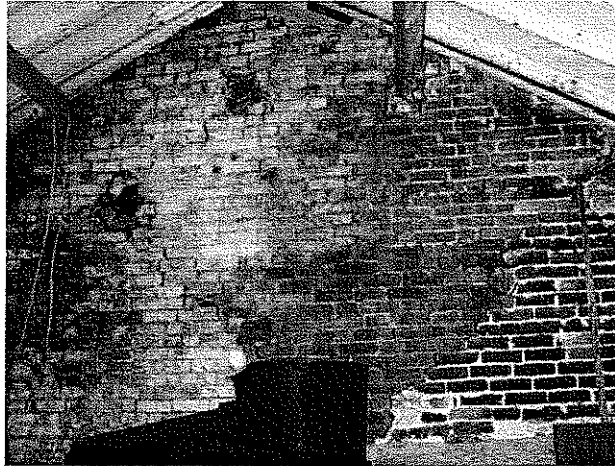
**38. Cracking within brick separating wall**

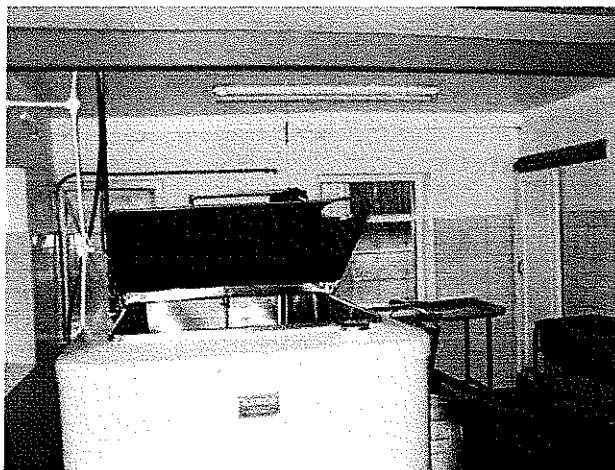
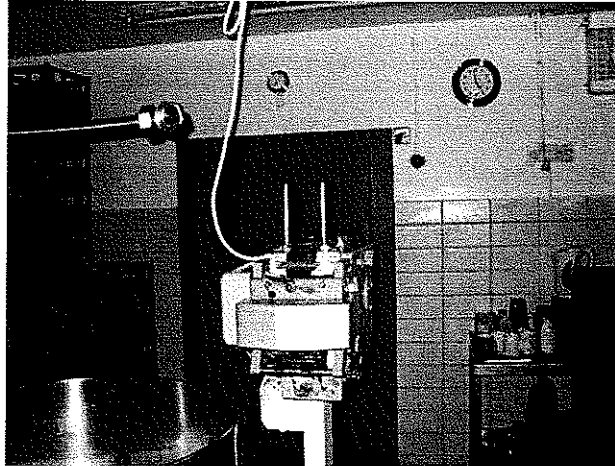
- 5.19 At ground floor level within the milk bottling room, the barn appears to be in a reasonable structural condition. The solid floor appears to be level with little evidence of any subsidence or cracking within the slab. There is also little evidence of any cracking within the main walls.

**40. Milk bottling room within barn 1**
