Installation of bored piled foundation underpinning to piers 33 & 34 and concrete structural lining to arch 34

**J1212 Whalley Viaduct (DJH/41) Span/Pier 34**

**Interim Review of Structural Monitoring Readings Provided by Datum Monitoring**

**Installation of underpinning and arch alterations:  
Whalley Viaduct, Whalley, Lancashire.**

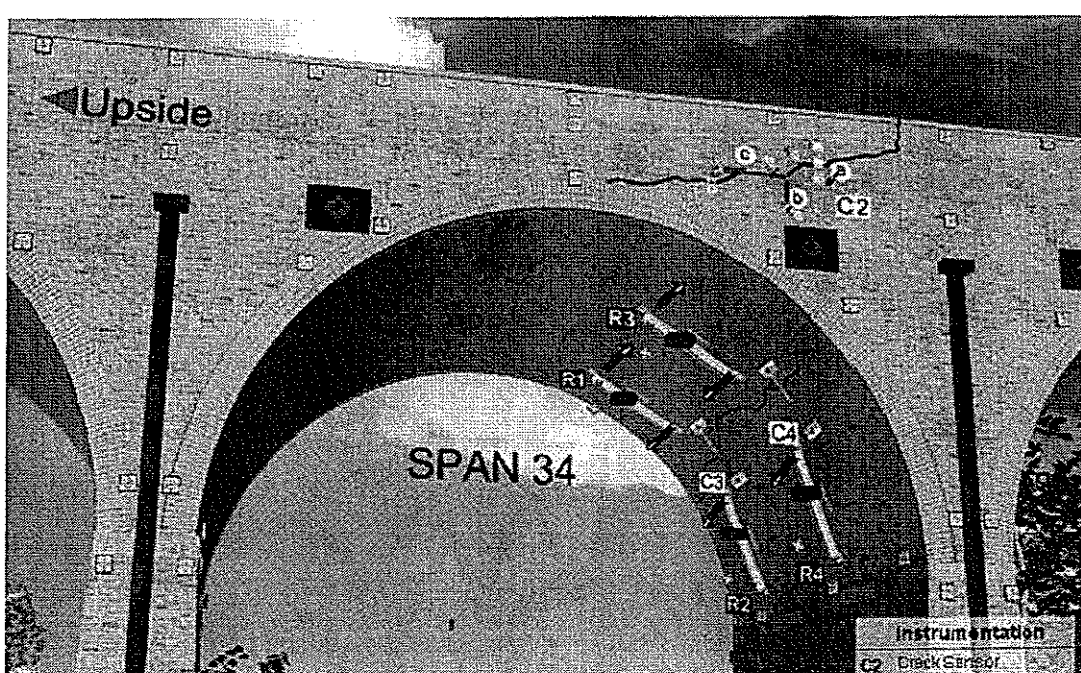
Over the last 6 months, up to 25mm (approx) of arch rotation has occurred. From the image (produced by Datum Monitoring) below it is evident that points R3 and R4 demonstrate a difference in moving, which if unrestricted would result in the arch folding over the pier.

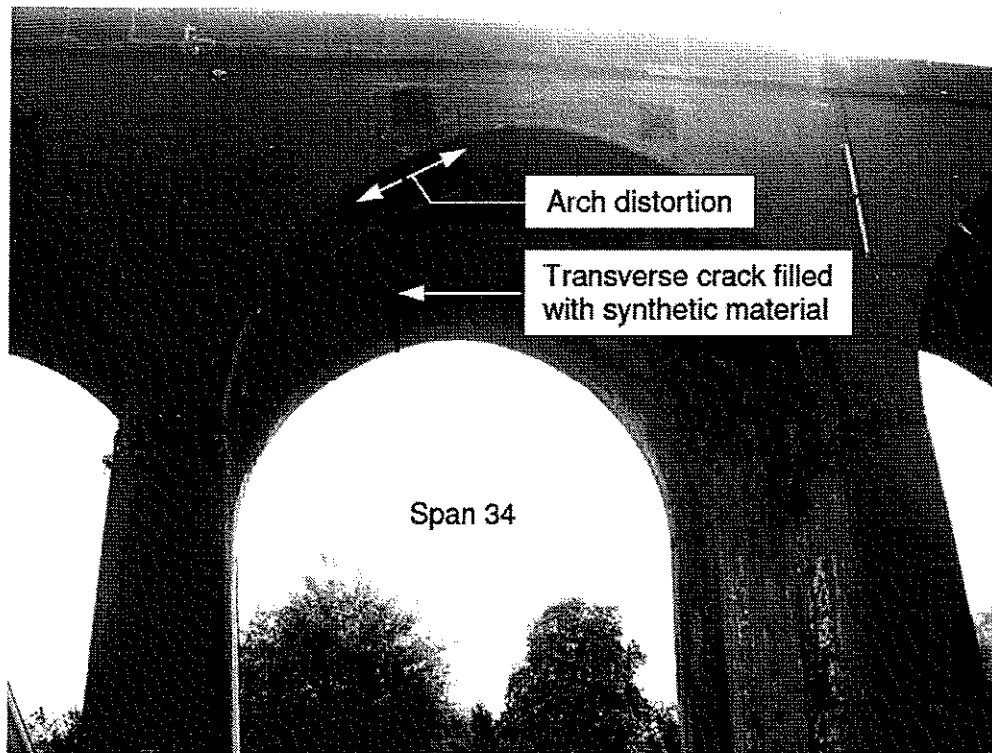
The bridge pier 34 has settled and that in turn has resulted in the cracks in span 34. The cracks widen when it rains hard and the settlement deepens and when it gets hot and the bridge expands. As a result, monitoring has been undertaken in order to ascertain a full understanding of the problem to provide a suitable solution. The level of monitoring on this arch is intensive, with alarms set to indicate any trigger movements. The monitoring system allows a level of control such that any movement, no matter how small, will be picked up and reported within minutes by the automated monitoring system.

The analysis from the survey information supports the conclusion that the settlement of Pier 34 has caused the transverse crack/hinge in the arch barrel of Span 34. Readings recorded from the rotation sensors in the monitoring exercise indicated a longitudinal rotation of the arch barrel around the transverse crack trending with changes in ambient temperature and hence thermal expansion and contraction of the structure. When the temperature drops, so does the rotation, but full recovery is not apparent. This suggests that the capacity of the arch barrel may be compromised if only the works to rectify settlement of Pier 34 is addressed. It is considered that strengthening works to the arch barrel is undertaken in addition to the underpinning works.

Photograph 3 – West elevation (Down Side), arch distortion and transverse cracking

In order to strengthen this location on Whalley viaduct Network Rail intend to undertake works to Arch 34 and Piers 33 and 34. The proposal includes the installation of a bored piled foundation, which will underpin the existing timber foundations at the base of the brickwork piers (33 & 34) and the installation of a concrete lining (under ring) to the arch barrel to arch 34.

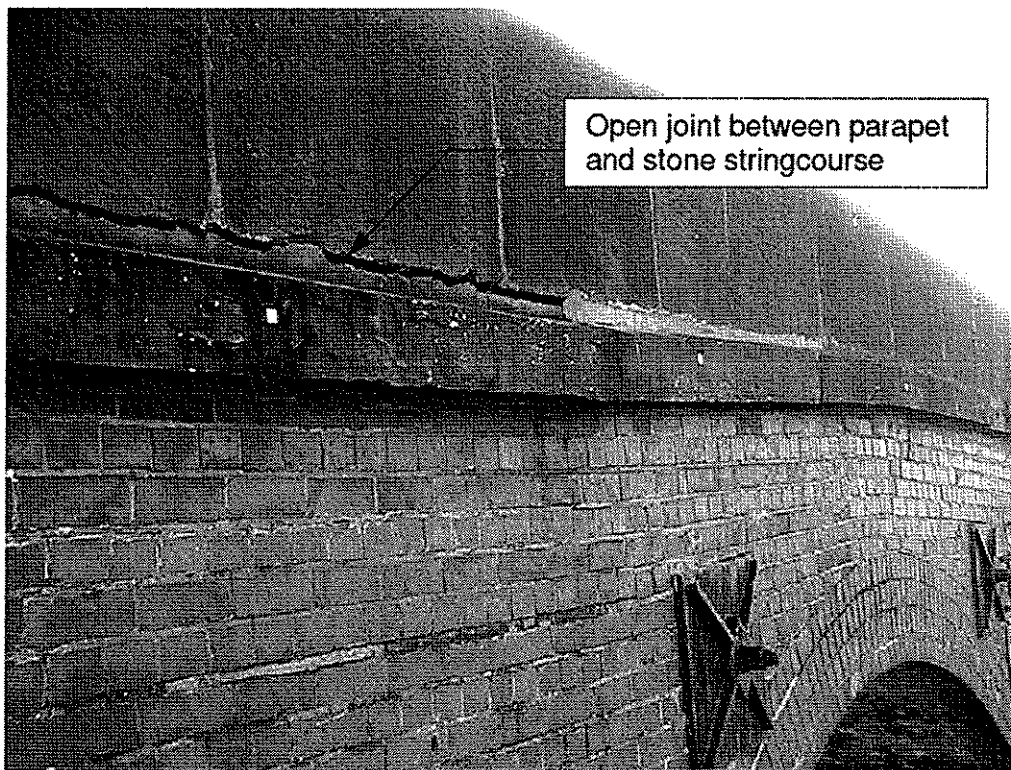
Photograph 4 – West elevation, spandrel, stringcourse and parapet forced upward over arch barrel to span 34

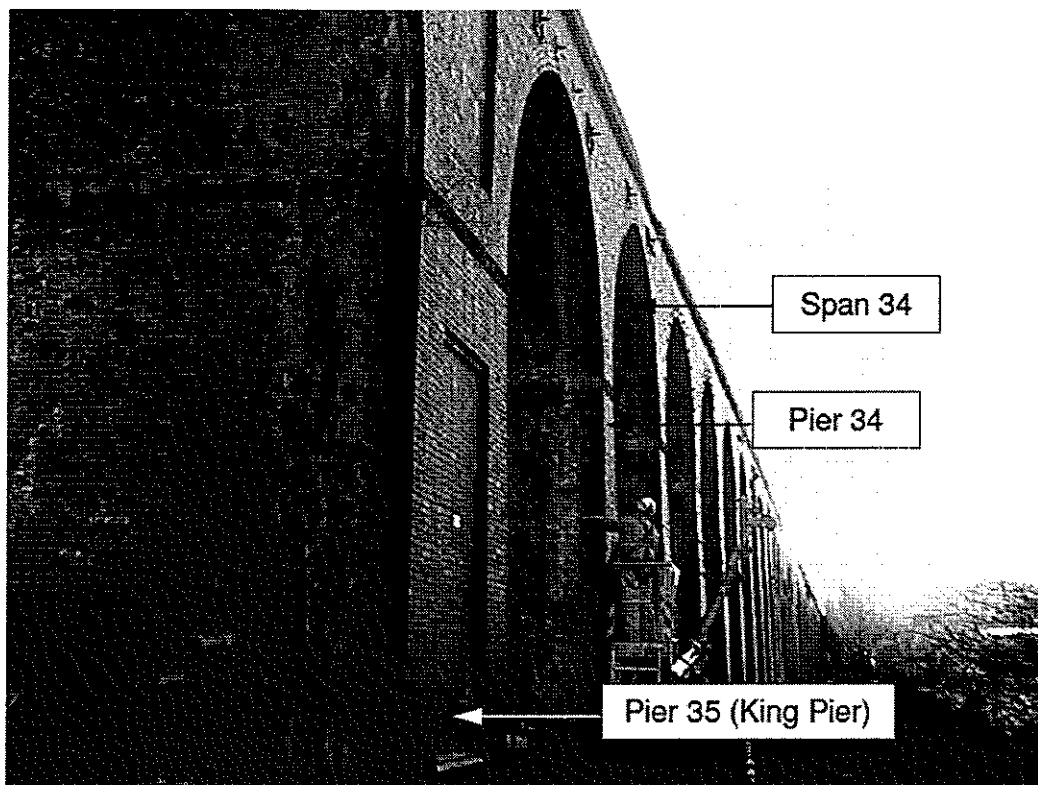
Photograph 1 – West elevation, looking south

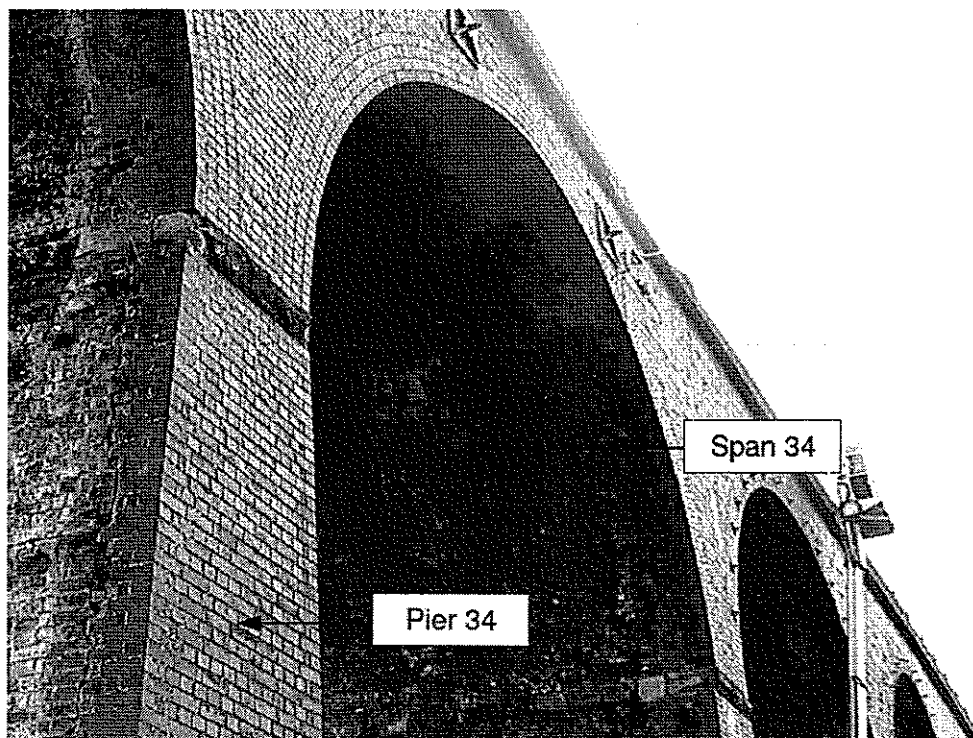
Significant defects to span 34, including flattening to the west ring face of the arch barrel were noted following completion of recent 2010/2011 maintenance works to the viaduct.

Photograph 2 – West elevation, Span 34
