**4. INSPECTION PROCEDURE  
HODDER HIGHER (No: 1043/B1)**

The Principal Inspection was carried out by Thorburn Colquhoun on 25 January 1997. The weather conditions during the inspection were dry with sunny spells. The depth of the River Hodder passing under Hodder Higher Bridge was a maximum of 1.2m. It was not necessary to effect any traffic management measures on the C354 in order to carry out the inspection.

Lancashire County Council  
Hodder Higher Bridge (No: 1043) - PBI

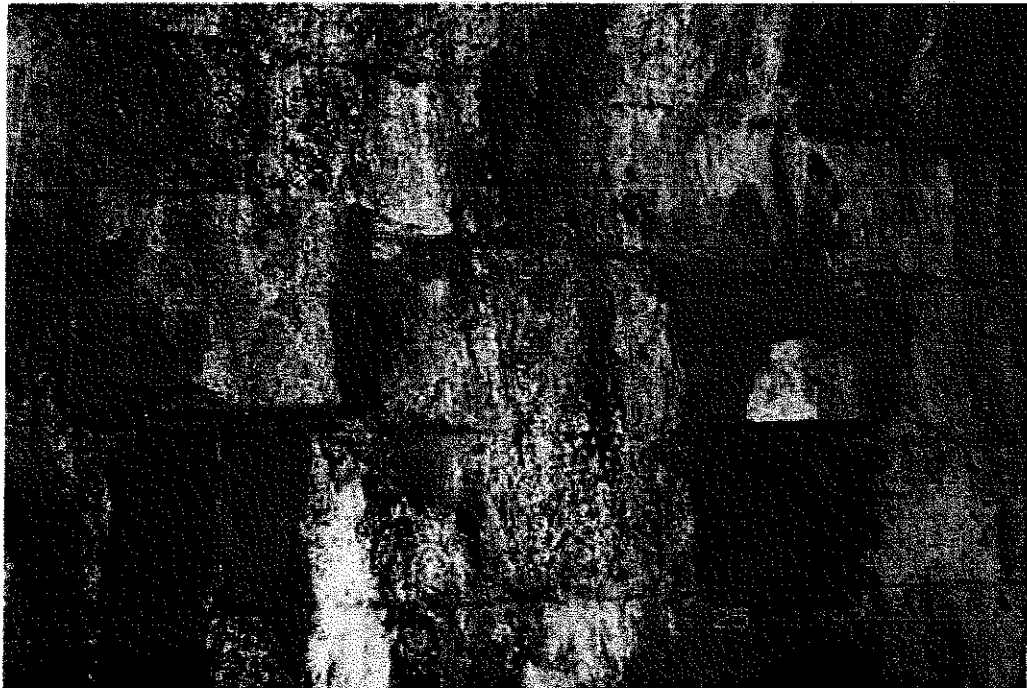
| COMPONENT | | INSPECTION RESULT | | PHOTO/<br>SKETCH | PAGE<br>No. | RECOMMENDATIONS/ACTION | TIME<br>SCALE |
|---|---|---|---|---|---|---|---|
| | | 4I | The ribs on both piers have weathered and spalled at their corners. | P1<br>P2 | 21<br>21 | No Action | |

P2 SPALLED NOGGINS AND LEACHING

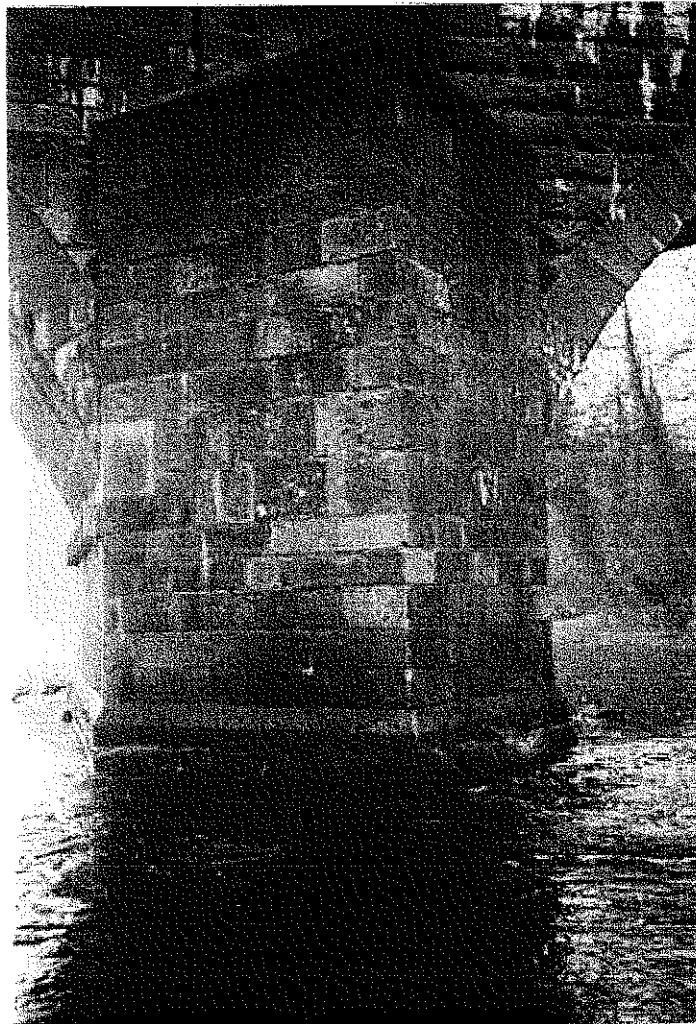
| COMPONENT | | INSPECTION RESULT | | PHOTO/<br>SKETCH | PAGE<br>No. | RECOMMENDATIONS/ACTION | TIME<br>SCALE |
|---|---|---|---|---|---|---|---|
| | | 4D | On the North elevation there is general weathering of the masonry. Rocks around the upstream cutwater provided for scour protection by Lancashire County Council as part of remedial works in 1993. | P3 | 22 | No Action | |

**P3    GENERAL VIEW OF NORTH END OF WEST PIER**

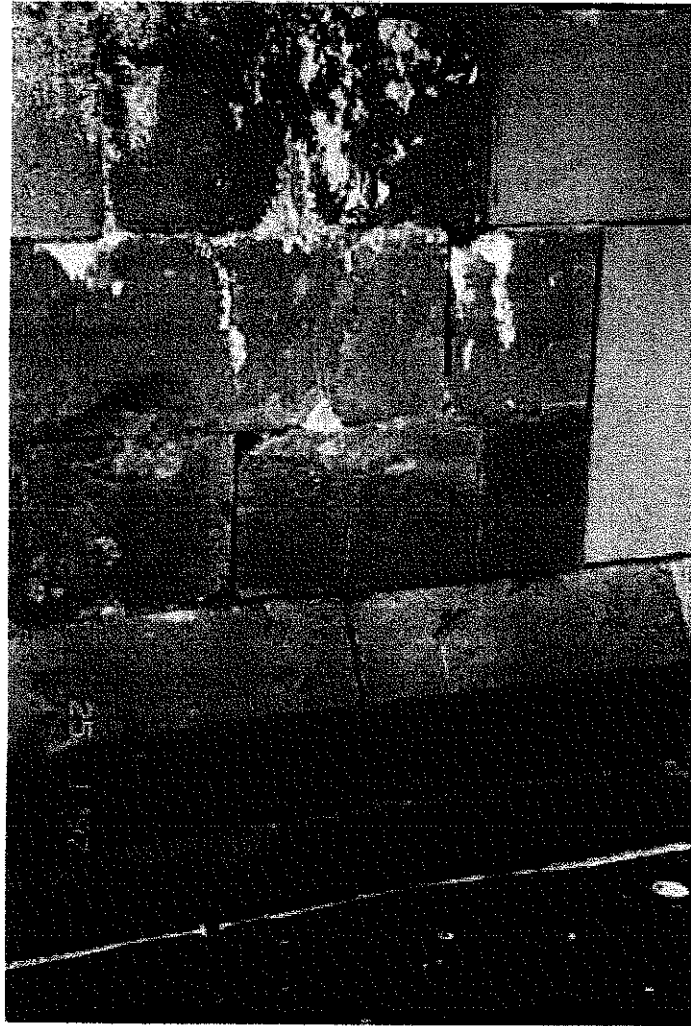
| COMPONENT | | INSPECTION RESULT | | PHOTO/<br>SKETCH | PAGE<br>No. | RECOMMENDATIONS/ACTION | TIME<br>SCALE |
|---|---|---|---|---|---|---|---|
| | | 4F | On the West elevation of the West pier there are 5 No. hairline to 3mm wide cracks and areas of mortar loss to the joints of upto 150mm deep. | SK2<br>P4<br>P8<br>P10 | 47<br>23<br>27<br>28 | Repoint and monitor | L |

**P4     CRACKING IN PIER ON WEST SIDE**

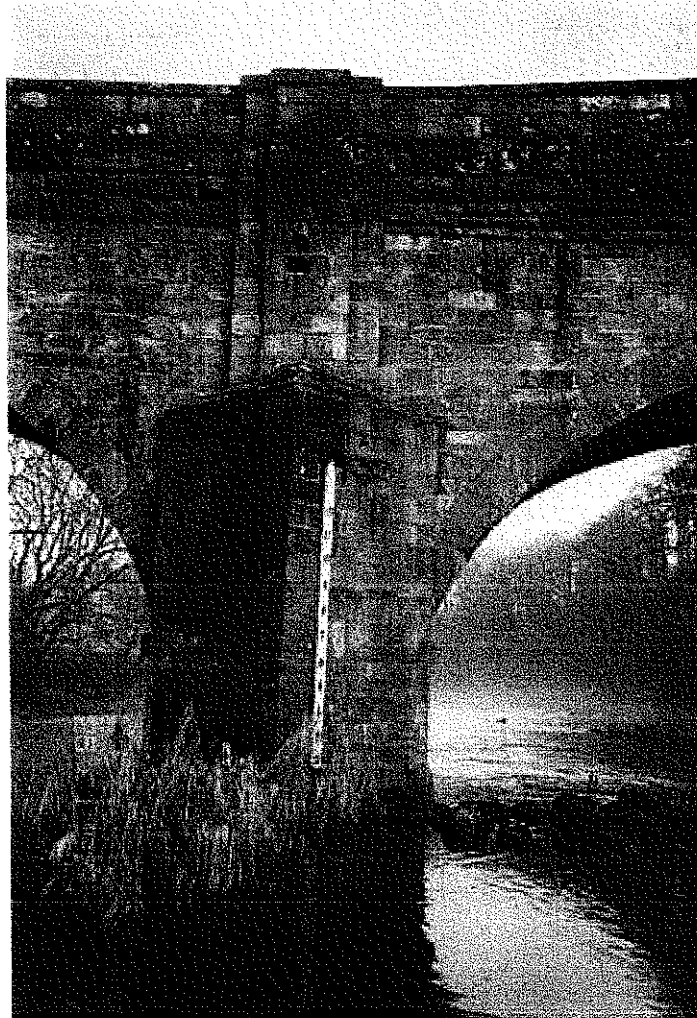
| COMPONENT | | INSPECTION RESULT | | PHOTO/<br>SKETCH | PAGE<br>No. | RECOMMENDATIONS/ACTION | TIME<br>SCALE |
|---|---|---|---|---|---|---|---|
| | | 4C | On the West pier there are 2 No. vertical cracks (hairline to 5mm wide) through the bottom 3 courses with active seepage and a small area of spalling to stone face on the South elevation. | P5<br>P6<br>P7<br>P11 | 24<br>25<br>26<br>29 | Monitor | L |

**P5    GENERAL VIEW OF SOUTH END  
SHOWING SHALLOW WATER AND VEGETATION**

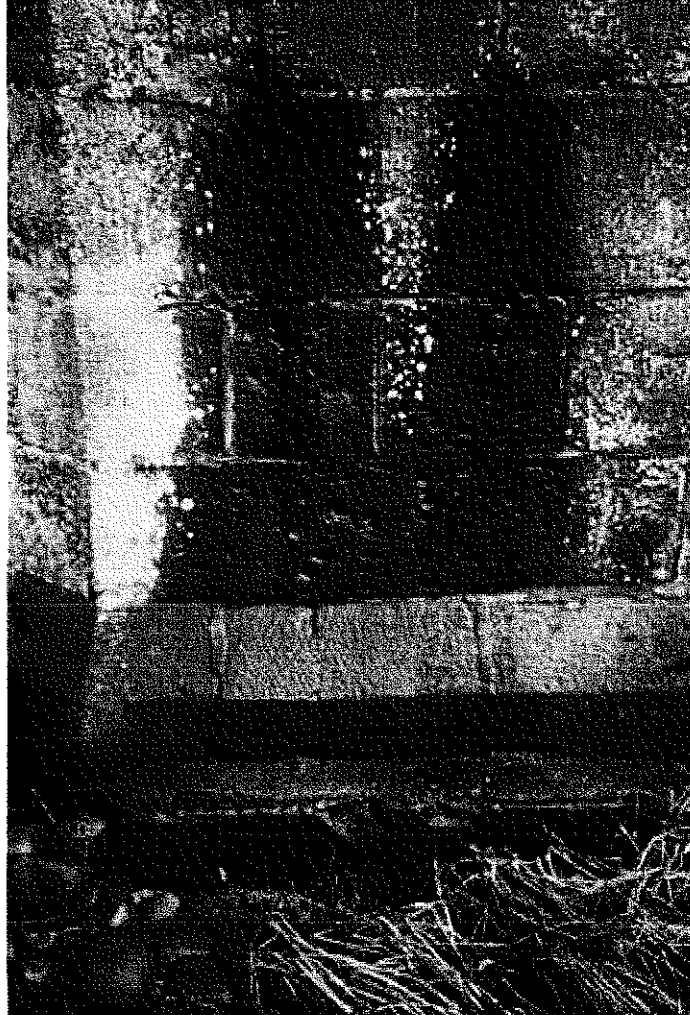
**P6 ACTIVE WATER SEEPAGE AT FOOT OF PIER**

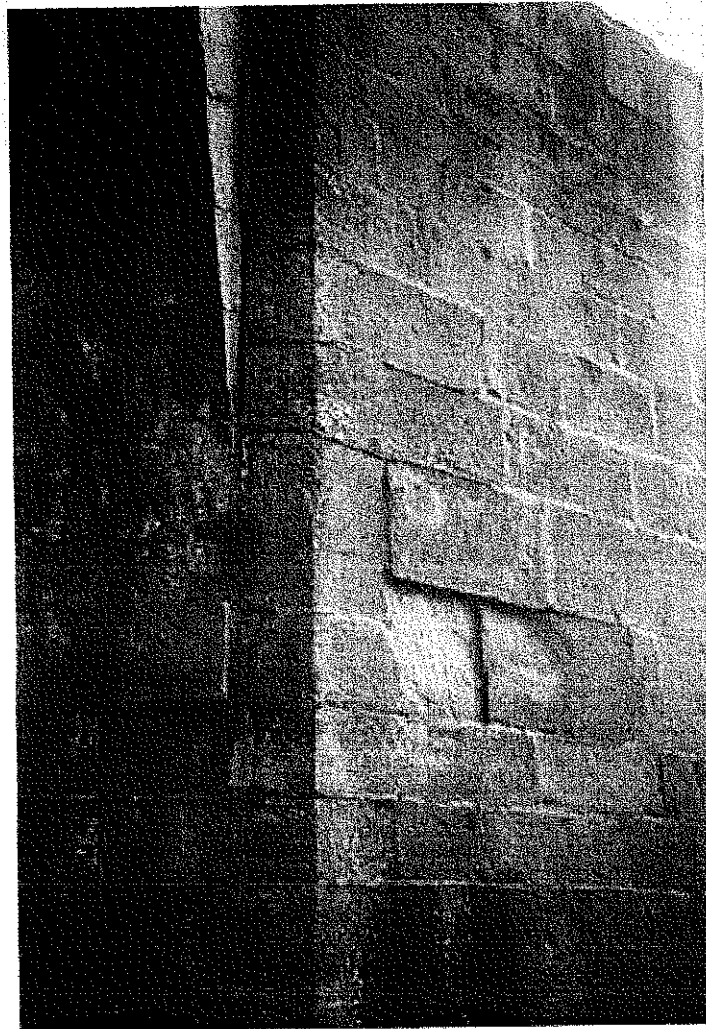
**P7 SPALLED MASONRY BLOCK**

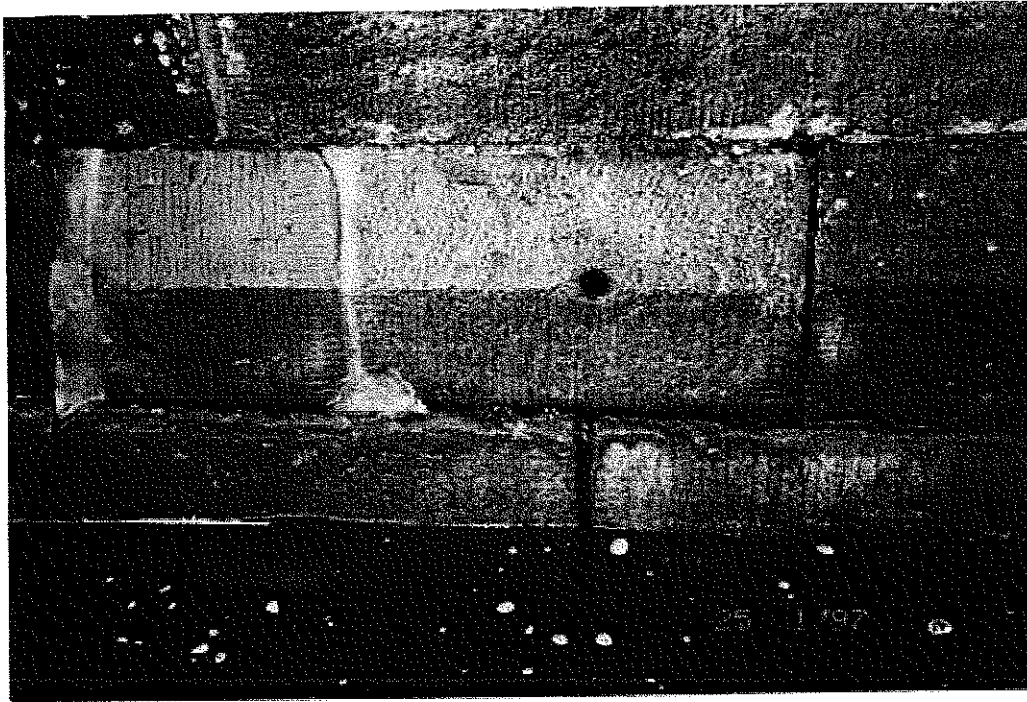
**P8 MORTAR LOSS AND CRACKING TO WEST PIER**

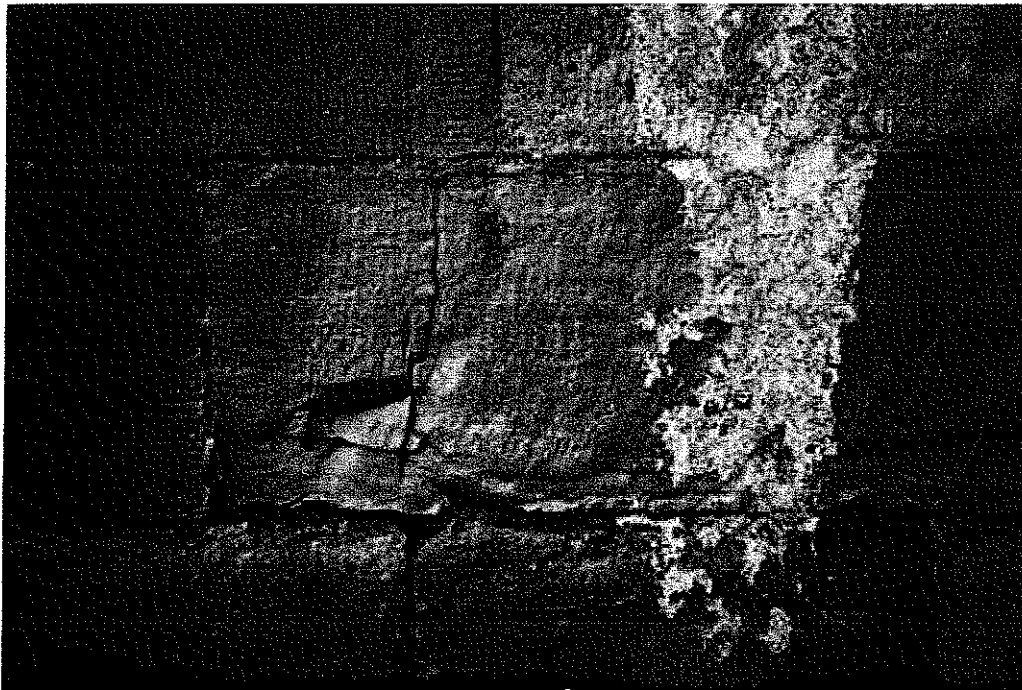
| COMPONENT | | INSPECTION RESULT | | PHOTO/<br>SKETCH | PAGE<br>No. | RECOMMENDATIONS/ACTION | TIME<br>SCALE |
|---|---|---|---|---|---|---|---|
| | | 4E | On the East elevation of the West pier there is mortar loss to joints of upto 200mm deep and a crack, hairline to 1mm wide, through a stone course. | SK1<br>P9 | 46<br>27 | Repoint and monitor | L |

**P9 CRACKING AND SPALLING TO STONE BLOCK IN WEST PIER**

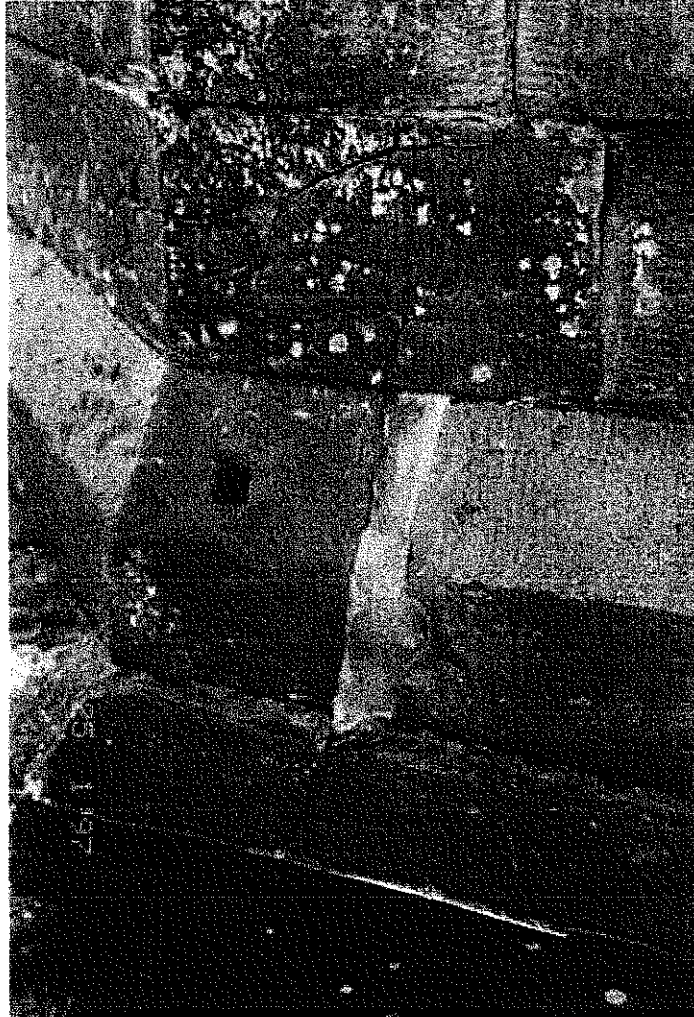
**P10    CRACKING IN CORNER OF WEST PIER (NORTH END)**

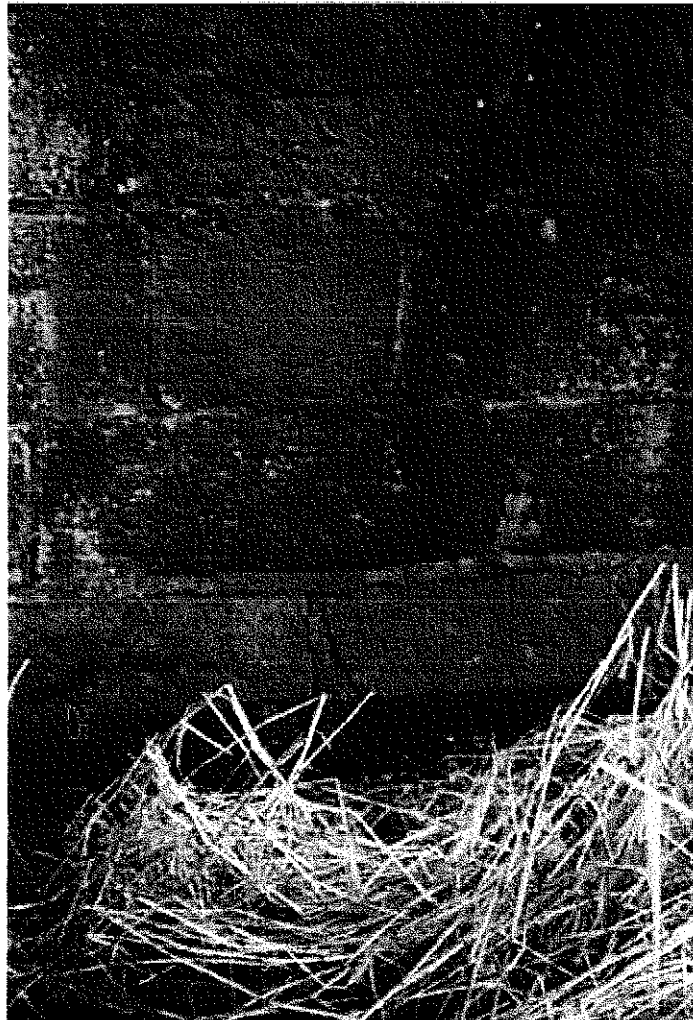
**P11 CRACK AT BOTTOM OF WEST PIER (SOUTH END)**

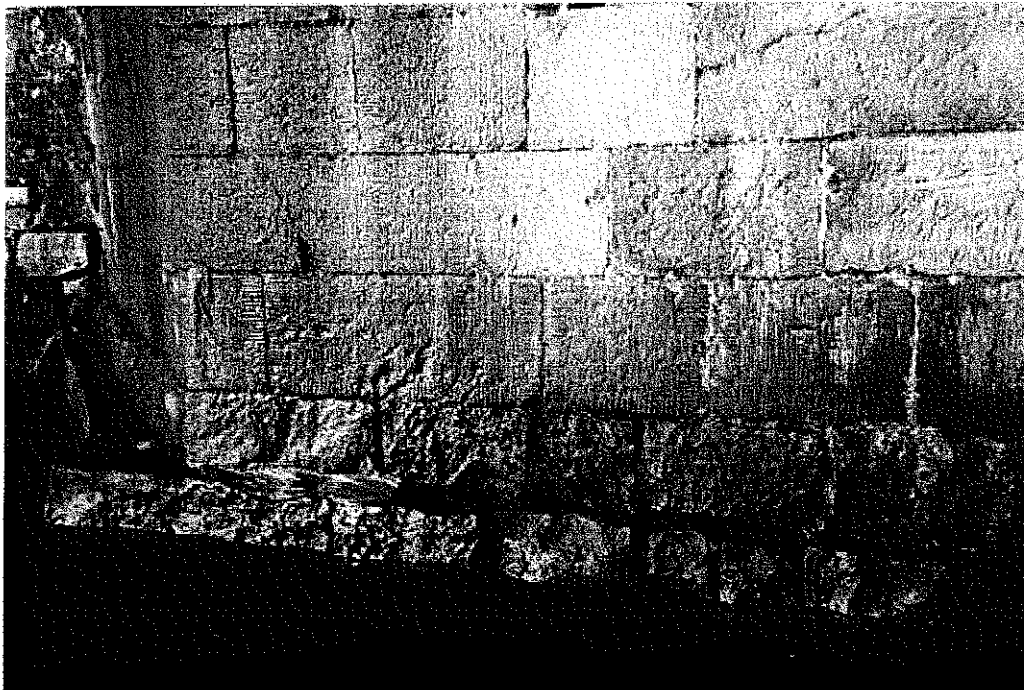
| COMPONENT | | INSPECTION RESULT | | PHOTO/<br>SKETCH | PAGE<br>No. | RECOMMENDATIONS/ACTION | TIME<br>SCALE |
|---|---|---|---|---|---|---|---|
| | | 5B | There is joint loss upto 150 deep in the West abutment along the bottom courses. There is a hairline crack through a stone at the South end. | P13<br>SK4 | 30<br>49 | Repoint and monitor | L |

**P13** OPEN JOINTS IN BOTTOM COURSE WITH HAIRLINE CRACKING OF BLOCK 29677/6/11

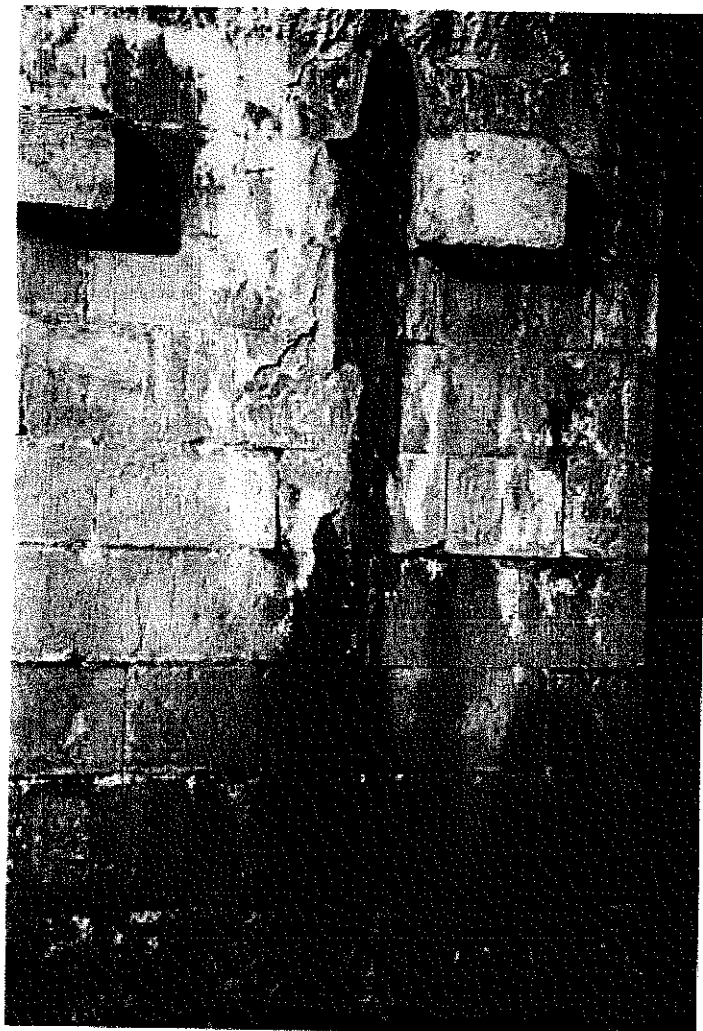
| COMPONENT | | INSPECTION RESULT | | PHOTO/<br>SKETCH | PAGE<br>No. | RECOMMENDATIONS/ACTION | TIME<br>SCALE |
|---|---|---|---|---|---|---|---|
| | | 5C | The West abutment face is generally damp with areas of active seepage present on day of inspection. | P12<br>P14<br>SK4 | 30<br>31<br>49 | Provide effective waterproofing | L |
| | | 5D | There is an area of drummy, eroded masonry and potential spall to the North side of the West abutment (1m x 1m approximate area). | P14<br>SK4 | 31<br>49 | Repair | L |

**P14 LEACHING AND POTENTIAL SPALLING OF WEST ABUTMENT**

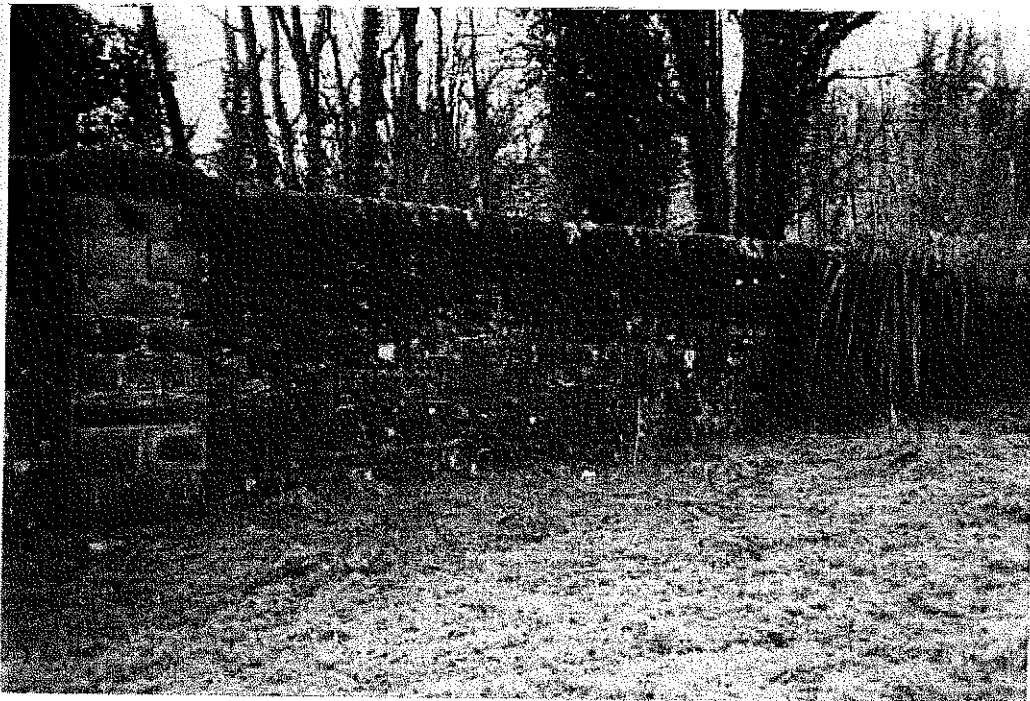
| COMPONENT | | INSPECTION RESULT | | PHOTO/<br>SKETCH | PAGE<br>No. | RECOMMENDATIONS/ACTION | TIME<br>SCALE |
|---|---|---|---|---|---|---|---|
| 6 | Wing Walls | 6A | On the North West side the wing wall is constructed from random coursed, dressed masonry blocks. There are a number of cracks in the top ten courses which go through the full thickness of the wall. Mortar loss is evident in isolated areas of upto 70mm deep. The bottom courses of the wall are generally damp with areas of green staining and leaching. | P15 | 32 | Repoint and monitor | L |

P15 VIEW OF NORTH WEST WING WALL

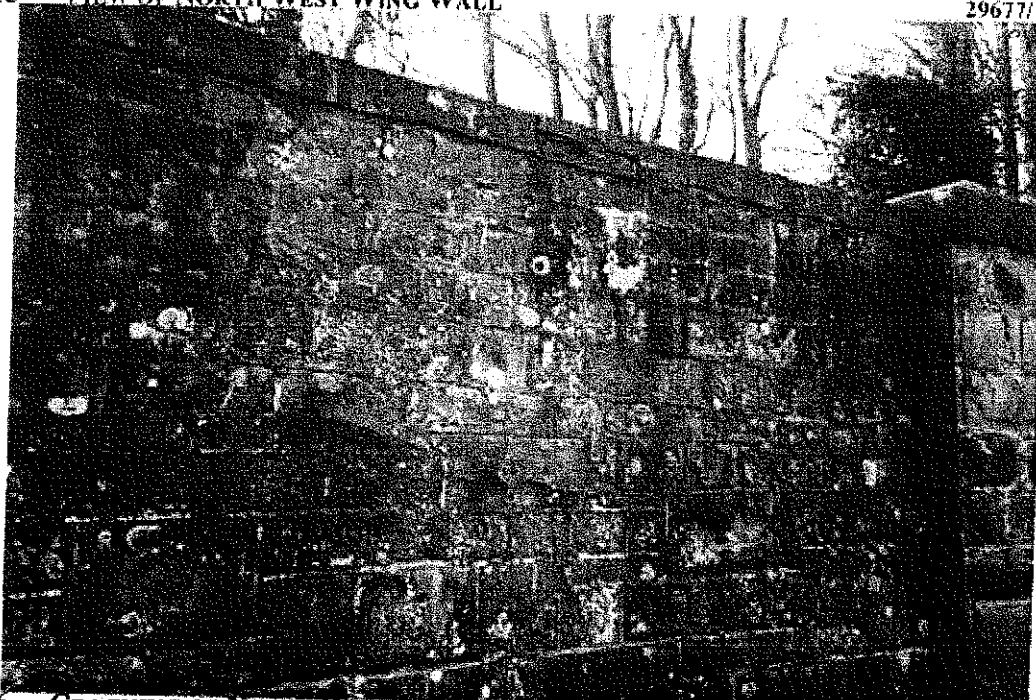
P16 CRACKING OF NORTH WEST WING WALL  
(INDICATED BY YELLOW ARROWS)

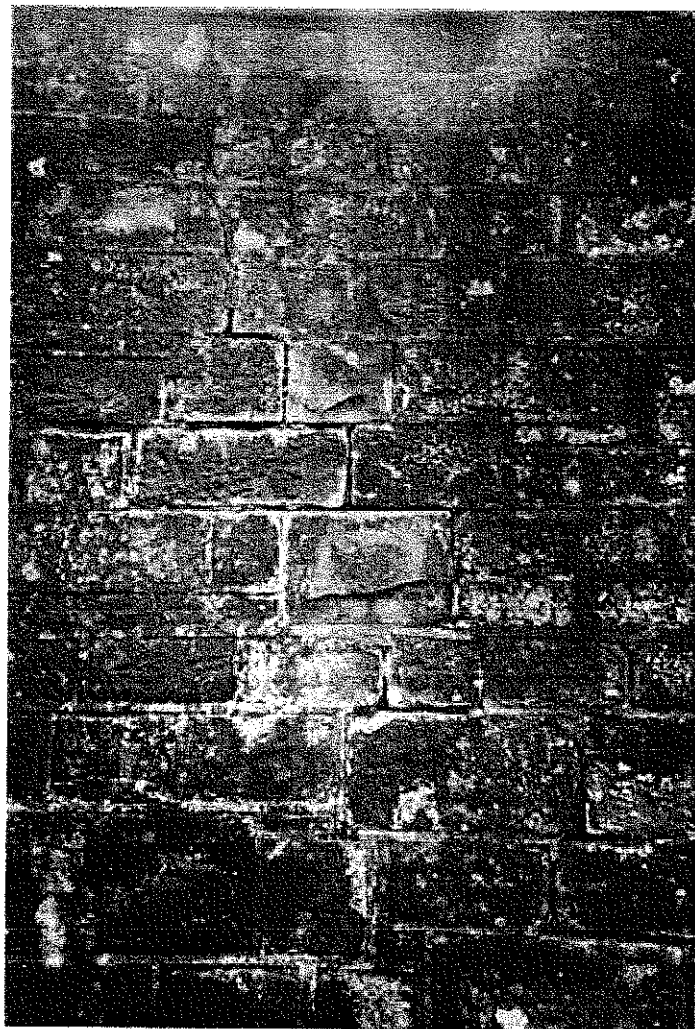
**P17 OPEN JOINTS AND CRACKING IN NORTH WEST  
WING WALL**

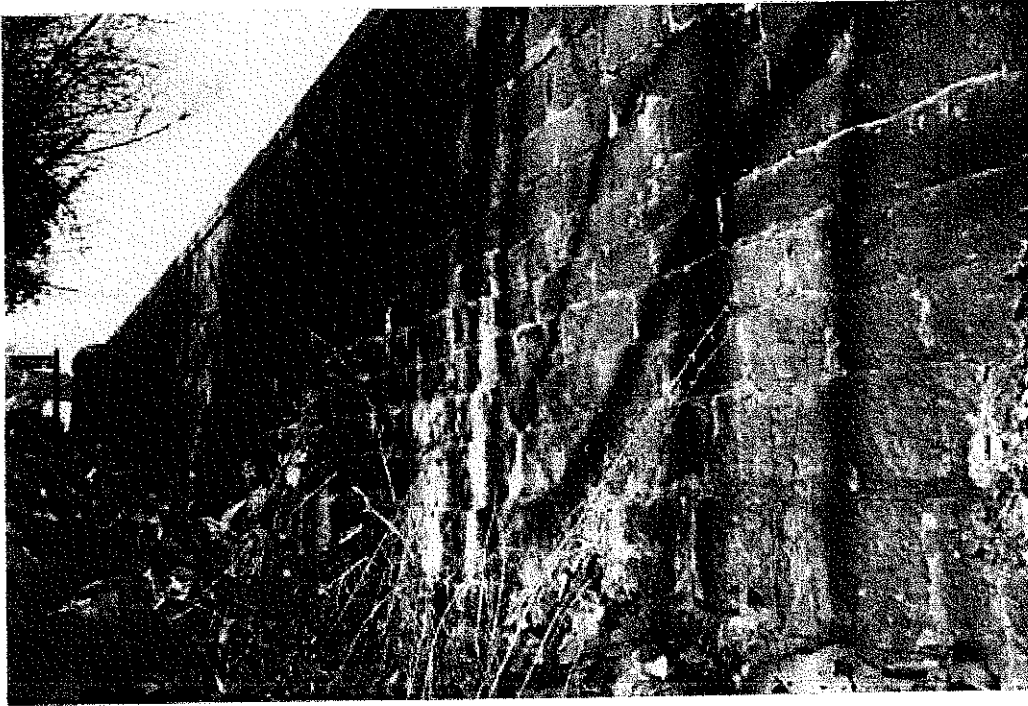
| COMPONENT | | INSPECTION RESULT | | PHOTO/<br>SKETCH | PAGE<br>No. | RECOMMENDATIONS/ACTION | TIME<br>SCALE |
|---|---|---|---|---|---|---|---|
| | | 6B | The South West wing wall is generally in good condition. There are isolated areas of leaching and mortar loss upto 20mm deep. There is moss and ivy growing on the embankment side of the wall over the bottom ten courses.<br><br>On the embankment side there is a large area of leaching and dampness with a number of hairline cracks through joints.<br><br>There is a crack upto 2mm wide the full height of the wall on the road side and approximately 1m long on the embankment side. | P18 | 33 | Repoint and monitor cracking | L |

P18 GENERAL VIEW LOOKING WEST OF EMBANKMENT SIDE  
OF SOUTH WEST WING WALL

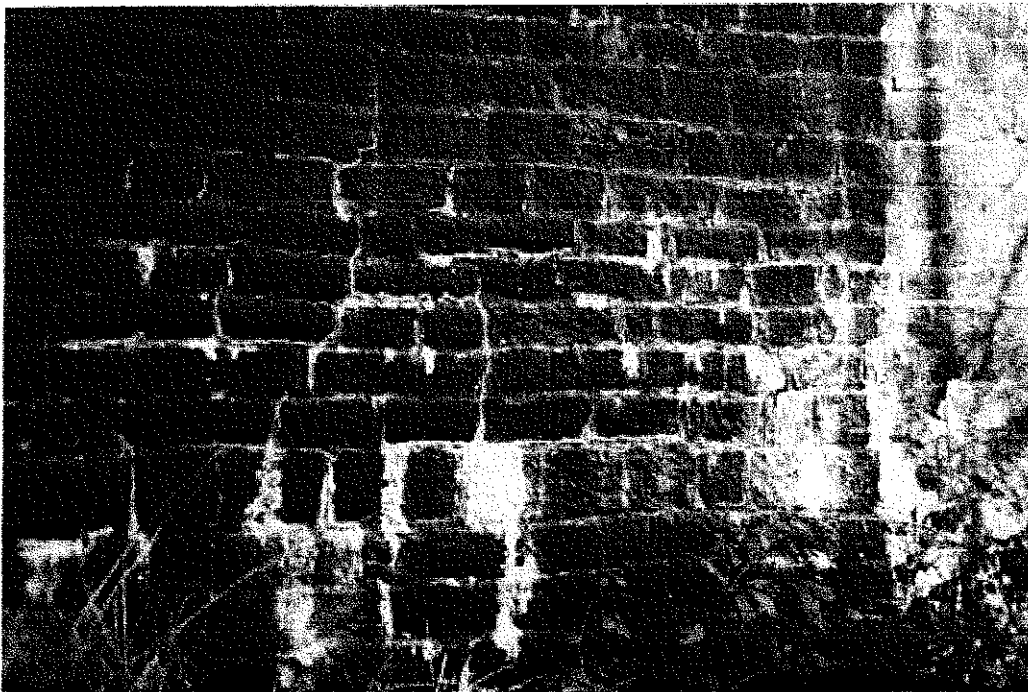
P19 AREA OF LEACHING AND HAIRLINE CRACKS - SOUTH WEST WINGWALL

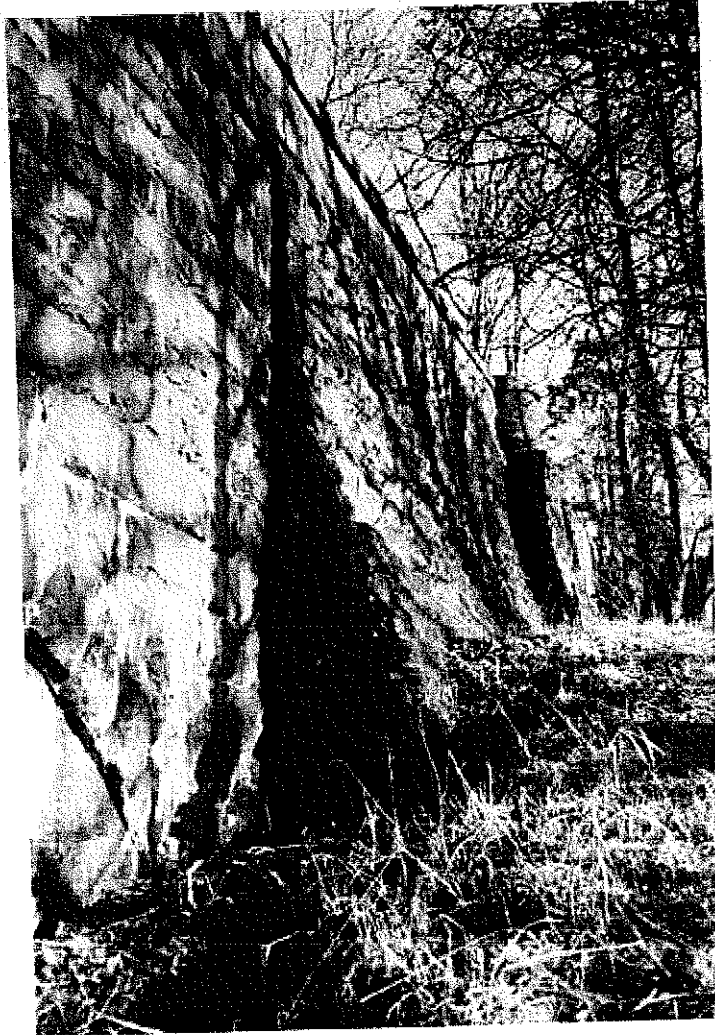
| COMPONENT | | INSPECTION RESULT | | PHOTO/<br>SKETCH | PAGE<br>No. | RECOMMENDATIONS/ACTION | TIME<br>SCALE |
|---|---|---|---|---|---|---|---|
| | | 6C | The South East wing wall is generally in good condition with vegetation growing on the bottom metre. There is a horizontal crack of approximately 2m in length across the course where the wall begins to curve out. The mortar is generally loose and friable and 50% of the area has mortar loss of upto 20mm deep. | P20 | 34 | Remove vegetation. Repoint and monitor cracking | L |

P20 VIEW LOOKING EAST OF EMBANKMENT  
SIDE OF SOUTH EAST WING WALL

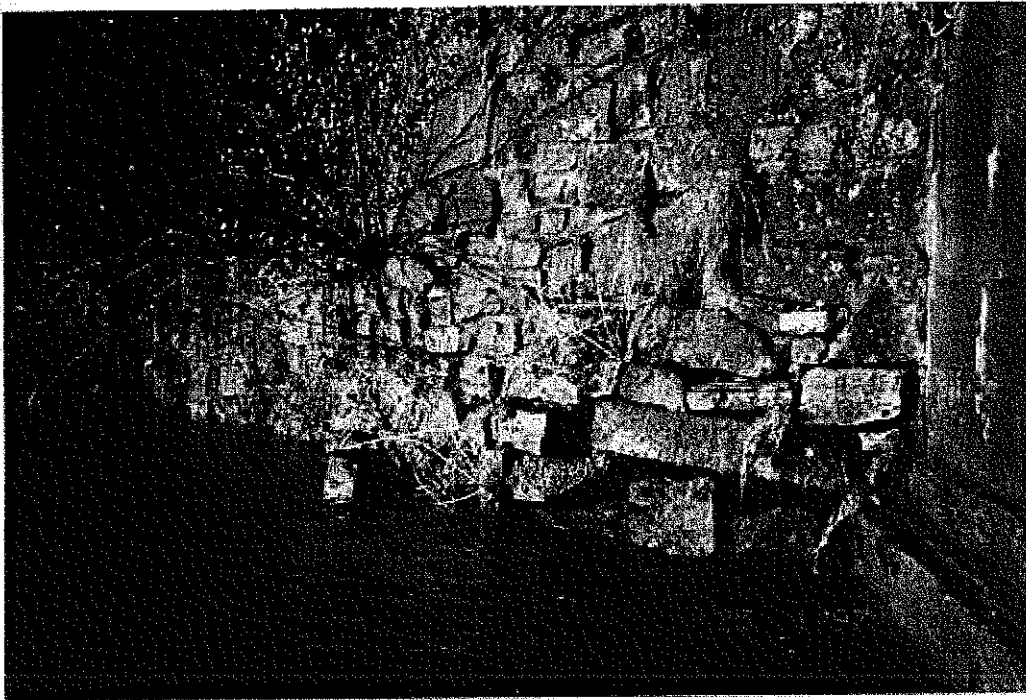
| COMPONENT | | INSPECTION RESULT | | PHOTO/<br>SKETCH | PAGE<br>No. | RECOMMENDATIONS/ACTION | TIME<br>SCALE |
|---|---|---|---|---|---|---|---|
| 7 | Training Walls | 7A | The South West training wall consists of uncoursed, rubble masonry.<br>Approximately half the face is covered with vegetation and a tree is growing out of a joint. There are no signs of major distress to the wall due to the tree.<br>Towards the base of the wall adjacent to the West abutment there are signs of movement with a number of stones having dropped with mortar loss and undermining upto 200mm deep. This movement does not seem to be recent. | P21 | 36 | Remove tree and repoint. Monitor movement | L |

P21 GENERAL VIEW OF SOUTH WEST TRAINING WALL

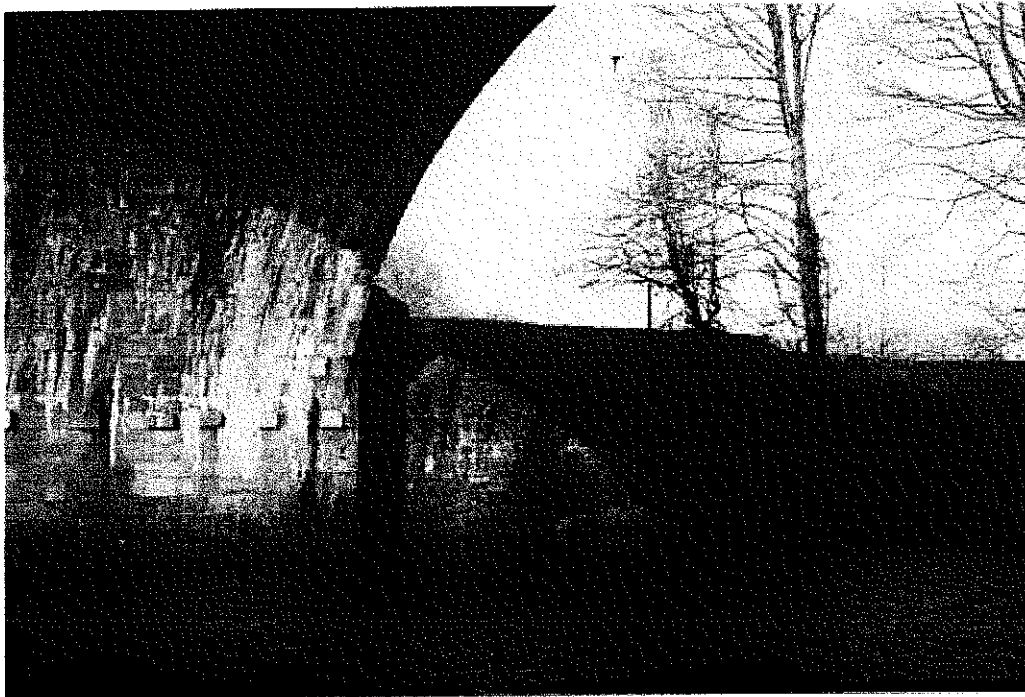
| COMPONENT | | INSPECTION RESULT | | PHOTO/<br>SKETCH | PAGE<br>No. | RECOMMENDATIONS/ACTION | TIME<br>SCALE |
|---|---|---|---|---|---|---|---|
| | | 7B | The North West training wall consists of random coursed, dressed masonry. | P22 | 36 | Repoint | L |

P22 GENERAL VIEW OF NORTH WEST TRAINING WALL

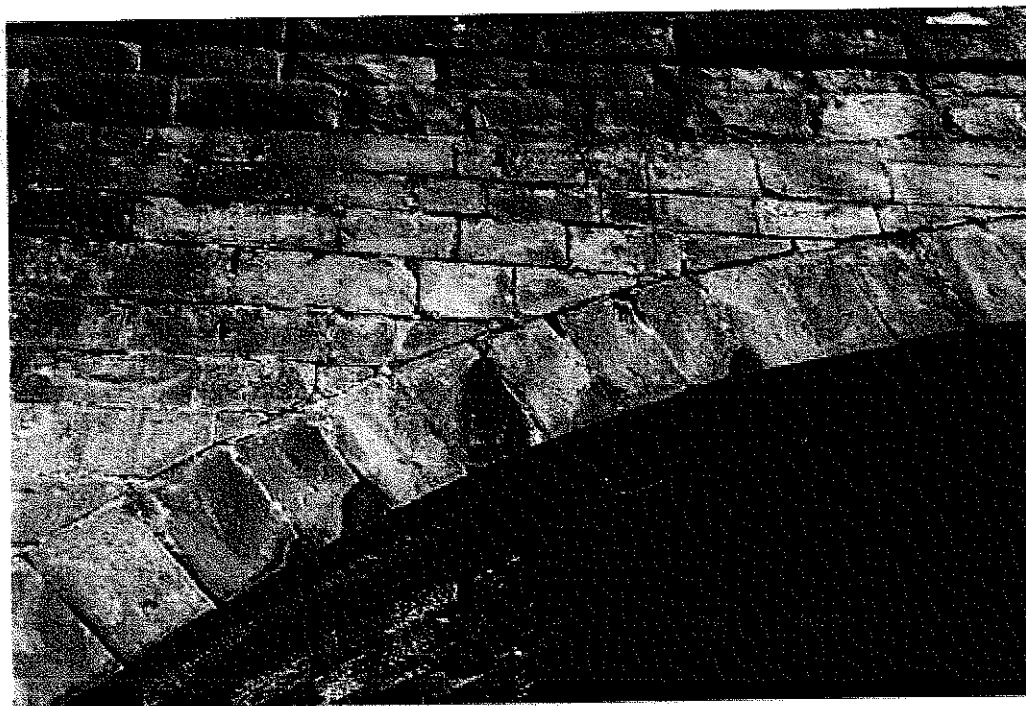
| COMPONENT | | INSPECTION RESULT | | PHOTO/<br>SKETCH | PAGE<br>No. | RECOMMENDATIONS/ACTION | TIME<br>SCALE |
|---|---|---|---|---|---|---|---|
| | | 16B | The South West arch barrel elevation is in good condition. There is mortar loss to the vertical joints adjacent to the West abutment. Localised cracking and mortar loss is present between the interface of the spandrel and the elevation of the ring. There is active water seepage near the springing of the West abutment. | P23<br>SK6 | 37<br>51 | Repoint. Provide waterproofing membrane effective | L |

**P23 WATER STAINING AND MORTAR LOSS IN SOUTH WEST ELEVATION**

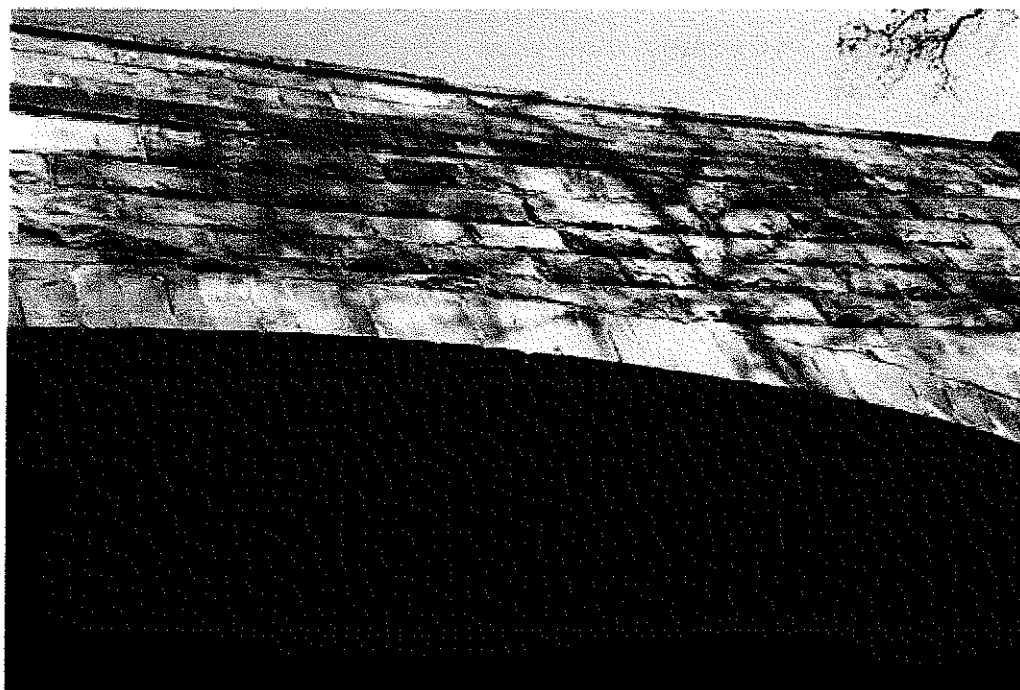
**P24 LEACHING THROUGH JOINTS ON SOUTH EAST ELEVATION**

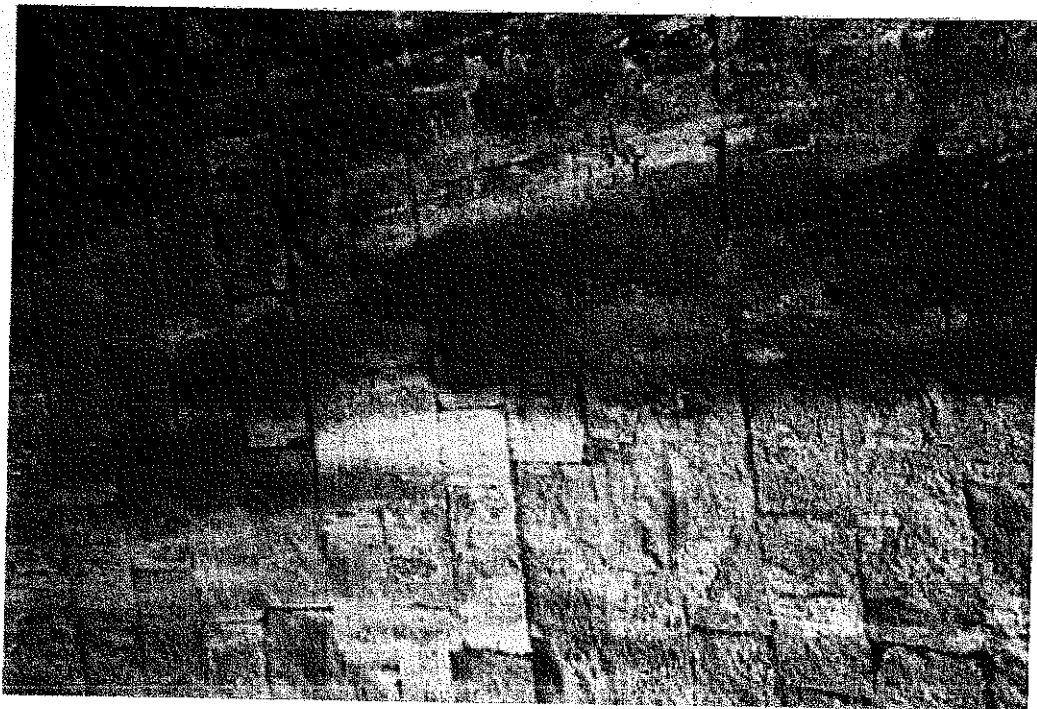
| COMPONENT | | INSPECTION RESULT | | PHOTO/<br>SKETCH | PAGE<br>No. | RECOMMENDATIONS/ACTION | TIME<br>SCALE |
|---|---|---|---|---|---|---|---|
| 16 | Arch Soffit<br>Middle Arch | 16F | The middle arch soffit has at the crown position a large area of black staining probably due to past seepage. | P25<br>P27<br>SK7 | 38<br>39<br>52 | Remove staining | L |

**P25** BLACK STAINING TO SOFFIT OF MIDDLE SPAN

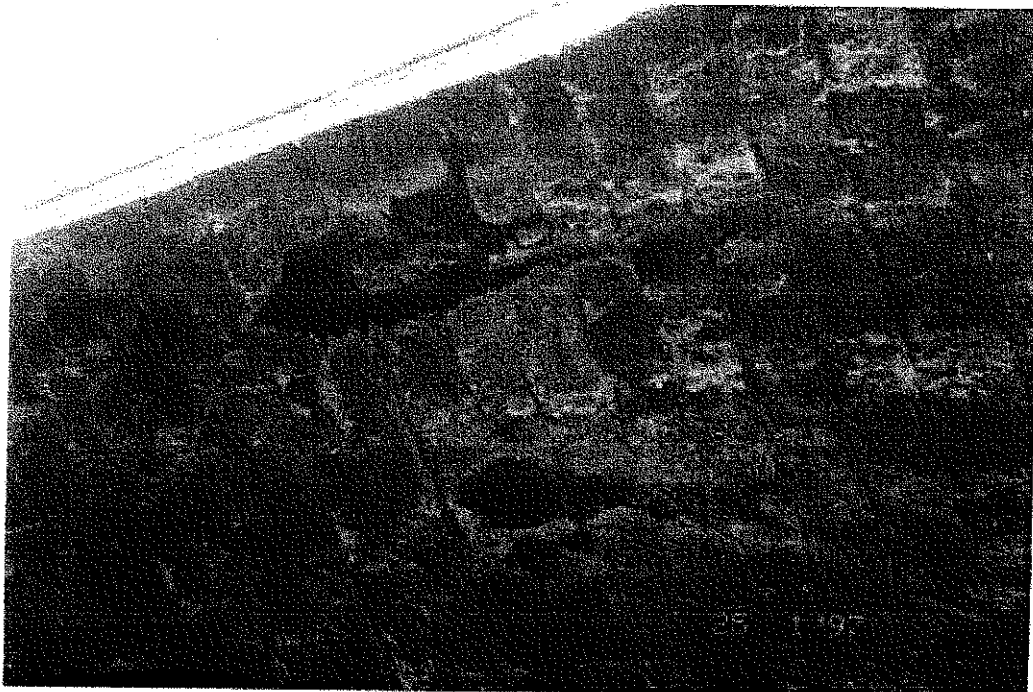
| COMPONENT | | INSPECTION RESULT | | PHOTO/<br>SKETCH | PAGE<br>No. | RECOMMENDATIONS/ACTION | TIME<br>SCALE |
|---|---|---|---|---|---|---|---|
| | West Arch | 16I | The West arch soffit has black staining along the middle length. | P26<br>P28<br>SK8 | 38<br>40<br>53 | Remove staining. Repoint | L |

**P26** WATER STAINING AND LEACHING TO EDGE OF WEST SPAN SOFFIT

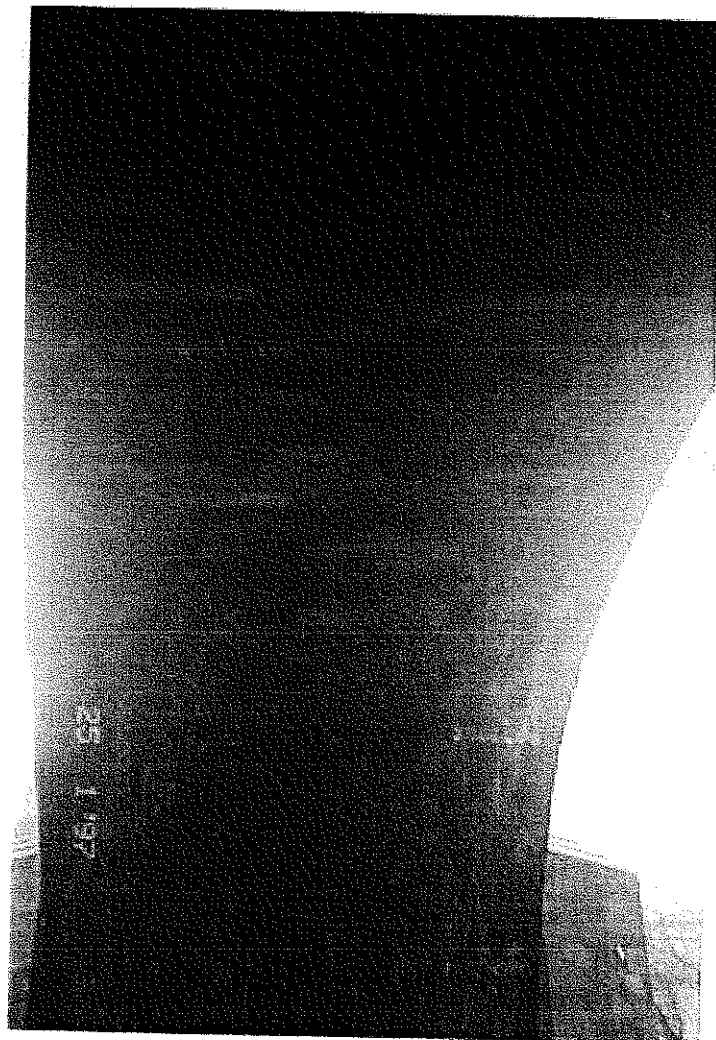
| COMPONENT | | INSPECTION RESULT | | PHOTO/<br>SKETCH | PAGE<br>No. | RECOMMENDATIONS/ACTION | TIME<br>SCALE |
|---|---|---|---|---|---|---|---|
| | Middle Arch | 16G | There is extensive leaching and dampness on the outside 1.5m strips of the barrel, with isolated areas of active seepage. | P27 | 39 | Provide waterproofing | L |

**P27 GENERAL VIEW OF MIDDLE SPAN  
SOFFIT LOOKING WEST**

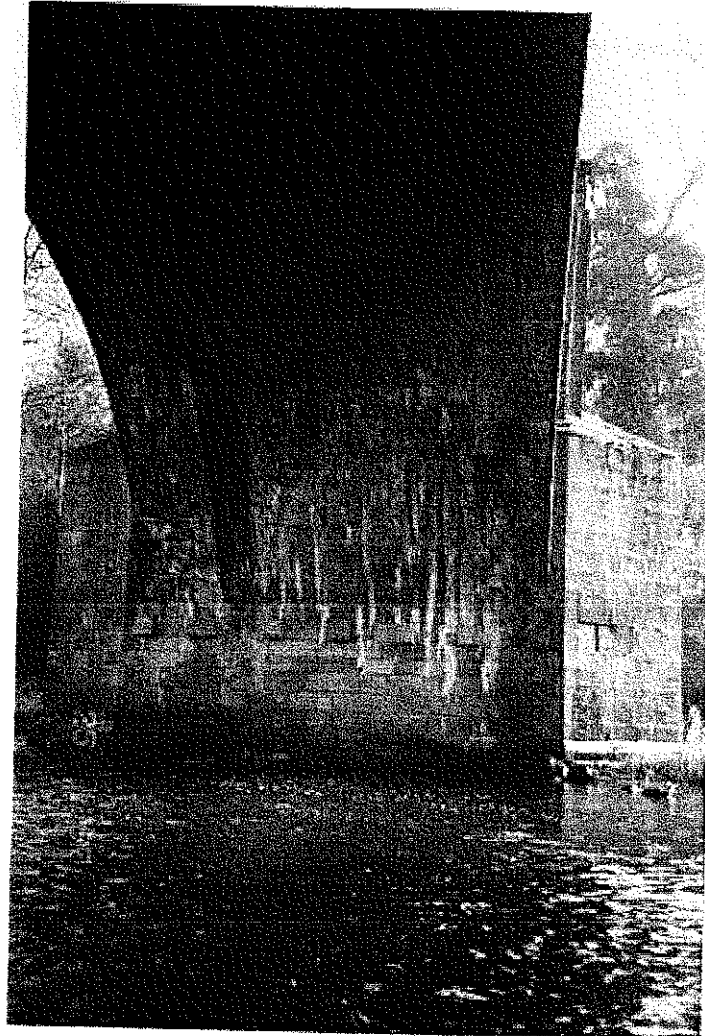
**P28** GENERAL VIEW OF WEST SOFFIT LOOKING EAST

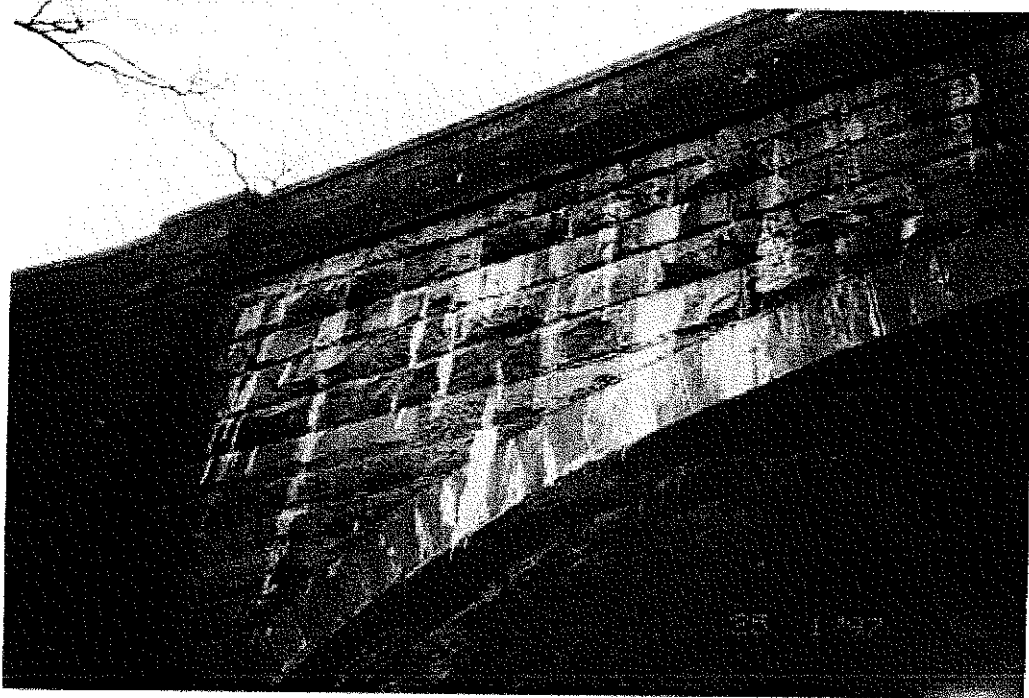
| COMPONENT | | INSPECTION RESULT | | PHOTO/<br>SKETCH | PAGE<br>No. | RECOMMENDATIONS/ACTION | TIME<br>SCALE |
|---|---|---|---|---|---|---|---|
| | | 17D | The middle arch North elevation has extensive areas of wetness with leaching through the joints staining the face. | P29<br>SK5 | 41<br>50 | Provide waterproofing | L |

**P29 WATER STAINING OF NORTH MIDDLE ELEVATION SPANDRELS**

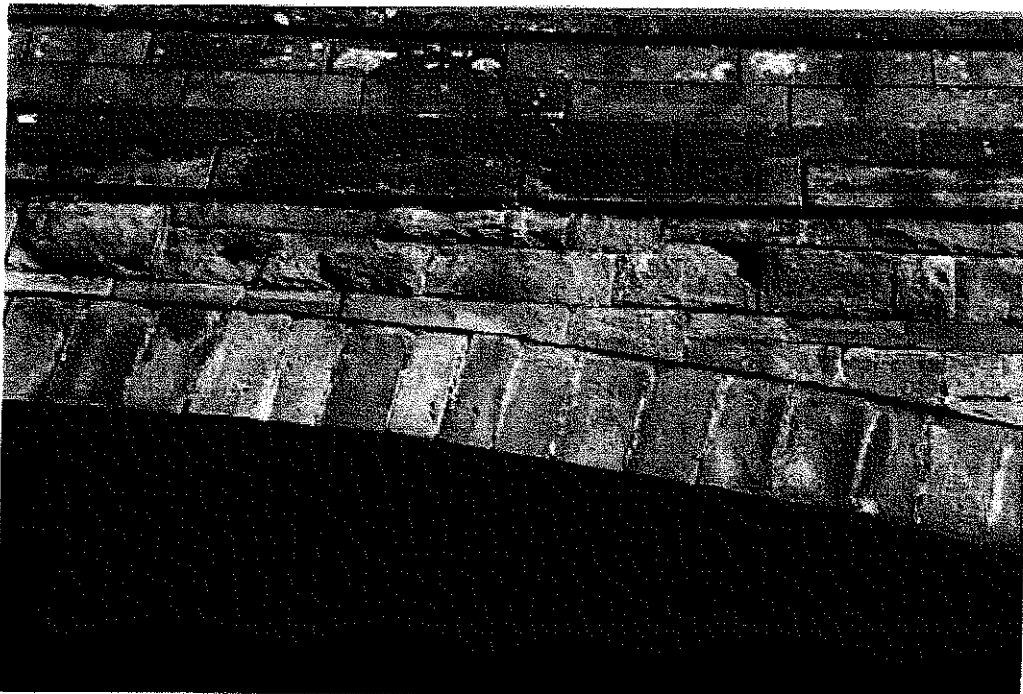
| COMPONENT | | INSPECTION RESULT | | PHOTO/<br>SKETCH | PAGE<br>No. | RECOMMENDATIONS/ACTION | TIME<br>SCALE |
|---|---|---|---|---|---|---|---|
| | | 17B | The South West elevation has a line of open joints above the voussers. There is active water seepage at both springing positions with a crack emanating from the South West pier buttress up the face approximately 1.5m long. | P30<br>SK6 | 41<br>51 | Provide waterproofing. Repoint. Monitor cracking | L |

**P30 SPALLING OF SOUTH WEST SPANDREL**
