**4. INSPECTION PROCEDURE  
HODDER HIGHER (No: 1043/B1)**

The Principal Inspection was carried out by Thorburn Colquhoun on 25 January 1997. The weather conditions during the inspection were dry with sunny spells. The depth of the River Hodder passing under Hodder Higher Bridge was a maximum of 1.2m. It was not necessary to effect any traffic management measures on the C354 in order to carry out the inspection.

Lancashire County Council  
Hodder Higher Bridge (No: 1043) - PBI

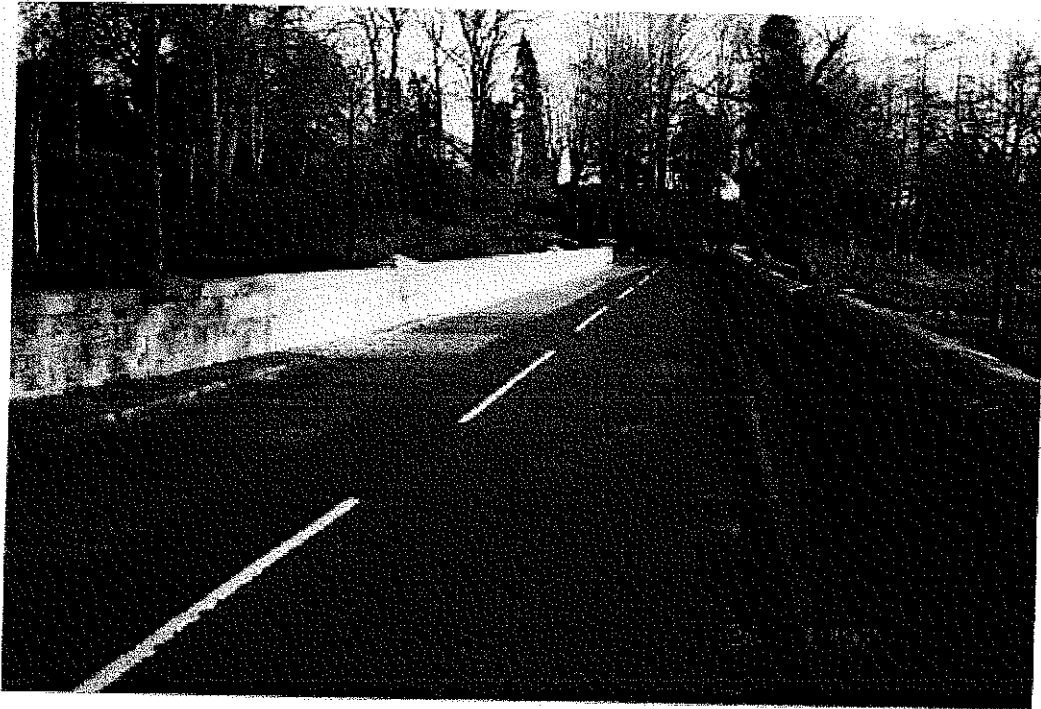
| COMPONENT | | INSPECTION RESULT | | PHOTO/<br>SKETCH | PAGE<br>No. | RECOMMENDATIONS/ACTION | TIME<br>SCALE |
|---|---|---|---|---|---|---|---|
| 21 | Surfacing | 21A | The tarmacadam carriageway surfacing is generally in good condition, but the surface has worn away at the East approach curve at the bottom of the approach hill. | P31 | 42 | Repair | L |
| | | 21B | There is a kerb margin either side of the road approximately 600mm wide. They are in satisfactory condition. | P32<br>P31 | 42<br>42 | Remove vegetation. Replace cracked flags | L |

P31 GENERAL VIEW LOOKING EAST

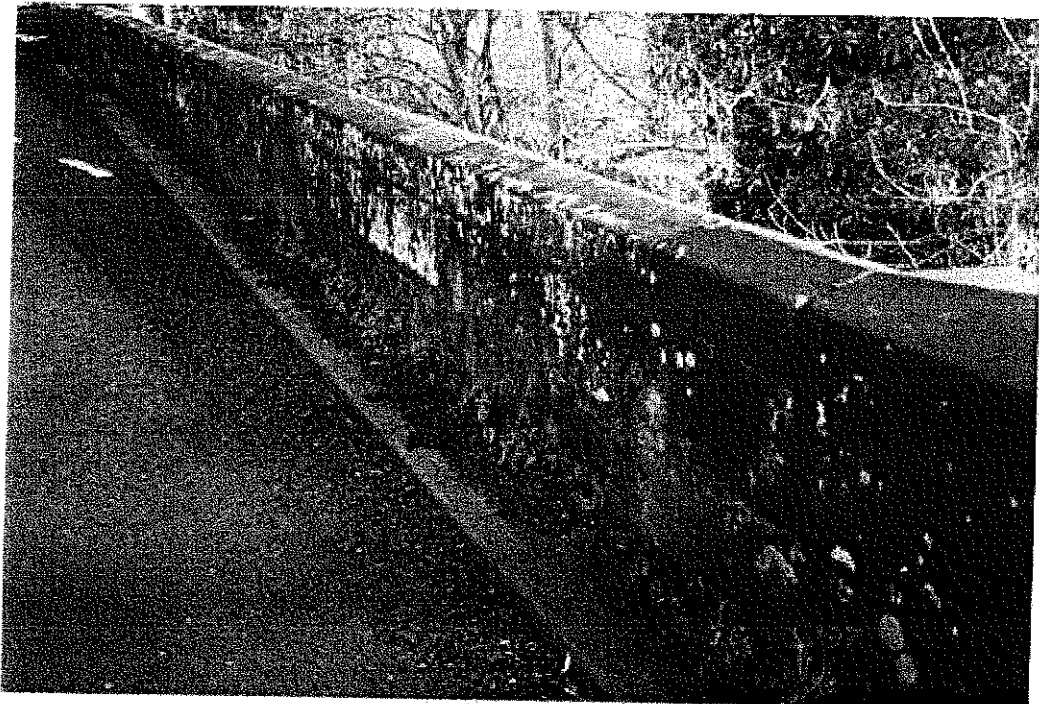
P32 VEGETATION GROWTH ON ROADSIDE OF SOUTH EAST WING WALL

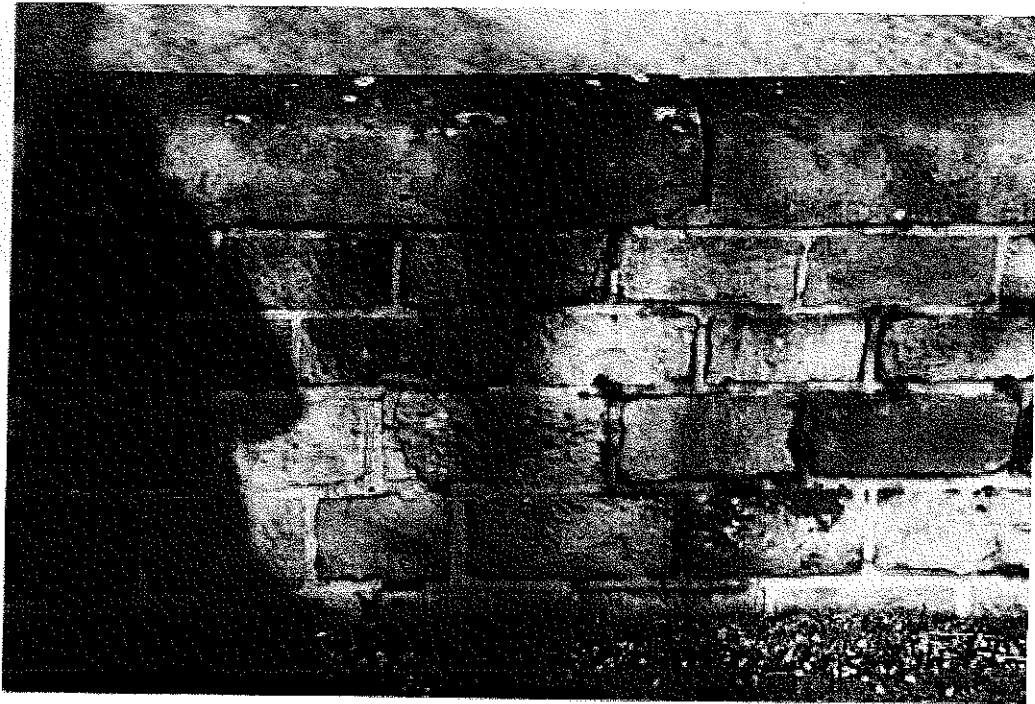
| COMPONENT | | INSPECTION RESULT | | PHOTO/<br>SKETCH | PAGE<br>No. | RECOMMENDATIONS/ACTION | TIME<br>SCALE |
|---|---|---|---|---|---|---|---|
| | | 24B | There are a number of vertical cracks in both parapets which extend full depth. At the North West side there is a large crack through the wall with slight movement of the blocks. | P33<br>SK5<br>SK6 | 43<br>50<br>51 | Monitor | L |

P33 CRACKING THROUGH FULL DEPTH OF JOINT IN NORTH WEST PARAPEL 29677/7/10

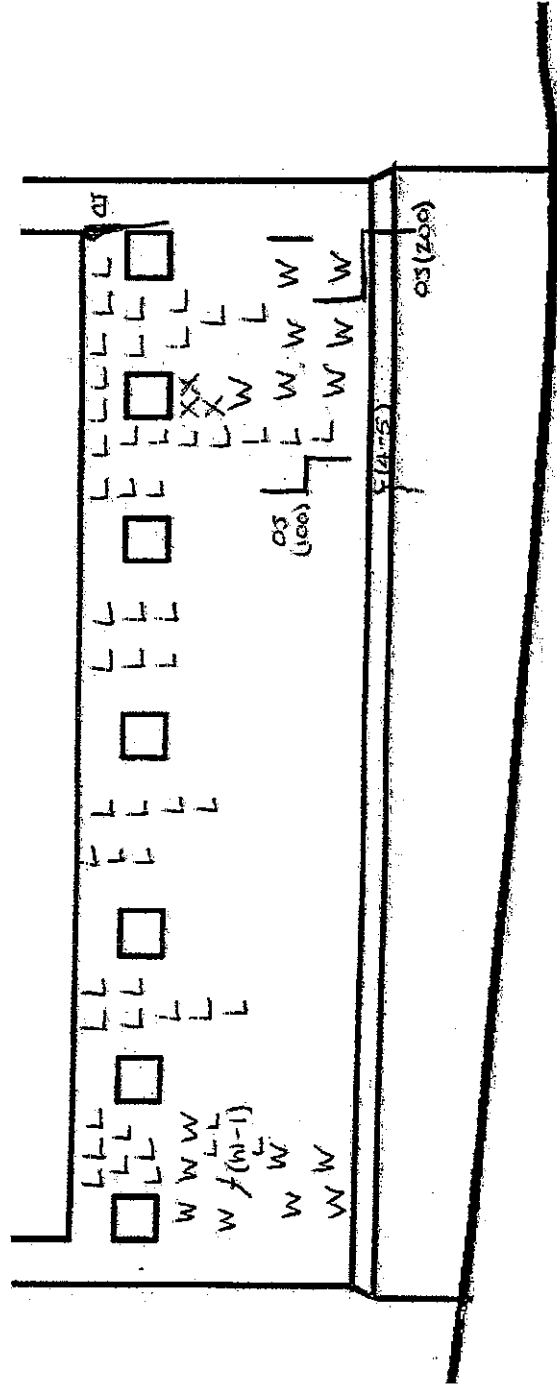
SKI EAST ELEVATION OF WEST PIER

| COMPONENT | | INSPECTION RESULT | | PHOTO/<br>SKETCH | PAGE<br>No. | RECOMMENDATIONS/ACTION | TIME<br>SCALE |
|---|---|---|---|---|---|---|---|
| | | 4E | On the East elevation of the West pier there is mortar loss to joints of upto 200mm deep and a crack, hairline to 1mm wide, through a stone course. | SK1<br>P9 | 46<br>27 | Repoint and monitor | L |

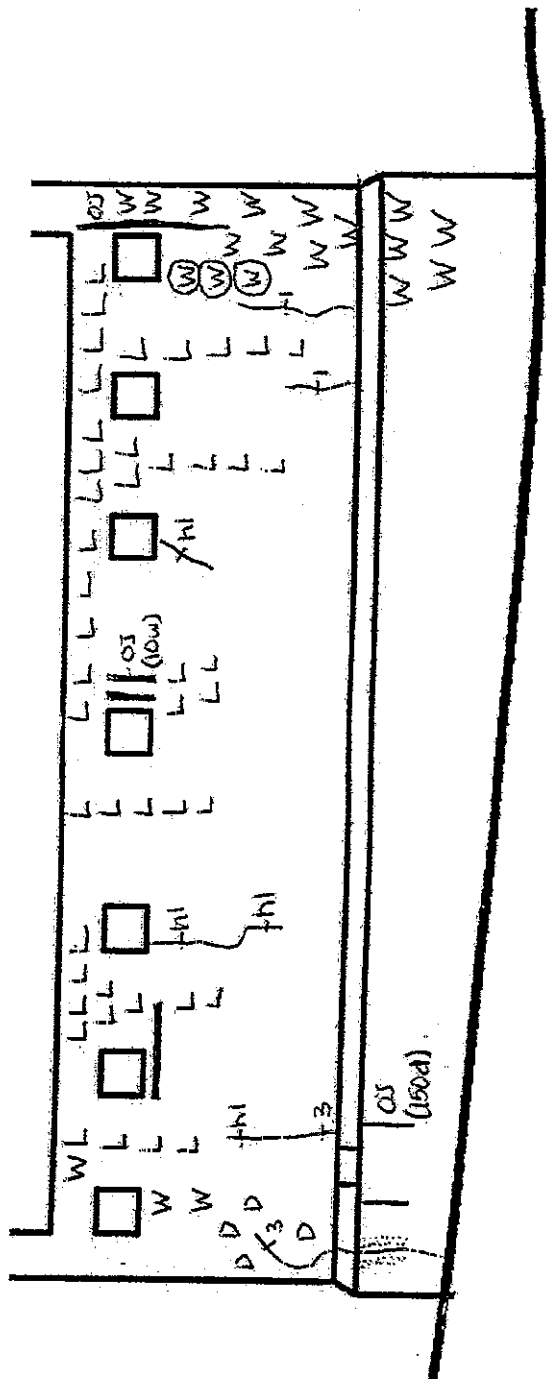
SK2 WEST ELEVATION OF WEST PIER

| COMPONENT | | INSPECTION RESULT | | PHOTO/<br>SKETCH | PAGE<br>No. | RECOMMENDATIONS/ACTION | TIME<br>SCALE |
|---|---|---|---|---|---|---|---|
| | | 4F | On the West elevation of the West pier there are 5 No. hairline to 3mm wide cracks and areas of mortar loss to the joints of upto 150mm deep. | SK2<br>P4<br>P8<br>P10 | 47<br>23<br>27<br>28 | Repoint and monitor | L |

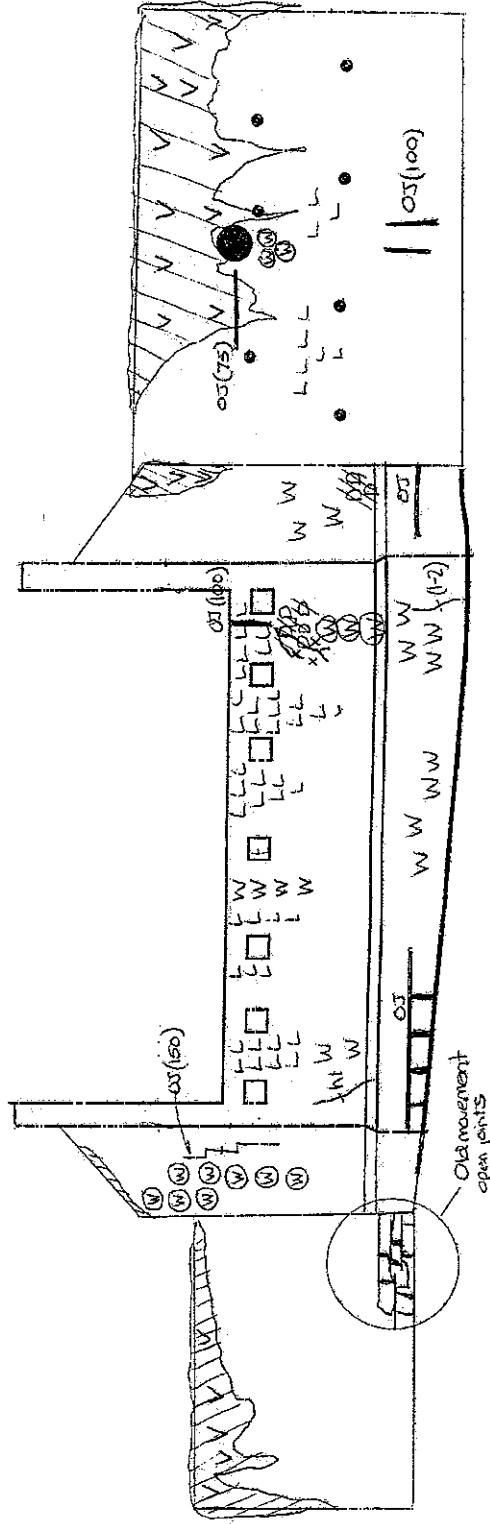
SK4 ELEVATION OF WEST ABUTMENT

| COMPONENT | | INSPECTION RESULT | | PHOTO/<br>SKETCH | PAGE<br>No. | RECOMMENDATIONS/ACTION | TIME<br>SCALE |
|---|---|---|---|---|---|---|---|
| | | 5B | There is joint loss upto 150 deep in the West abutment along the bottom courses. There is a hairline crack through a stone at the South end. | P13<br>SK4 | 30<br>49 | Repoint and monitor | L |
| | | 5C | The West abutment face is generally damp with areas of active seepage present on day of inspection. | P12<br>P14<br>SK4 | 30<br>31<br>49 | Provide effective waterproofing | L |
| | | 5D | There is an area of drummy, eroded masonry and potential spall to the North side of the West abutment (1m x 1m approximate area). | P14<br>SK4 | 31<br>49 | Repair | L |

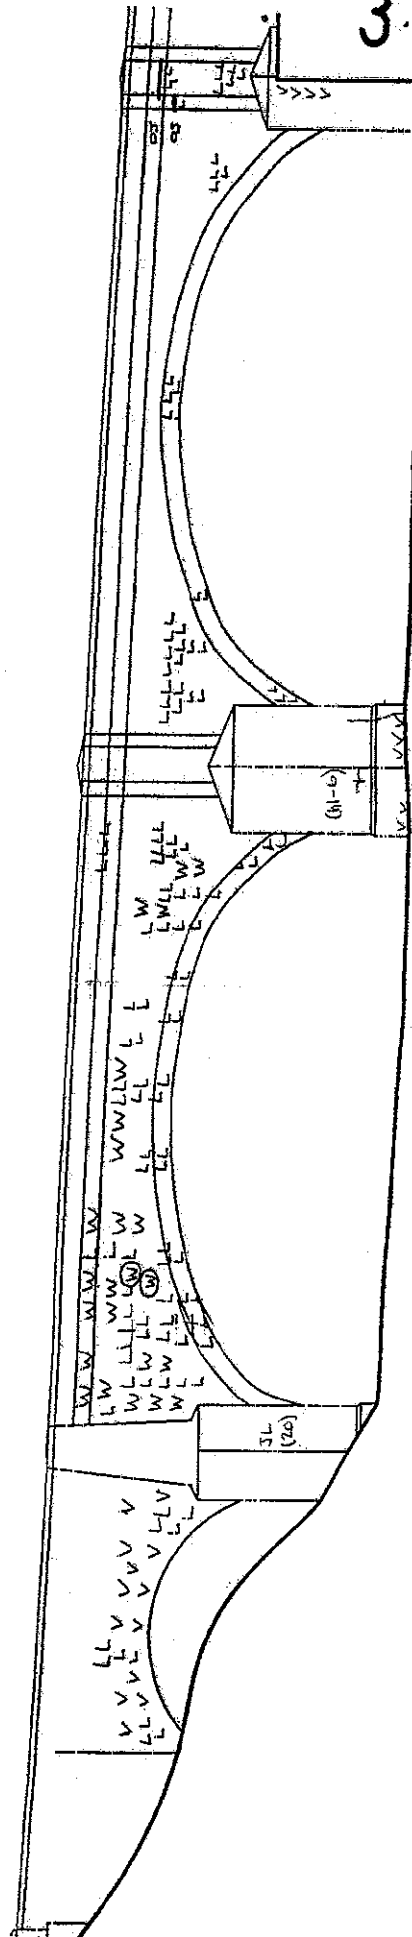
SK5 NORTH ELEVATION

| COMPONENT | | INSPECTION RESULT | | PHOTO/<br>SKETCH | PAGE<br>No. | RECOMMENDATIONS/ACTION | TIME<br>SCALE |
|---|---|---|---|---|---|---|---|
| | | 16C | The North West arch barrel elevation has been recently repointed and is in good condition. There are isolated areas of leaching along its length. | SK5 | 50 | Provide effective waterproofing membrane | L |

| COMPONENT | | INSPECTION RESULT | | PHOTO/<br>SKETCH | PAGE<br>No. | RECOMMENDATIONS/ACTION | TIME<br>SCALE |
|---|---|---|---|---|---|---|---|
| | | 16D | The North East elevation has areas of leaching along its length with mortar loss to vertical joints at the crown position. | SK5 | 50 | Repoint. Provide waterproofing membrane effective | L |

| COMPONENT | | INSPECTION RESULT | | PHOTO/<br>SKETCH | PAGE<br>No. | RECOMMENDATIONS/ACTION | TIME<br>SCALE |
|---|---|---|---|---|---|---|---|
| | | 17D | The middle arch North elevation has extensive areas of wetness with leaching through the joints staining the face. | P29<br>SK5 | 41<br>50 | Provide waterproofing | L |

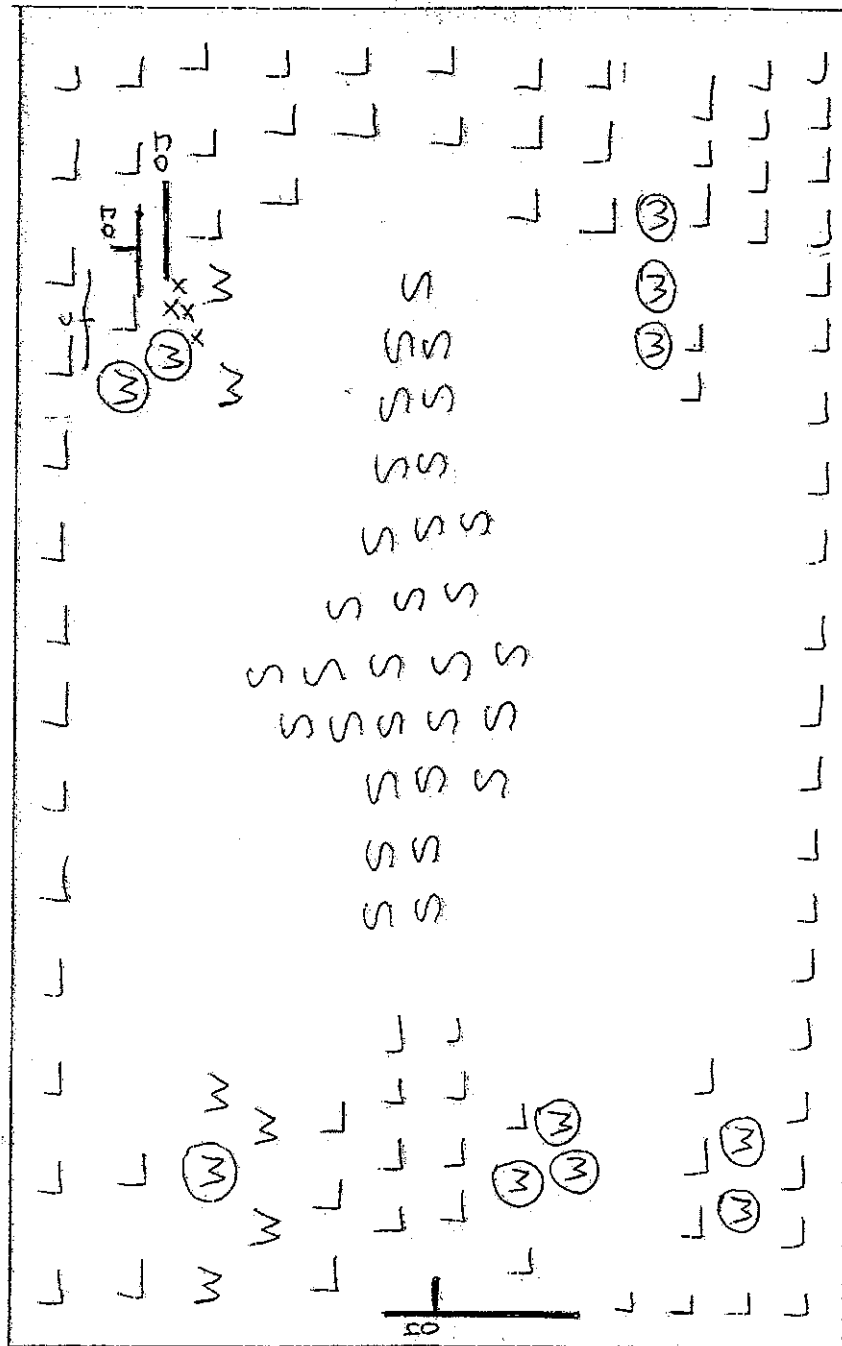
SK7 MIDDLE ARCH SOFFIT

| COMPONENT | | INSPECTION RESULT | | PHOTO/<br>SKETCH | PAGE<br>No. | RECOMMENDATIONS/ACTION | TIME<br>SCALE |
|---|---|---|---|---|---|---|---|
| 16 | Arch Soffit<br>Middle Arch | 16F | The middle arch soffit has at the crown position a large area of black staining probably due to past seepage. | P25<br>P27<br>SK7 | 38<br>39<br>52 | Remove staining | L |

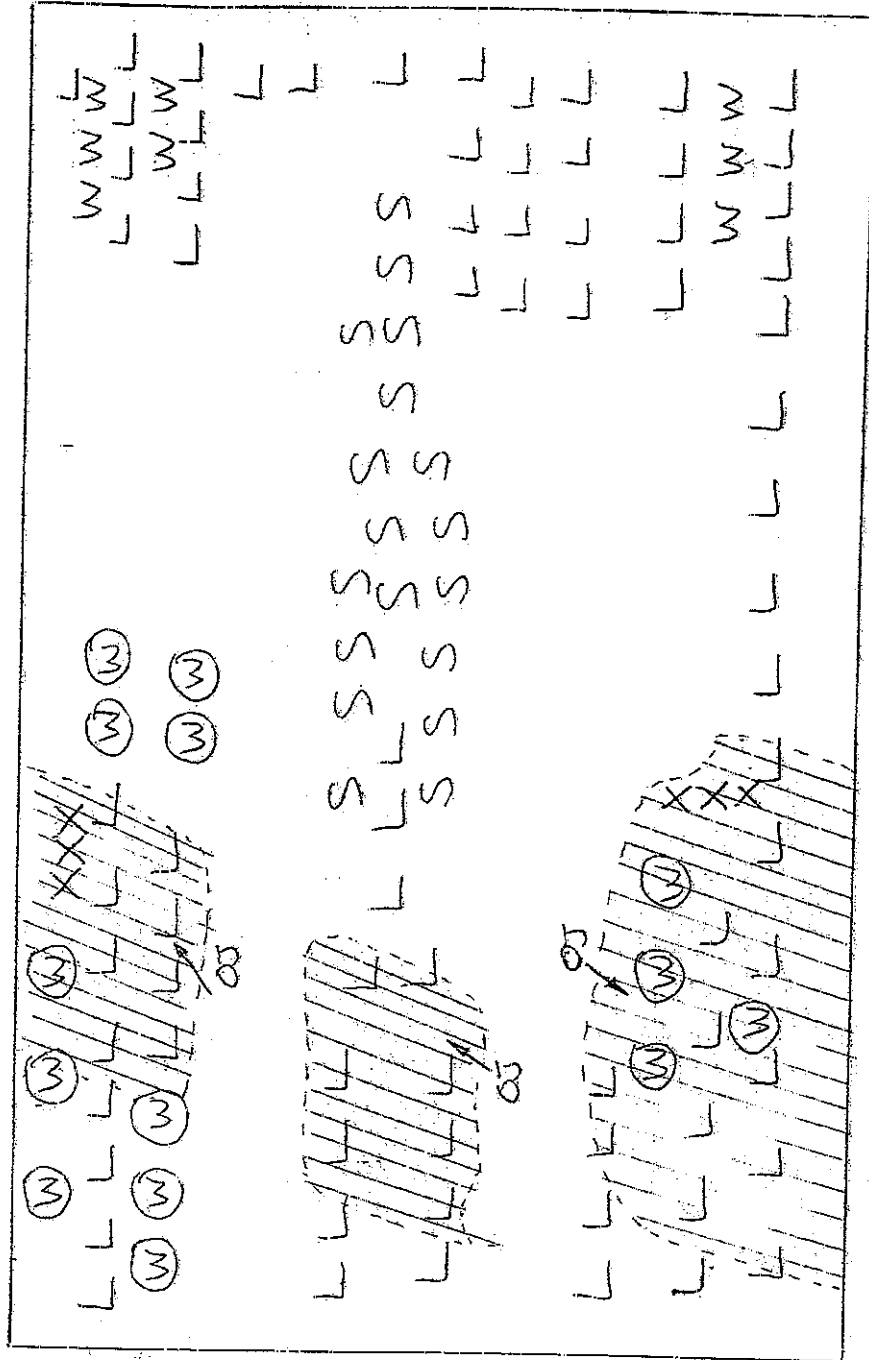
SK8 WEST ARCH SOFFIT

| COMPONENT | | INSPECTION RESULT | | PHOTO/<br>SKETCH | PAGE<br>No. | RECOMMENDATIONS/ACTION | TIME<br>SCALE |
|---|---|---|---|---|---|---|---|
| | West Arch | 16I | The West arch soffit has black staining along the middle length. | P26<br>P28<br>SK8 | 38<br>40<br>53 | Remove staining. Repoint | L |

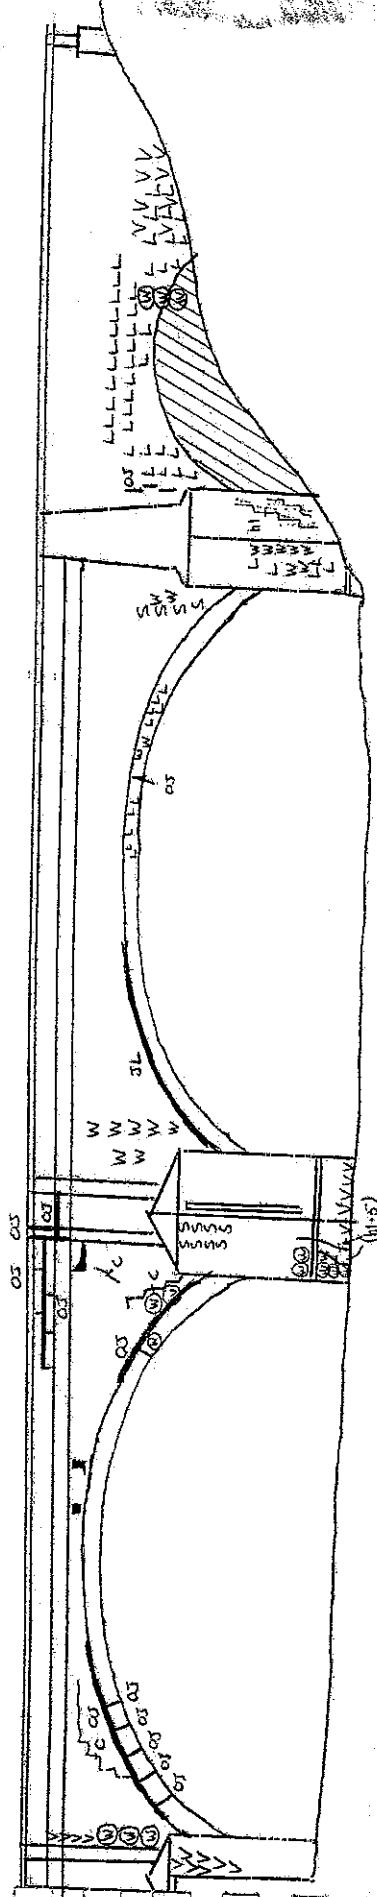
SK6 SOUTH ELEVATION

| COMPONENT | | INSPECTION RESULT | | PHOTO/<br>SKETCH | PAGE<br>No. | RECOMMENDATIONS/ACTION | TIME<br>SCALE |
|---|---|---|---|---|---|---|---|
| | | 16B | The South West arch barrel elevation is in good condition. There is mortar loss to the vertical joints adjacent to the West abutment. Localised cracking and mortar loss is present between the interface of the spandrel and the elevation of the ring. There is active water seepage near the springing of the West abutment. | P23<br>SK6 | 37<br>51 | Repoint. Provide waterproofing membrane effective | L |

| COMPONENT | | INSPECTION RESULT | | PHOTO/<br>SKETCH | PAGE<br>No. | RECOMMENDATIONS/ACTION | TIME<br>SCALE |
|---|---|---|---|---|---|---|---|
| | | 17B | The South West elevation has a line of open joints above the voussers. There is active water seepage at both springing positions with a crack emanating from the South West pier buttress up the face approximately 1.5m long. | P30<br>SK6 | 41<br>51 | Provide waterproofing. Repoint. Monitor cracking | L |

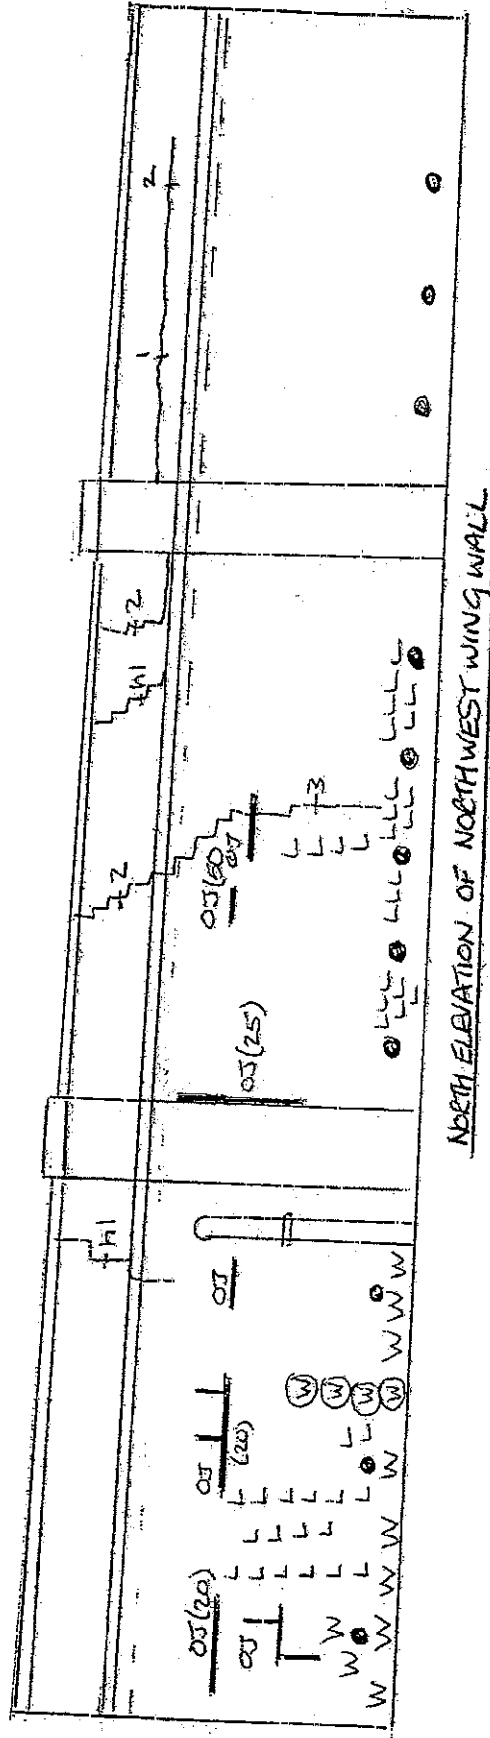
SK9 NORTH WING WALL ELEVATIONS

| COMPONENT | | INSPECTION RESULT | | PHOTO/<br>SKETCH | PAGE<br>No. | RECOMMENDATIONS/ACTION | TIME<br>SCALE |
|---|---|---|---|---|---|---|---|
| 6 | Wing Walls | 6A | On the North West side the wing wall is constructed from random coursed, dressed masonry blocks. There are a number of cracks in the top ten courses which go through the full thickness of the wall. Mortar loss is evident in isolated areas of upto 70mm deep. The bottom courses of the wall are generally damp with areas of green staining and leaching. | P15 | 32 | Repoint and monitor | L |

| COMPONENT | | INSPECTION RESULT | | PHOTO/<br>SKETCH | PAGE<br>No. | RECOMMENDATIONS/ACTION | TIME<br>SCALE |
|---|---|---|---|---|---|---|---|
| | | 6E | On the North East wing wall there is 20% mortar loss over the embankment face upto 20mm deep. It is generally obscured with vegetation. | SK9 | 54 | Repoint and remove vegetation | L |

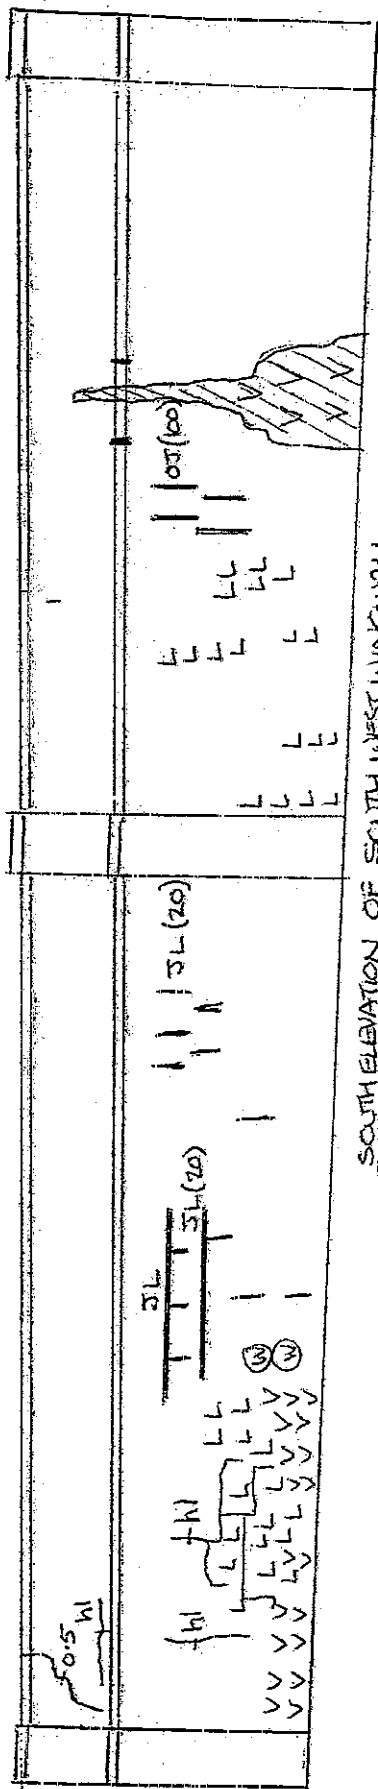
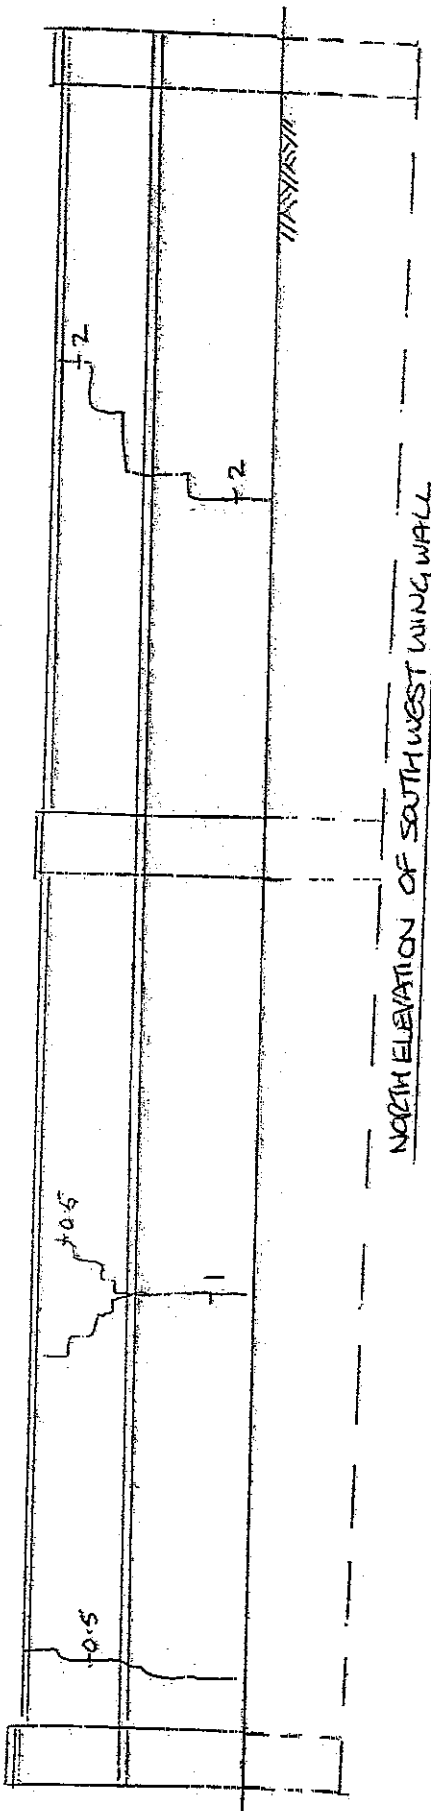
SK10 SOUTH WING WALL ELEVATIONS

| COMPONENT | | INSPECTION RESULT | | PHOTO/<br>SKETCH | PAGE<br>No. | RECOMMENDATIONS/ACTION | TIME<br>SCALE |
|---|---|---|---|---|---|---|---|
| | | 6B | The South West wing wall is generally in good condition. There are isolated areas of leaching and mortar loss upto 20mm deep. There is moss and ivy growing on the embankment side of the wall over the bottom ten courses.<br><br>On the embankment side there is a large area of leaching and dampness with a number of hairline cracks through joints.<br><br>There is a crack upto 2mm wide the full height of the wall on the road side and approximately 1m long on the embankment side. | P18 | 33 | Repoint and monitor cracking | L |
