# SLAIDBURN BRIDGE PBI

Lancashire County Council's Highway Consultancy undertook the Principal Inspection of Slaidburn Bridge, L.C.C. No. 4263, on 9 October 1996. The weather during the inspection was dry.

**SLAIDBURN BRIDGE L.C.C. No. 4263  
SPECIAL INSPECTION REPORT  
INSPECTION FOR ASSESSMENT  
APPENDIX A**

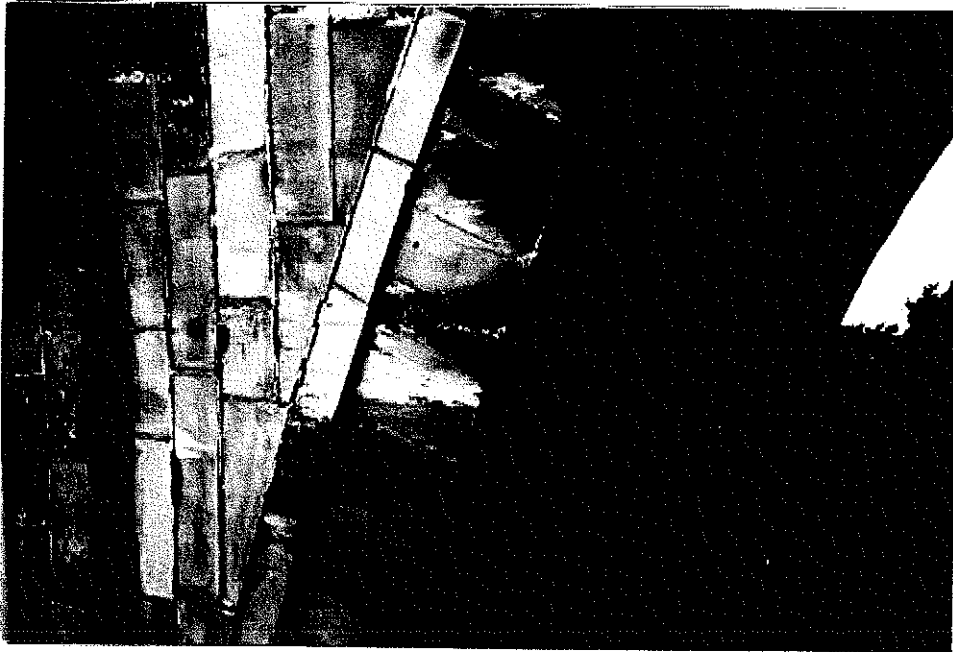
| COMPONENTS | INSPECTION RESULTS | PHOTO (P) No &<br>SKETCH (S) No | PAGE<br>No | RECOMMENDATIONS/ACTION | TIMESCALE |
|---|---|---|---|---|---|
| | Water seepage and surface deposits to outer ring on northern side. | P18 S4 | 18 | Monitor. | |

18. Water seepage and surface deposits

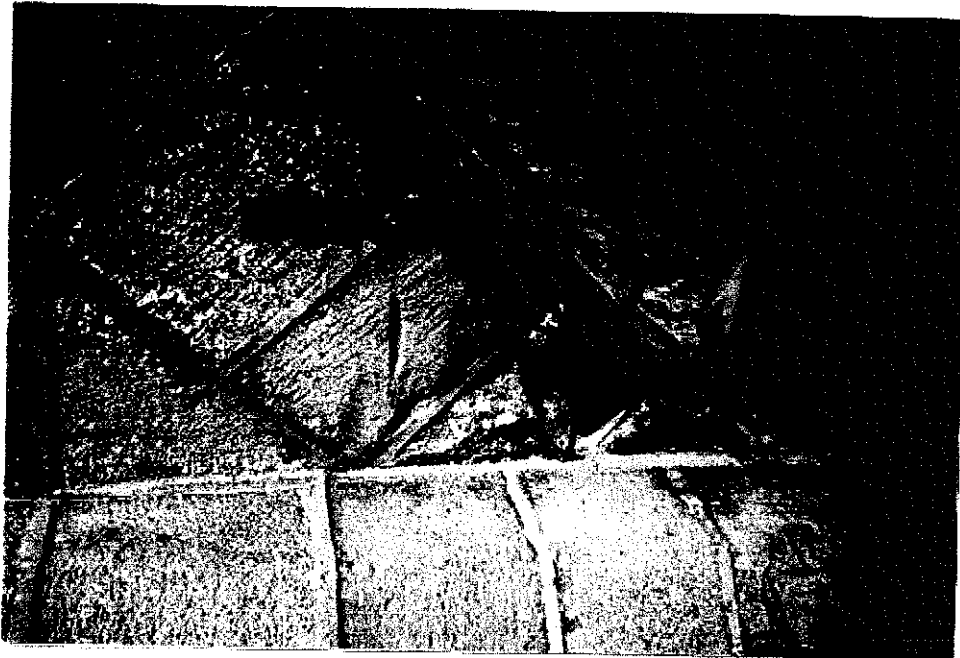
| COMPONENTS | INSPECTION RESULTS | PHOTO (P) No & SKETCH (S) No | PAGE No | RECOMMENDATIONS/ACTION | TIMESCALE |
|---|---|---|---|---|---|
| | Damage to outer blocks caused by gate on southern side. | P28 S3 | 23 | Monitor. | |

28. Damage to outer blocks

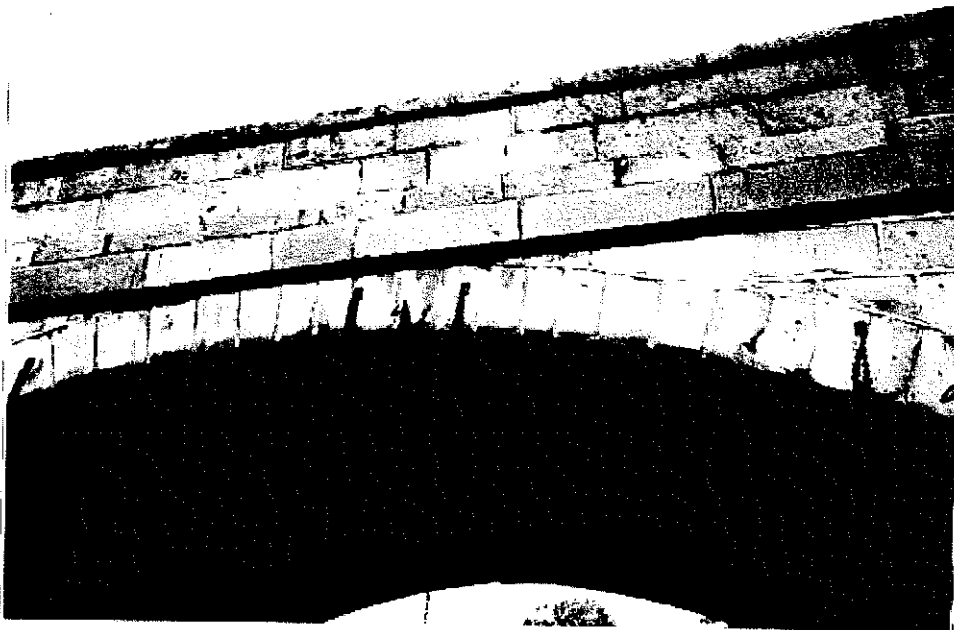
| COMPONENTS | INSPECTION RESULTS | PHOTO (P) No & SKETCH (S) No | PAGE No | RECOMMENDATIONS/ACTION | TIMESCALE |
|---|---|---|---|---|---|
| | Water seepage at crown and leached deposits to outer blocks on southern side. | P29 S3 | 24 | Monitor. | |

29. Water seepage at crown and leached deposits

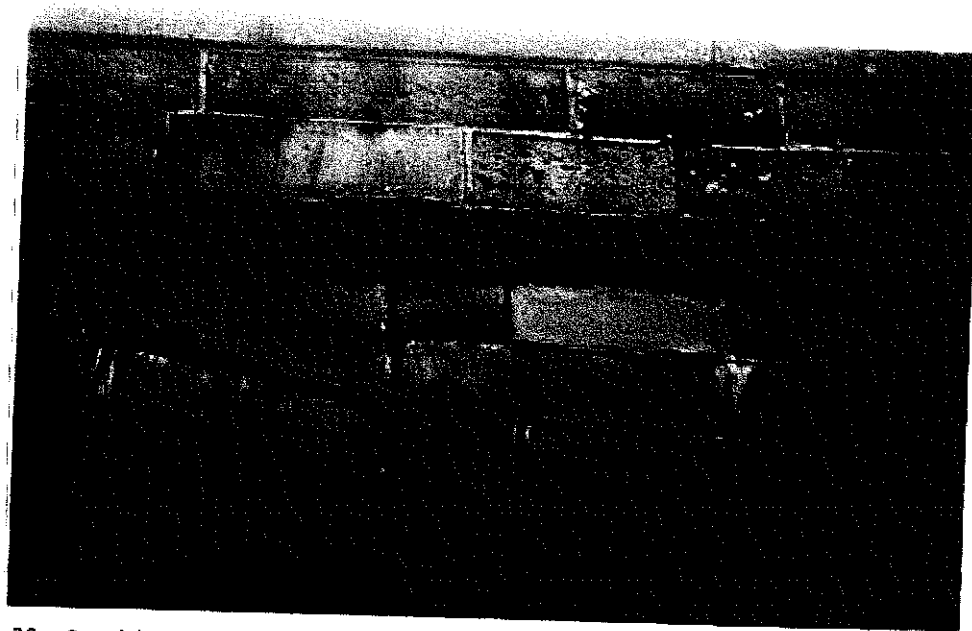
| COMPONENTS | INSPECTION RESULTS | PHOTO (P) No &<br>SKETCH (S) No | PAGE<br>No | RECOMMENDATIONS/ACTION | TIMESCALE |
|---|---|---|---|---|---|
| | Cracking to pointing between masonry blocks extending from arch ring through parapet. | P38 S4 | 28 | Repoint. | |

38. Cracking to pointing

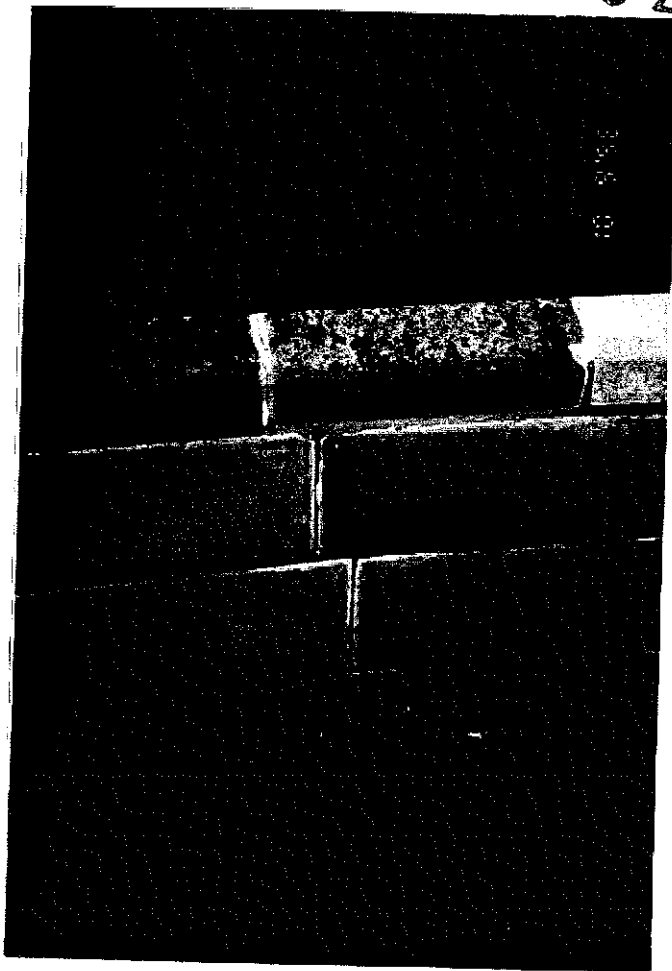
41. Missing  
pointing

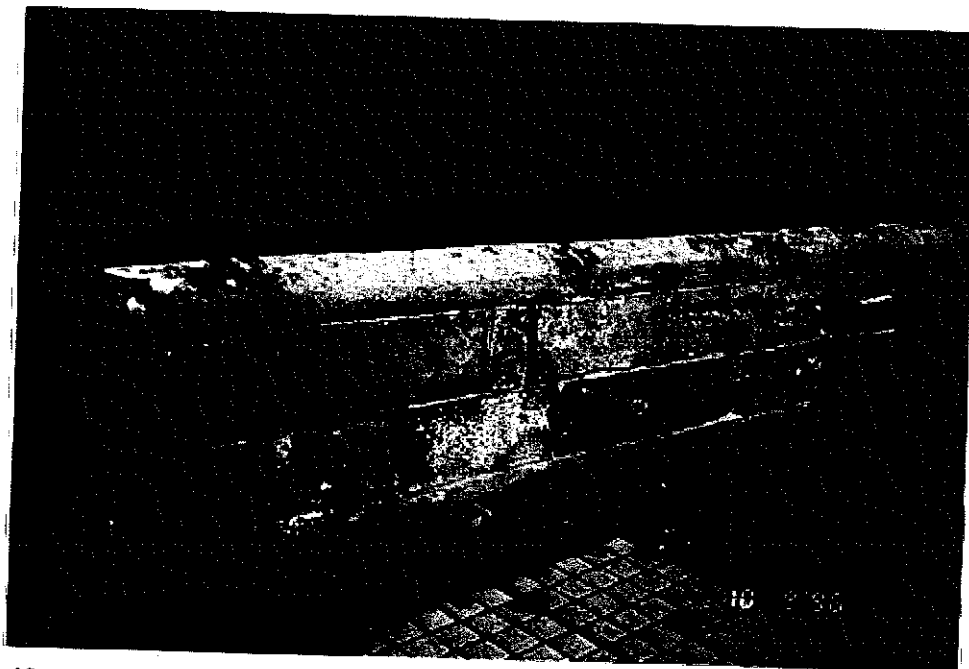
42. Cracked and missing pointing

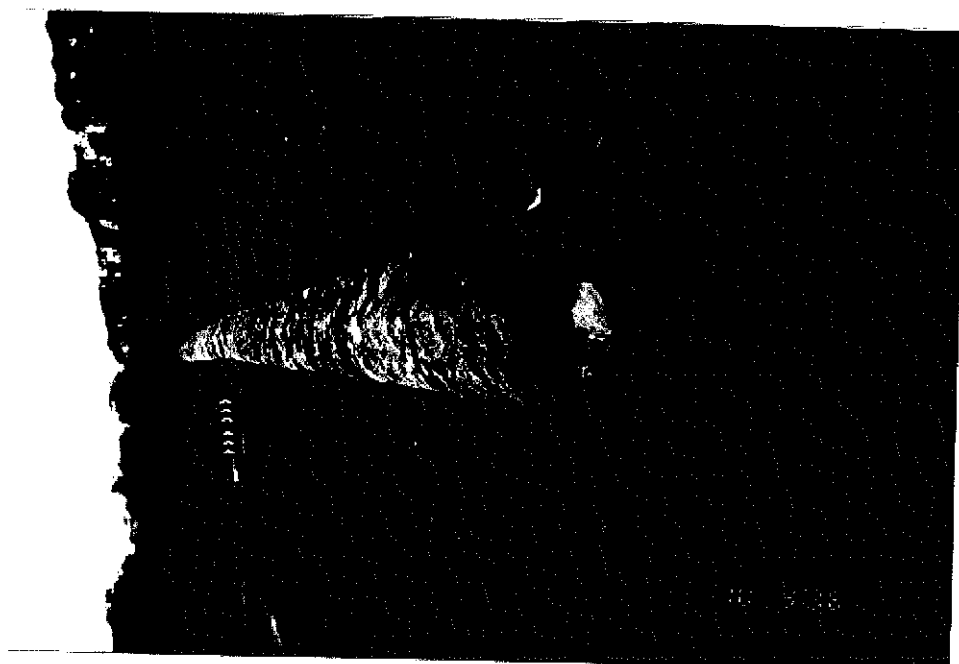
| COMPONENTS | INSPECTION RESULTS | PHOTO (P) No &<br>SKETCH (S) No | PAGE<br>No | RECOMMENDATIONS/ACTION | TIMESCALE |
|---|---|---|---|---|---|
| | Deviation in line of parapet. | P44 S5 | 31 | Monitor. | |

44. Deviation in line of parapet

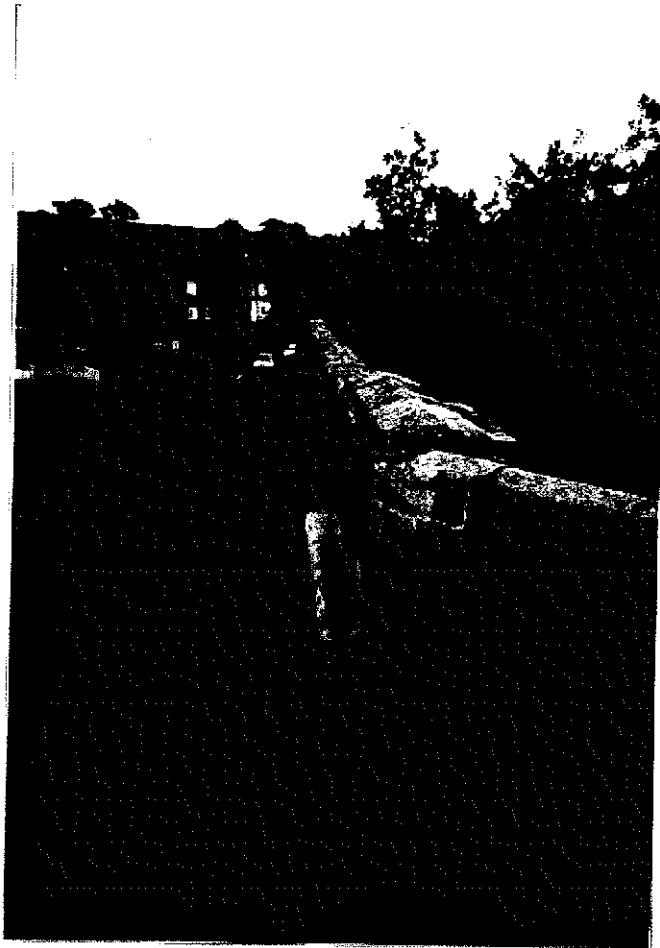
| COMPONENTS | INSPECTION RESULTS | PHOTO (P) No &<br>SKETCH (S) No | PAGE<br>No | RECOMMENDATIONS/ACTION | TIMESCALE |
|---|---|---|---|---|---|
| | Worn kerb stones, cracked mortar, open joints and impact damage on inside corner of bend. | P45 S5 | 32 | Replace spalled masonry kerbs on corner and repoint remaining cracks. | M |

45. Damaged parapet,  
kerb and open  
joints
