**"WHALLEY BRIDGE"**

LANCASHIRE COUNTY COUNCIL

INITIAL UNDERWATER STRUCTURAL INSPECTION BY DIVERS

SEPTEMBER 1998

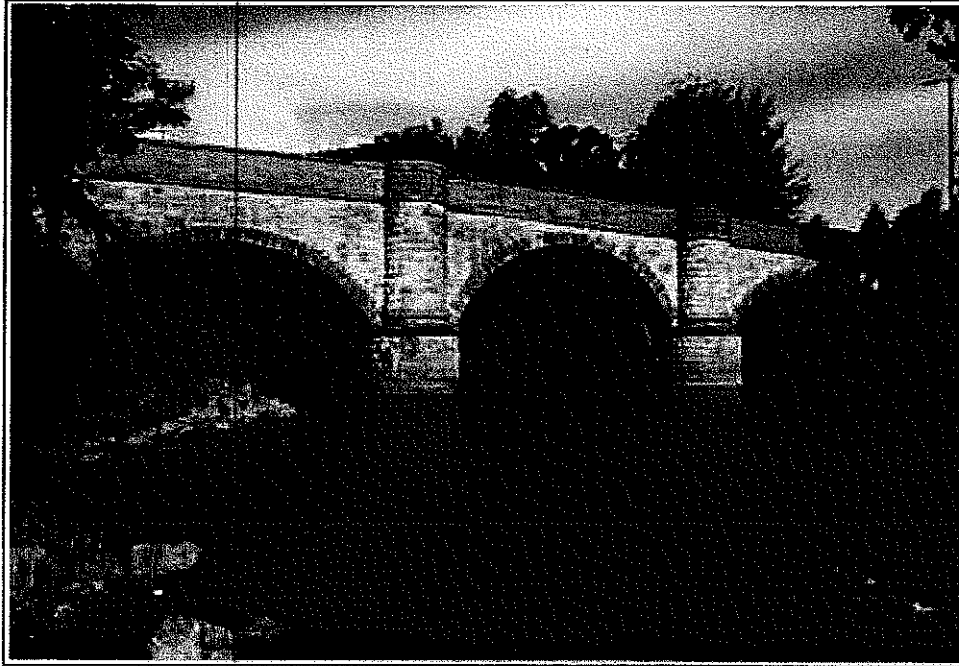
**No.1** General view of upstream face looking downstream

Multiple segmental arch with variable soffit profiles to upstream extension

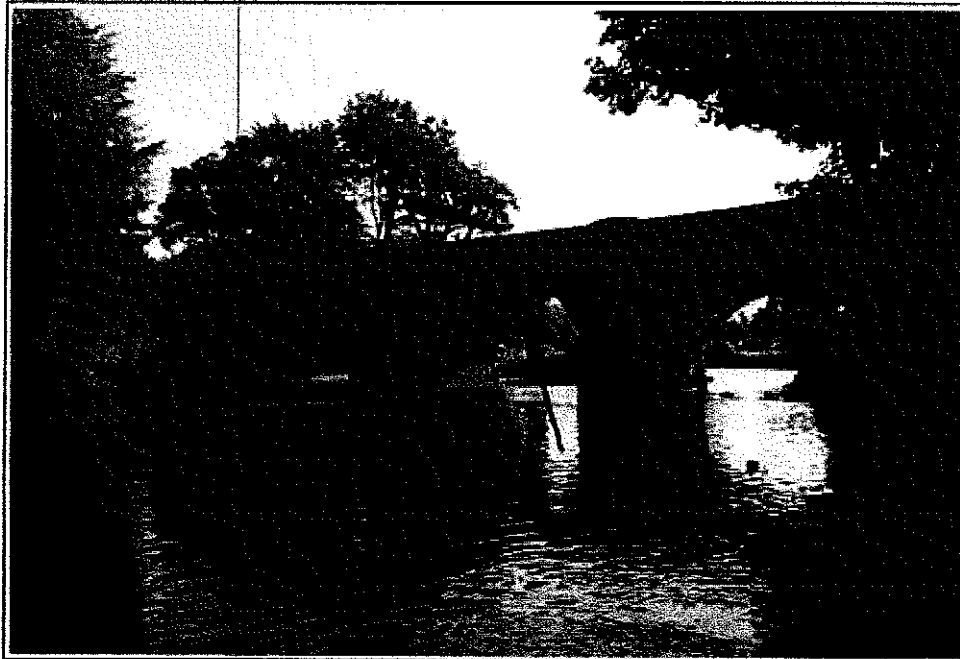
**No.2** General view of downstream face looking upstream

Multiple segmental arch with variable soffit construction throughout

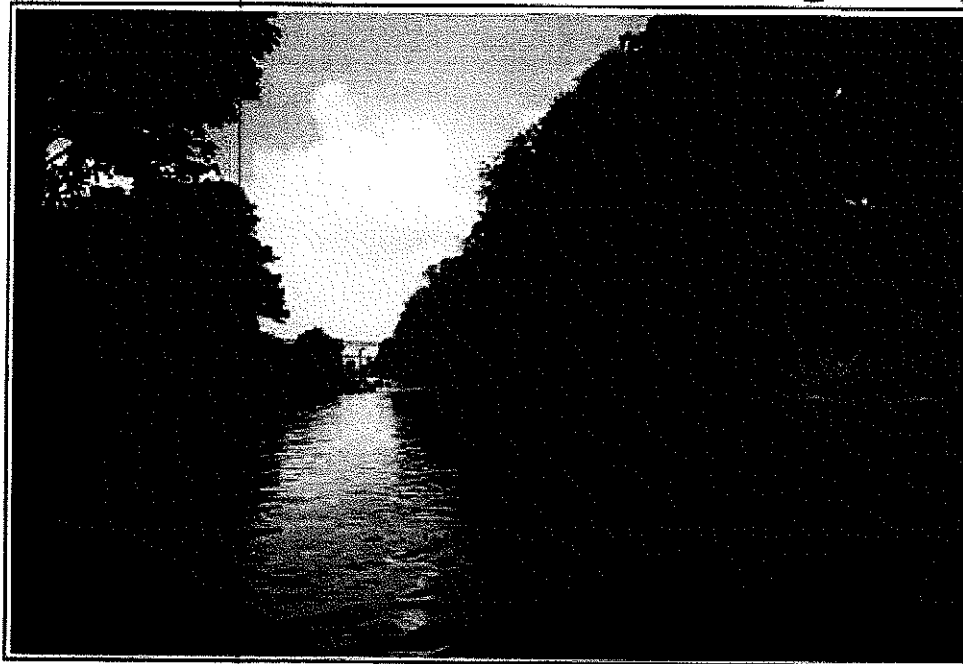
**No.4** General view from downstream face looking downstream

River Calder weir controlled channelled watercourse downstream

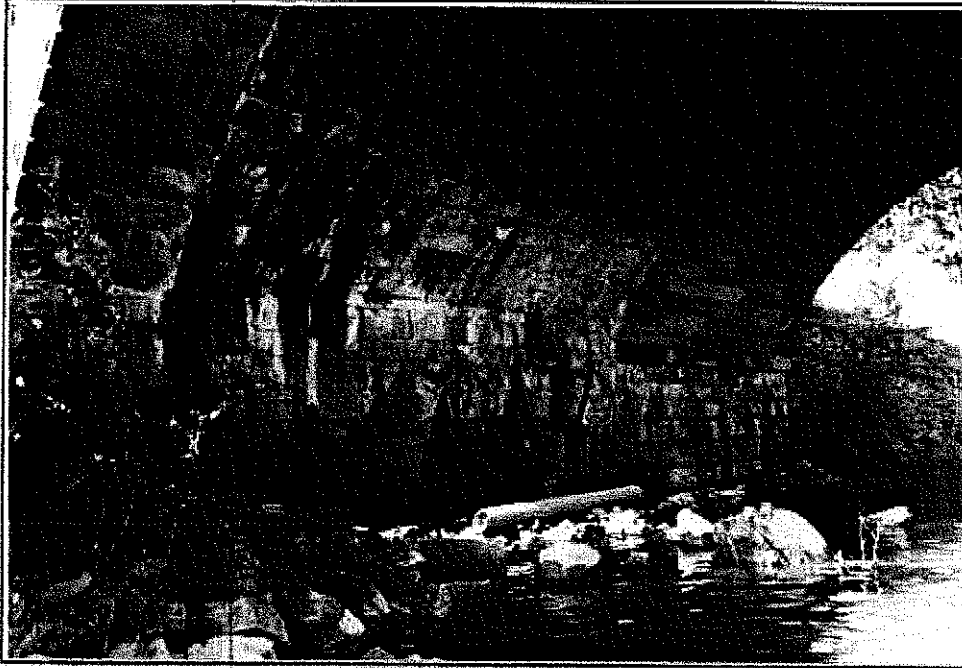
**No.5** Detail view of left abutment

Upstream and downstream extensions with abutment masonry exposed under normal conditions

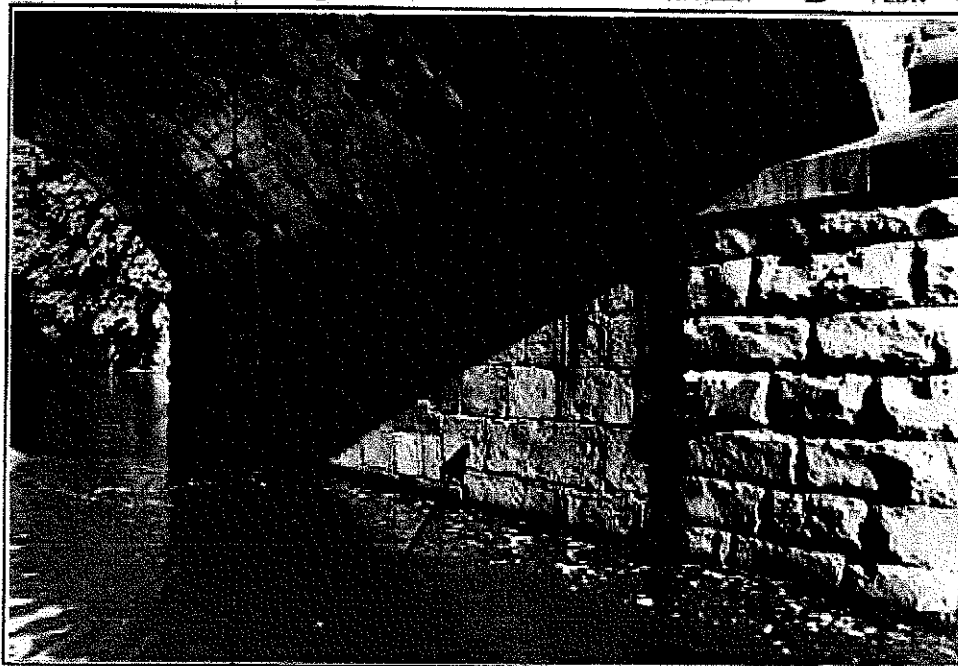
**No.7** Detail view of pier one left face looking downstream

Typical pier and soffit masonry condition with surface mortar loss and isolated spalling throughout

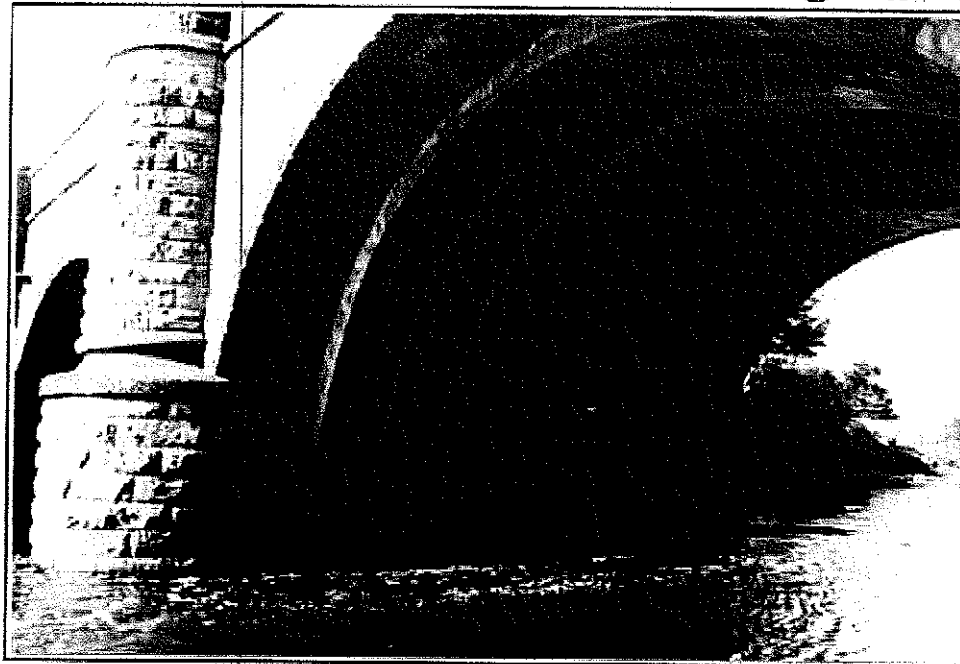
**No.8** Detail view of pier one right face

Typical pier and soffit masonry condition with variable extensions and isolated spall void at waterline

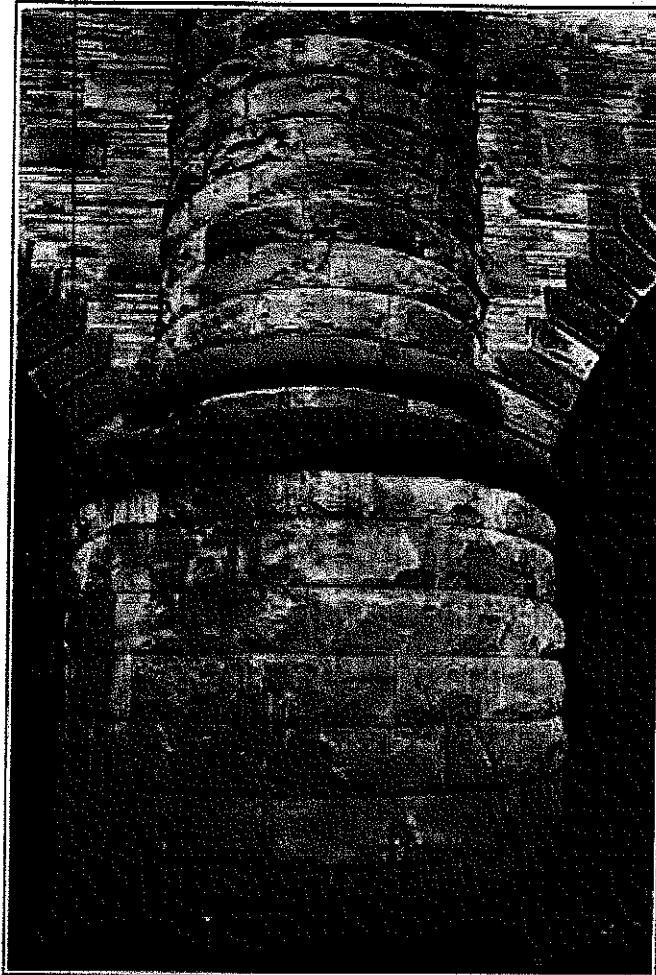
**No.9** Detail view of pier one upstream bullnose

Typical condition of bullnose and spandrel masonry with distinct vortex rotor formation

Evidence of sustained bowave-vortex rotor formation.

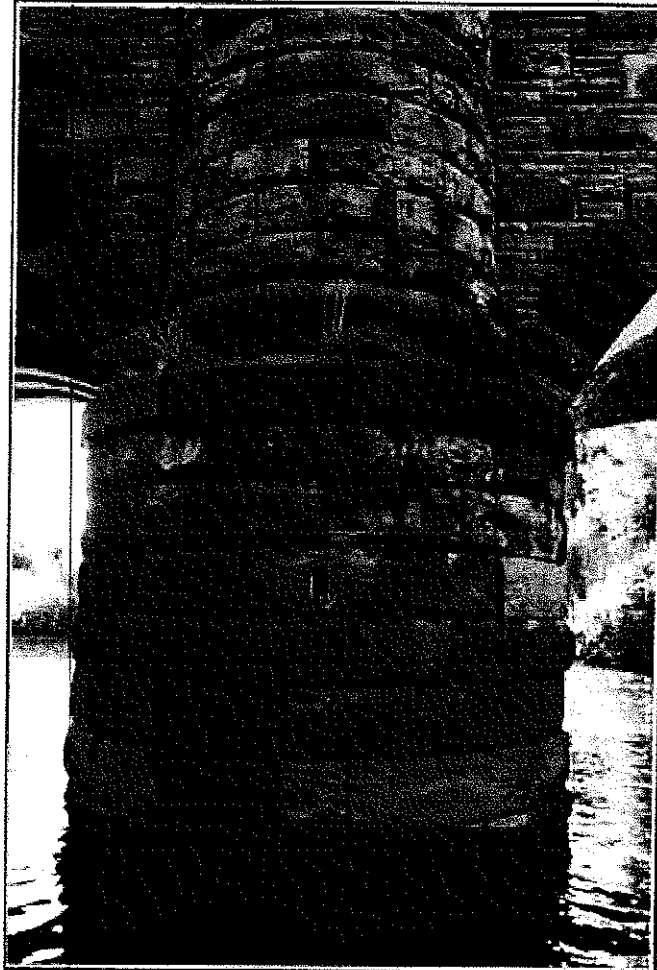
**No.10** Detail view of pier one downstream bulnose

Condition of bulnose masonry with localised seepage staining from coping

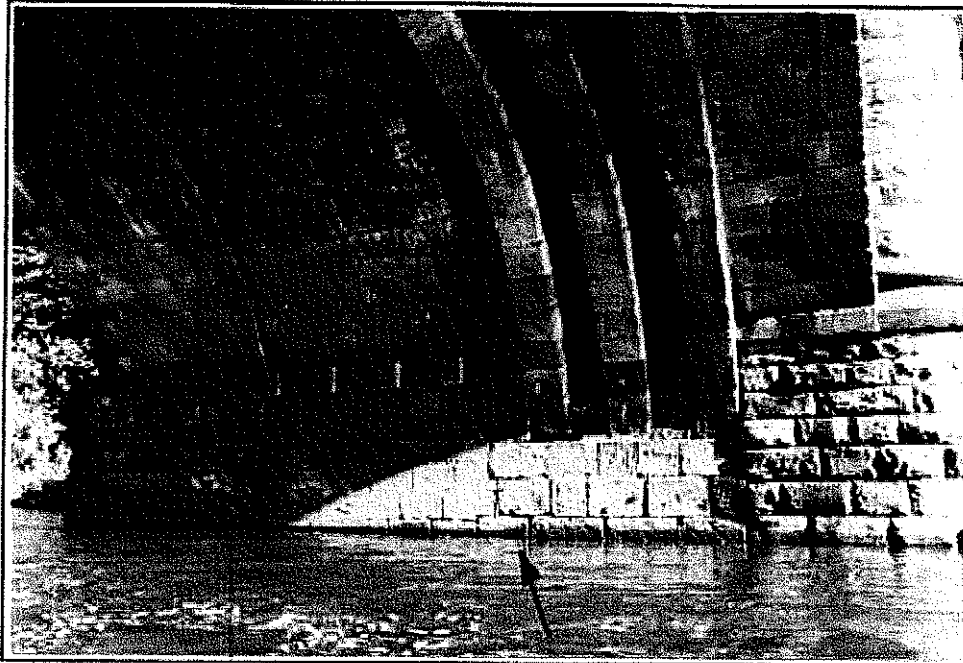
**No.11** Detail view of pier two left face

Typical pier and soffit masonry condition with isolated mortar washout to midsection waterline courses

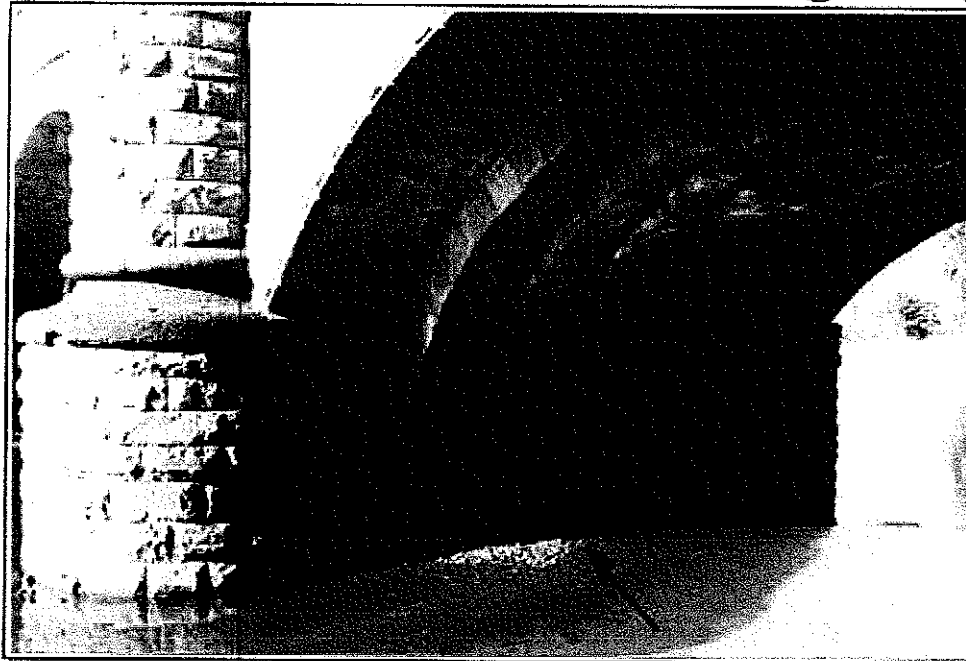
**No.12** Detail view of pier two right face

Bed deposit accumulations with isolated mortar washout to midsection base courses

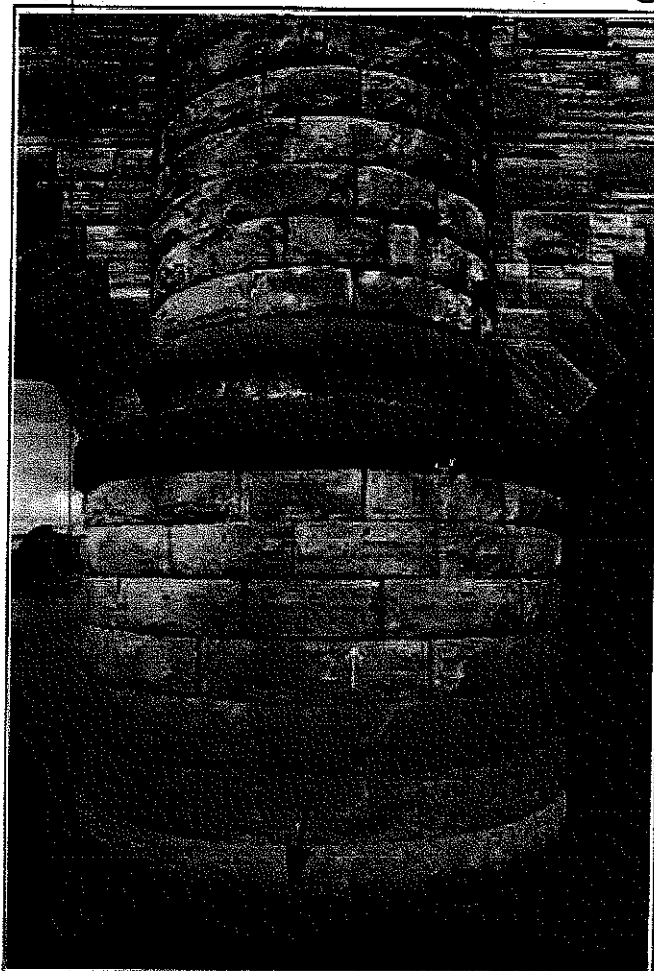
**No.13** Detail view of pier two upstream bulinose

Extension masonry in good condition with vortex rotor depressions to bed material

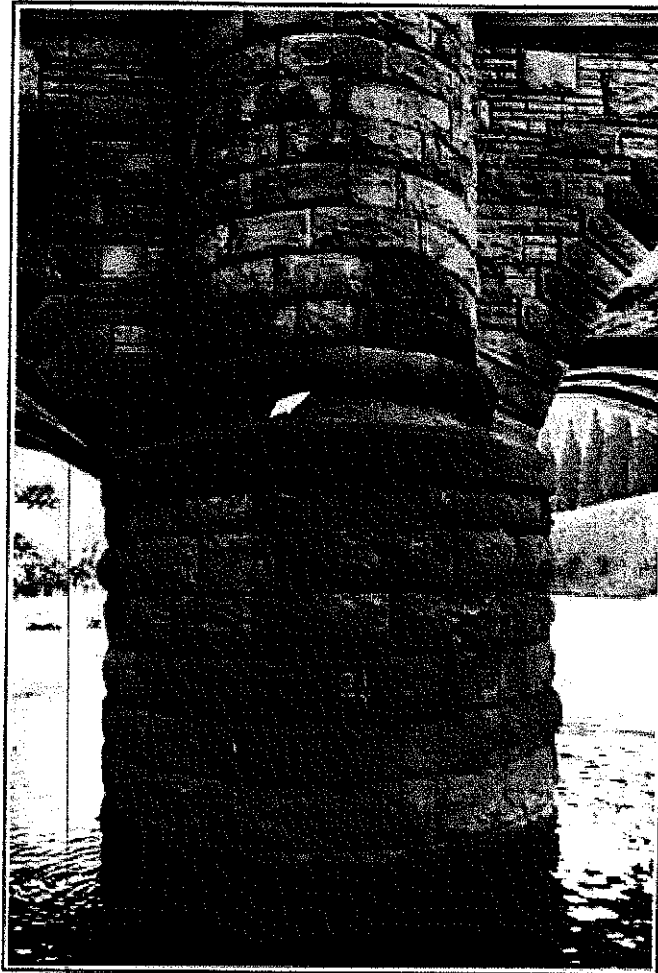
**No.14** Detail view of pier two downstream bullnose

Bullnose and spandrel masonry in good condition

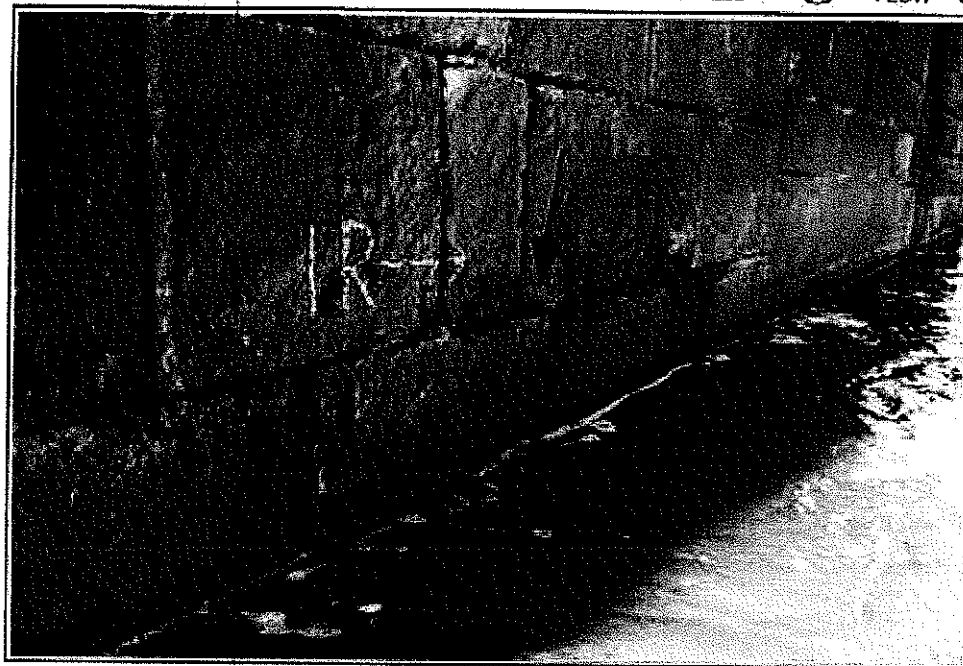
**No.15** Detail view of pier one upstream right waterline

Spall void with surrounding mortar loss on tight joints

Waterline spall void to pier one upstream right face 200mm wide \* 100mm high \* 30mm deep at maximum. Isolated minor surface spalling throughout remainder

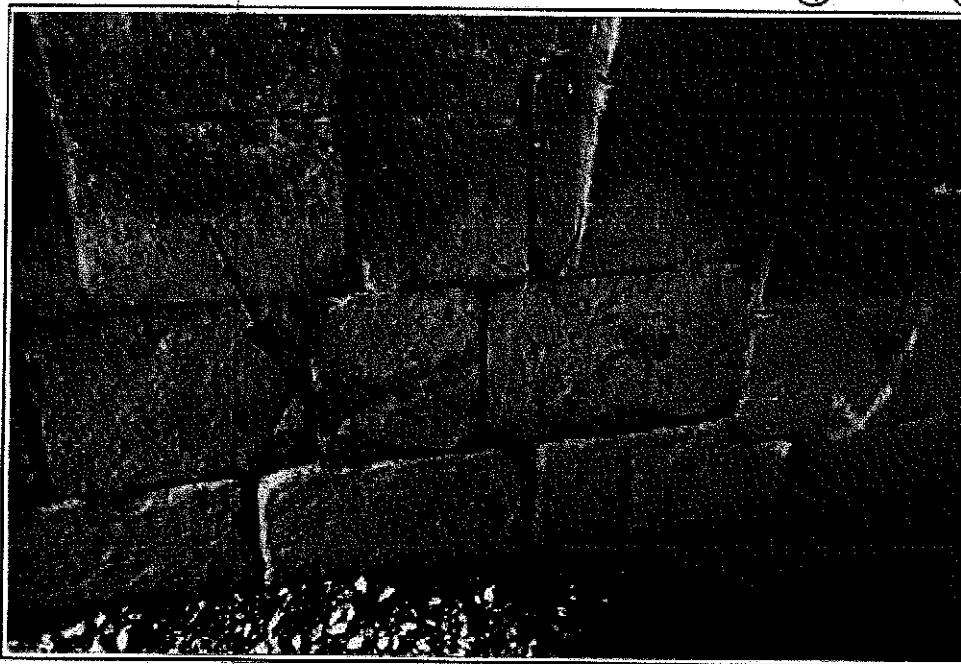
**No.16** Detail view of pier two upstream right waterline

Mortar loss and minor spalling to initial upstream extension with adjacent speedliner markings (purpose unknown)

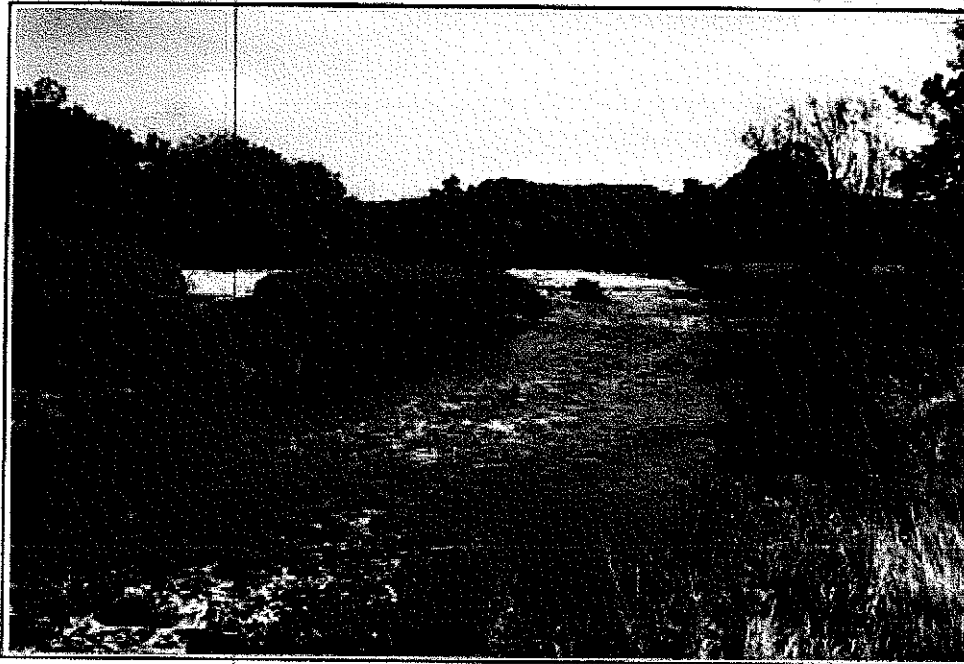
**No.A** Detail view of upstream watercourse

Upstream weir intact and functional

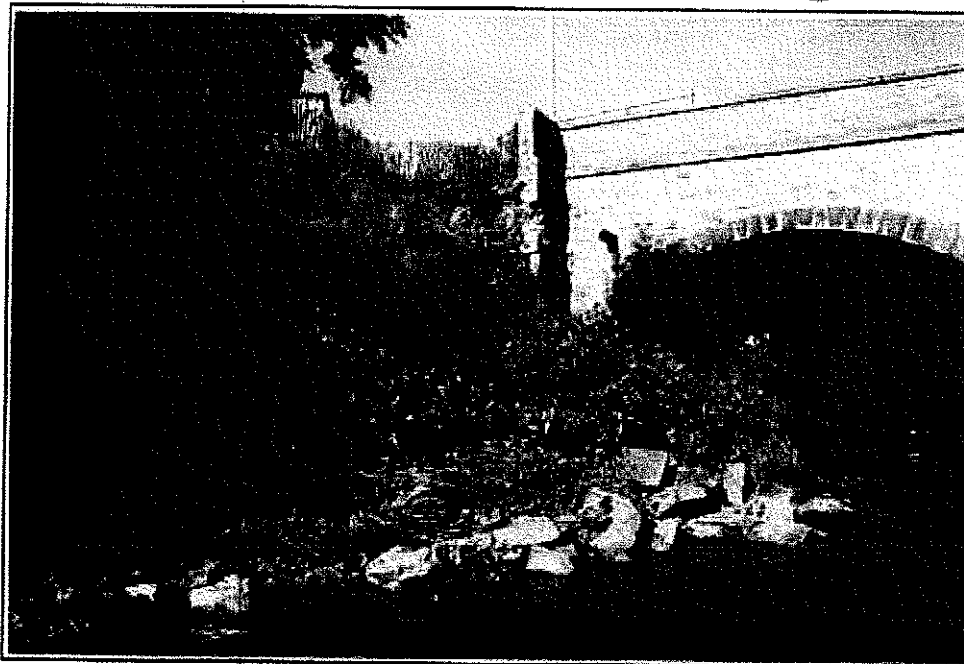
**No.B** Detail view of upstream left bank

Collapsed retaining wall partially influencing flow regime

The collapsed upstream left retaining wall is reported to have been in its present condition for some fourteen years and, while it does not represent an immediate structural concern, it is however, partially affecting the flow regime by concentrating the main flow through the centre span. This channelling creates a greater scour effect on the waterline masonry, bed equilibrium and ultimately the pier foundations, particularly during flood water conditions. Although this is not a short term problem, considerations should be given to rebuilding the retaining wall and clearing debris from the watercourse to enable the flow and resulting forces to balance between spans.

Consider rebuilding the upstream left retaining wall as a preventative measure
