# Heritage Statement

Reinstatement of Existing Travel Agency  
Shop, Repair of Shop Front and Internal and  
External Repairs.

6 Castle Street  
Clitheroe  
Lancashire  
BB7 2BX  
United Kingdom

# **Heritage Statement for Internal and External Repairs.**

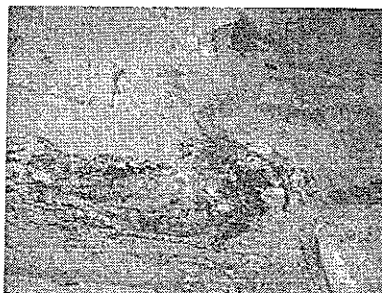
- a Replacement of gable wall internal embedded timbers, notably to the first floor gable wall

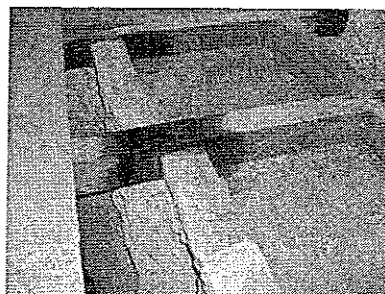
- b Auger drilling, impregnation and coating of ground or wall bearing timbers affected by wet rot.

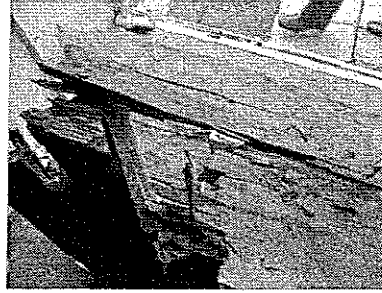
- c. Replacement of the rotten timber ground to first floor staircase; beyond repair due to historic wood boring insect attack and more current wet rot

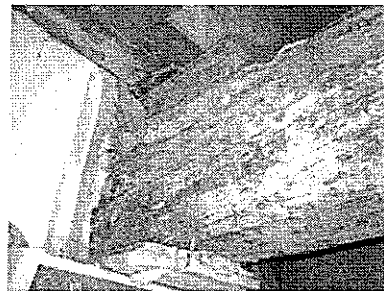
- d. Replacement of the rotten basement joists due to wet rot

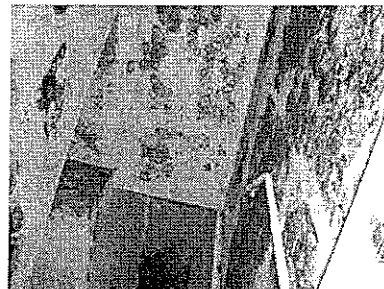
- e. Removal and replacement of water and mould affected plasterboard

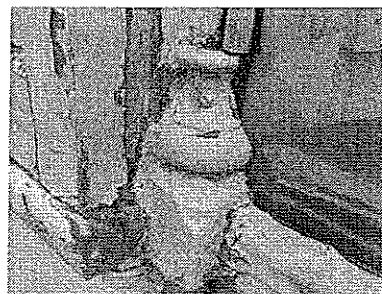
- a. Replacement or refixing of shop front timber mouldings. to match the existing. Also filling, preparing and painting to match the existing colours and profiles.

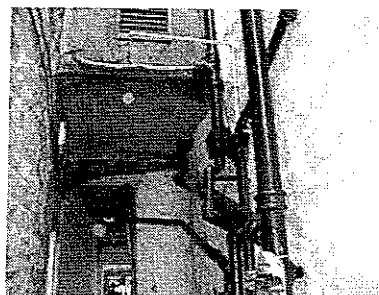
- b. Repairs to plumbing and rainwater goods to prevent dampness to external walls.

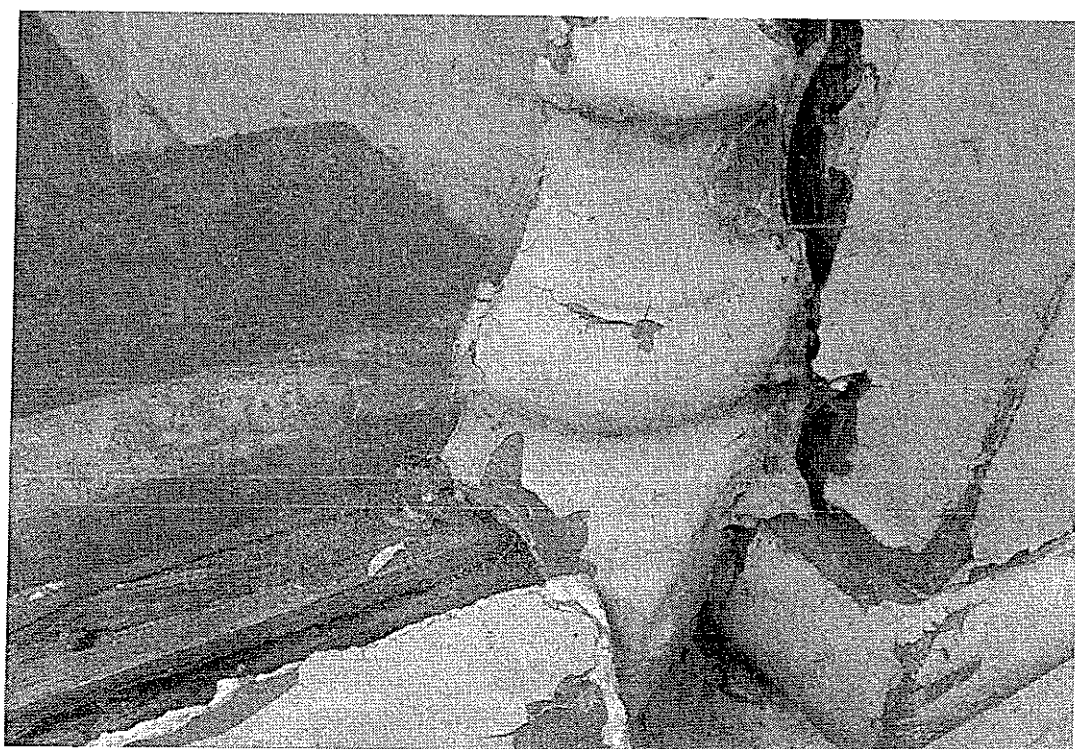
2. Condition of the existing pilaster and mullion detail

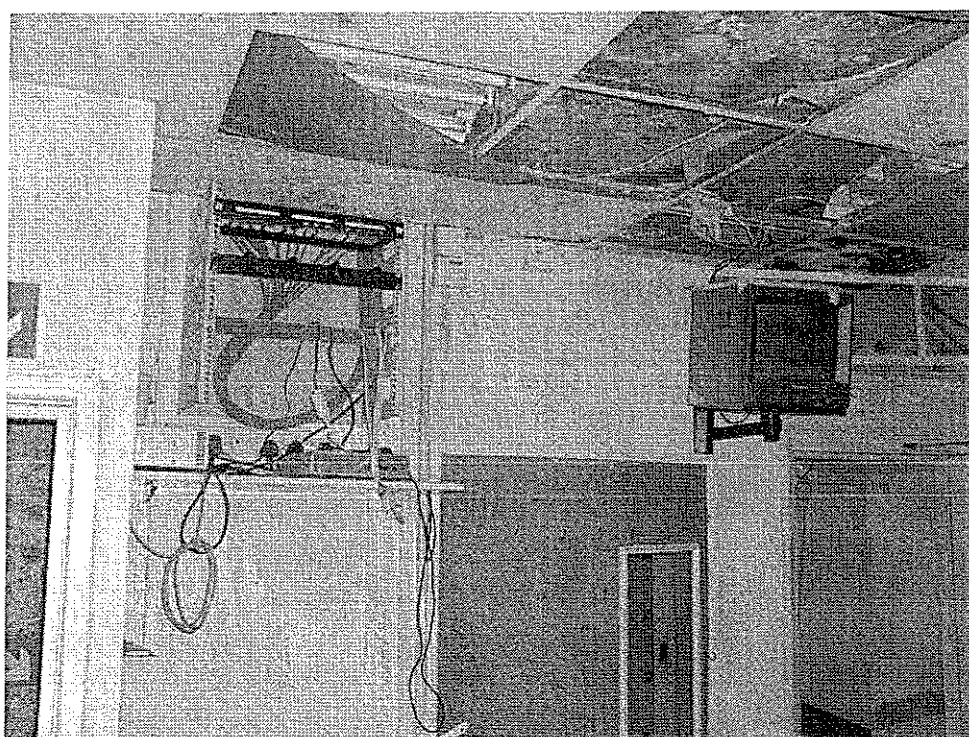
8. Back of house / admin area showing water damage from the flat above.

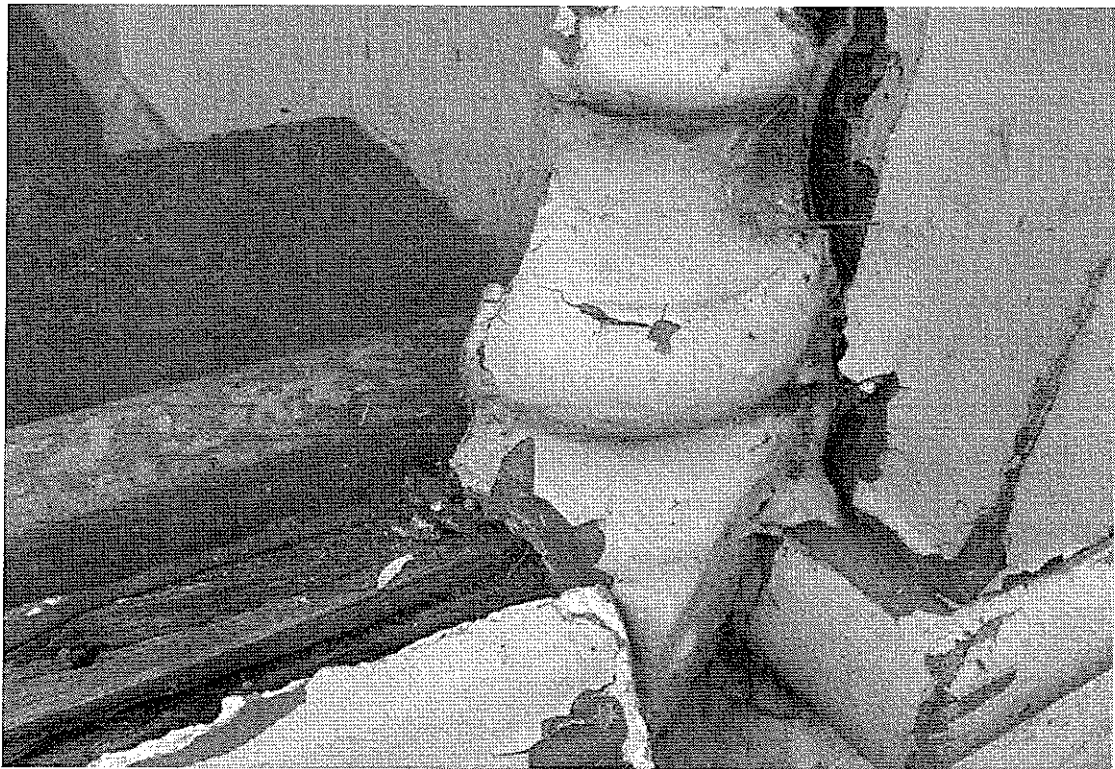
2. Condition of the existing pilaster and mullion detail

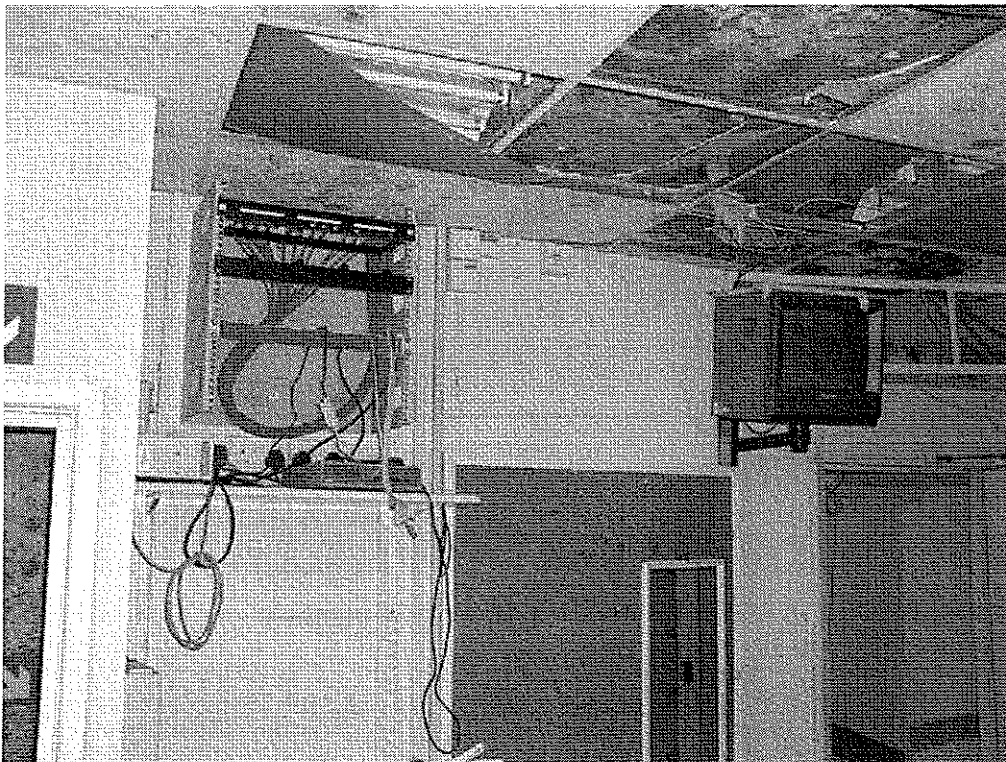
**8. Back of house / admin area showing water damage from the flat above.**

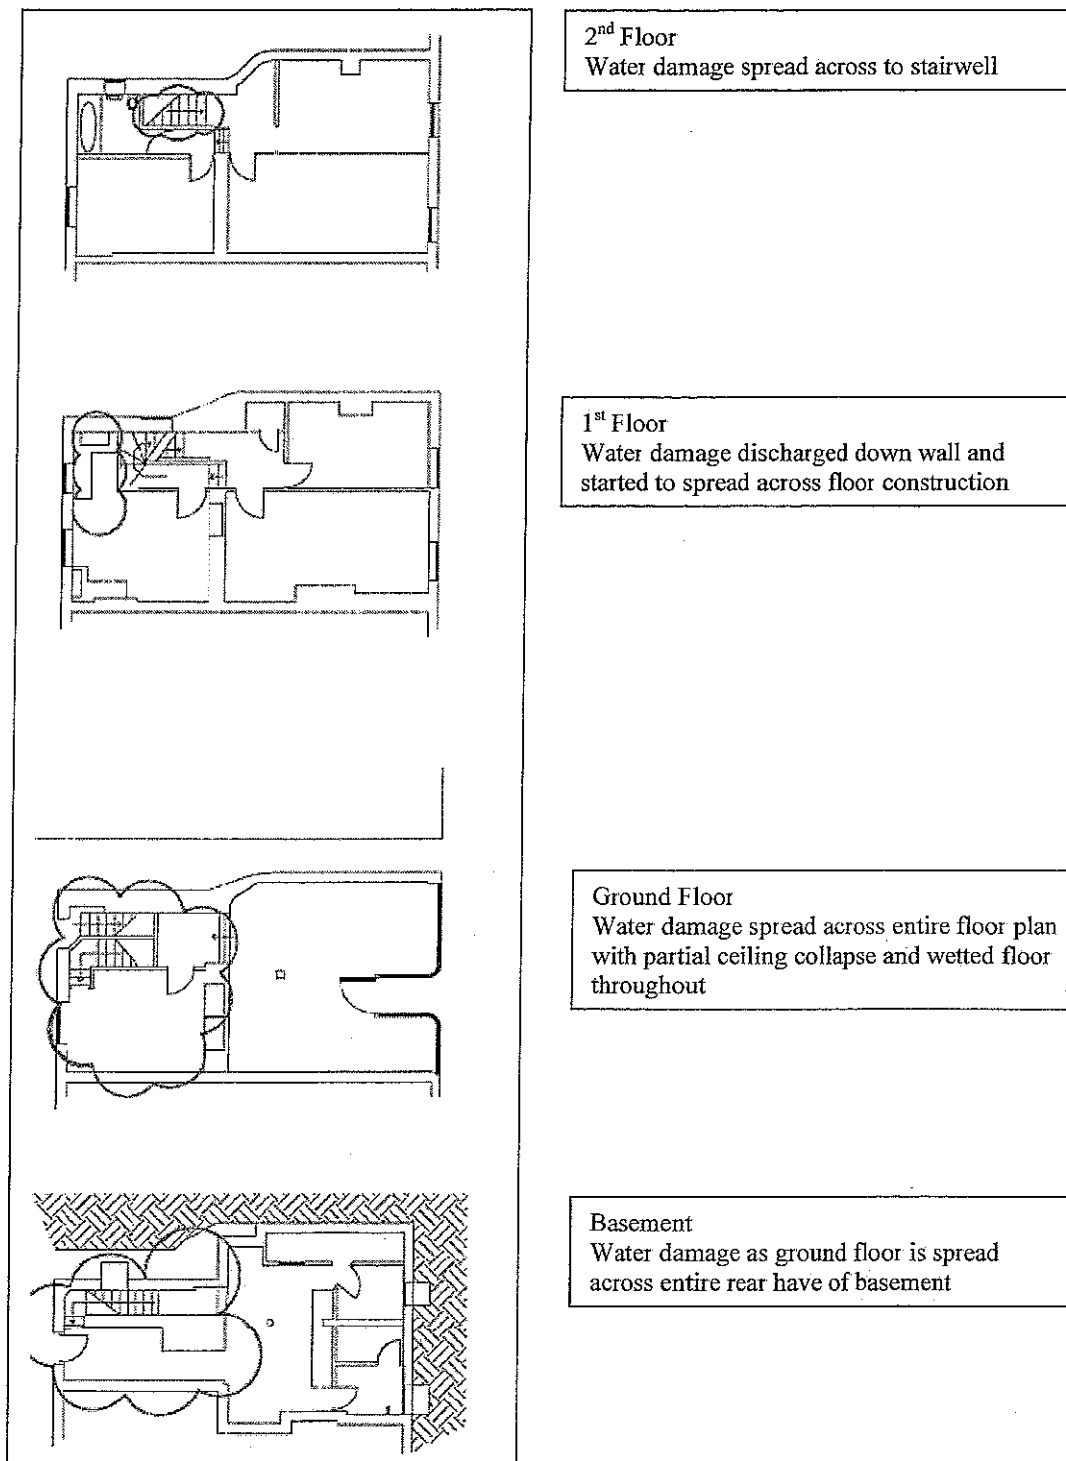
- 4.1 The indicative sketches below show the general spread of visible damage caused by the bathroom leak at the 2<sup>nd</sup> Floor, which illustrates the rear half of the property being the main areas of water damage, with visible water issues increasing in size as the water moves down the property and tracks across floor and ceiling constructions.

- 4.2 The main issue and cause of the damage is as discussed a previous leak at the 2<sup>nd</sup> floor bathroom. The water damage has generally spoiled finishes to walls and floors, contaminated plaster substrates, exacerbated mould growth severely, germinated fungal growth, destroyed ceilings tiles and possibly caused timber decay, and no doubt introduced moisture into the structure that will continue to 'sweat' and cause moisture vapour problems in the long term before it dries down. To address the water damage we recommend the following:

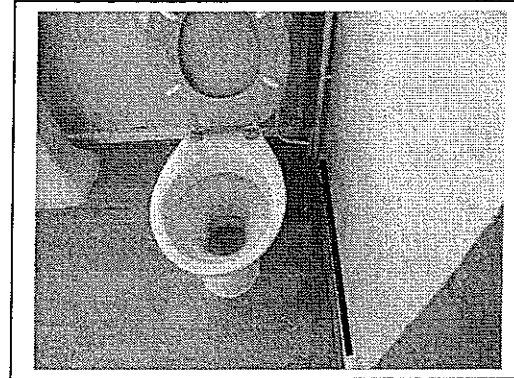
2.

| ITEM | DESCRIPTION | PHOTOGRAPHS |
|---|---|---|
| 2 | <p>Mould is noted at the beading to the timber laminate floor finish. This is relatively minor with damp staining and mould more visible to walls external of the bathroom itself.</p> <p>The extent of which water sat in the floor and the extent of decay to the floor joists is currently unknown</p> | 2 |

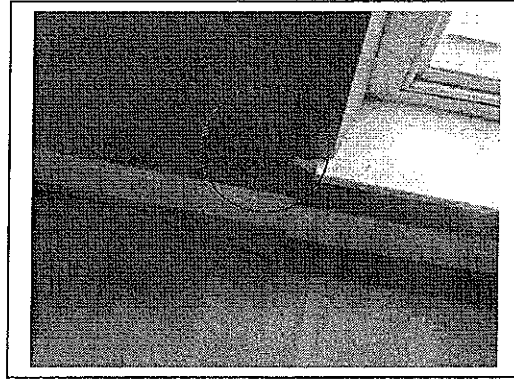
4.

| ITEM | DESCRIPTION | PHOTOGRAPHS |
|---|---|---|
| 4 | <p>The timber laminate floor finish is warping, indicating moisture vapour issues locally. The floor joists in general should be checked to verify performance.</p> | 4 |

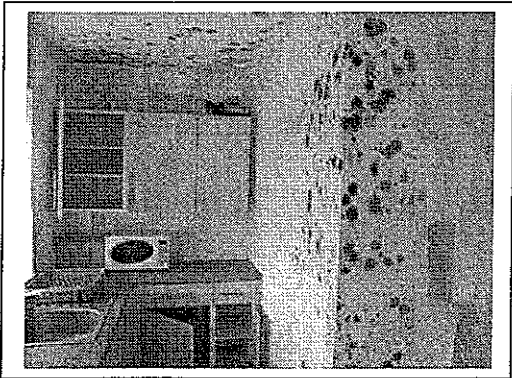
5.

| ITEM | DESCRIPTION | PHOTOGRAPHS |
|---|---|---|
| 6 | The ceiling and wall over the wall mounted cupboard unit has severe mould growth where previously wetted. This area is directly below the bathroom and the plaster substrates are stained and salt contamination is visible, indicating the migration of moisture through the substrates, which will restrict drying down and exacerbating moisture vapour and the formation of mould. | 5 |

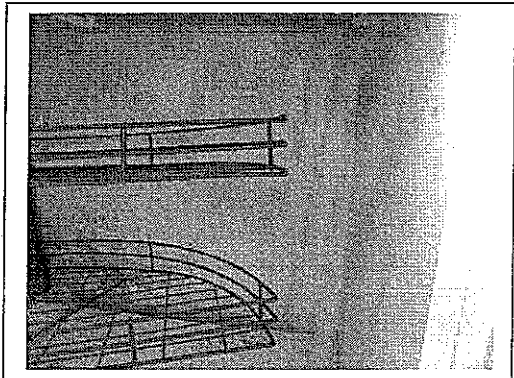
6.

| ITEM | DESCRIPTION | PHOTOGRAPHS |
|---|---|---|
| 7 | The wall at low level in the base unit of the kitchen fittings is similar to item 6 and has staining and deterioration with salting noted to the plaster substrates. As above, this contamination will act to keep substrates damp and whilst salts are not conducive to mould growth, the wetted wall paper is likely aiding the mould growth. | 6 |

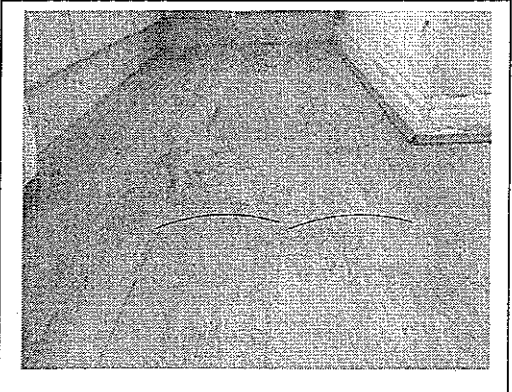
7.

| ITEM | DESCRIPTION | PHOTOGRAPHS |
|---|---|---|
| 8 | The timber laminate floor finish is sagging at the joints and has warped, this indicating where the water has ponded on the finish and migrated through to the floor construction below (if moisture vapour was rising from below, floor finish would be raised at the joints – 'cupping') | 7 |
| 11 | The curved wall detail at the staircase is directly below the bathroom is consequently in a poor condition with delamination of the wall paper finish, damp staining and mould growth evident (including ceiling). If the partitioning includes timber studwork, this will be vulnerable to decay and should be checked to verify its condition. | 7 |

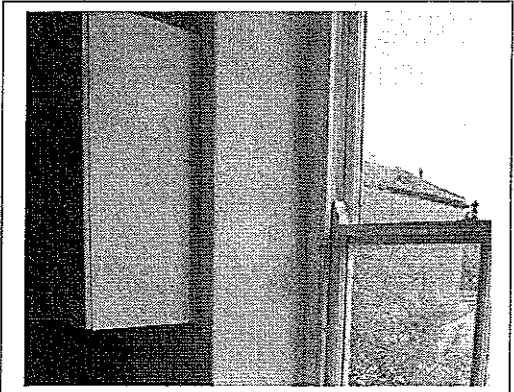
8.

| ITEM | DESCRIPTION | PHOTOGRAPHS |
|---|---|---|
| 9 | The window reveals are stained. This is either caused from ingress at the window opening or from above. This is not directly below the bathroom leak and therefore we suspected that ingress has migrated from the external side of the wall. The external cill was noted to be cracked to its upper edge and decoratively poor. | 8 |

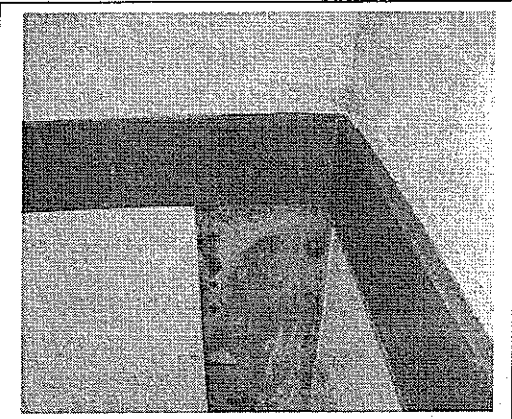
13.

| ITEM | DESCRIPTION | PHOTOGRAPHS |
|---|---|---|
| 15 | Water runs are evident down face of the wall paper finish, with mould growth evident and staining from water damage on the plasterboard substrate. Water damage has spread and largely encompasses the rear half of the property in this area. | 13 |

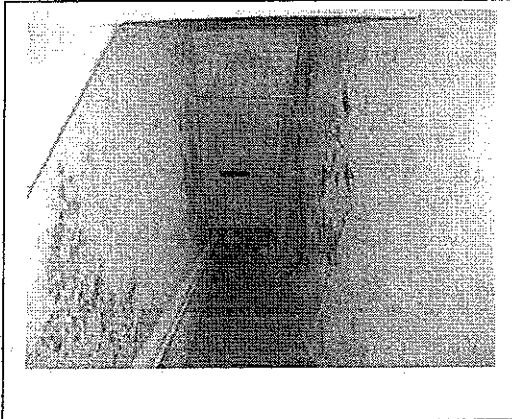
14.

| ITEM | DESCRIPTION | PHOTOGRAPHS |
|---|---|---|
| 16 | At the entrance to the flat at ground floor, the walls have severe mould growth evident and the leak has previously wetted the wall surfaces. | 14 |

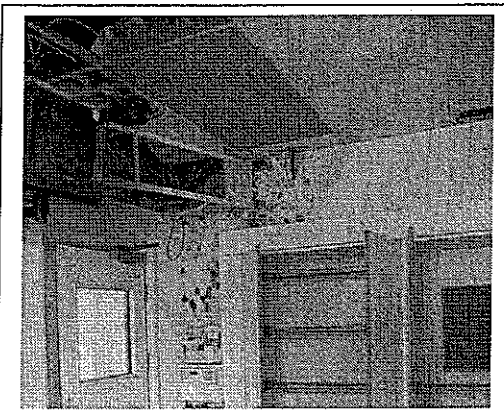
19.

| ITEM | DESCRIPTION | PHOTOGRAPHS |
|---|---|---|
| 19 | Walls have severe mould growth and have been wetted from the pipe leak at 2 <sup>nd</sup> floor. Substrates are contaminated and drying down will be restricted. Wall construction to be exposed and checked for decay. | 19 |

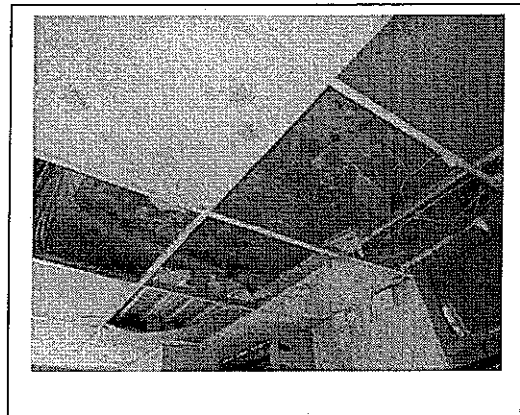
20.

| ITEM | DESCRIPTION | PHOTOGRAPHS |
|---|---|---|
| 20 | The ceiling tiles are stained and have collapsed where moisture from the pipe leak has spread and migrated through the floor construction. The chipboard fixed to the ceiling over the suspended grid has also deteriorated and collapsed, this showing the most severe water damage in the room generally. | 20 |

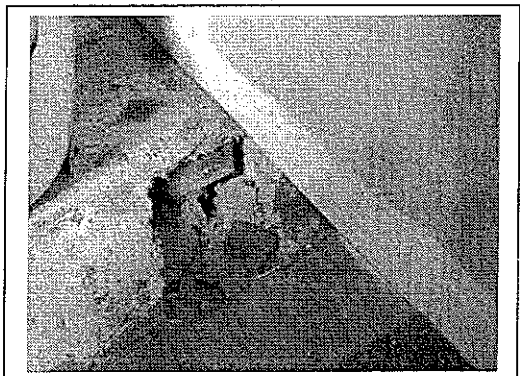
22.

| ITEM | DESCRIPTION | PHOTOGRAPHS |
|---|---|---|
| 23 | The floor was noted to be sagging and the carpet tiles and chipboard was exposed in 1no. location. The sagging was located at the joints between the chipboard where the joint is positioned between the joists. The chipboard was saturated and losing its composition. | 22 |

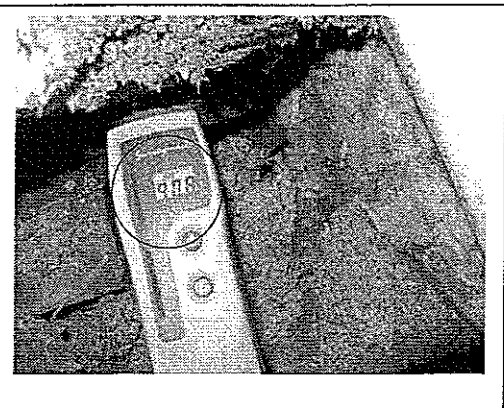
23.

| ITEM | DESCRIPTION | PHOTOGRAPHS |
|---|---|---|
| | <p>The moisture content % of the exposed joist was taken at 90.8%, this essentially showing the timber is saturated and the timbers are at risk to decay, especially during drying down periods. The moisture has sat within the floor void and where moisture has likely spread down into the basement areas, moisture vapour issues are still present.</p> | 23 |

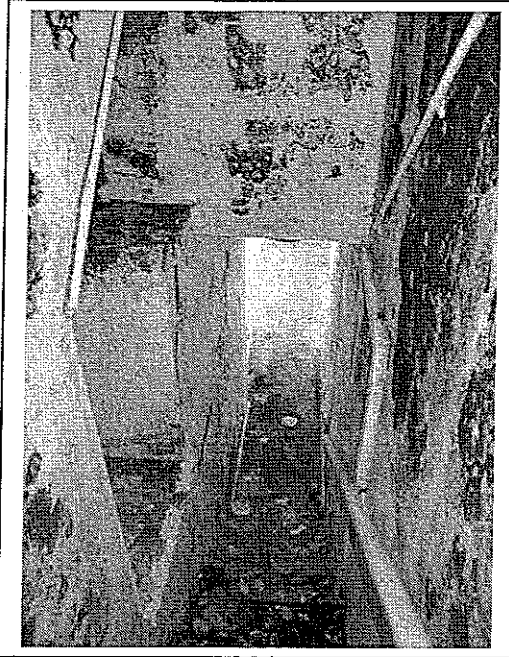
25.

| ITEM | DESCRIPTION | PHOTOGRAPHS |
|---|---|---|
| 25 | <p>The staircase leading to the basement is located below the bathroom leak and the general area, including walls, ceiling and floor is severely damp and has mould growth throughout. Wet rot strands are evident below the stair case to the flat accommodation. The walls have obviously been wetted and moisture vapour issues have caused further condensation to form on the wet substrates and further exacerbated mould growth.</p> <p>Generally the rear area to the ground floor has taken most of the moisture from the bathroom leak, whether it spread across the ceiling or accumulated in the floor void, the dampness is evident across the entire area. The damage is generally worse than at upper floors and all substrates are damp, requiring a full strip out to these areas.</p> | 25 |

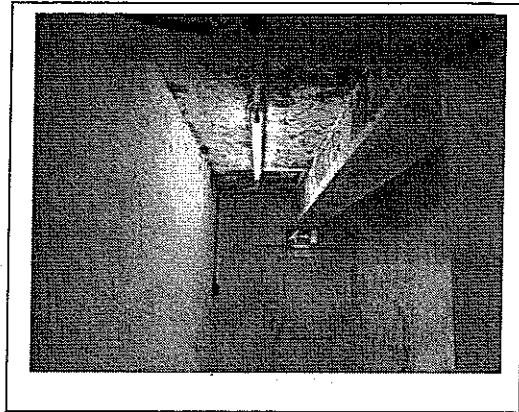
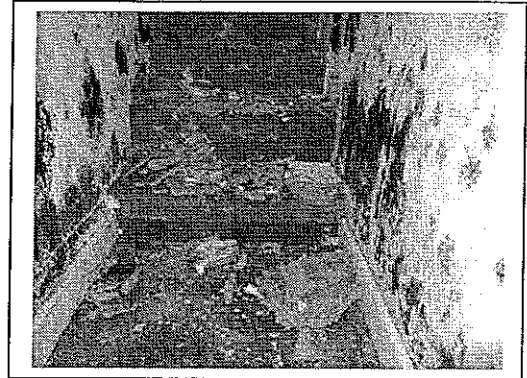
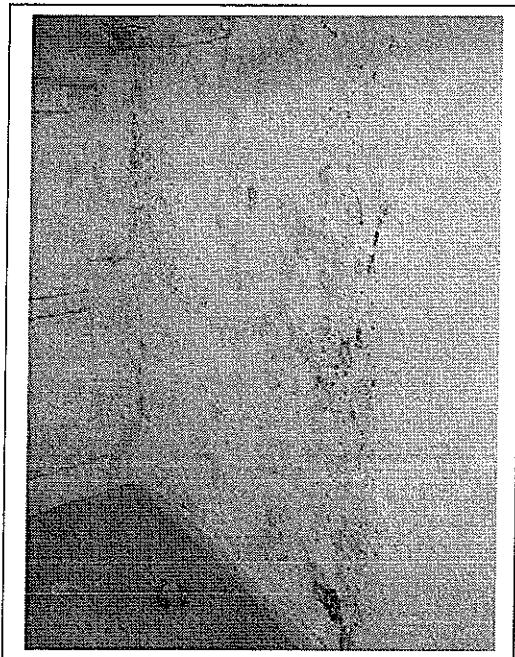
| ITEM | DESCRIPTION | PHOTOGRAPHS |
|---|---|---|
| 26 | The rear half of the basement has severe mould growth to most substrates, including the dry lining to walls, the timber floating floor and ceiling. The moisture from the pipe leak will have spread down the building to the lowest point and acted to wet the substrates on the dry side of the waterproofing system. This will hold the moisture and further increase moisture vapour issues. | 26-28 |

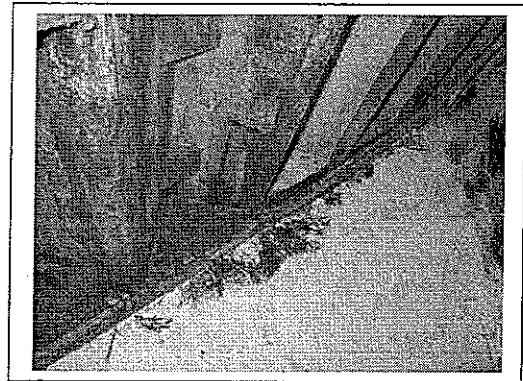
29.

| ITEM | DESCRIPTION | PHOTOGRAPHS |
|---|---|---|
| 27 | The stair case to the flat accommodation was exposed at the time of inspection and wet rot mycelium (coniothora puteana) is clearly visible across the timber and wall substrates. This is the most common cause of decay in woodwork which has been soaked by water leakage and the mycelium is usually only present in conditions of high humidity. | 29 |

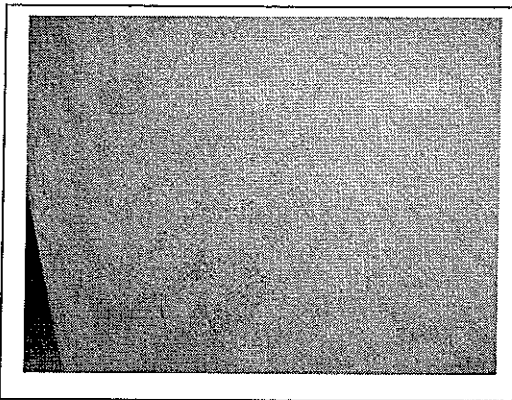
41.

| ITEM | DESCRIPTION | PHOTOGRAPHS |
|---|---|---|
| 38 | Mould is noted to the wall where increased levels of moisture vapour in the basement have exacerbated mould at cold surfaces. | 41 |
