**APPRAISAL OF ARCHITECTURAL & HISTORIC SIGNIFICANCE**  
**TO INFORM PROPOSED REPAIRS AND ALTERATIONS**

**RED SYKE GATE**

**TWISTON**

**The Trustees of The Hon. R. C. Assheton's Settlement**

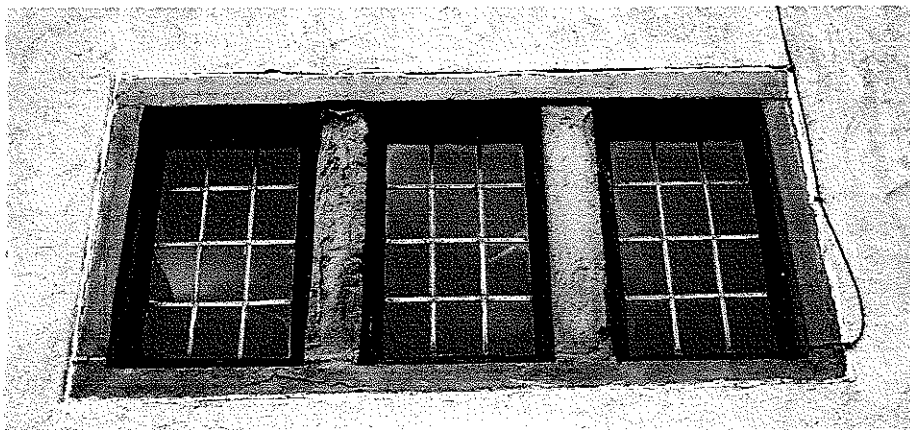
Image 2 - 3-bay stone square cut mullion window with metal framed leaded lights to Bedroom 2

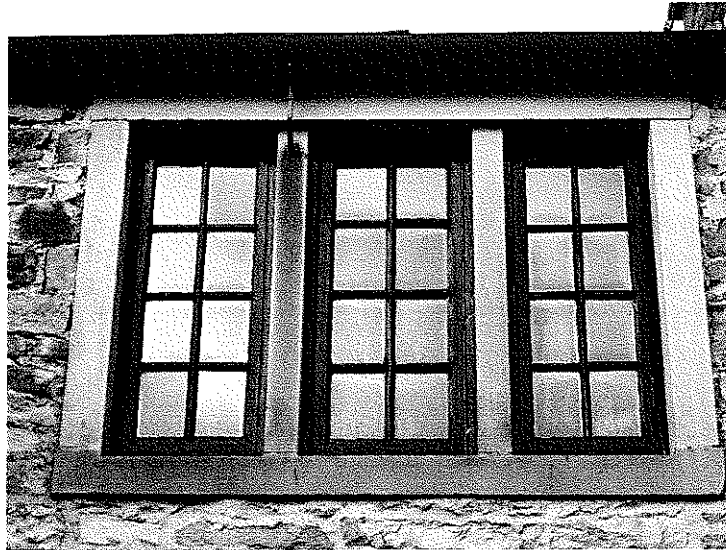
Windows to the front elevation of the house are predominantly metal framed (cast/wrought iron or mild steel) casement windows with leaded lights. However there are a range of alternative window designs, some being timber framed (**image 3**) and none contemporary with the original construction.

**Image 3 - modern timber casements and saw cut stone surround to Bedroom 5**

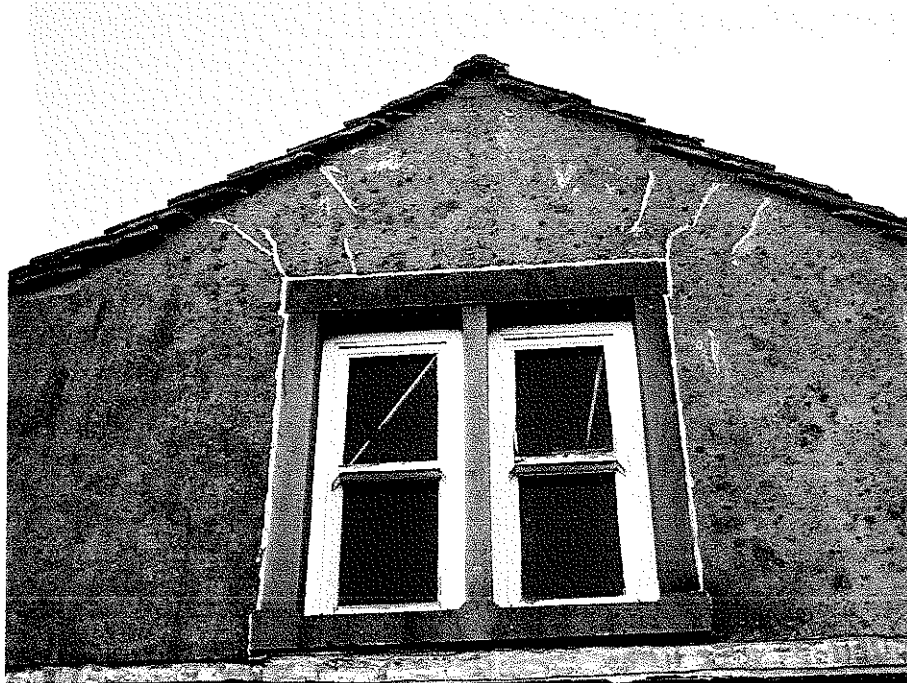
The external walls to the residential range (front and rear) have all been coated in hard cementitious render, probably early/mid 20<sup>th</sup>C, which is in a very poor state of repair (**image 5**). There are numerous cracks to all elevations which have been 'sealed' using flexible sealants. The impact of impervious cementitious renders on traditional vernacular 'breathing' walls is discussed in detail later in this report.

**Image 5 - 'sealed' cracking to render, rear elevation**

This is currently the case at Redsyke Gate as previously discussed. The external elevations have been coated in a hard impervious cement render which has cracked extensively and is allowing water to penetrate the building fabric without allowing that moisture to evaporate (**image 29**). This is worsened by the very exposed location of the building and the extent of wind driven rain. The result is significantly high condensation and damp levels throughout the interior of the building, even at first floor level (**images 5, 6, 30 & 31**).

It is therefore the proposal, subject to the granting of Listed Building Consent, to carefully remove the cement render and replace it with a natural lime-based rough cast render, synonymous with the rural north of England and recognised as a traditional coating for vernacular buildings in the North West of England, (English Heritage, 2006). There is evidence on the subject building that rough cast render was the original coating (**image 18**).

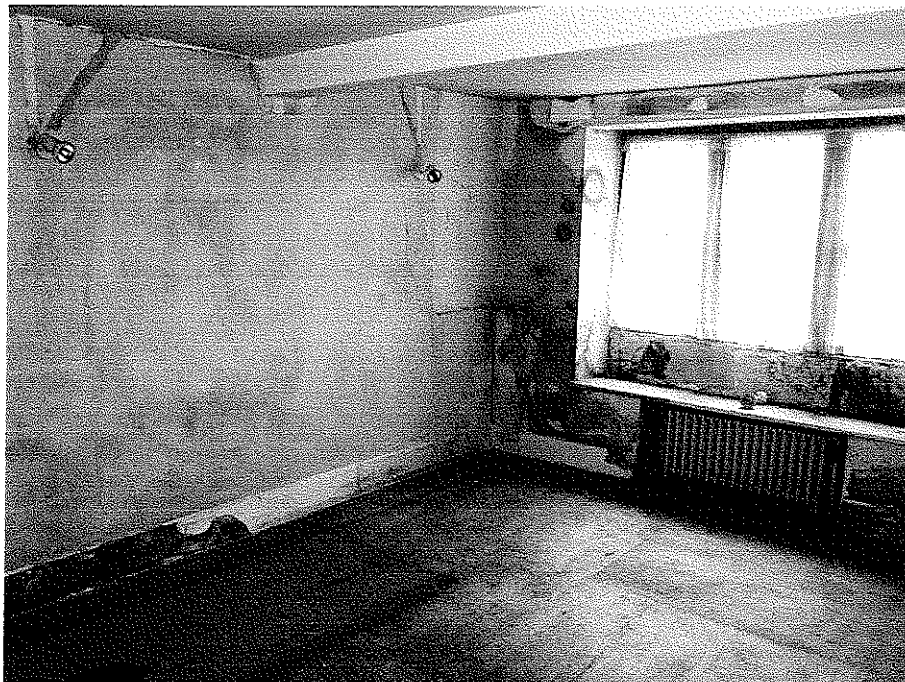
Internally, the majority of walls are suffering from excessive condensation and dampness caused by a combination of rising and penetrative dampness. It is considered the problem is significantly exacerbated by the presence of the aforementioned render.

**Image 6 - Evidence of serious penetrating dampness and condensation to Dining Room**

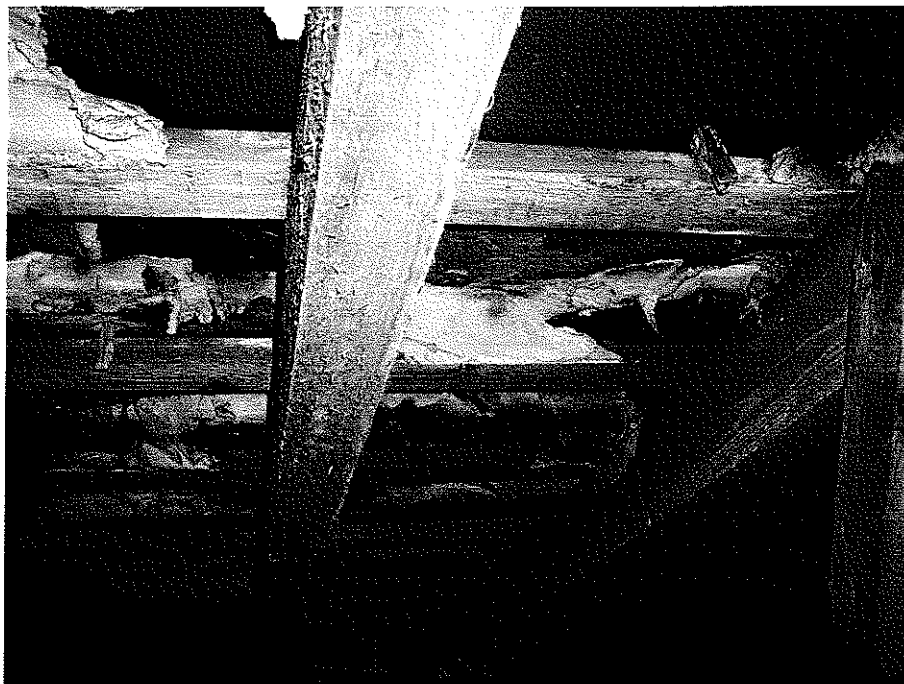
The roof structure supports a traditional stone slate roof to all elevations, which is contemporary (or original reclaimed stones have been re-laid) with the supporting roof structure. Interestingly, only the slates above the new Bedroom 1 are fixed with traditional timber pegs, other roofs being fixed with ferrous metal fixings, all of the roofs are torched with cement (not lime) mortar and there is no sarking felt provided other than the barn.

**Image 8 - Oak pegs, saw cut timbers and cement torching to stone slates, Bedroom 1**

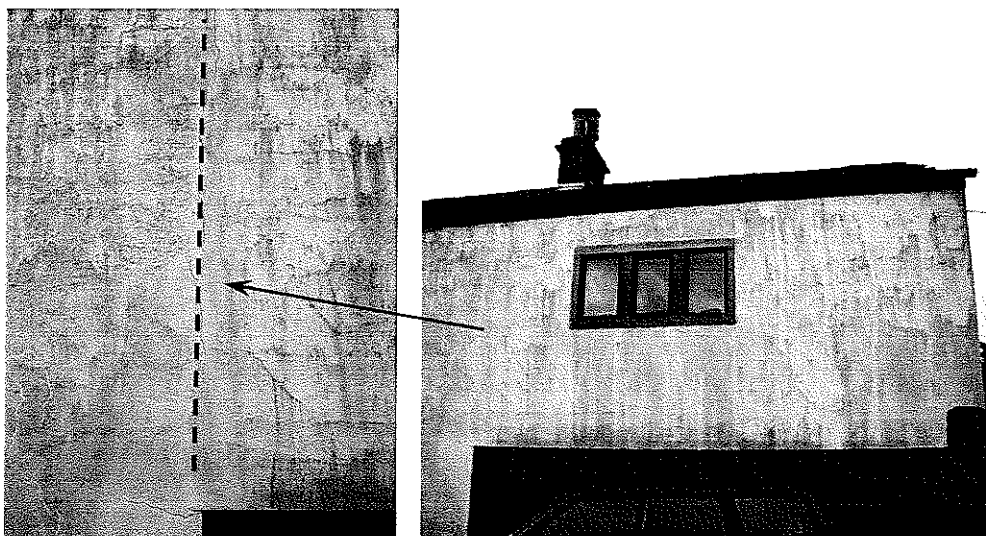
The building is generally in reasonable structural condition with the exception of the north extension. A new storey was added in the mid 20<sup>th</sup> C consisting of a concrete 'beam and block' flooring bearing upon the original outbuilding, new brick piers and on a new section of masonry to the north east corner with loads transferred via steel beams. There is evidence of subsidence to the north east corner, expressed by rotational movement and cracking to render at the junction between new and old. It is the intention of the proposed works, subject to the granting of Listed Building Consent, to address this issue as discussed within a later section of this report.

**Image 10 - Cracking between original structure and new extension**

The proposed new frontage to the ground floor garage will remedy this issue as the new front infill wall will be load bearing and will carry loads from the upper floor to the ground via a new concrete strip foundation. Loadings will therefore be spread evenly, reducing any point loading induced subsidence.

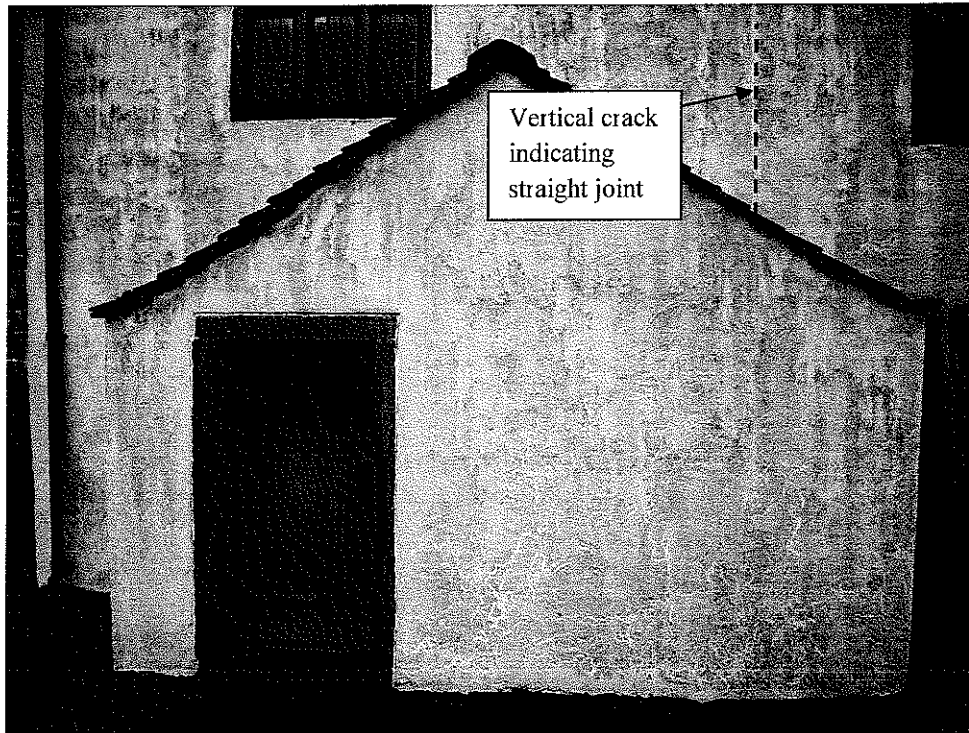
**Image 11 - Vertical crack indicating straight joint to front elevation**

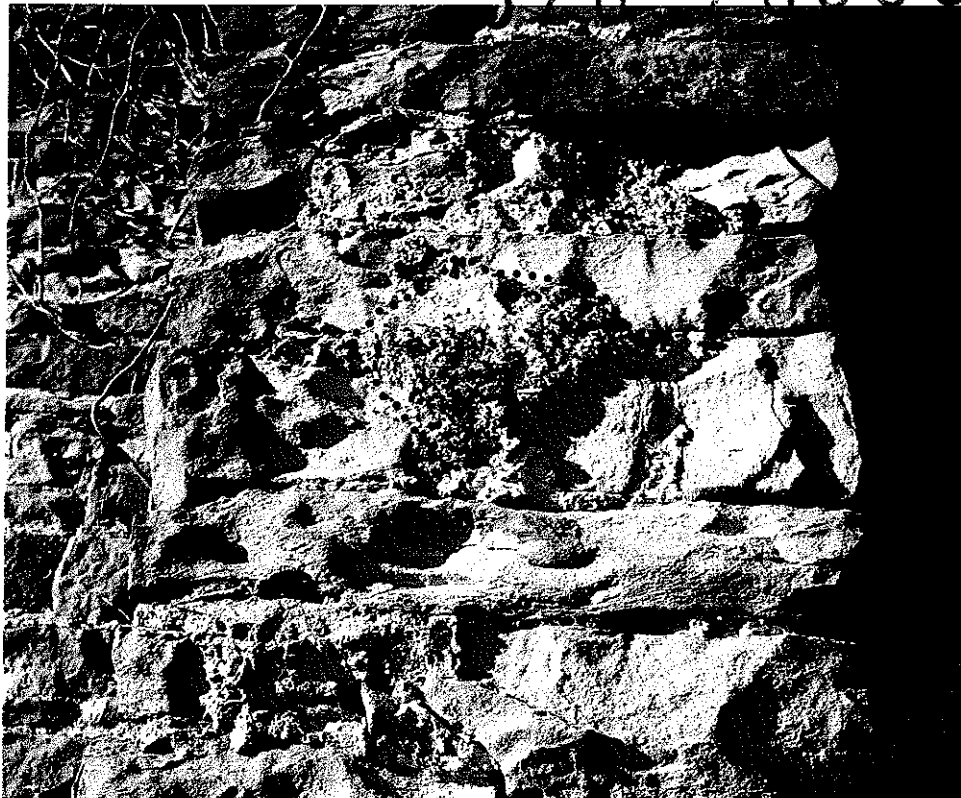
Image 18 - Evidence of original roughcast lime render to barn

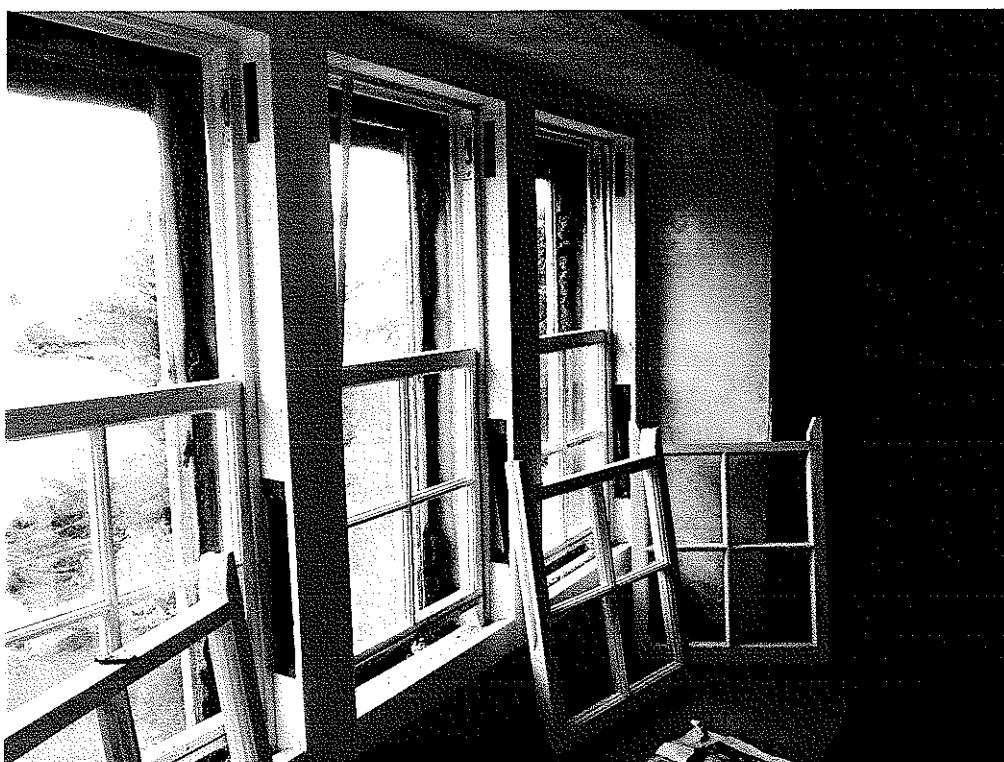
**Image 19 - Current condition of timber sliding sash windows to rear elevation (Bedroom 1)**

It is proposed to fully refurbish, draft-proof, re-glaze (where necessary), rebalance sashes and decorate all of the existing timber sliding sash windows to the west (rear elevation).

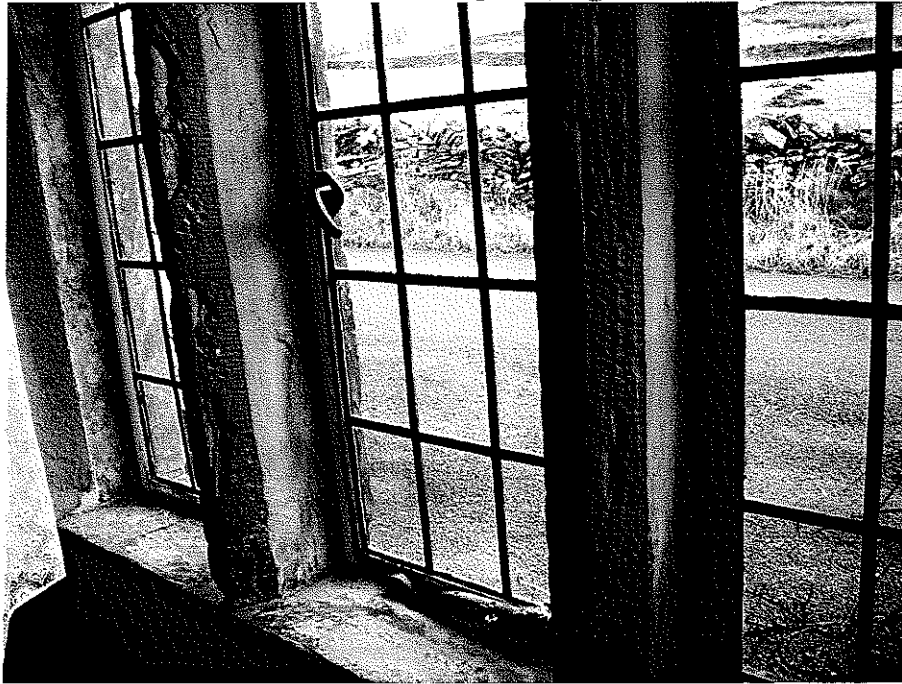
**Image 20 - Chamfered mullions to Sitting Room, note corrosion to central opening casement**

Metal windows to the front elevation will be made good, redecorated and eased wherever possible, however where corrosion is beyond repair a 'like for like' replacement will be employed so as not to affect the historic character of the building.

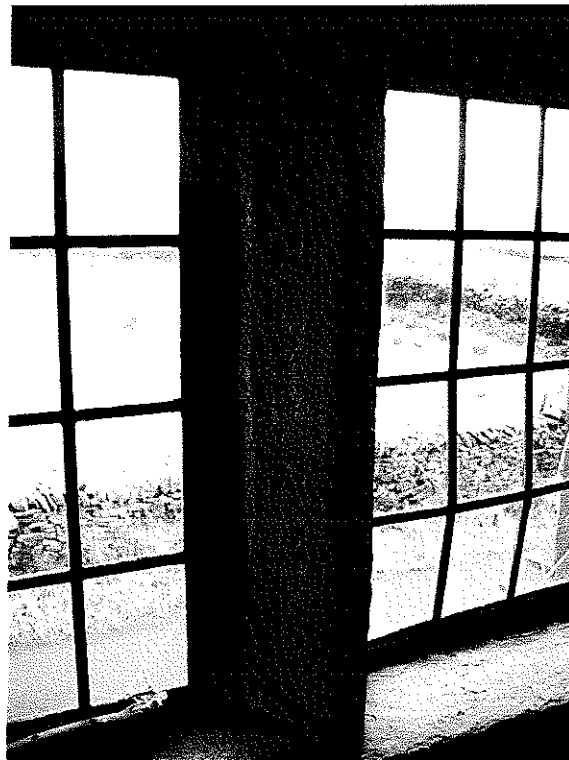
**Image 21 - Corrosion to metal casements and cracked leaded lights, Bedroom 2**

Replacement windows will be sourced from a company such as The Cotswold Casement Company who produce traditional steel units and leaded lights with good quality period hardware – [www.cotswold-casements.co.uk](http://www.cotswold-casements.co.uk). Neoprene gaskets are also supplied to improve draft proofing and reduce thermal bridging. These windows have been used previously with success at a property in Northumberland (images 22 & 23).

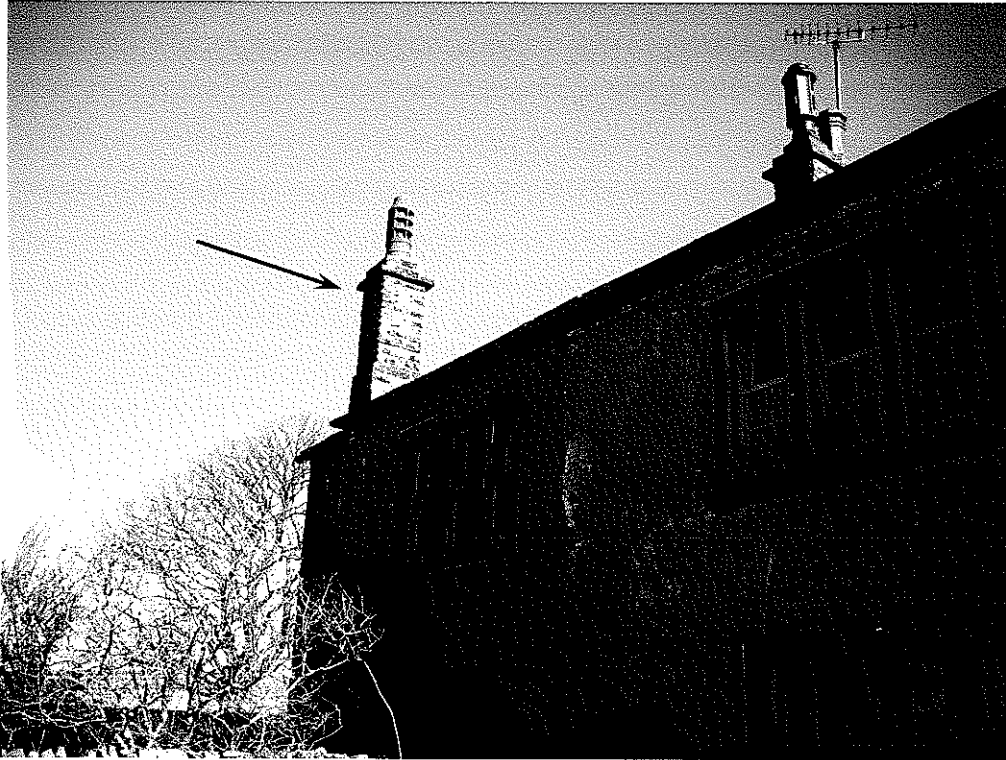
Image 24 – 20<sup>th</sup> C chimney to rear roof slope

It is proposed to remove the chimney to the rear roof slope currently serving the redundant boiler. The chimney is a mid-20<sup>th</sup> C intervention and is not considered to be of any architectural or historical significance. Its presence is currently detrimental to the historic fabric as rainwater penetration is occurring at the roof junction causing considerable damage internally. It is proposed to utilise the flue void to accommodate a soil pipe therefore reducing the visual impact of services following the installation of a new en-suite bathroom.

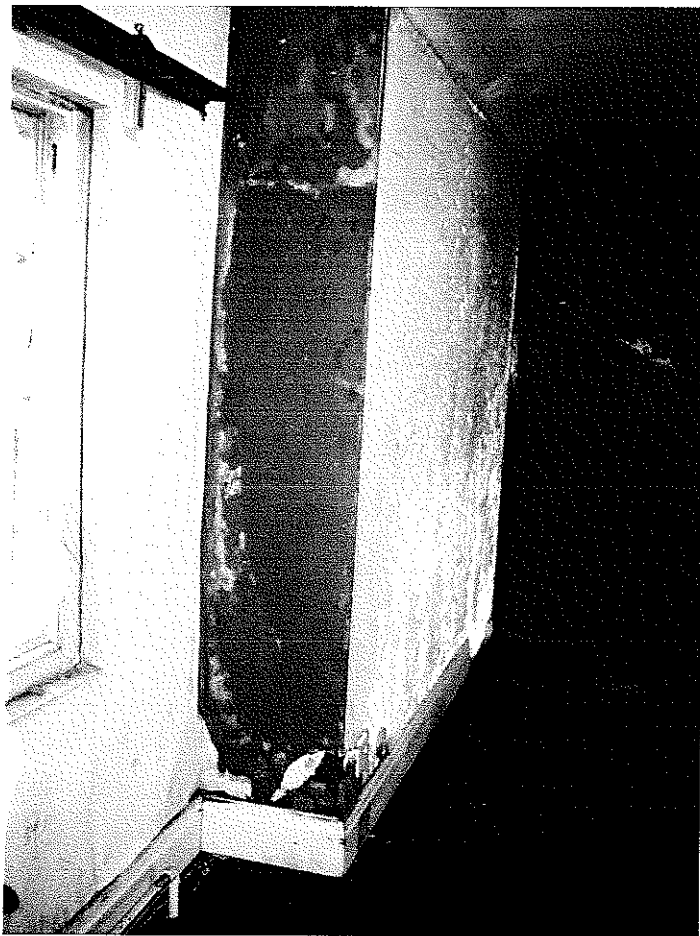
Image 25 - Water damage due to leaking junction at rear chimney/roof junction

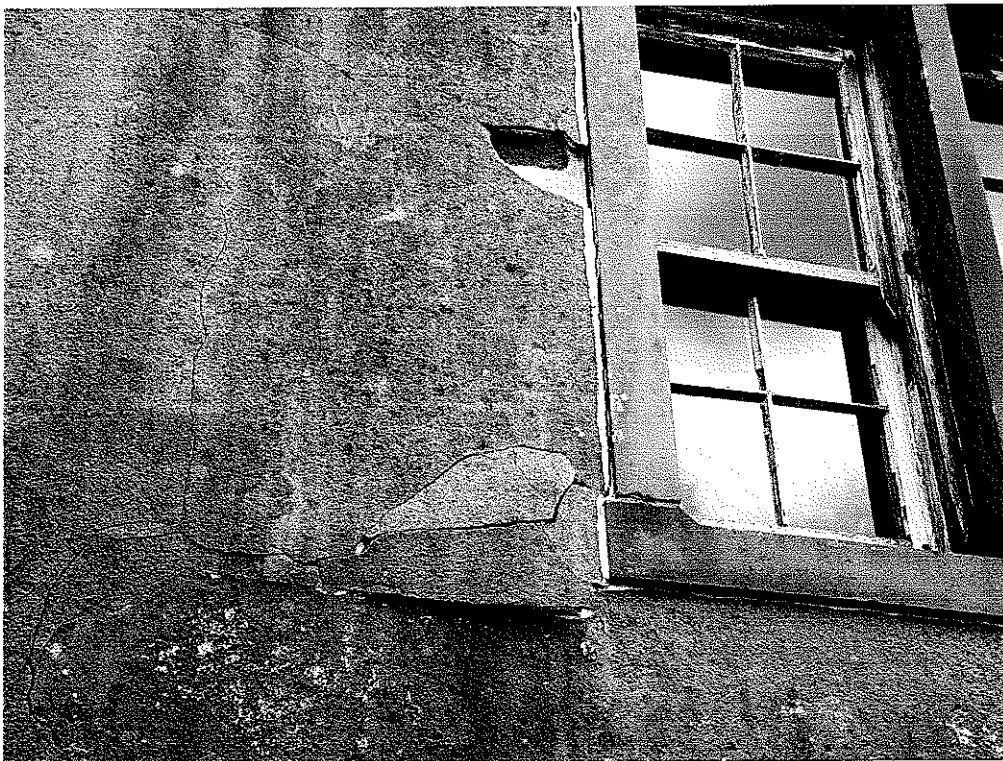
**Image 29 – Cracked and detached render to building façade**

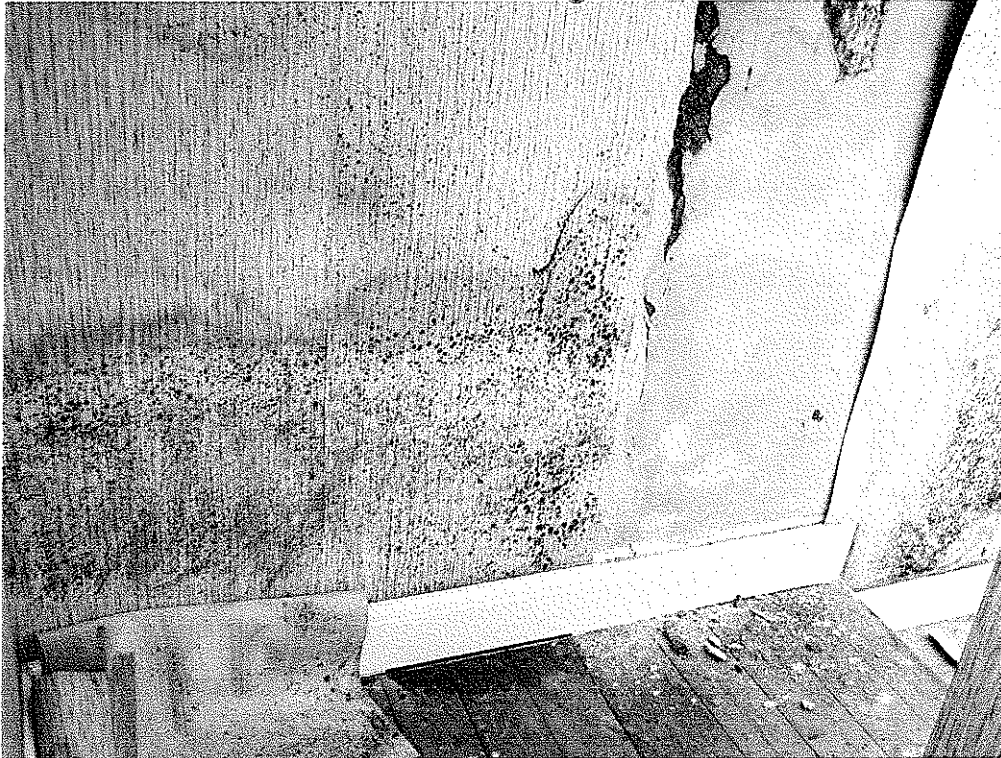
**Image 30 – Evidence of serious dampness and condensation at first floor level**

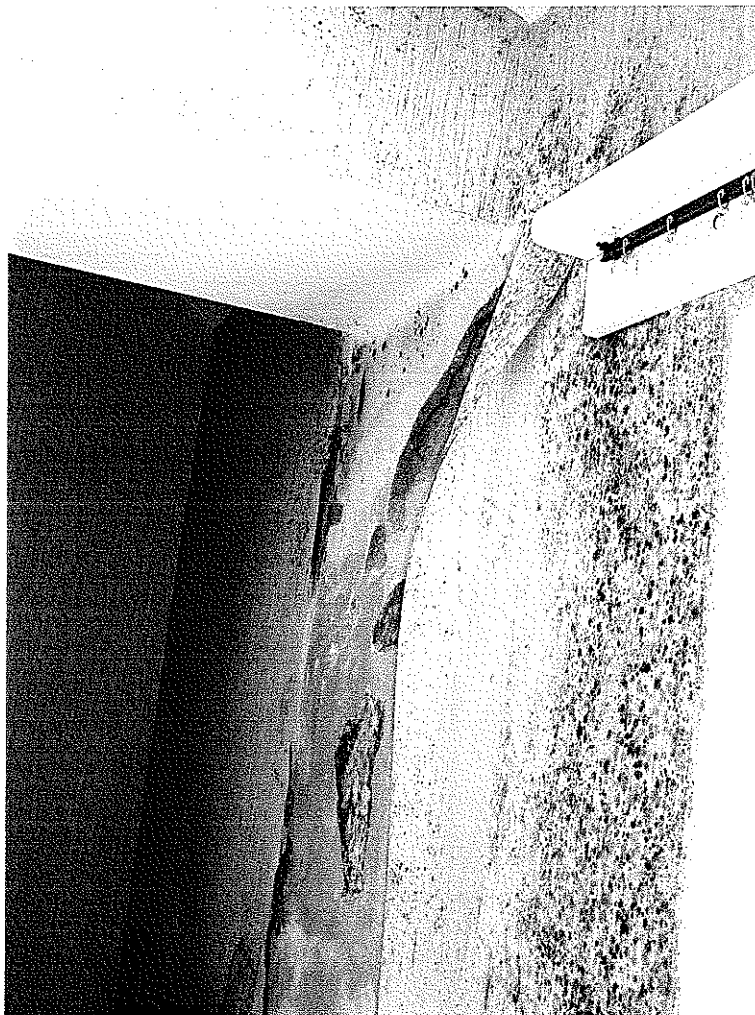
**Image 31 – Evidence of serious dampness and condensation at first floor level**
