## PROPOSED CHANGE OF USE OF PART PRIMROSE MILL INTO APARTMENT, DESIGN WORKSHOP AND INTERNAL GARDEN

### DESIGN AND ACCESS STATEMENT

**FOR THE FORMER MILL BUILDING  
PRIMROSE ROAD  
CLITHEROE, LANCASHIRE, BB7 1DR**

**JOB REF: 4221, DATED: 19/06/2012, VERSION 1.01**

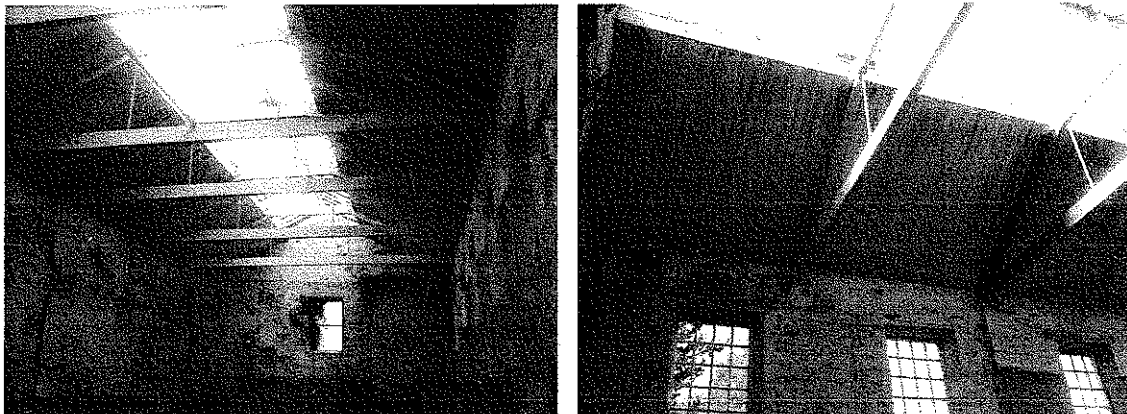
PL 1 Illustrating 'open plan' timber roof structure and linings from inside

Good to excellent with no signs of significant weathering or degradation. Leadwork present to junction with abutting existing wall. Surfaces appeared to be generally clean and free from debris. The roof coverings may have become potentially fragile overtime but not deemed to pose any significant risk, however, applying any load to existing roof glazing should be avoided due to being single glazed panes.

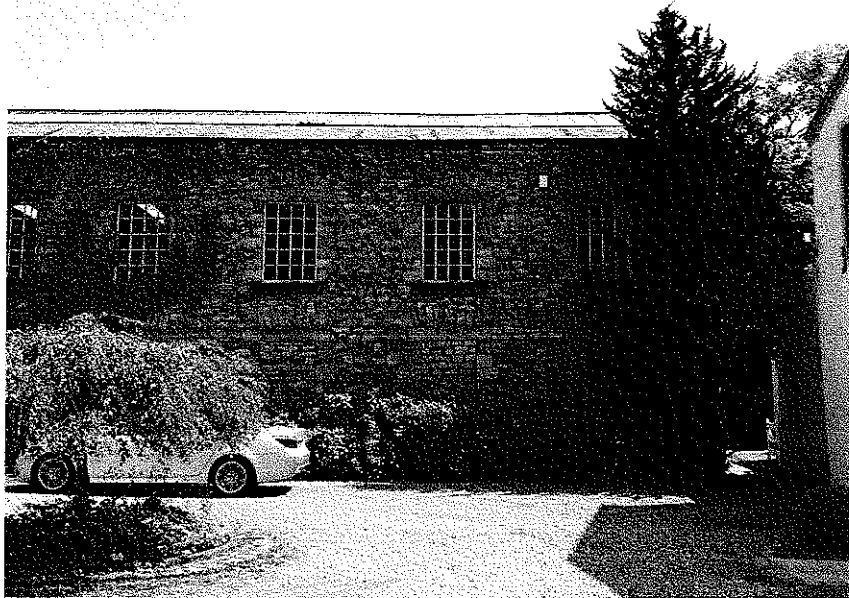
**PL. 2 View of South West structural wall from courtyard**

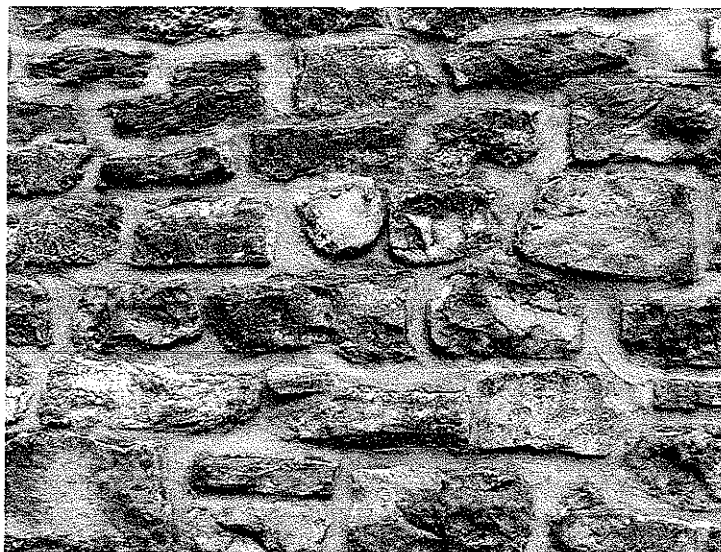
Externally the wall fabric was generally in excellent condition with no missing pointing.

**PL. 3 Condition of external wall and pointing generally**

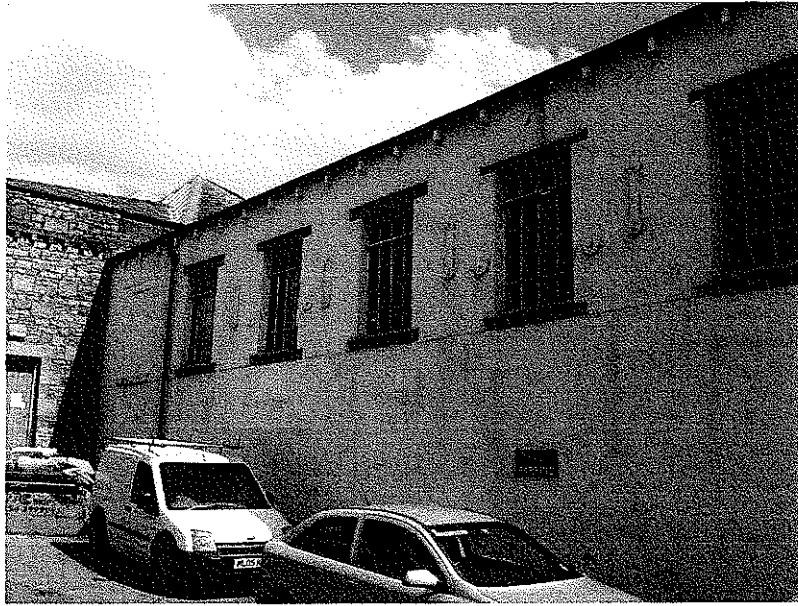
Render was in good condition where present with no significant signs of structural cracking.

**PL. 4 Condition of external wall where rendered**

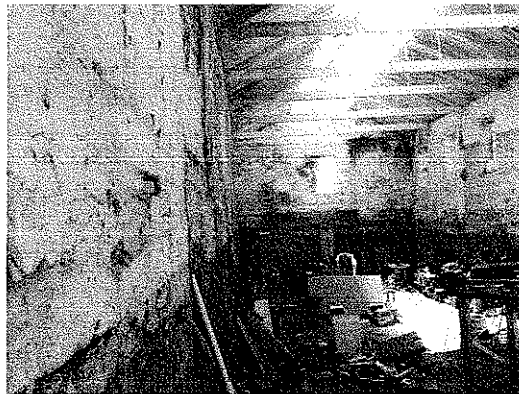
**PL. 5 Internally North West structural wall is bowing/leaning out**

- North West party wall has bowed / pushed out of line internally where the roof trusses have been transferring their load down through the external wall structure to the foundations, again lack of internal buttressing currently present.

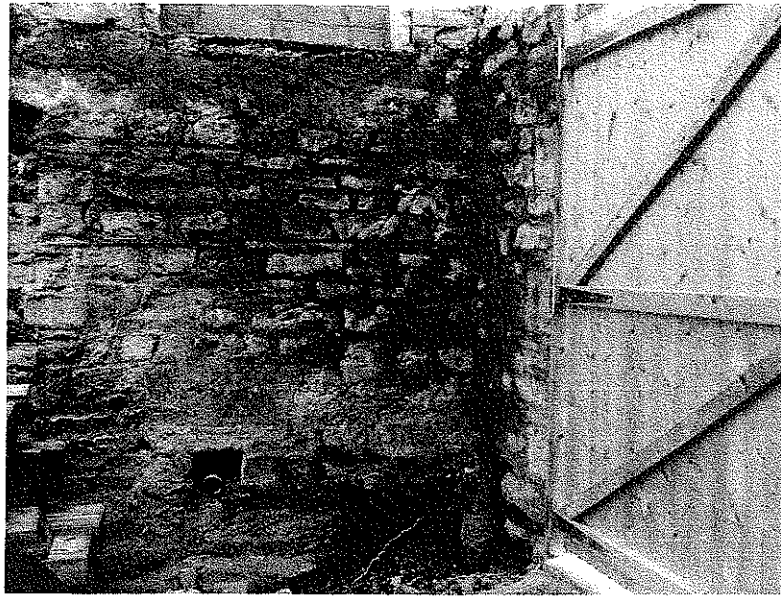
**PL. 6 Dampness internally to North West Facing gable**

- Evidence of internal dampness to low levels on North West facing structural wall internally due to being below ground level.

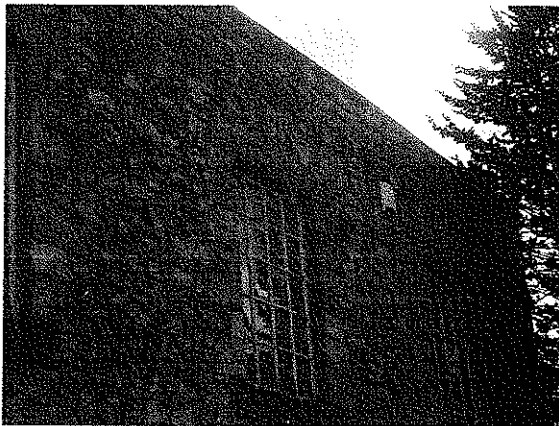
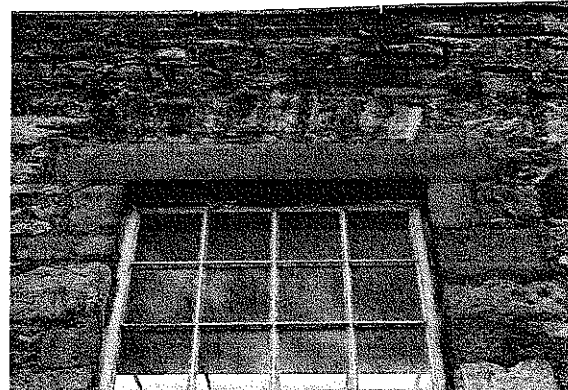
**PL. 7 Dislodged eaves coping to South West gable**

- Dislodged eaves coping and poor wall condition to sections of South West gable between window head and eaves. Areas to be inspected once safe working platform is in place, isolated re-building work required. These areas are showing signs of structural breakdown probably caused by roof loads pushing out eaves sections of wall due to lack of internal buttressing (no internal walls or floors).

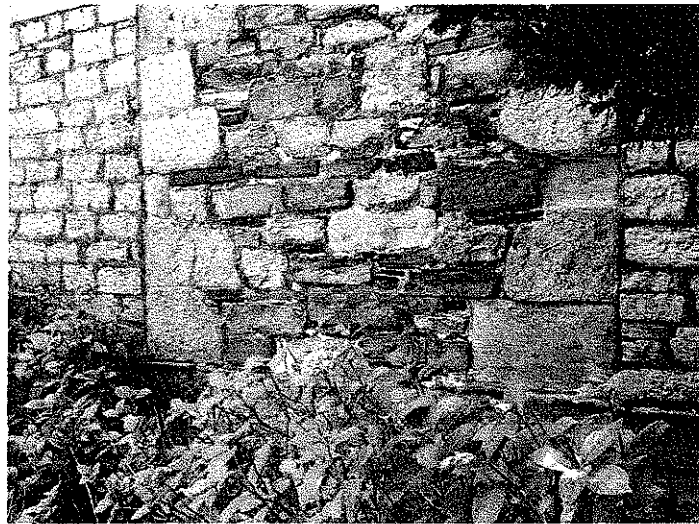
PL. 9 Re-point/build section of external wall.

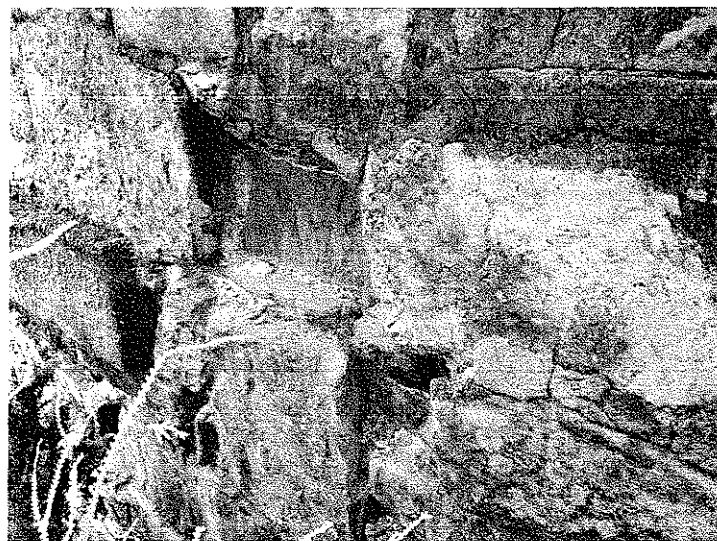
PL. 10 Ledge infill for potential water ingress and weakening of surrounding wall structure

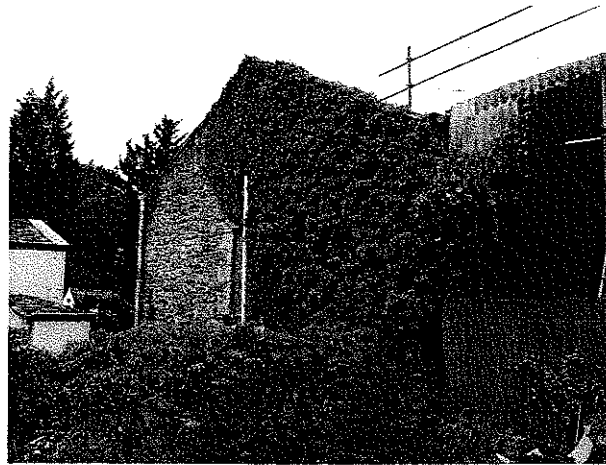
**PL 11 Vegetation growth potentially concealing defects / breaking down existing wall stability**

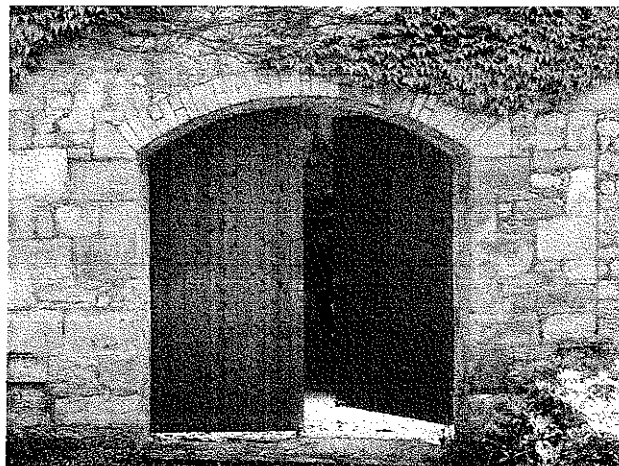
Arch constructions over external door openings to mill in excellent condition with no signs of cracking or failure to adjoining wall fabric.

**PL 12 Arch over main entrance to South West.**

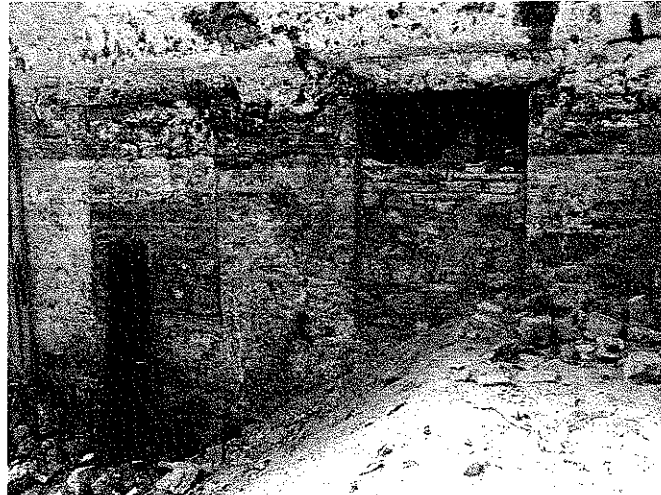
**PL 13 Wall fabric to internal openings, generally.**

- Wall fabric to infilled ground floor windows has become weak rubble fill overtime. Openings to be re-built or opened up as part of the mill conversion scheme.

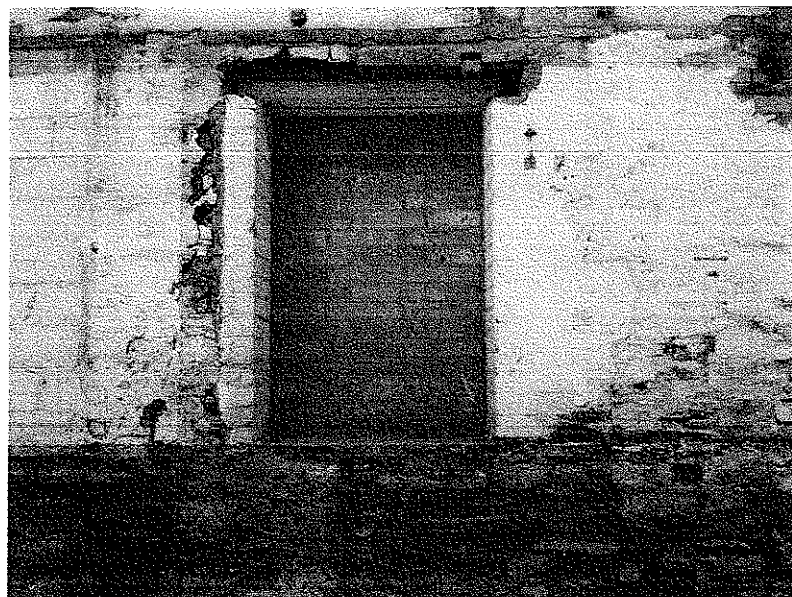
**PL 14 Dilapidated structural head and wall surrounds**

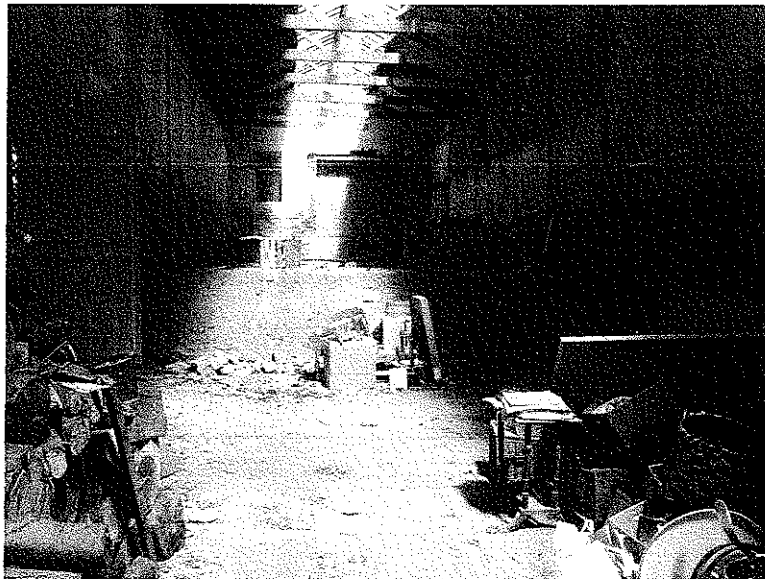
**PL 16 Illustrates earth floor construction currently on two levels**

Earth floor acting as suitable solid base currently. Insulated ground floor concrete slab on solid required with any change of use. Evidence of cut off timber joists where built in external wall structure. The conversion of the redundant storage barn will act as an ideal opportunity to re-construct floors within the mill to improve internal buttering support that is currently lacking.

Consideration should be given to installing new first floor as part of the conversion scheme to improve structural stability of the main building envelope through internal buttressing.

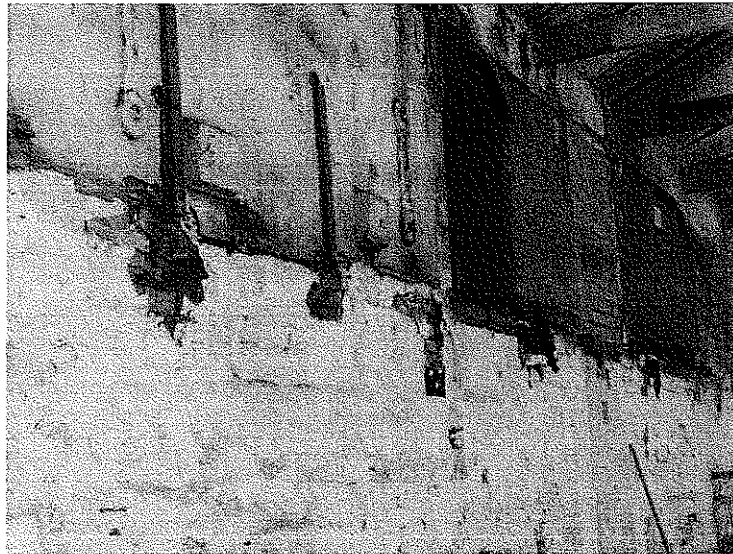
**PL 17 Evidence of existing floor joist slots**

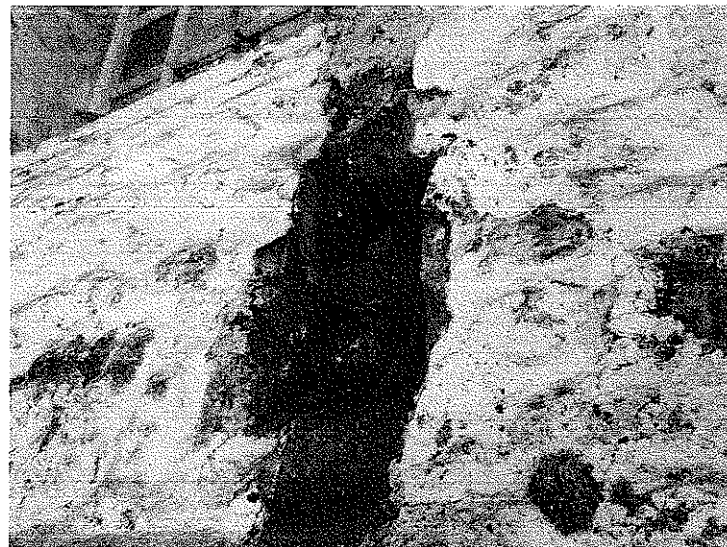
**PL 18 Evidence of existing timber floor joist cut off and left in-situ**

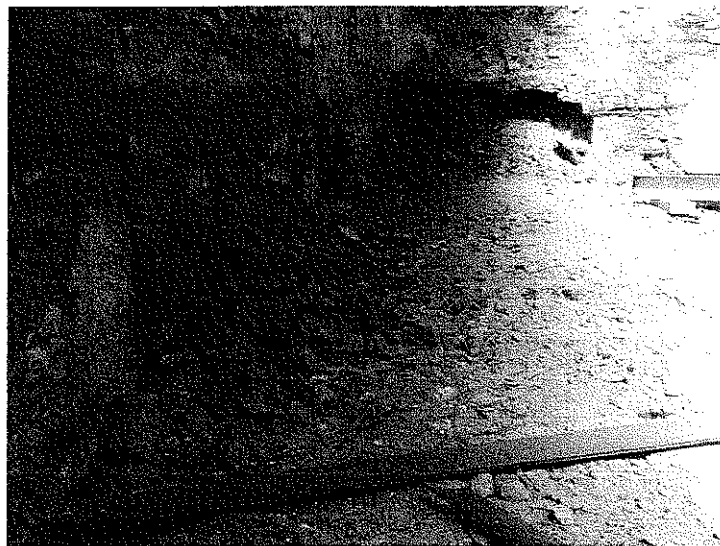
**PL. 19 Collapsed rubble infill to be re-built**

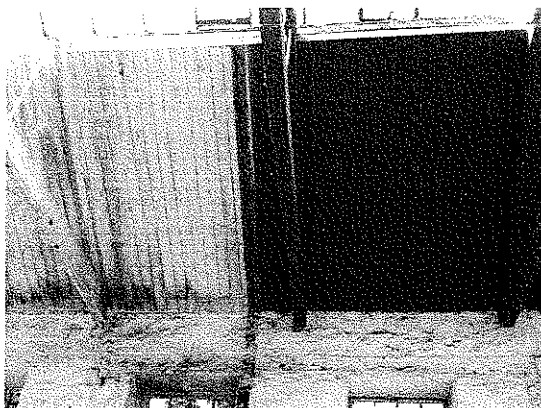
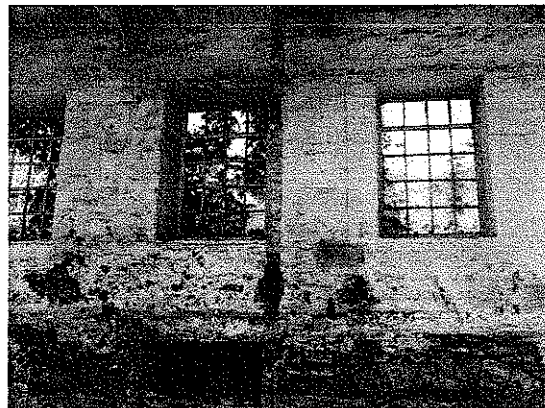
**PL. 20 Dark brown line on wall and roof indicates line of existing central divider wall which has been removed.**

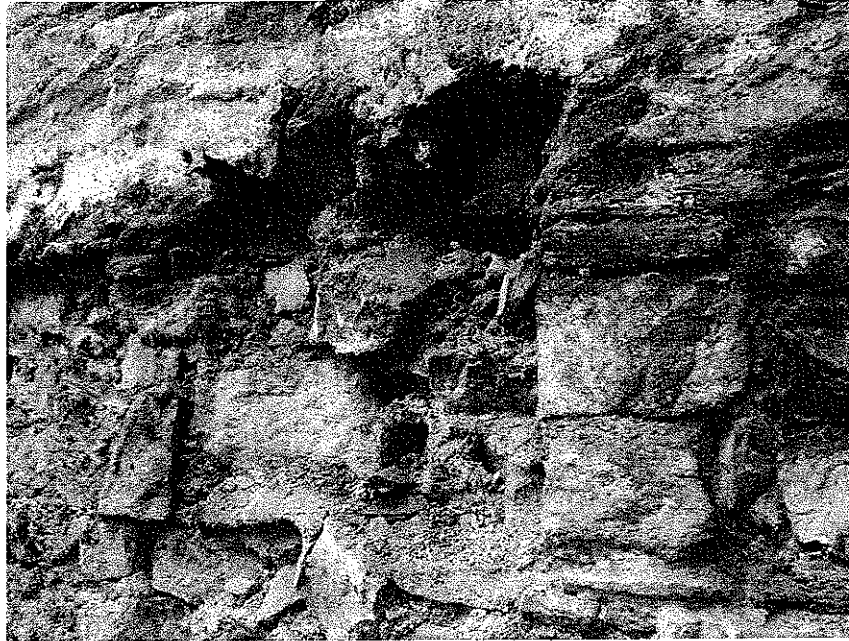
**PL 21 Collapsed rubble infill to be re-built**

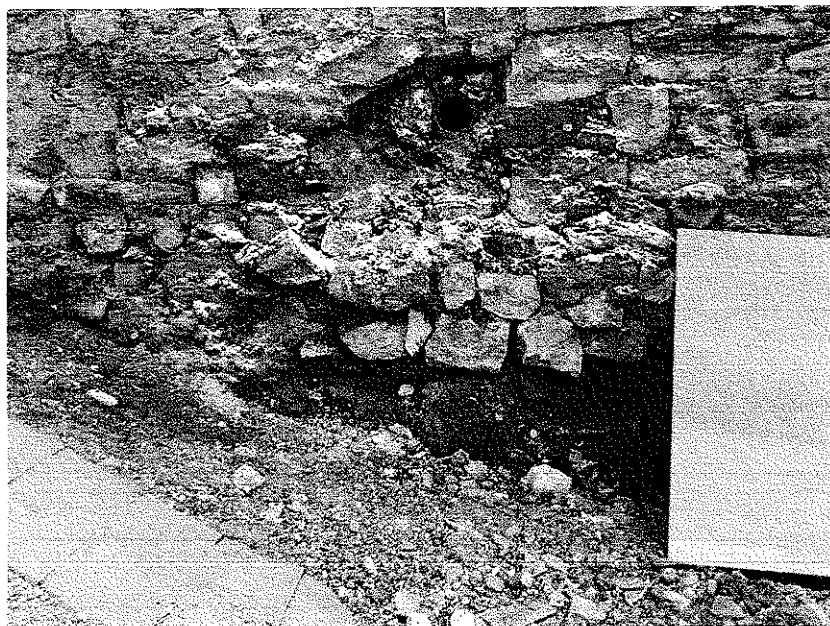
**PL 22 Collapsed rubble infill to be re-built due to probibly water ingress due to being below external ground level**
