## STRUCTURAL APPRAISAL REPORT

A1323 rev0

A1323 Huckle Ing Barn, Gisburn

**Structural appraisal report concerning the stability and integrity of the  
existing structure and the suitability for renovation**

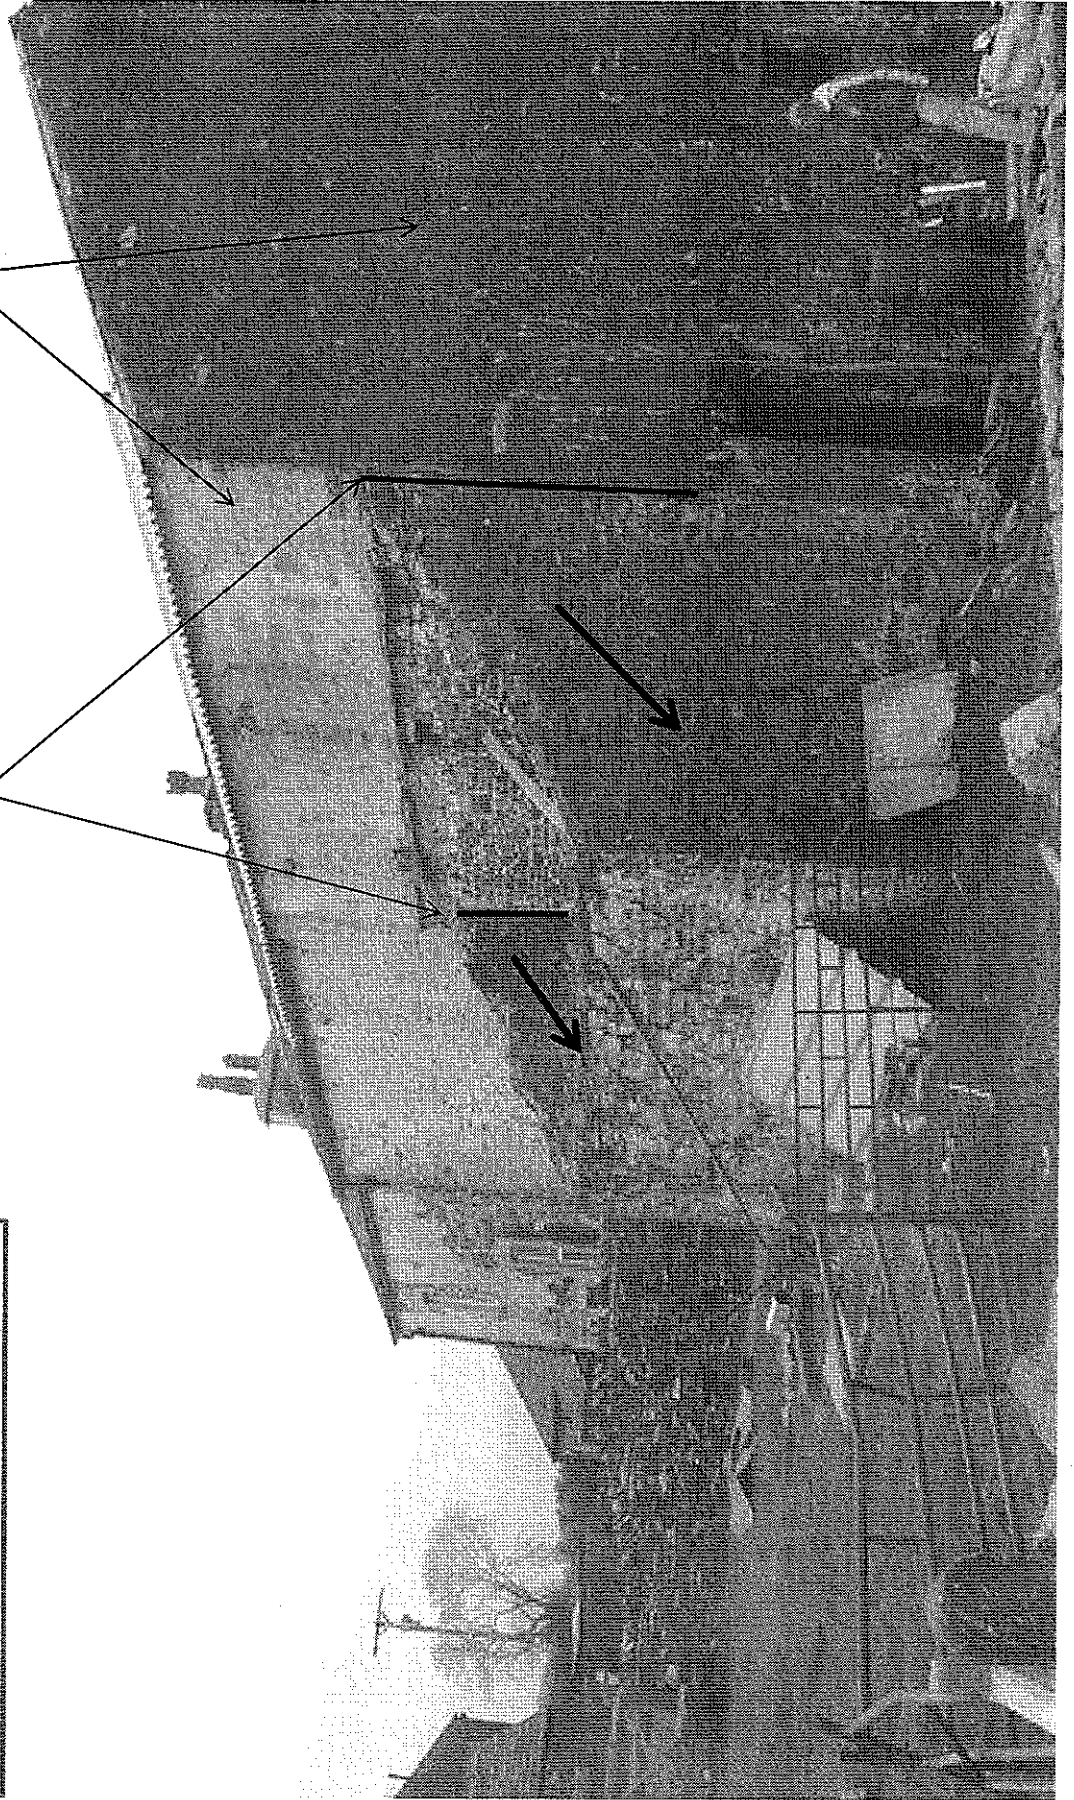
Photograph One showing the North flank wall and roofless lean-to as seen from the North - West

Both gable walls of the lean-to have parted from the main North elevation

Both walls shown are vertical and free from bulging or splitting

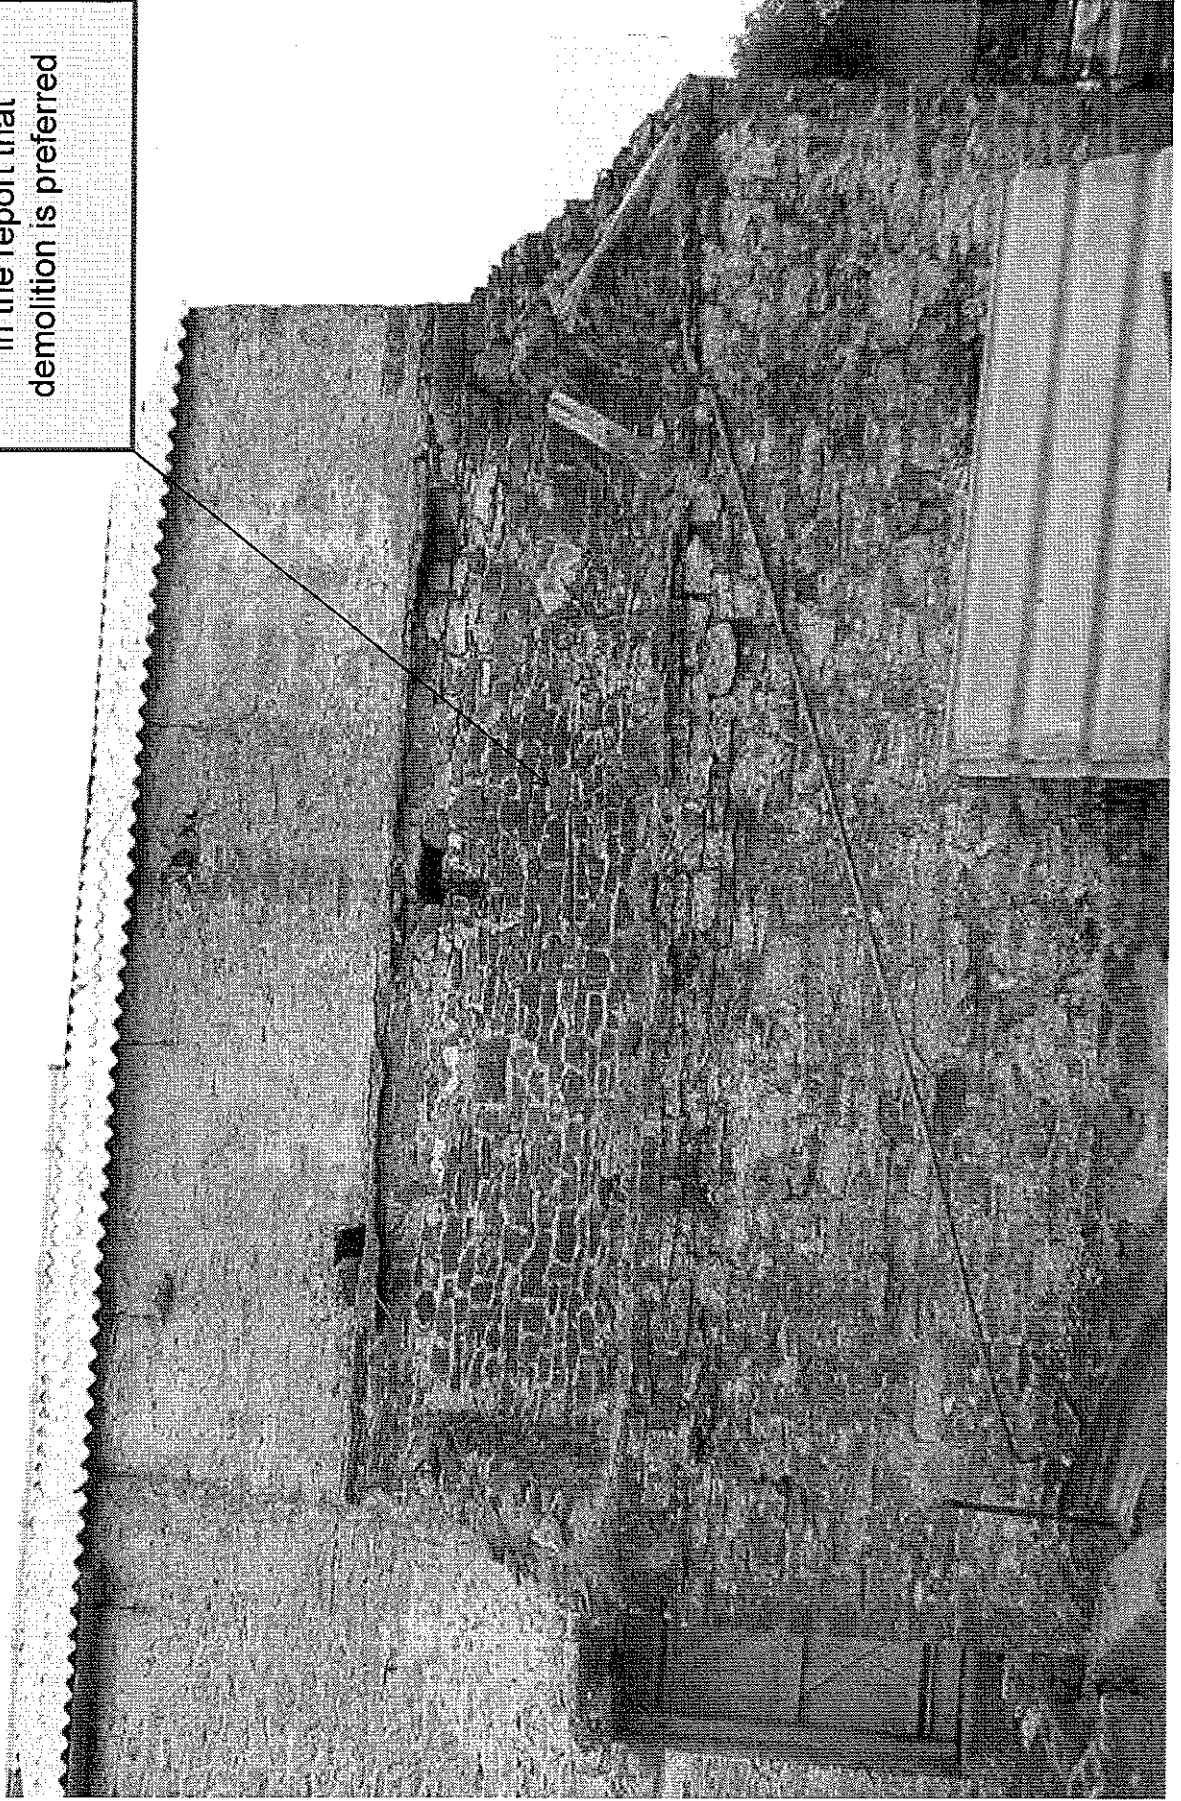
Photograph Three showing the rear roof cheek  
mostly covered with cement paste corrugated  
boarding

Lean-to walls with latent  
defects with a suggestion  
in the report that  
demolition is preferred

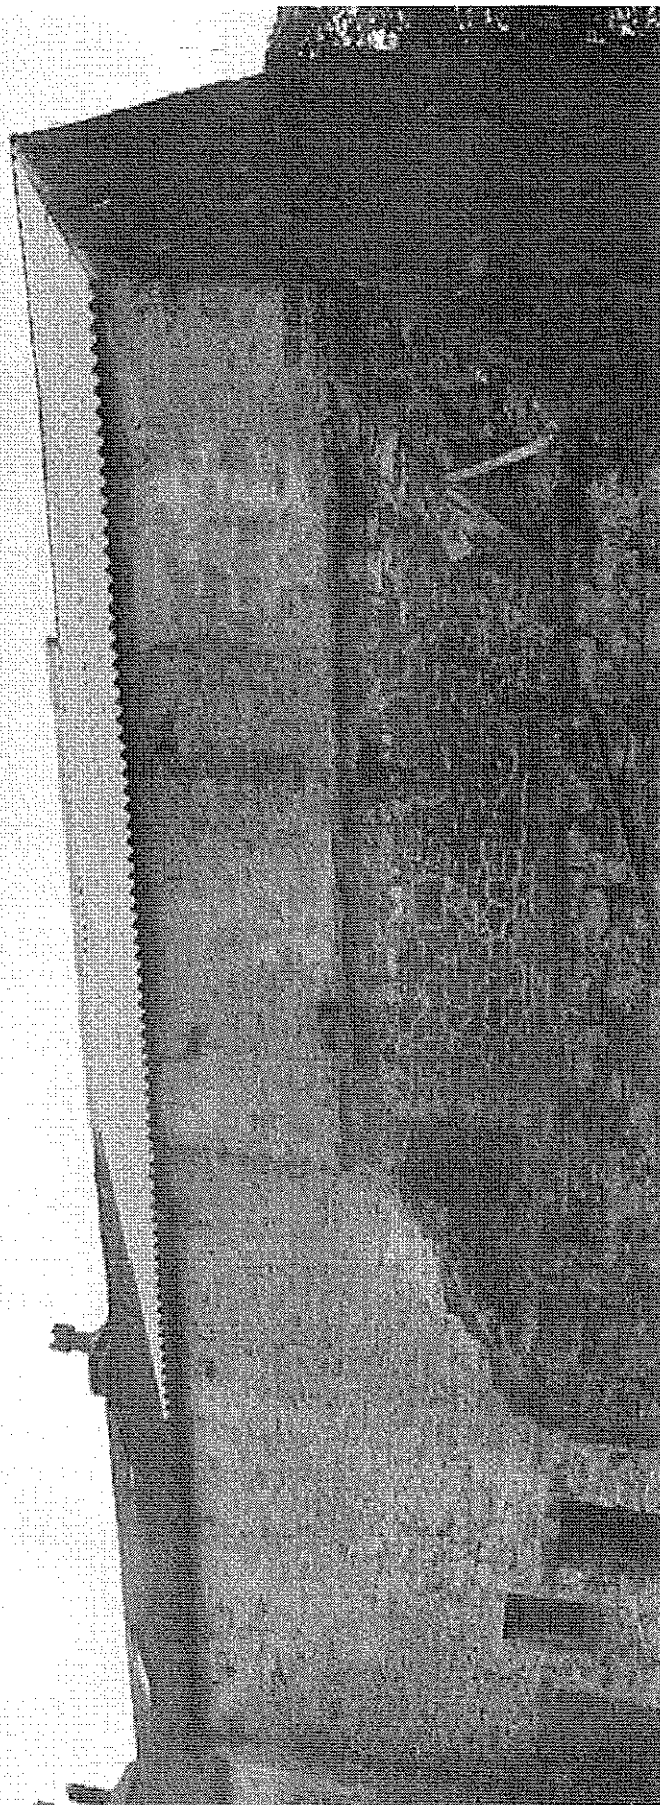
Photograph Four showing North roof cheek covered in cement paste corrugated boards and partly slate ; all to be replaced by tiles on felt on battens on new spars. Roof drainage non-existent

temporary and that for fit for purpose reasons and for Planning reasons the covering will be completely renewed as tile on new battens on felt on new spars on the existing trusses (which require structural checking - *refer Section 2.0*). The roof drainage is currently none existent and will have to be renewed (*refer to Section 2.0*).

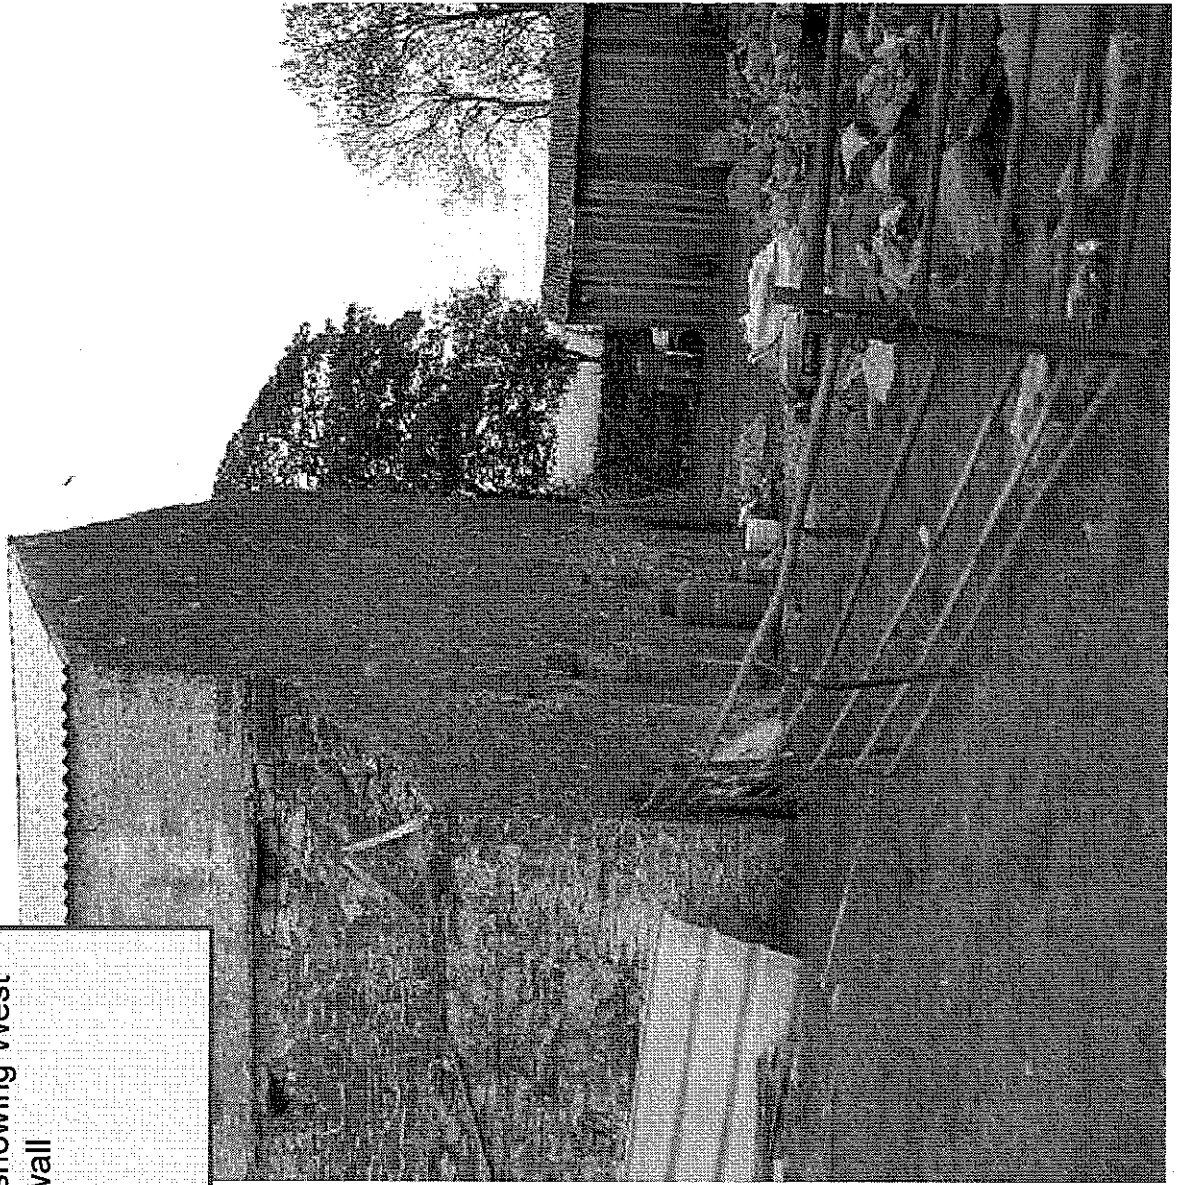
Photograph Five showing West  
gable wall

- 1.0.4 External survey : West Gable. Photographs Five and Six note that a spirit level survey showed that the elevation, again of random rubble limestone is vertical and free from any serious bulging. Unusually for barns of this height and nature, there was little evidence of any serious strain cracking to the wall. However, in consideration to the height of the wall and to the fact that the roof loading will be back to a heavier weight of tiles etc., then tying-in to a new First Floor structure and a new inside skin is recommended (*refer to Section 2.0*). It must be noted that there is a working septic tank (*refer to Section 2.0*) in field opposite to the gable, immediately inside the field enclosure. The field is also the property of the client.

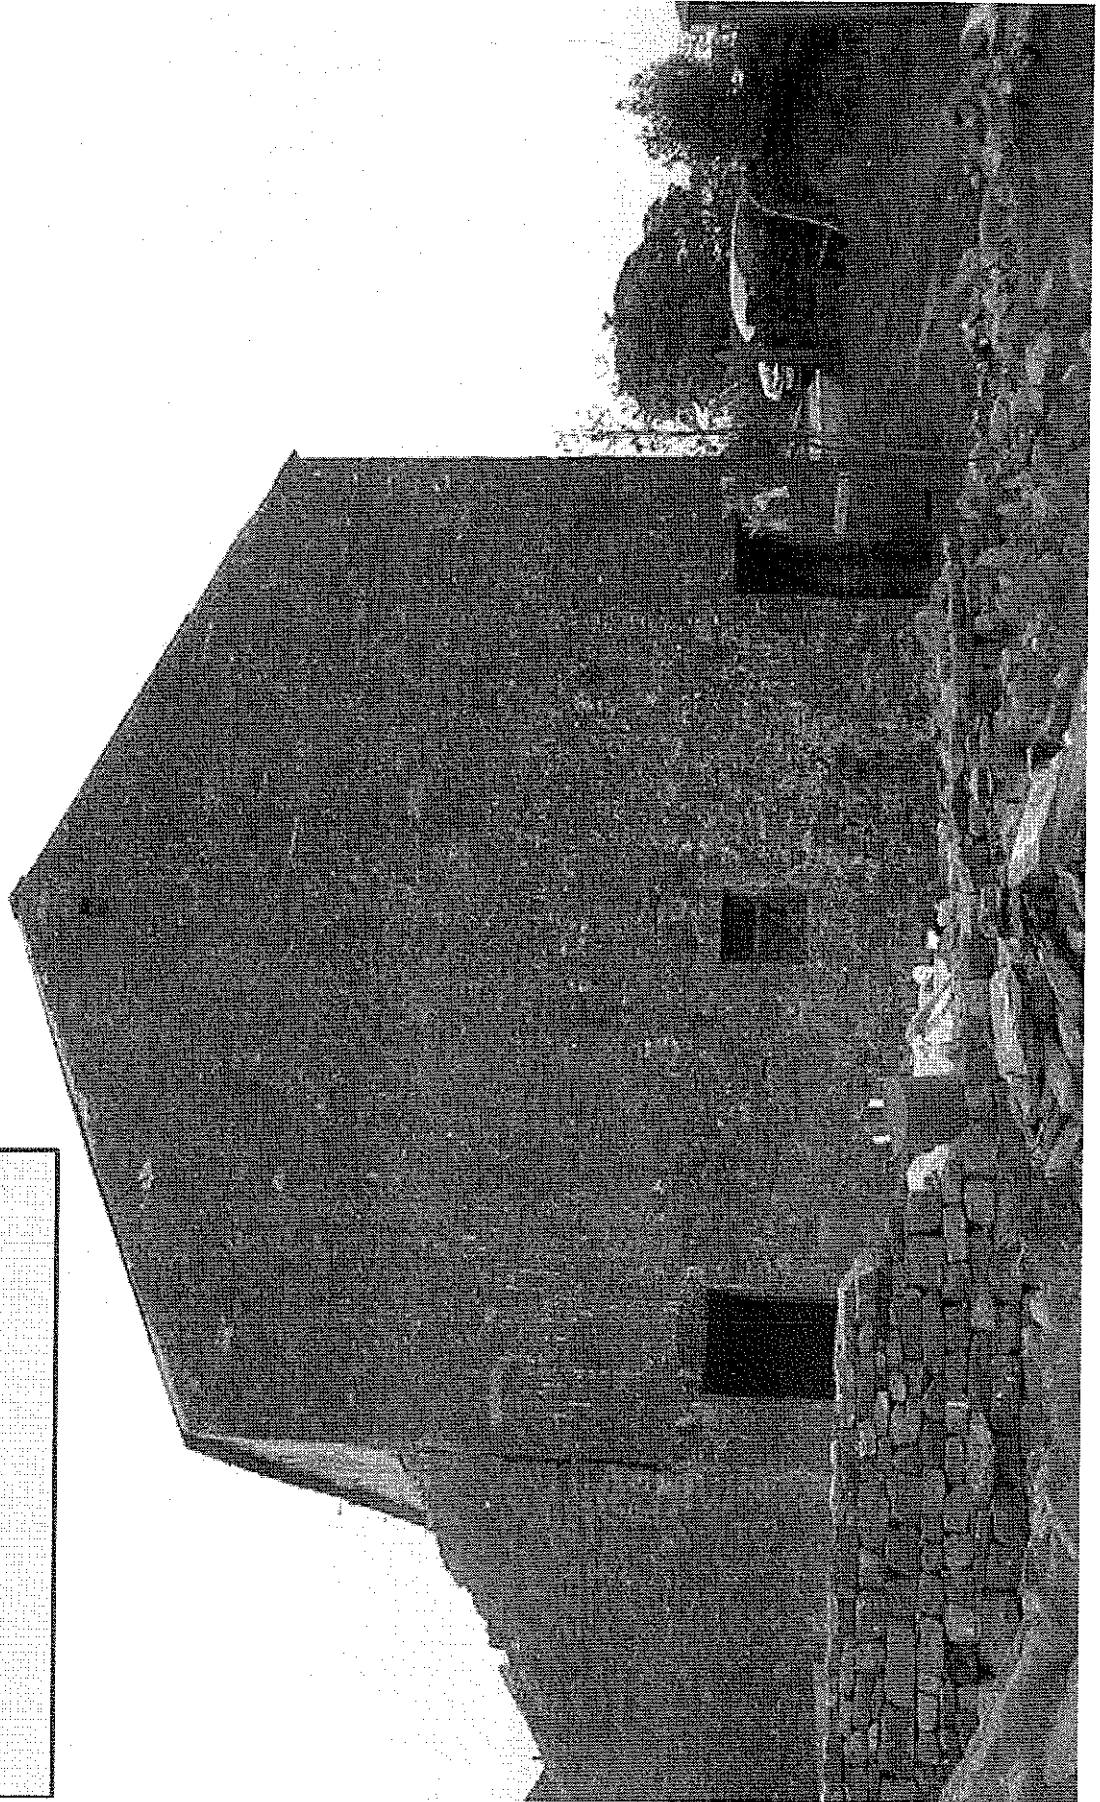
Photograph Six showing West gable wall - all external walls have an average thickness of 570 mm and appear to be in reasonable condition

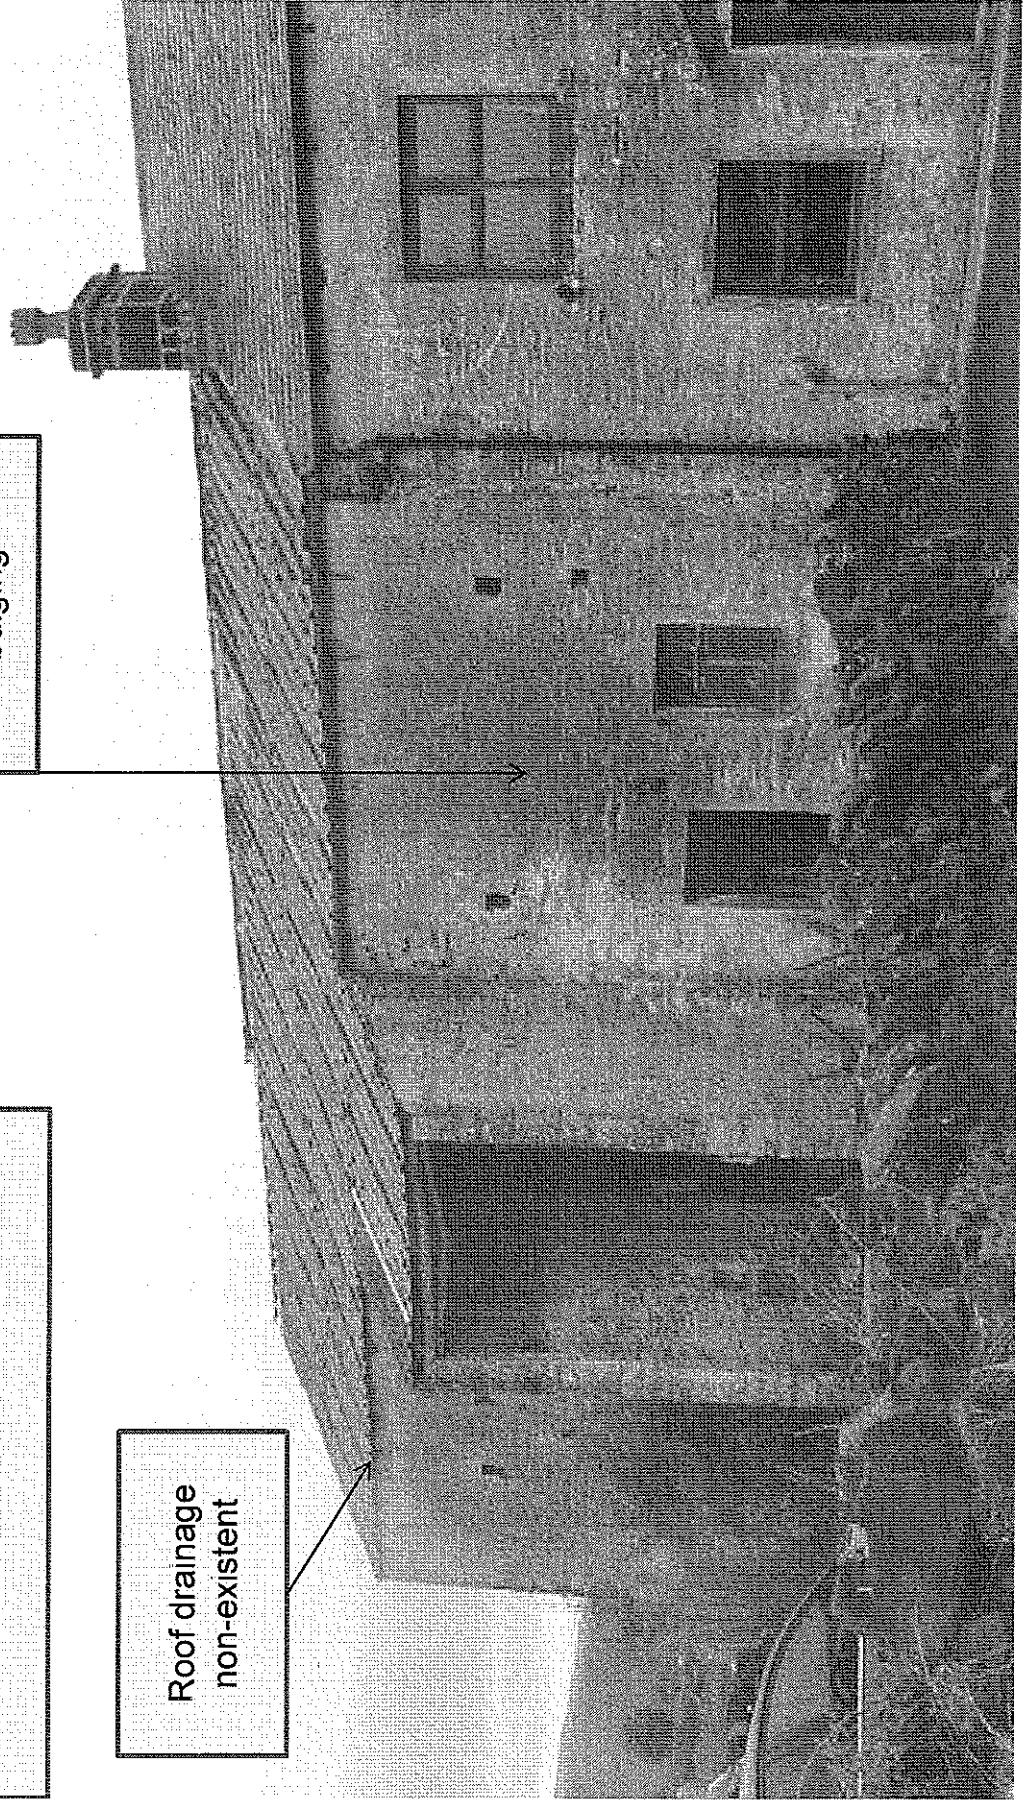
- 1.0.5 External survey : South Elevation. The South Elevation flank walls and also entrance wing walls are shown on Photograph Seven. The notes on the Photograph show that the walls (including the wing walls), of random rubble limestone, are generally vertical and free from any serious bulging or strain cracking. Photograph Eight, however, shows that the two timber beams supporting the roof covering over the entrance are not fit for purpose and require replacement (*refer to Section 2.0*).

Photograph Seven showing South  
Elevation including traditional full-height  
barn doorway : roof completely covered in  
cement paste corrugated sheets to be  
completely re-covered - see report and  
also Photograph Four

Roof drainage  
non-existent

Walls of South  
Elevation vertical  
and straight with  
little evidence of  
strain cracking or  
bulging

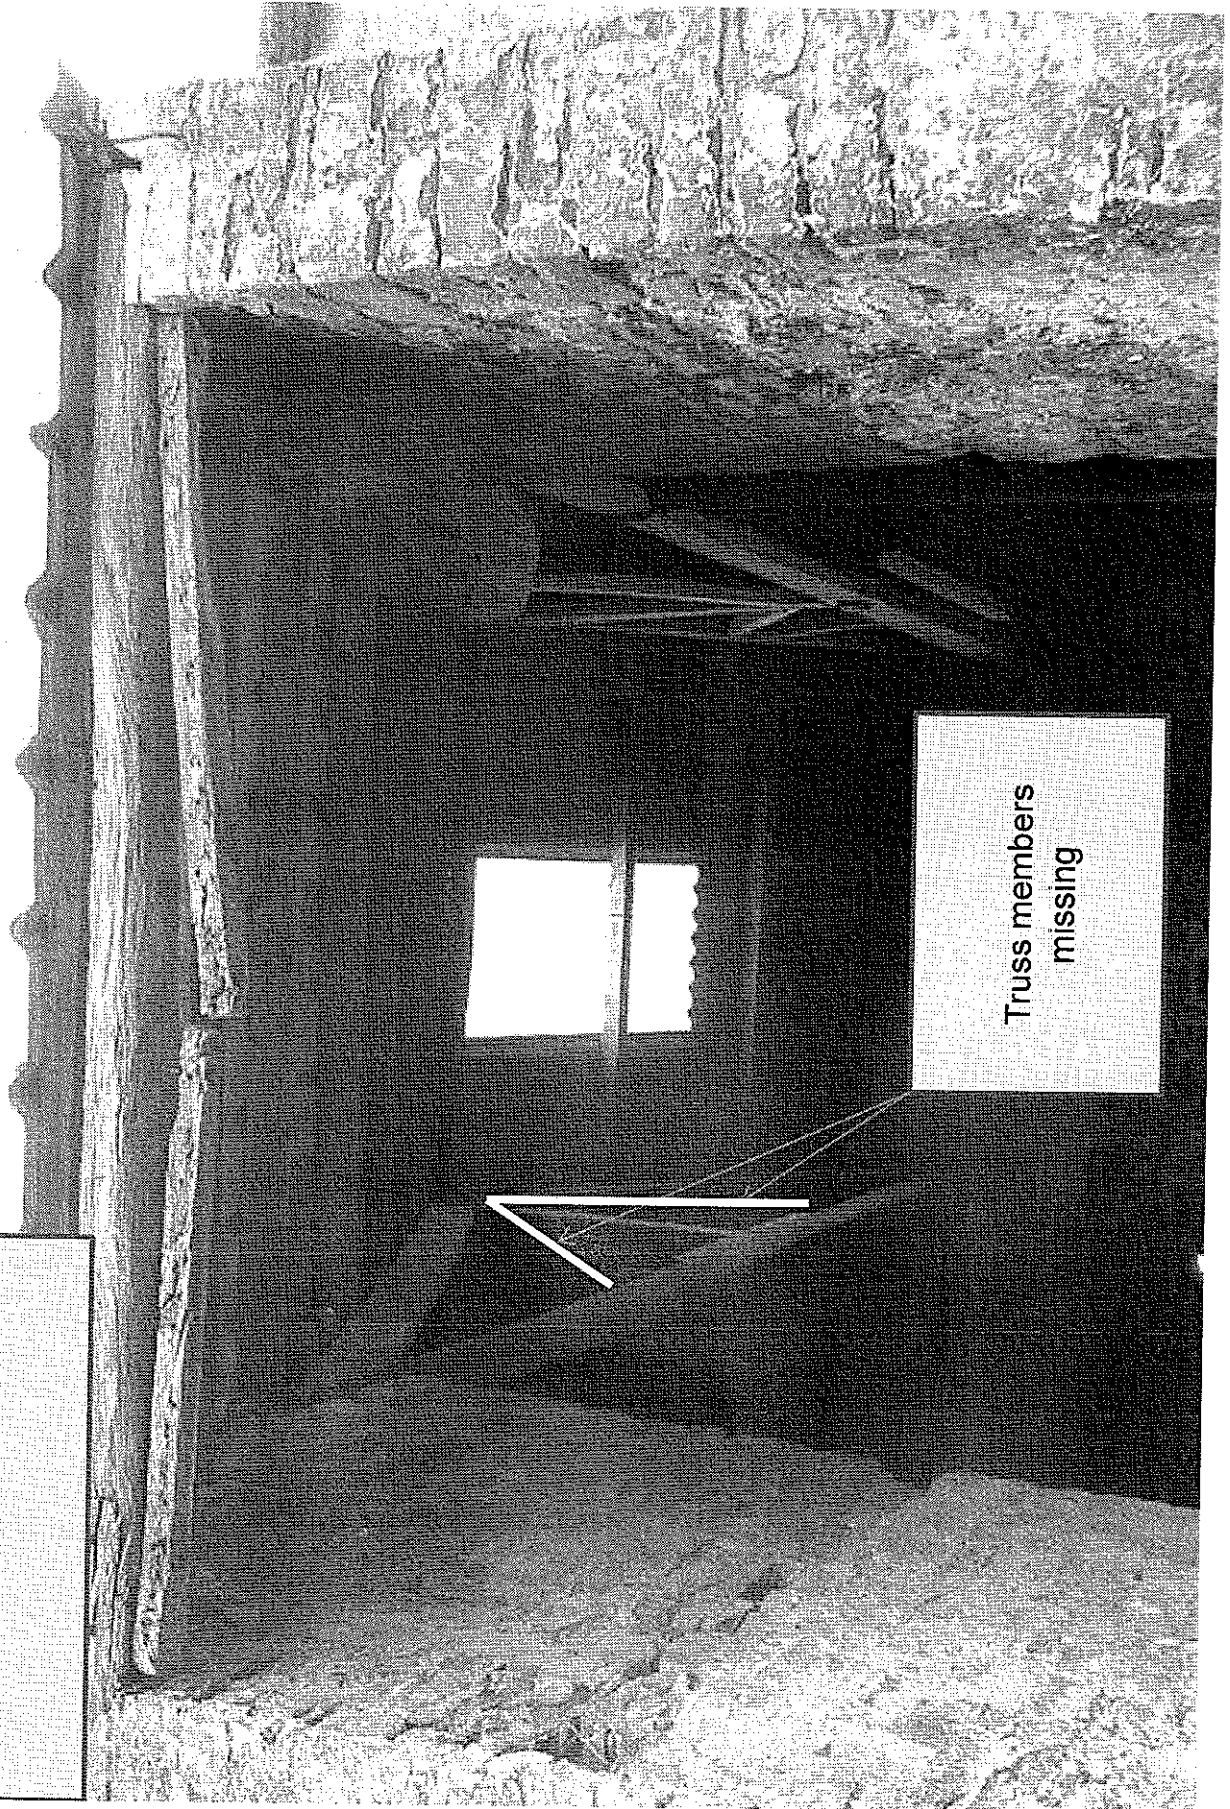
Photograph Eight

- 1.0.7 Internal survey : roof structure. The roof structure comprises of 5 bays of purlins on 4 oak trusses. Two of the trusses (in the West section) have missing members which require replacing as shown on Photographs Eight and Nine (*refer to Section 2.0*). However the internal diagonals of all the trusses need checking for fit for purpose and also the condition of the North end of the Western-most truss requires examination by a timber specialist for insect and fungal attack (*refer to Section 2.0*).

Truss members  
missing

- 2.0.3 The existing roof covering to be removed and the existing trusses checked for strength, insect attack and also suitable diagonal pieces re-inserted. The roof covering to be renewed with tiles on new battens on felt on new spars blocked up as required to ensure a straight roof ridge and straight roof cheeks. The timbers over the North main entrance are to be replaced by similar new timbers or by stonework if the front entrance is to be built-up to eaves level. New roof drainage in keeping with the attached re-furbished farmhouse to be incorporated and the drains and septic tank checked for fitness of purpose.

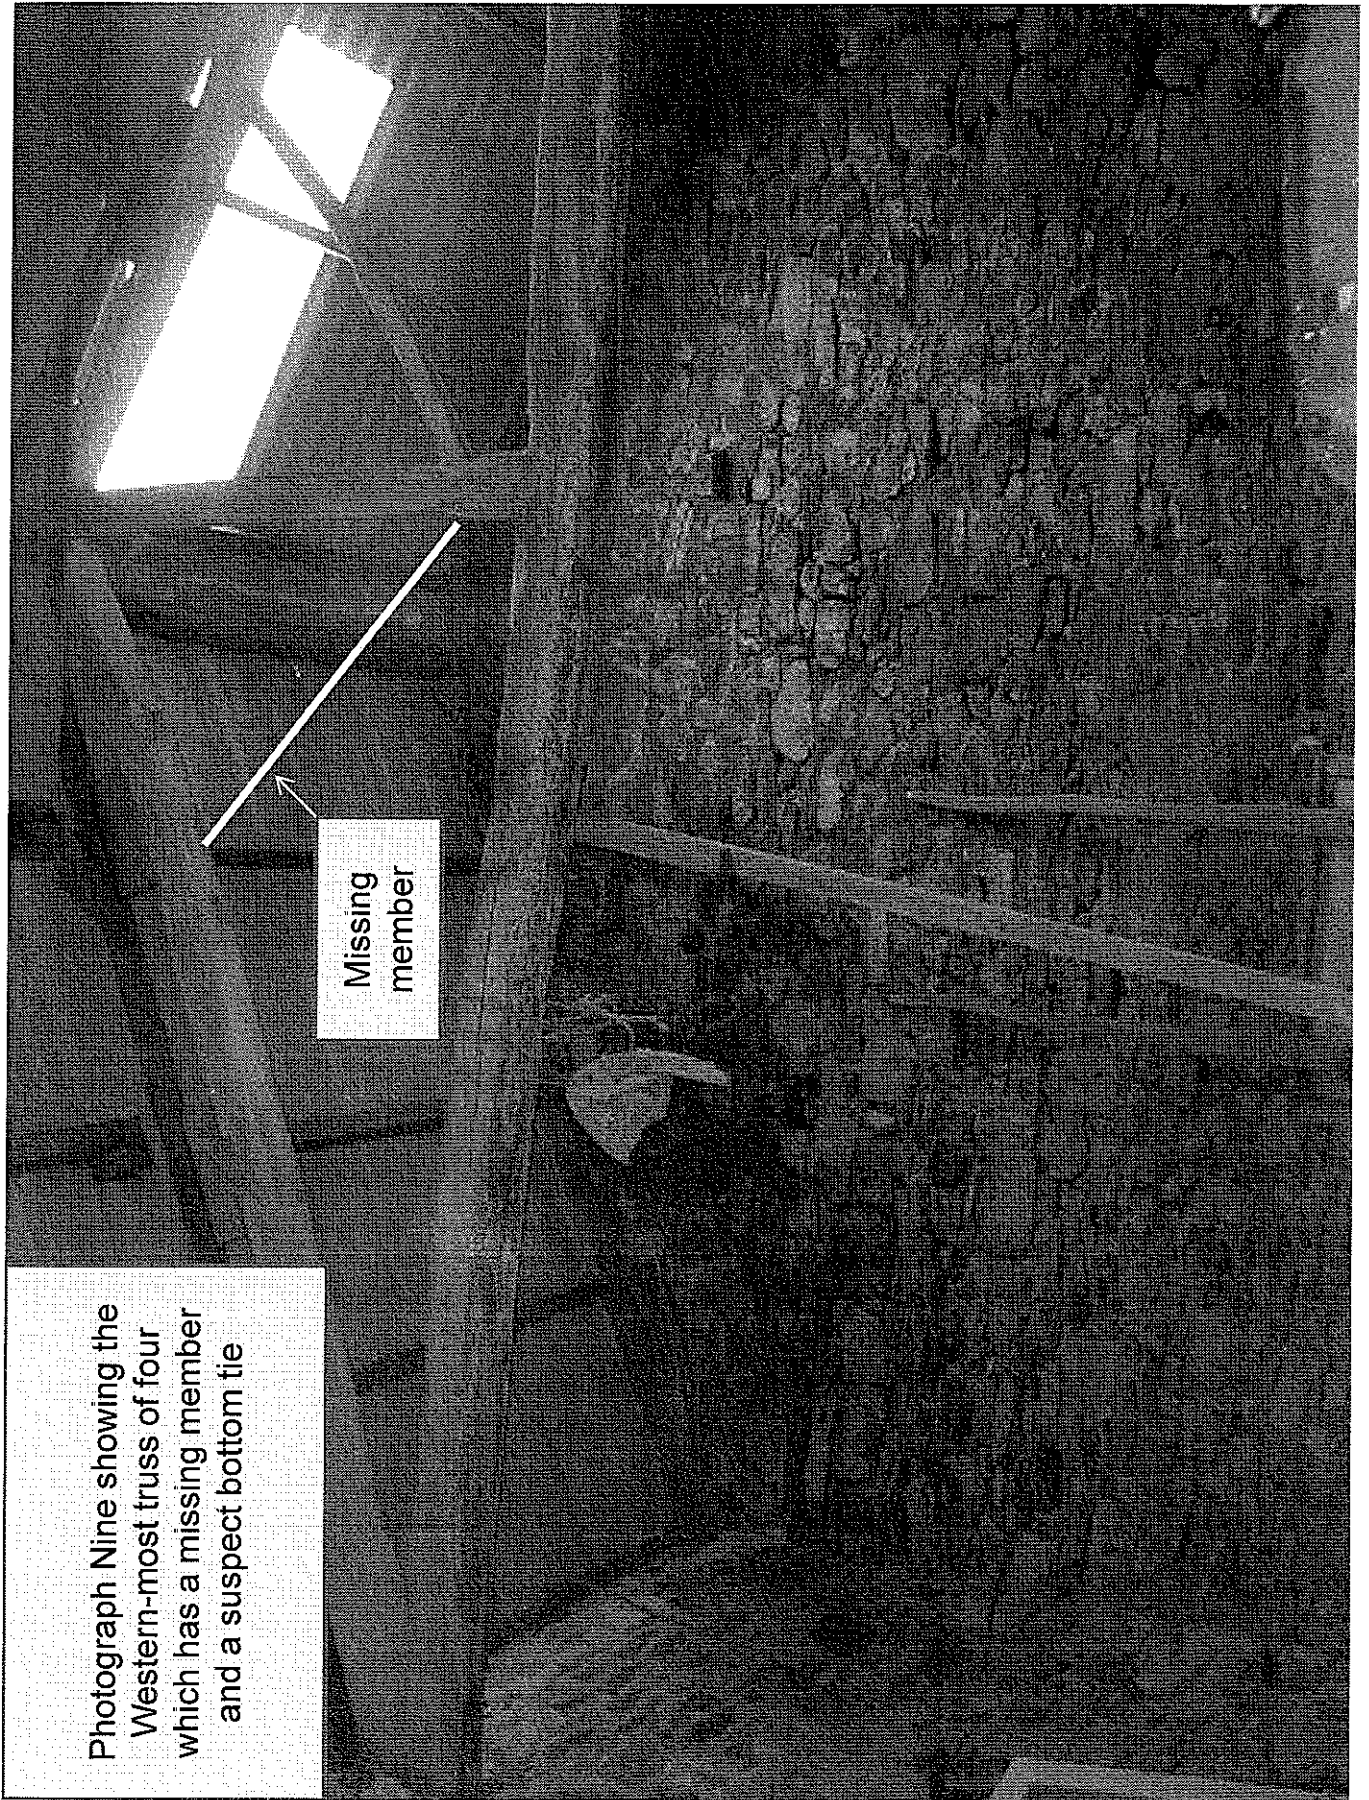
Photograph Nine showing the Western-most truss of four which has a missing member and a suspect bottom tie

Missing member

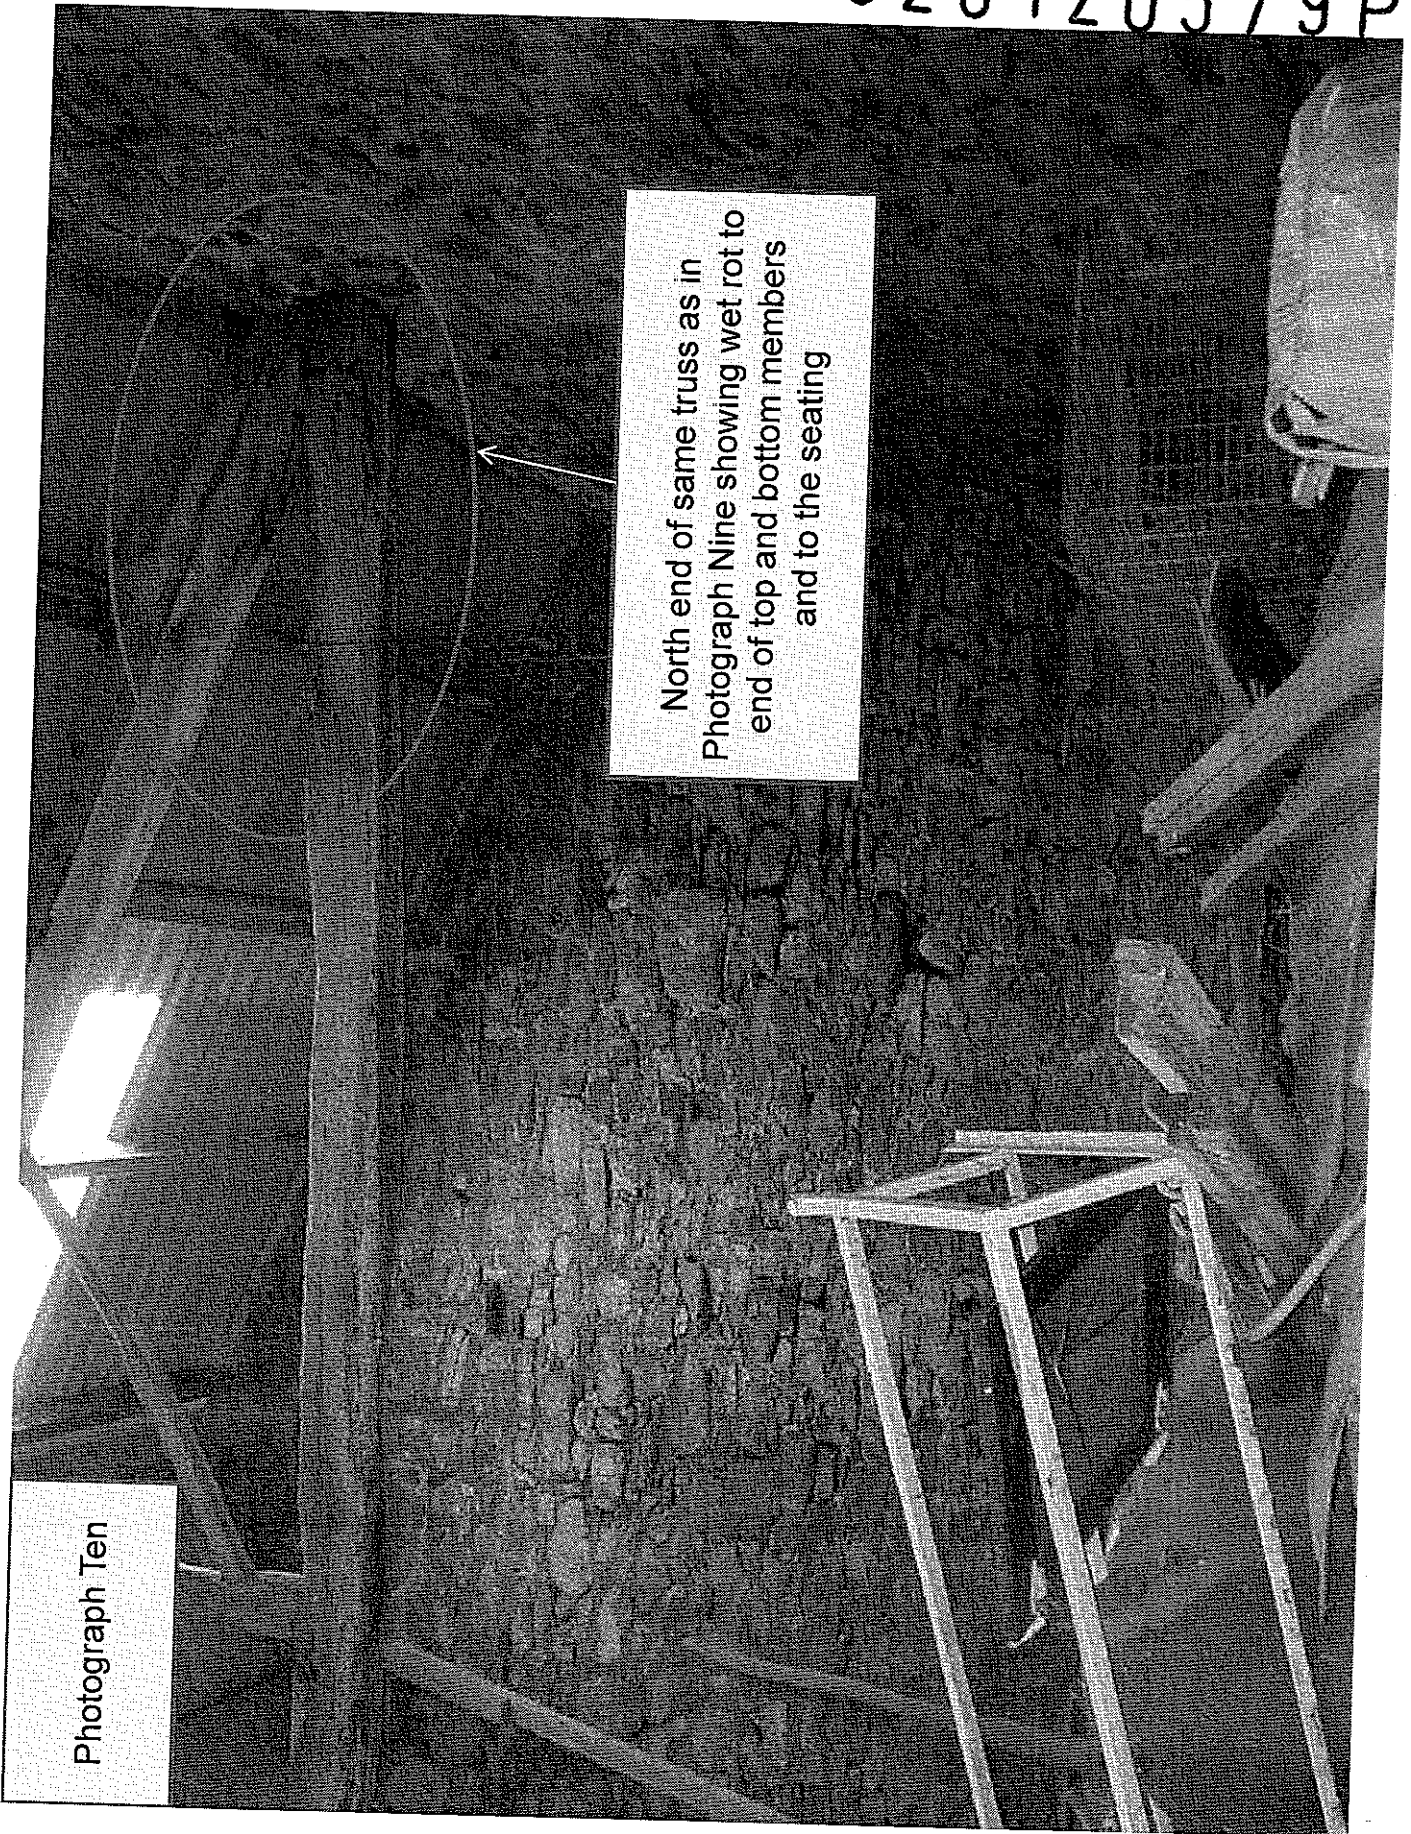
Photograph Ten

North end of same truss as in  
Photograph Nine showing wet rot to  
end of top and bottom members  
and to the seating

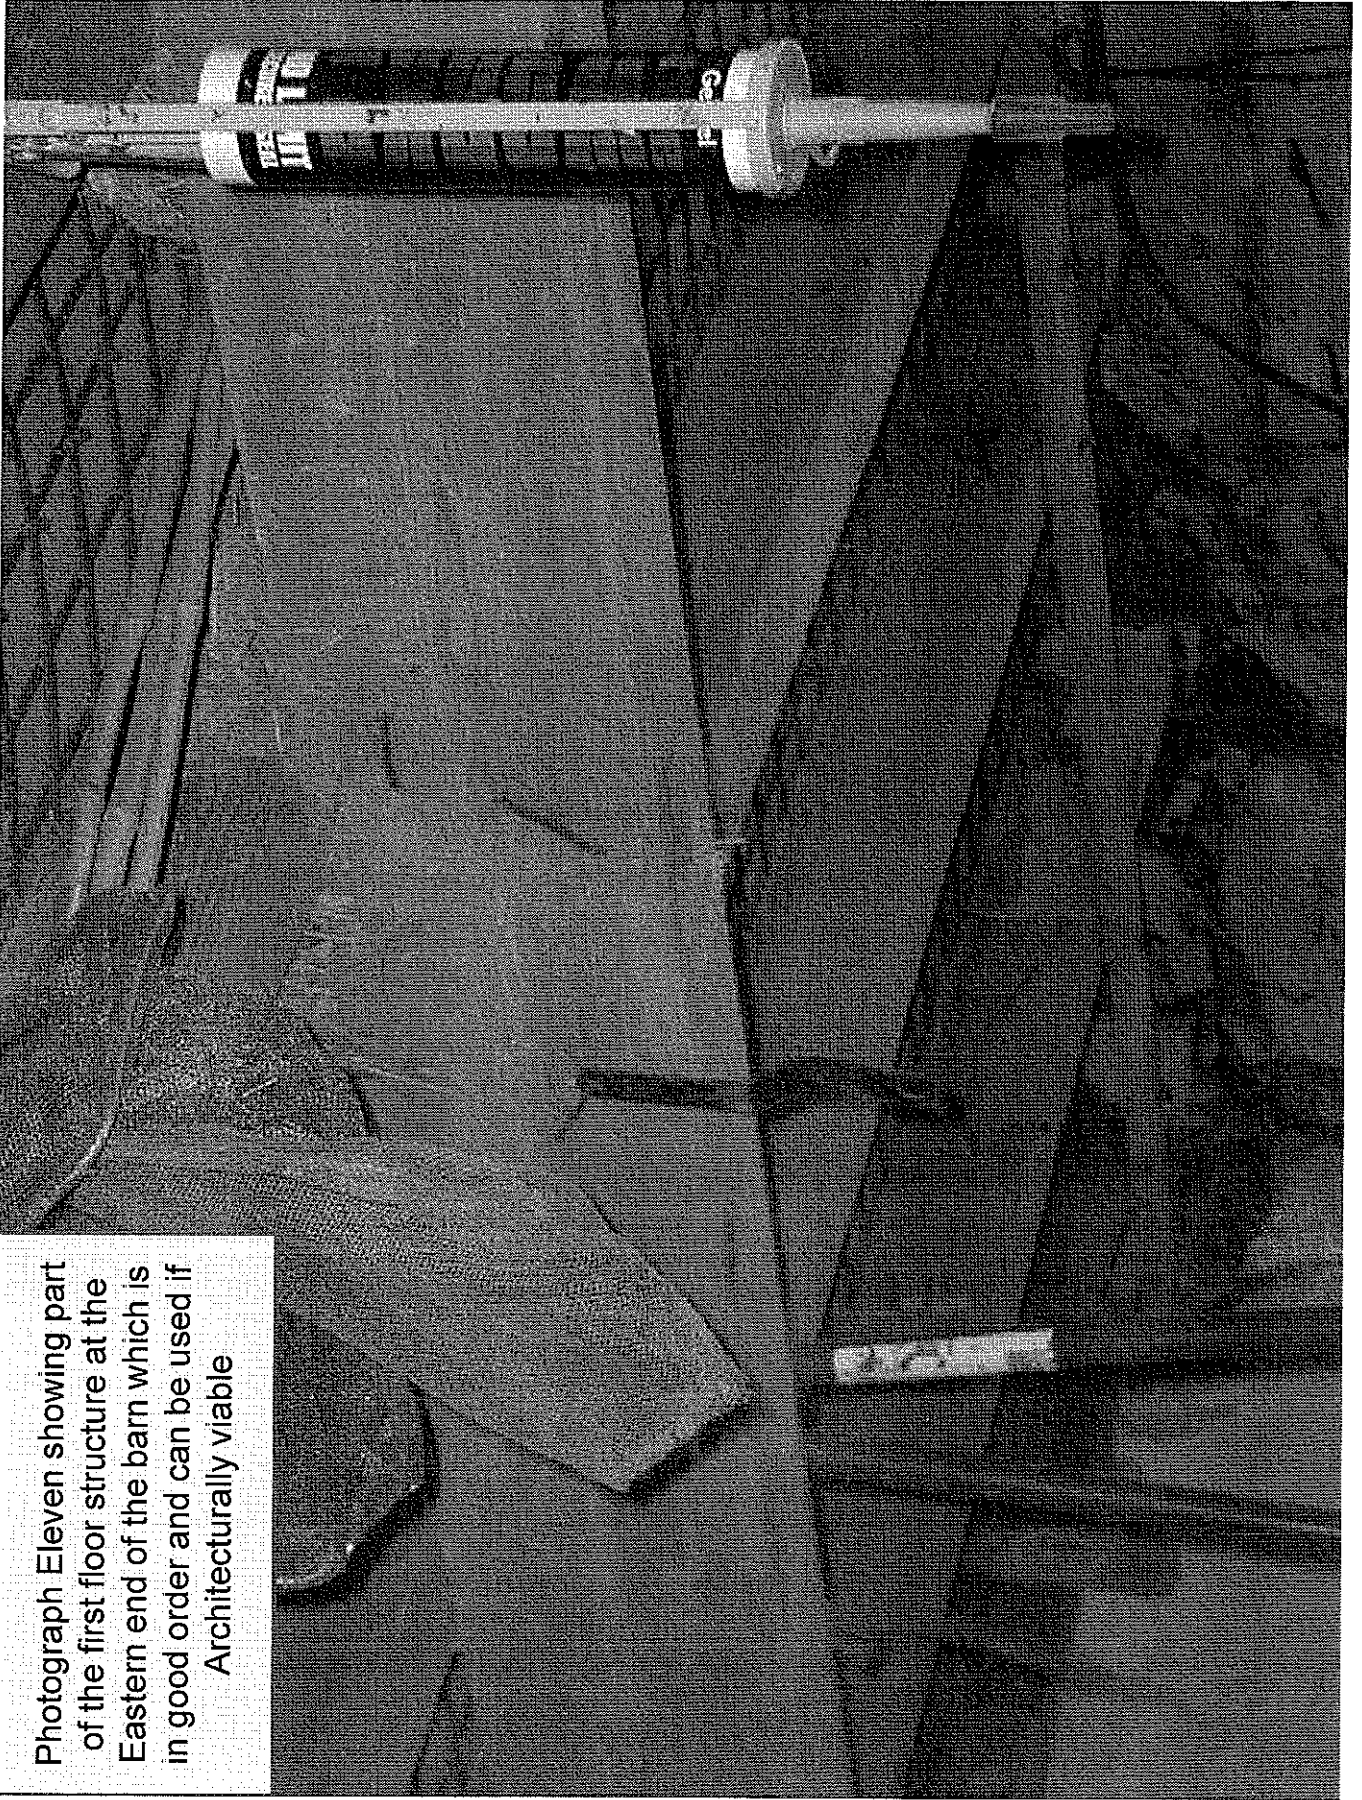
Photograph Eleven showing part  
of the first floor structure at the  
Eastern end of the barn which is  
in good order and can be used if  
Architecturally viable

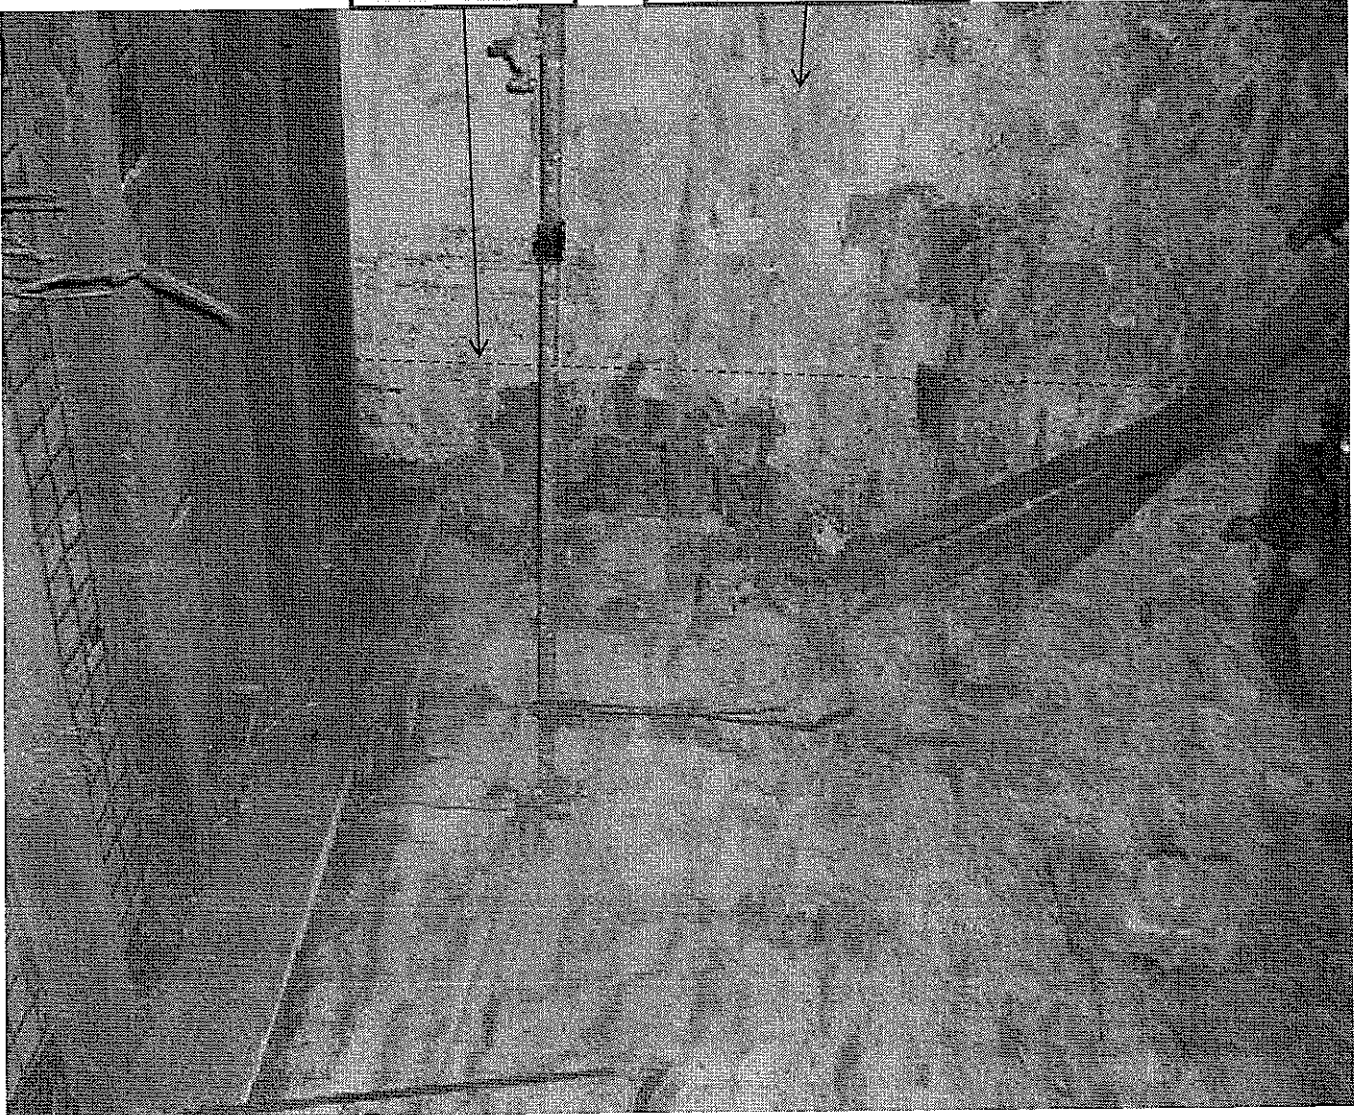
Photograph Twelve  
showing the North  
East corner of the  
barn and of the First  
Floor Construction

- 1.0.6 Internal Survey. The earth and concrete Ground Floor of the barn interior is currently not fit for purpose and will require replacement. The replacement with a concrete slab must include the usual perimeter slab thickening to support a new wall inner skin (*refer to Section 2.0*). Photograph Eleven shows that the portion of timber floor existing is in a reasonable condition structurally and may be used in the refurbishment if head height permits and if it can be incorporated in a proposed inner skin (*refer to Section 2.0*). The other section of flooring and dividing wall to the West of the main doorway is not fit for purpose, is not aiding the stability of the structure and may be demolished. Photograph Twelve calls attention to the fact that there is a return on the North Elevation to the party wall between the barn and a farmhouse (renovated) structure.

Approximate  
position of wall  
return

Party Wall with  
farmhouse
