**BAILEY HALL BARN,
HURST GREEN,
CLITHEROE
LANCASHIRE**

REPORT

on an appraisal of the structural condition of the Barn and surrounding outbuildings at Bailey Hall, Hurst Green on behalf of:

20th April 2012

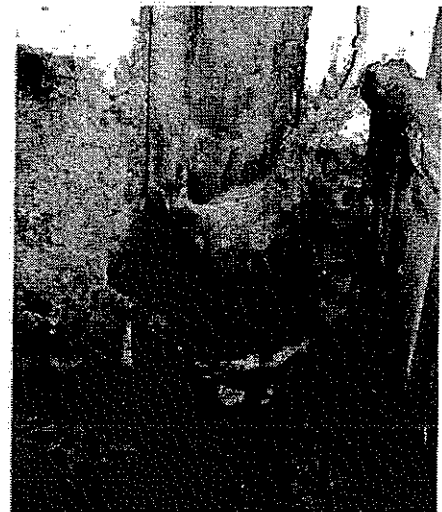
The foot of the blade on the east side of frame 2 has a marked slope down to the north. The stone plinth has been rendered with cement, or may have been replaced with concrete and there are no signs that the base has slipped sideways in the recent past. There are what appear to be two bolts in the face of the post and it is possible that it has been "bolted" back to the wall. Further investigation is required to ensure its continued stability.

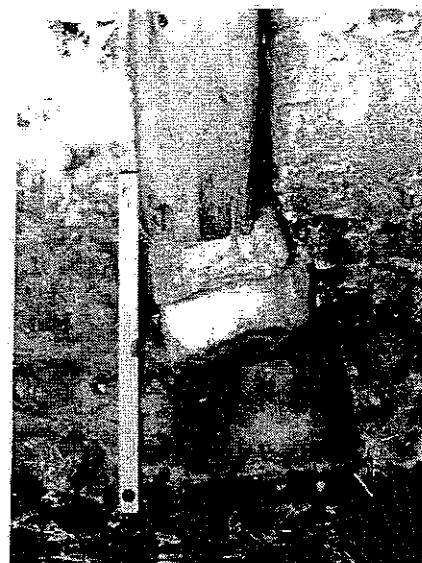
The plinth supporting the foot of the west blade of frame 4 has tilted over to the south by about 110mm, the timber projects beyond the stone by 25mm and the top stone has a slope of at least 80mm down to the south. There is a gap of 80mm between the timber and the wall to the north. The wall to the north follows the tilt of the plinth but there is a gap of 25mm between the two suggesting that there has been movement since the wall was built. There is no evidence of any recent movement but this situation is clearly not stable and strengthening works involving tying the timber / plinth back to the wall will be required.

The plinth supporting the west blade of frame 4 has tilted over to the south by about 110mm, the timber projects beyond the stone and the top stone of the plinth has a pronounced slope down to the south. There is a large gap between the timber and the wall to the north. The wall to the north follows the tilt of the plinth but a gap has developed between the two suggesting that there has been movement since the wall was built. There is no evidence of any recent movement but this situation is clearly not stable. Strengthening works involving tying the timber / plinth back to the wall with stainless steel rods resin anchored into the wall or propping the plinth / timber on the south side with timber / masonry will be required.
