**NORTH ELEVATION**

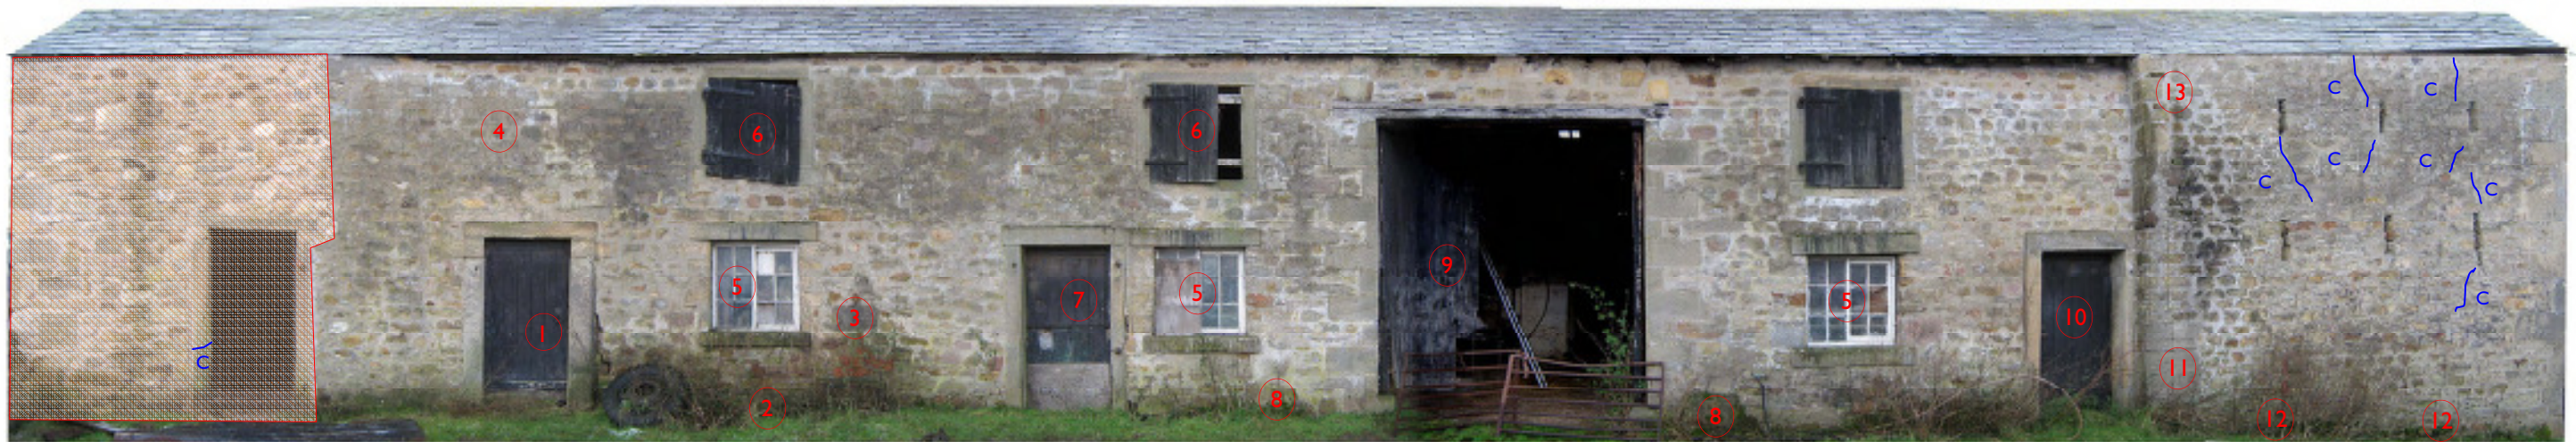
1. D2 timber boarded door. Decayed sections at head and base. RH stone jamb displaced
2. Stone pad and section of dwarf wall (phase I) to base of Truss II

3. delaminating (face bedded) stone and sections of later brick repairs.
4. 'slobbered' masonry—largely cementitious mortar across whole elevation
5. Yorkshire sliding sash window in poor condition—glazing bars and several panes of glass missing

6. Timber shutter in poor condition—displaced/missing boards, rusting iron hinges and fixings causing damage to stonework
7. Timber door in poor condition with plywood panel fixed at base. Damage to inner face of LH stone jamb from rusting iron fixing. RH jamb cracked in 2 places from rusting iron fixings

8. Stone pad to base of Truss III/IIII
9. timber doors in poor condition— sections of timber boarding missing/decayed
10. Timber door. Rusting iron fixings in RH stone jamb

11. Section of insitu concrete (at base of Truss V)
12. Ventilation slots infilled with brickwork
13. Open joints in masonry

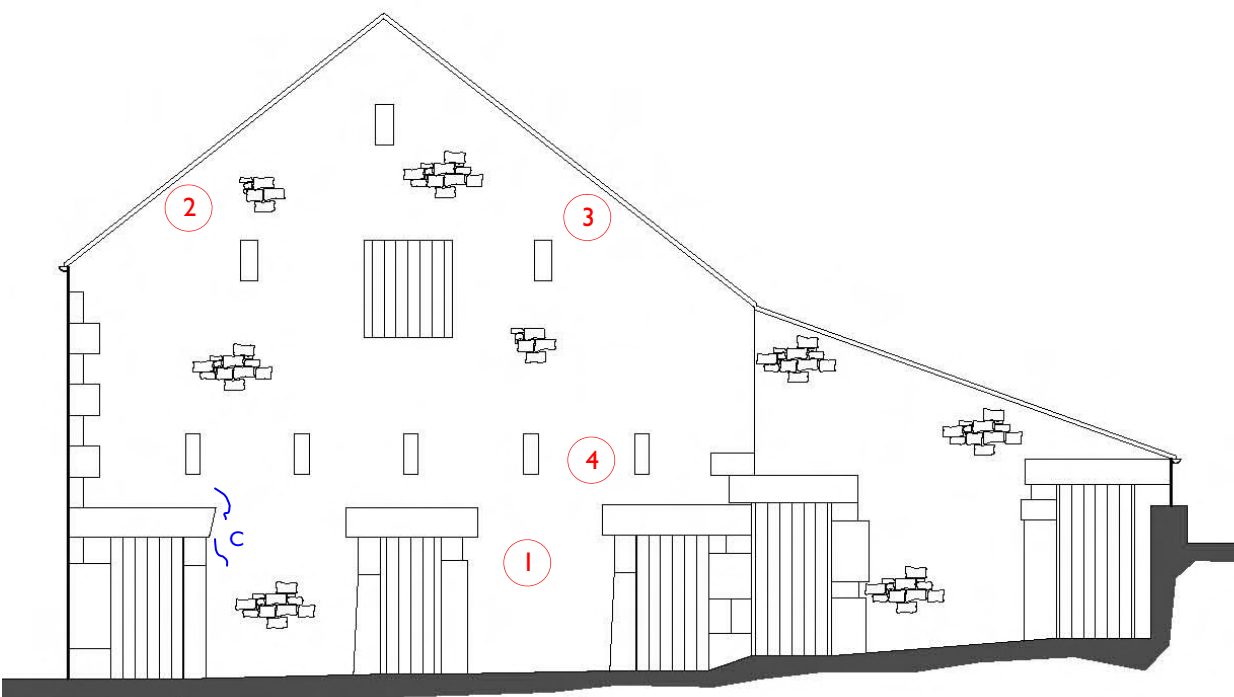
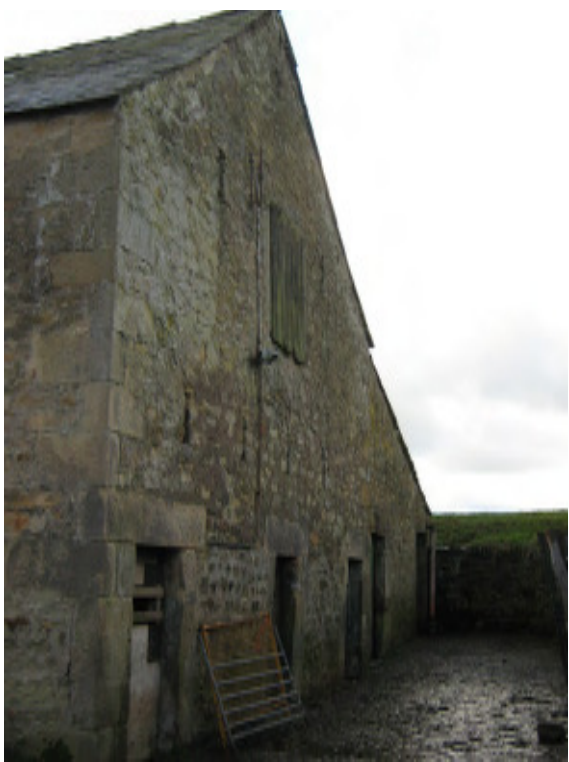
- c crack
1. Stonework roughly repointed with cementitious mortar
  2. Void in stonework– possibly associated with replacement of upper purlin to bay V
  3. End of timber purlin visible
  4. Ventilation slots infilled on inner leaf

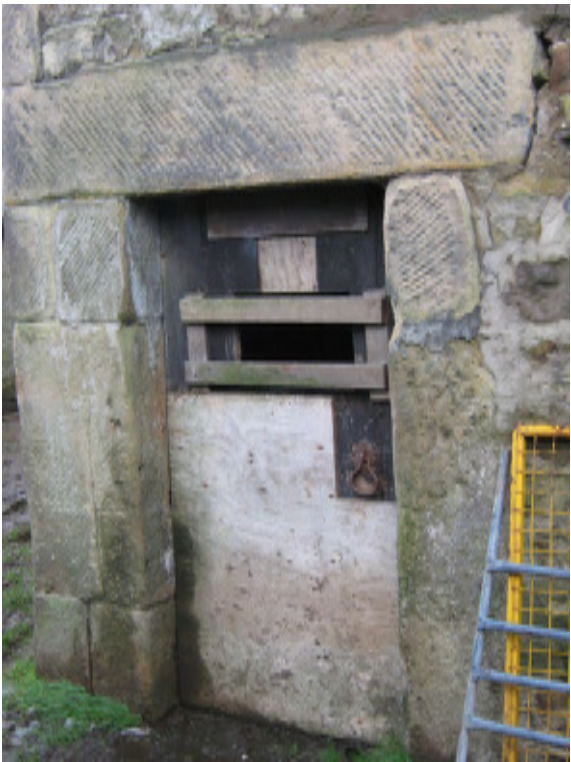
D6—timber door in poor condition

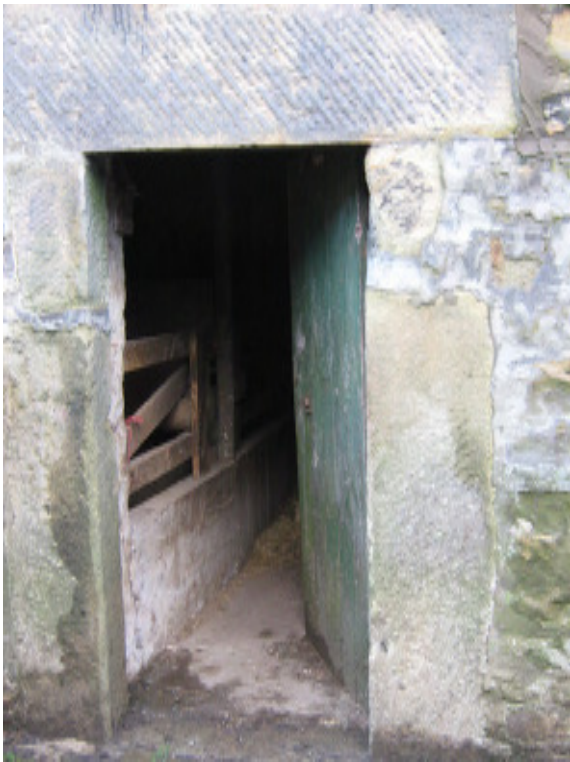
D7—timber door in poor condition/binds on floor

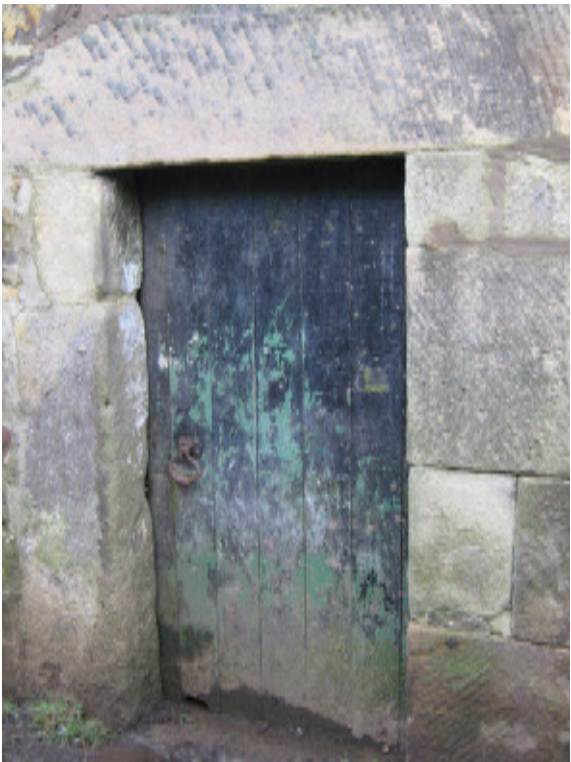
D8—areas of decay to timber

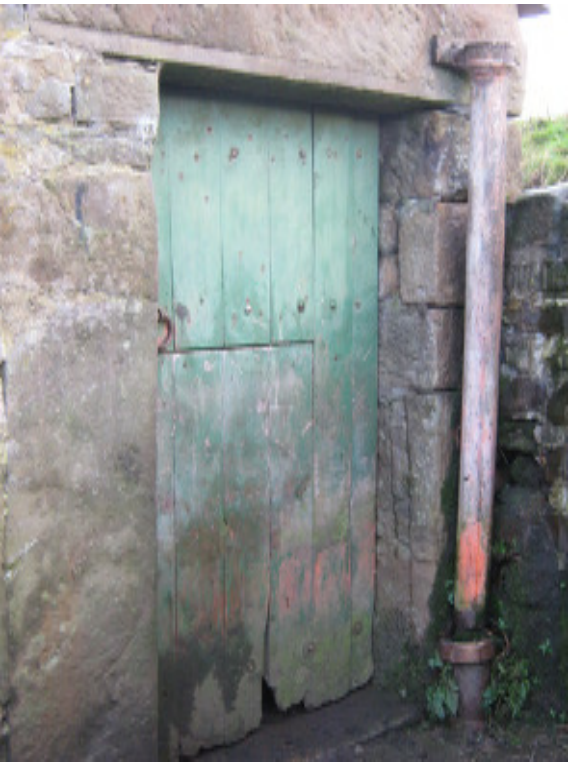
D10—base of door decayed

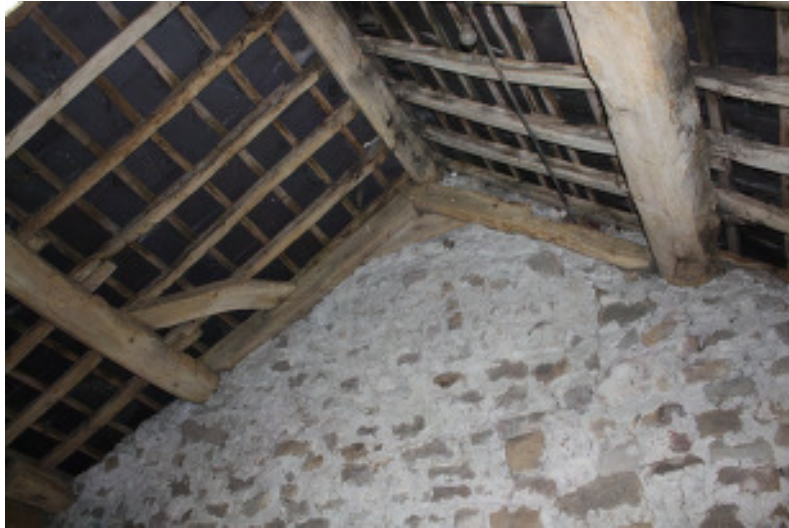
Re-set timber framing at apex of south wall to bay I

- Detailed inspection of trusses by Structural Engineer required.
- Evidence of insect infestation in trusses—probably historic.
- Several wind braces missing
- Tie beams sawn out.
- Wallplate evident on east elevation and section of wall post remains on east side of Truss II

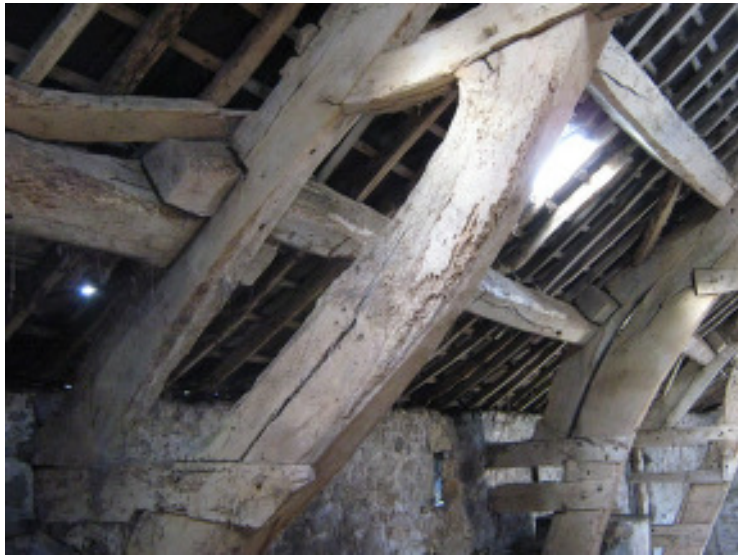
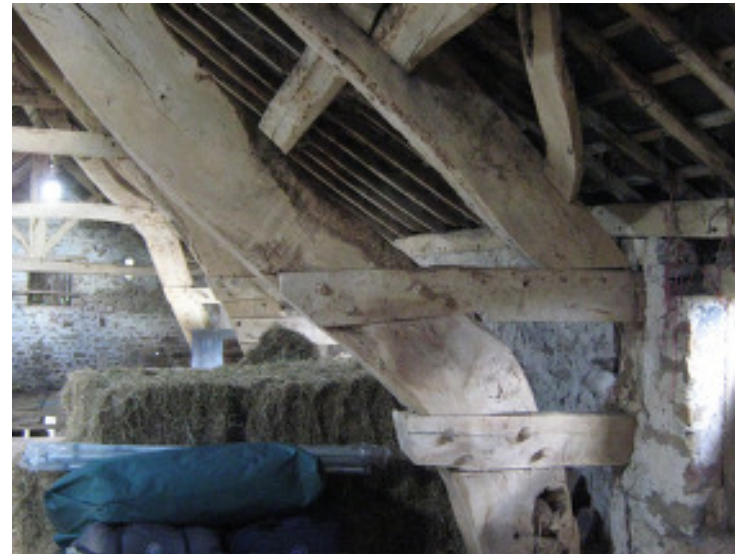
Truss II—note displaced windbrace on west side; section of wall post and wall plate on east side

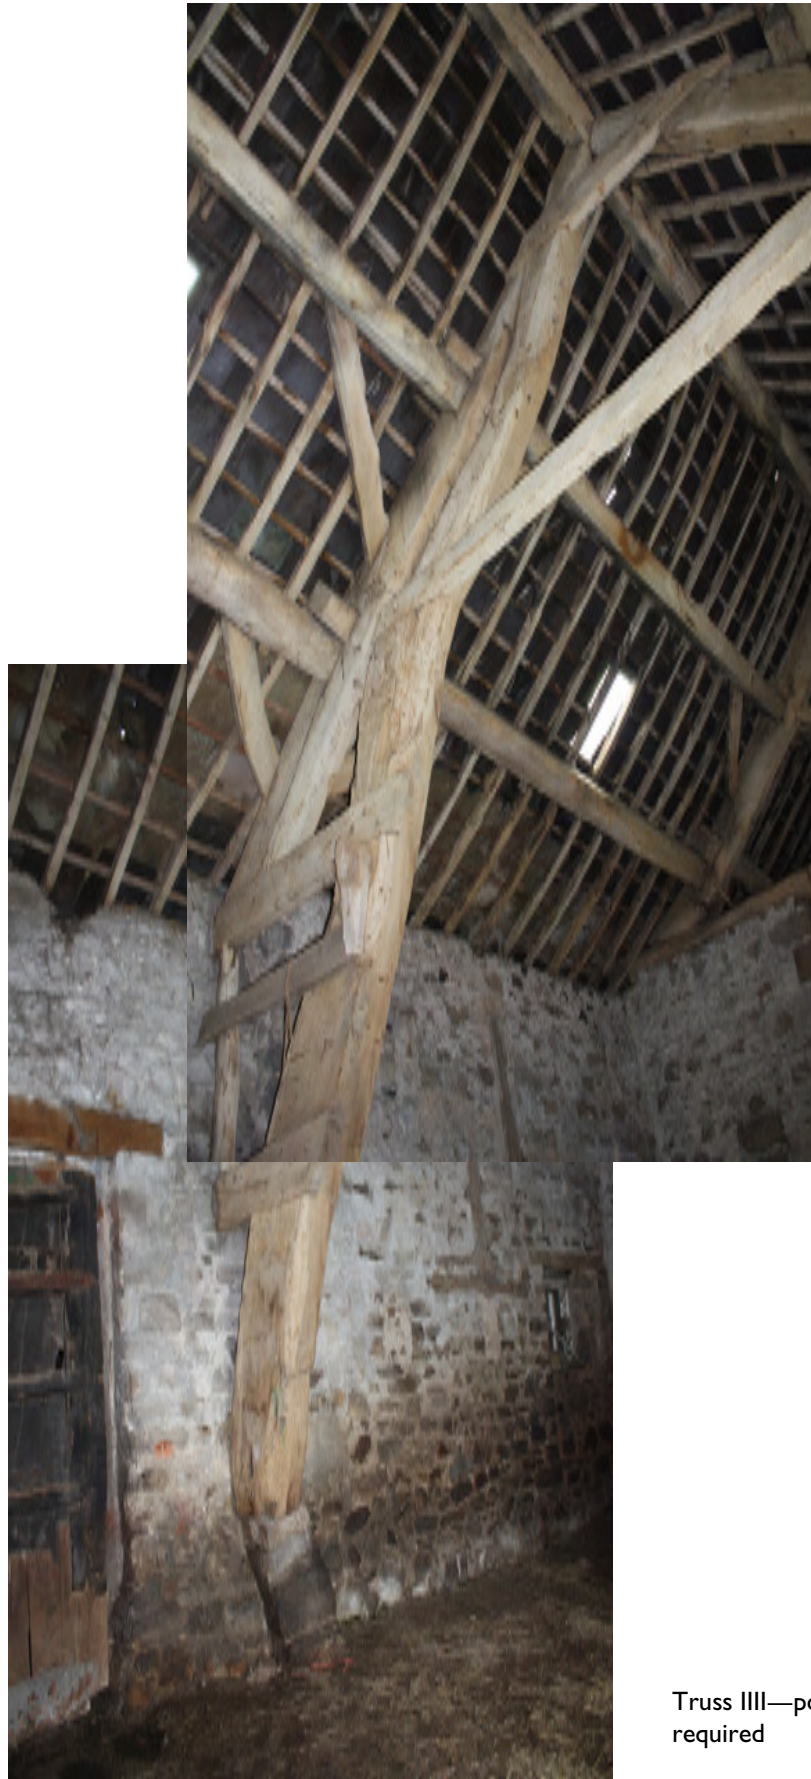
Truss IIII—possible lateral displacement—further investigation by structural engineer required

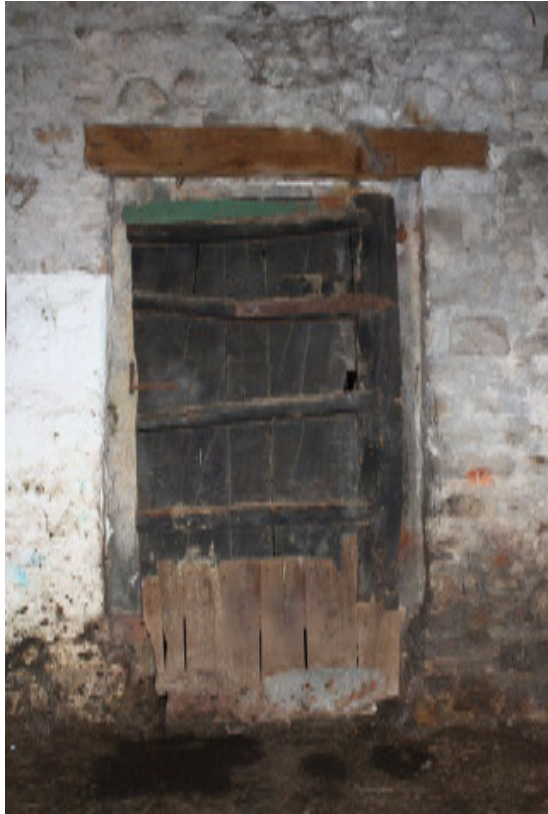
D12—base of door decayed and boards fixed to face of door

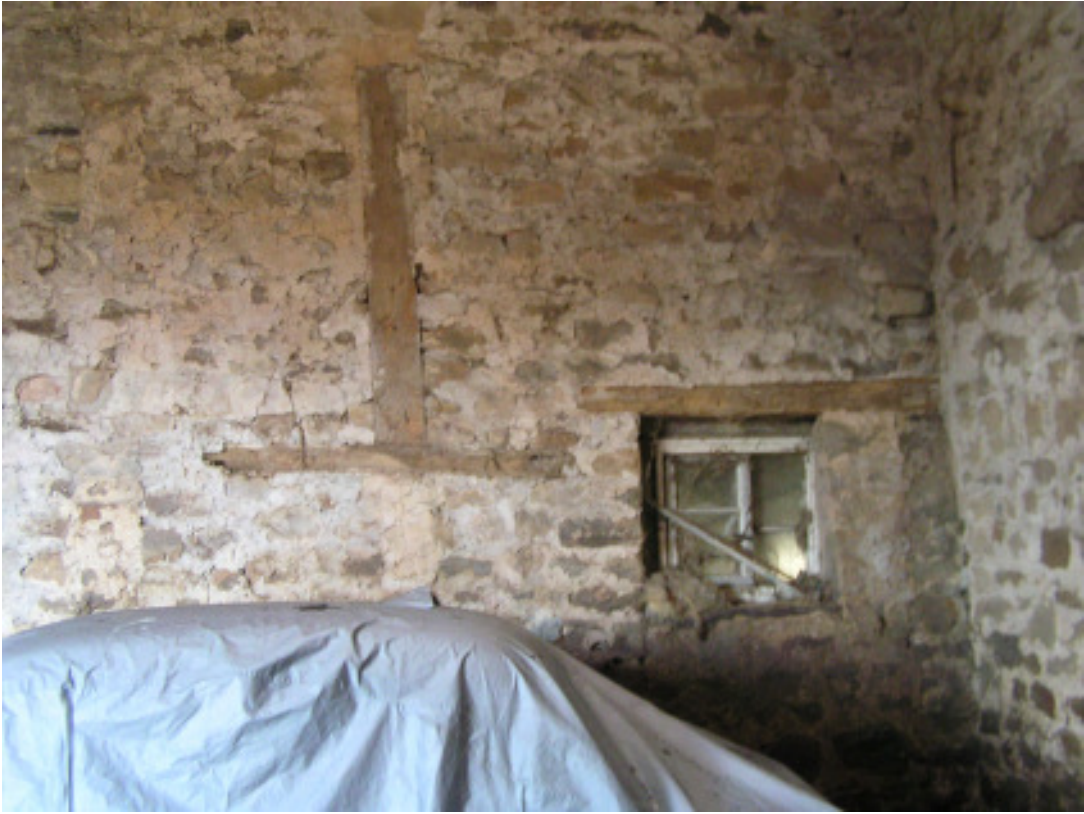
Re-set timber framing and window in west wall of Bay 4

- Detailed inspection of trusses by Structural Engineer required.
- Evidence of insect infestation in timber framing—probably historic.
- Detailed inspection of all embedded timbers in walls required

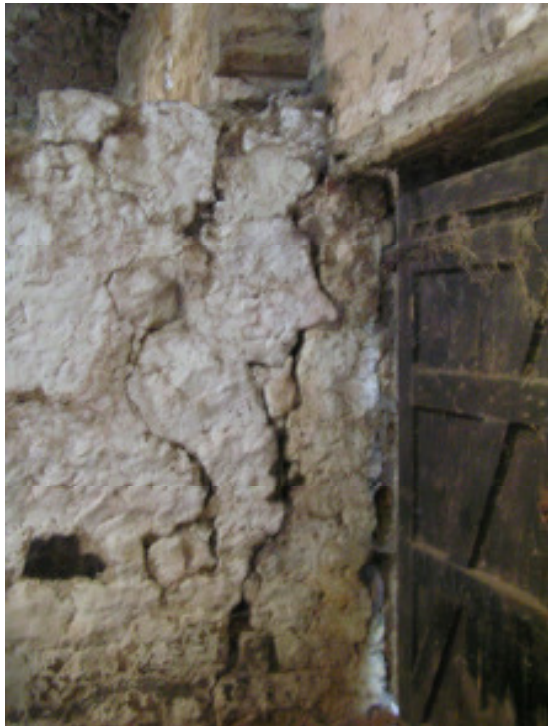
Evidence of movement cracks at east end of wall below Truss V

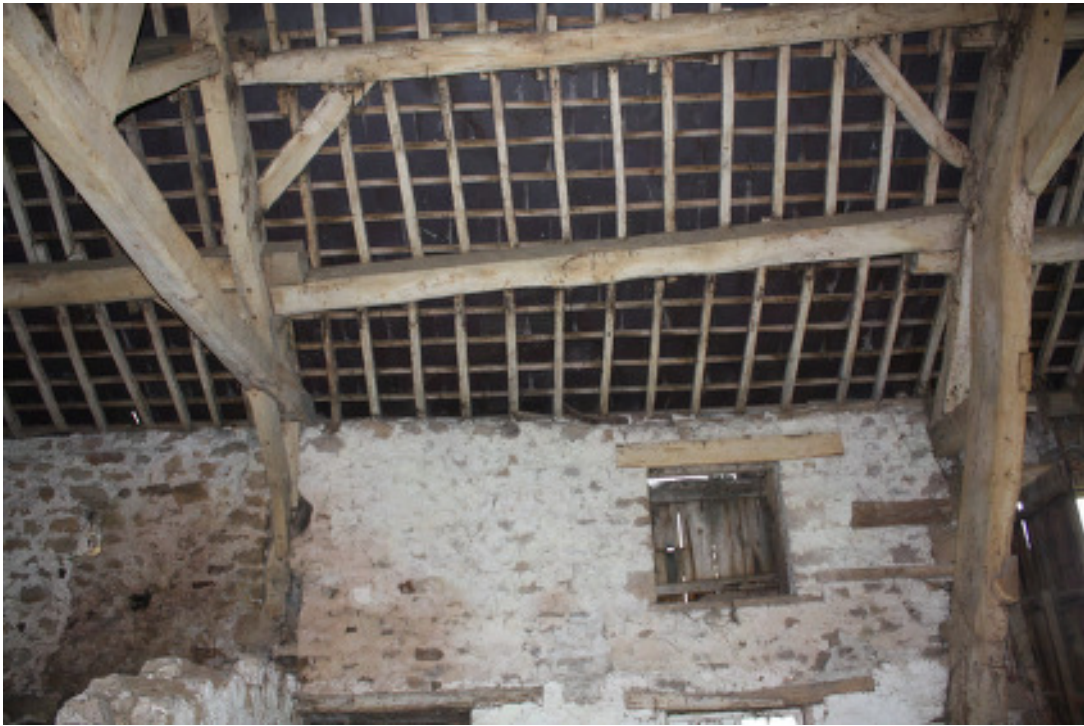
Timber lintols to inner face of openings in east wall. Note wall post and brace below Truss V

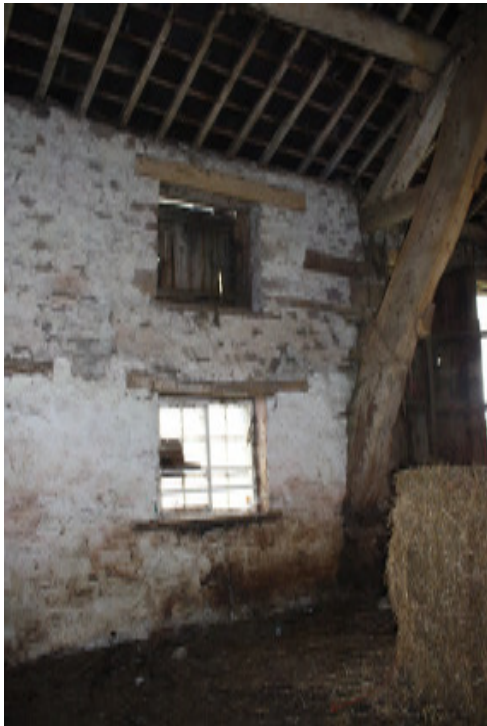
East wall—Window openings with timber lintols above

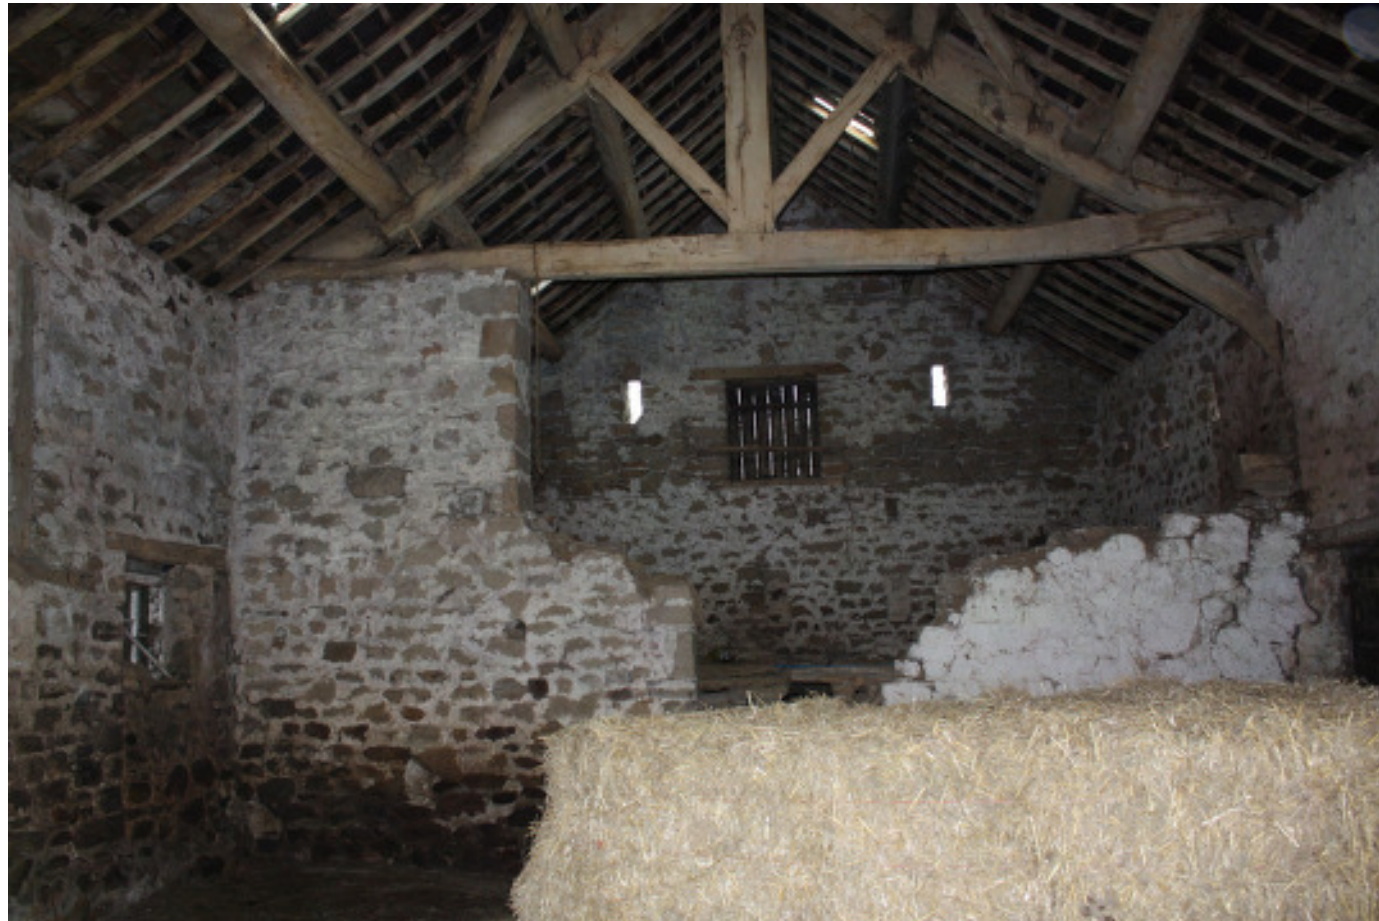
Note cracks in wall at east end below Truss V

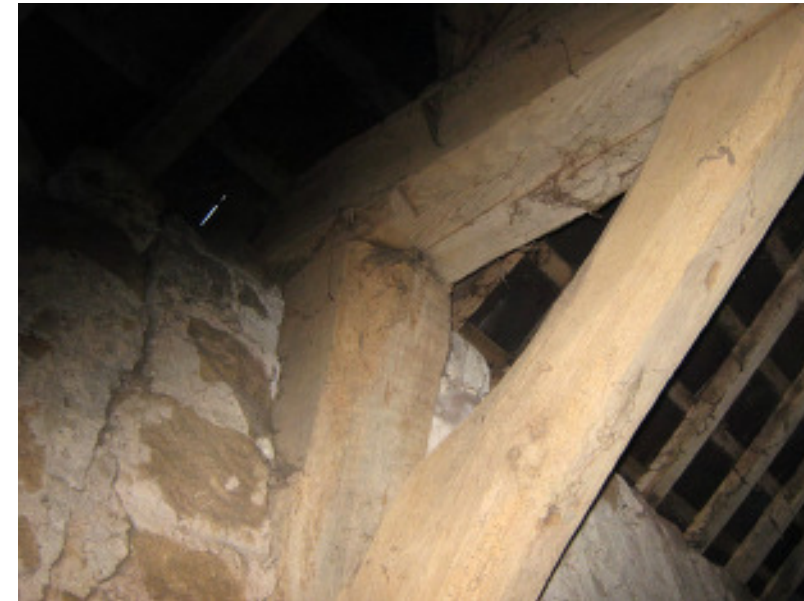
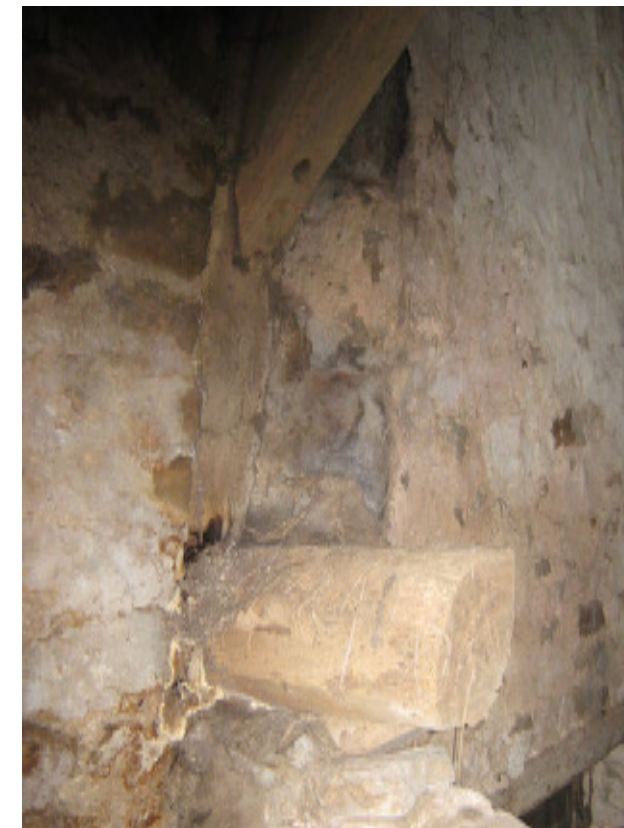
Wall post, brace and sawn off tie to underside of east end of Truss V. Note decay to base of wall post.

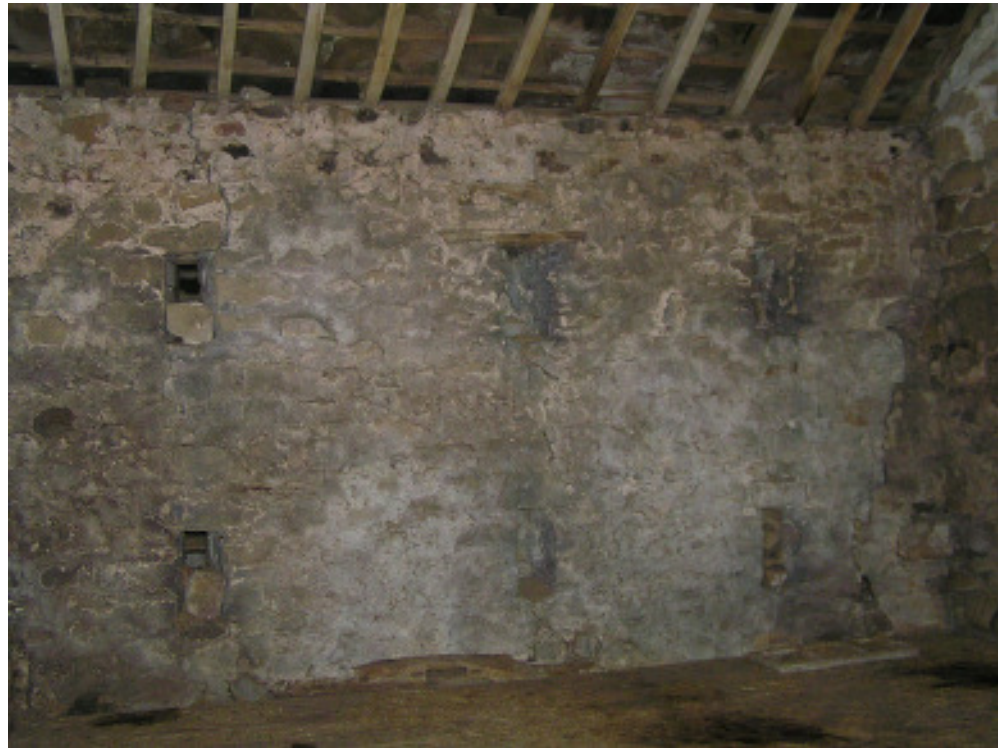
West wall above hay loft—cracks evident in various locations

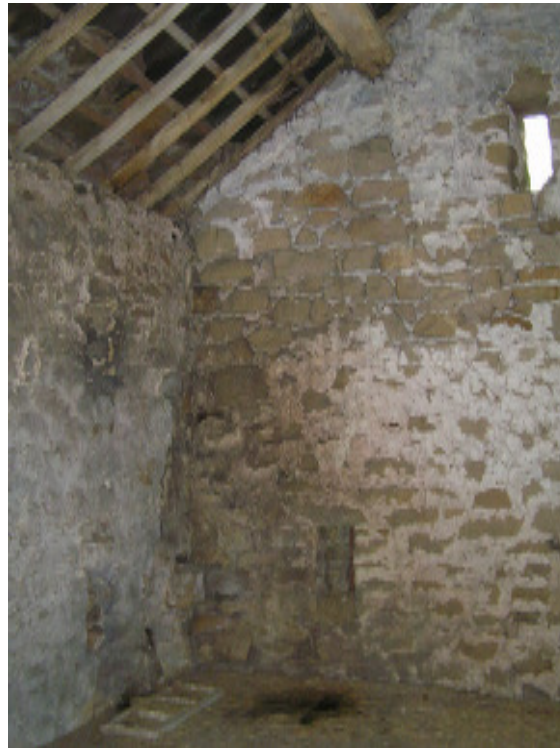
NW corner above hay loft—cracks evident in various locations

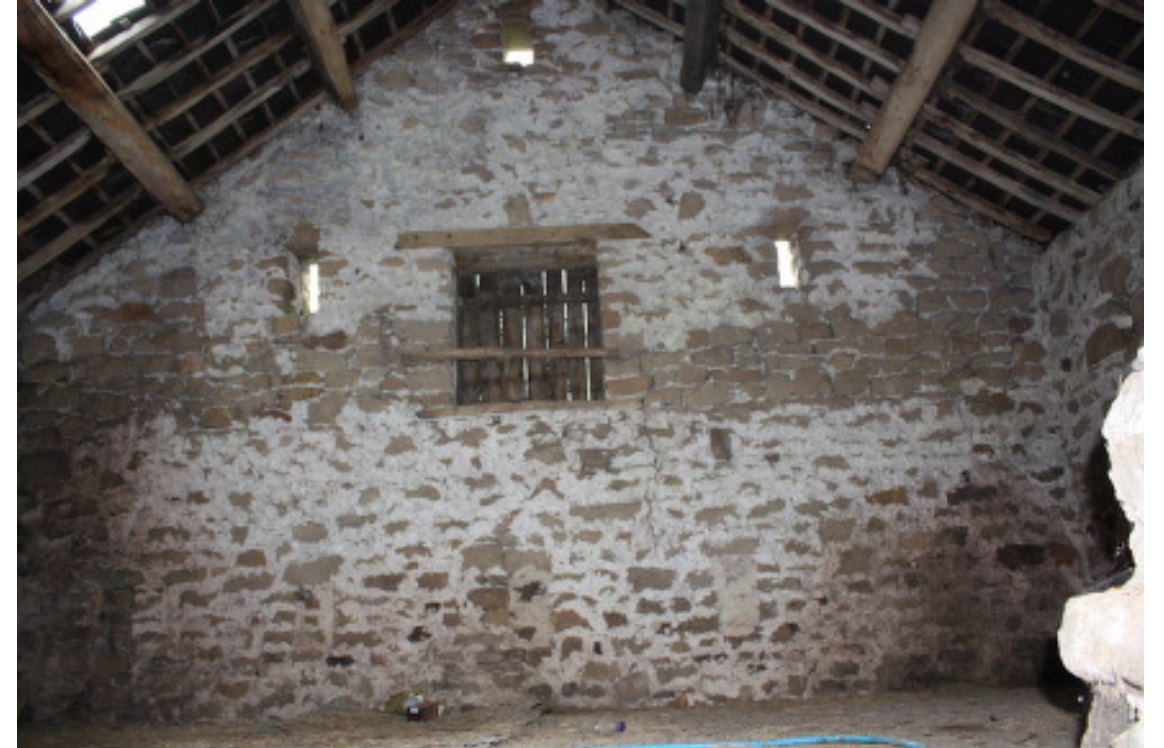
North wall above hay loft—cracks evident in various locations and substantial 'displacement' evident in gable wall. Note blocked ventilation slots above floor level

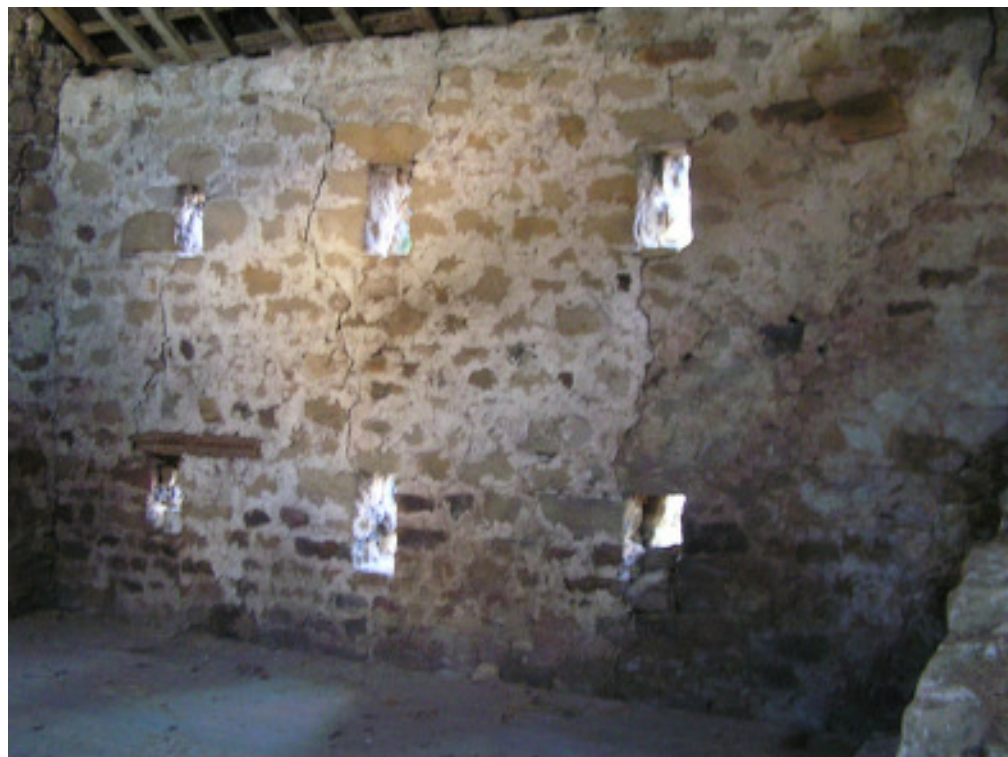
East wall above hay loft—cracks evident in various locations (also visible externally)

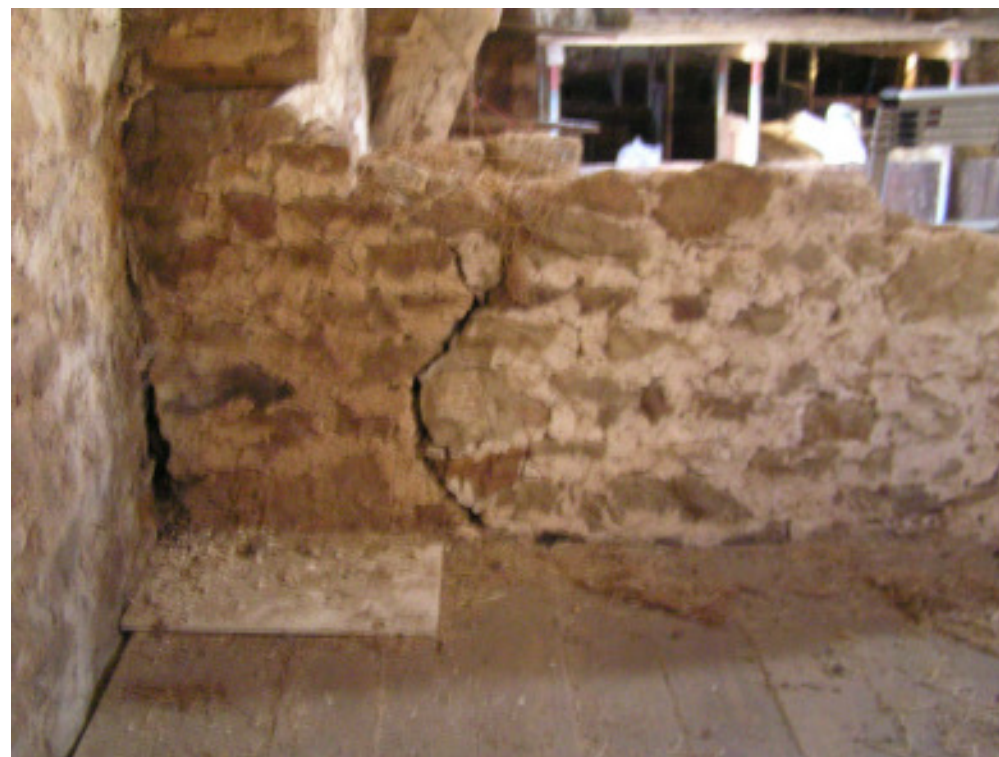
East end of wall below Truss V (north side)—cracks evident in on both faces of wall

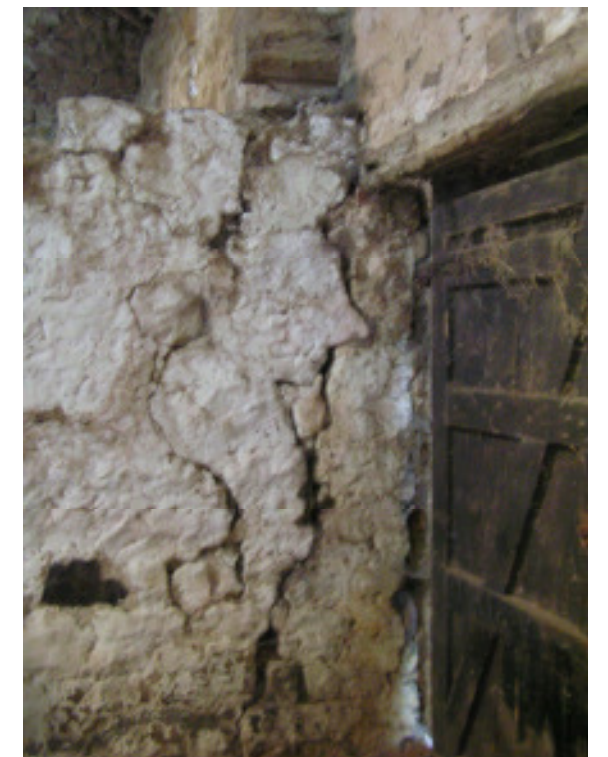
East end of wall below Truss V (south side)—cracks evident in on both faces of wall

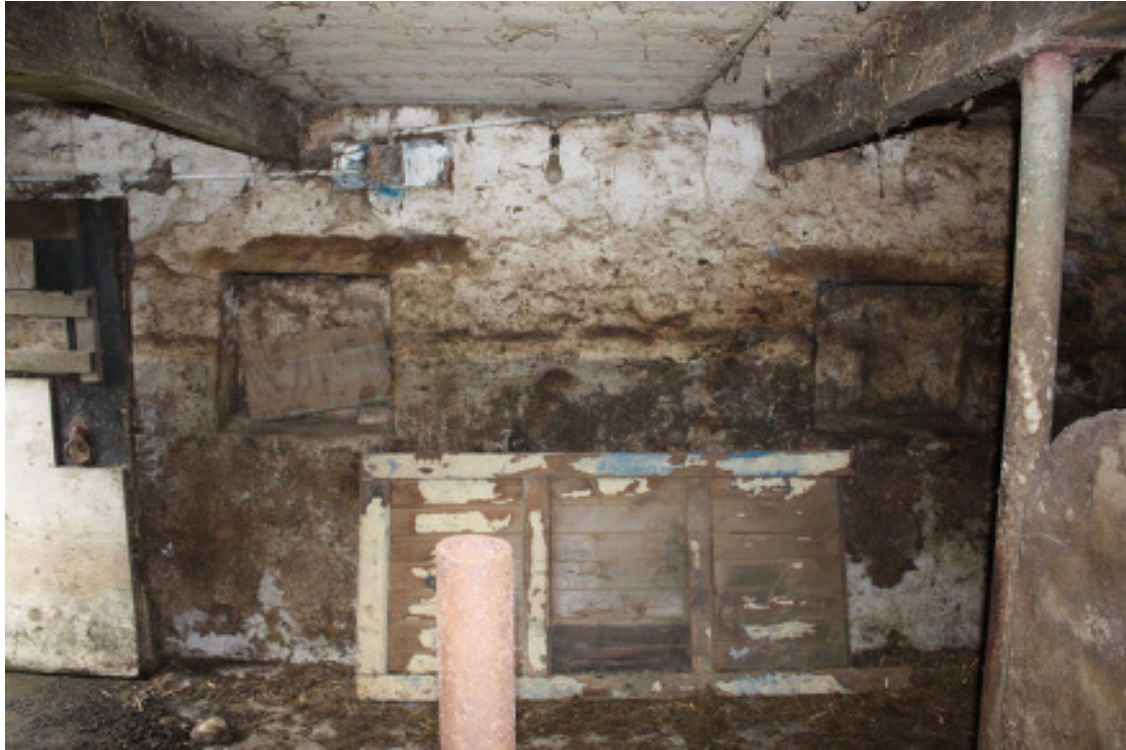
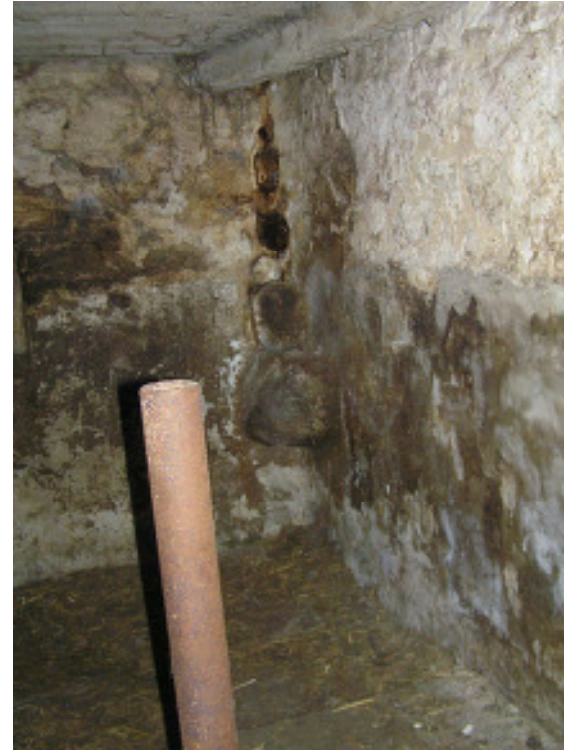
East wall. Note recesses and raised stone pad in SE corner. Roughly plastered walls in poor condition. Concrete floor

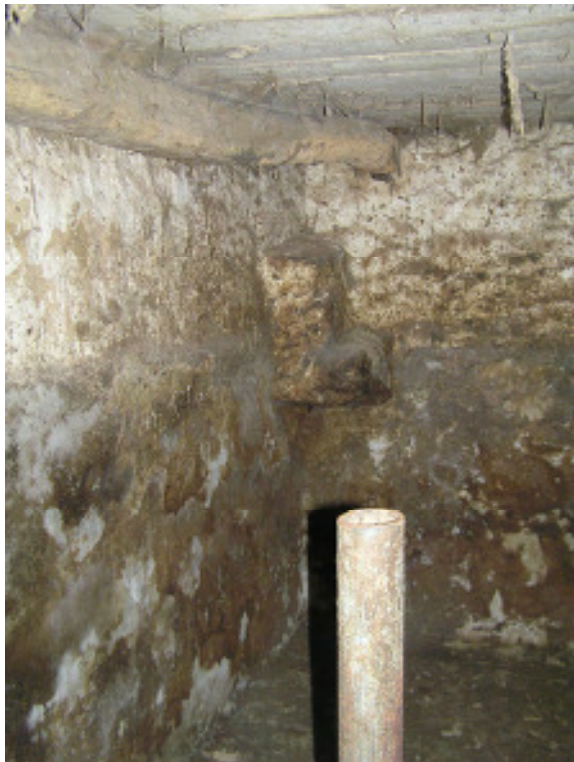
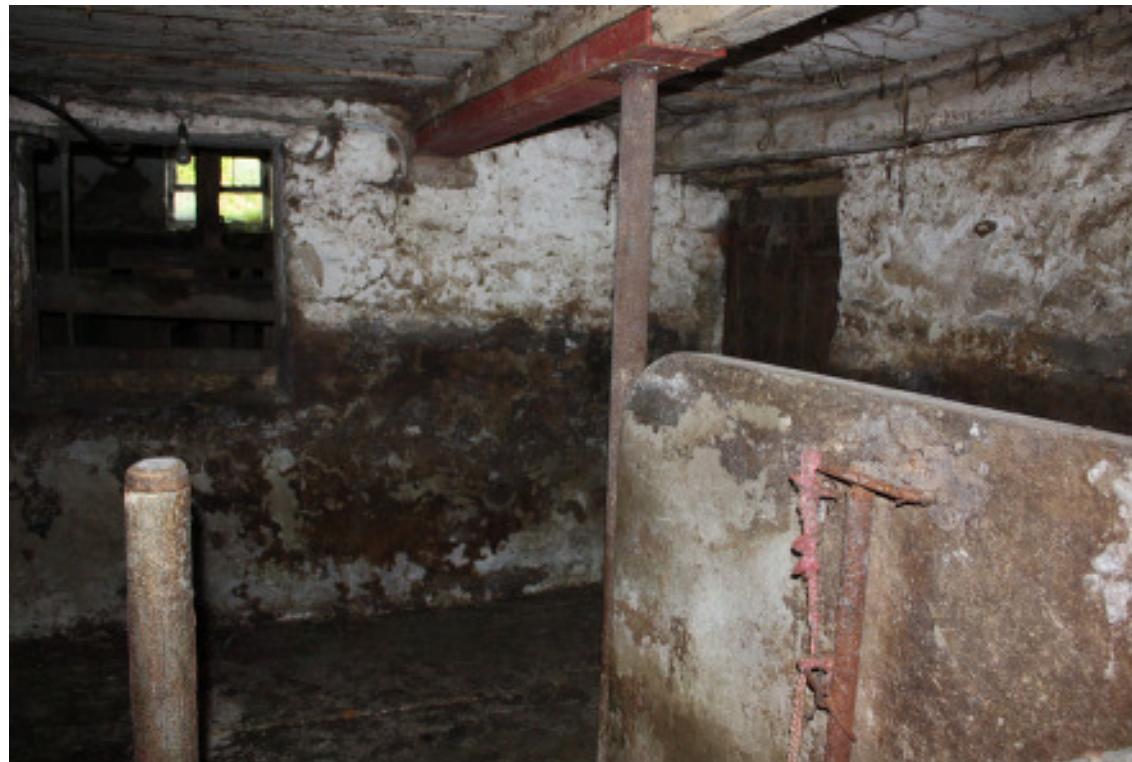
West wall. Roughly plastered walls in poor condition

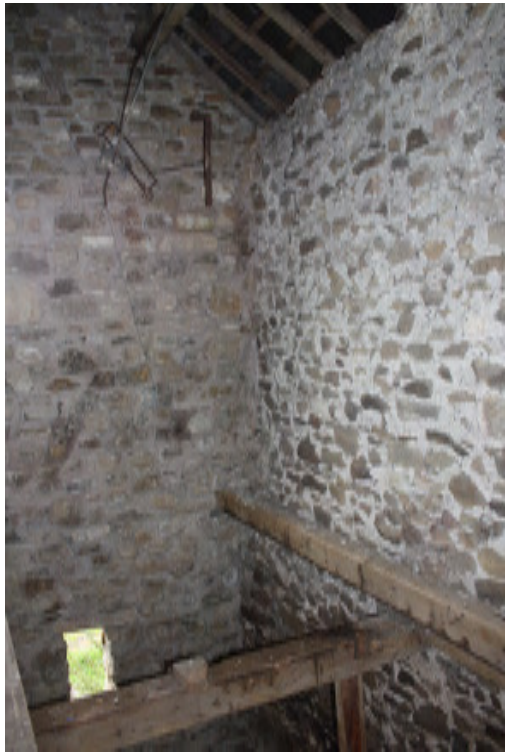
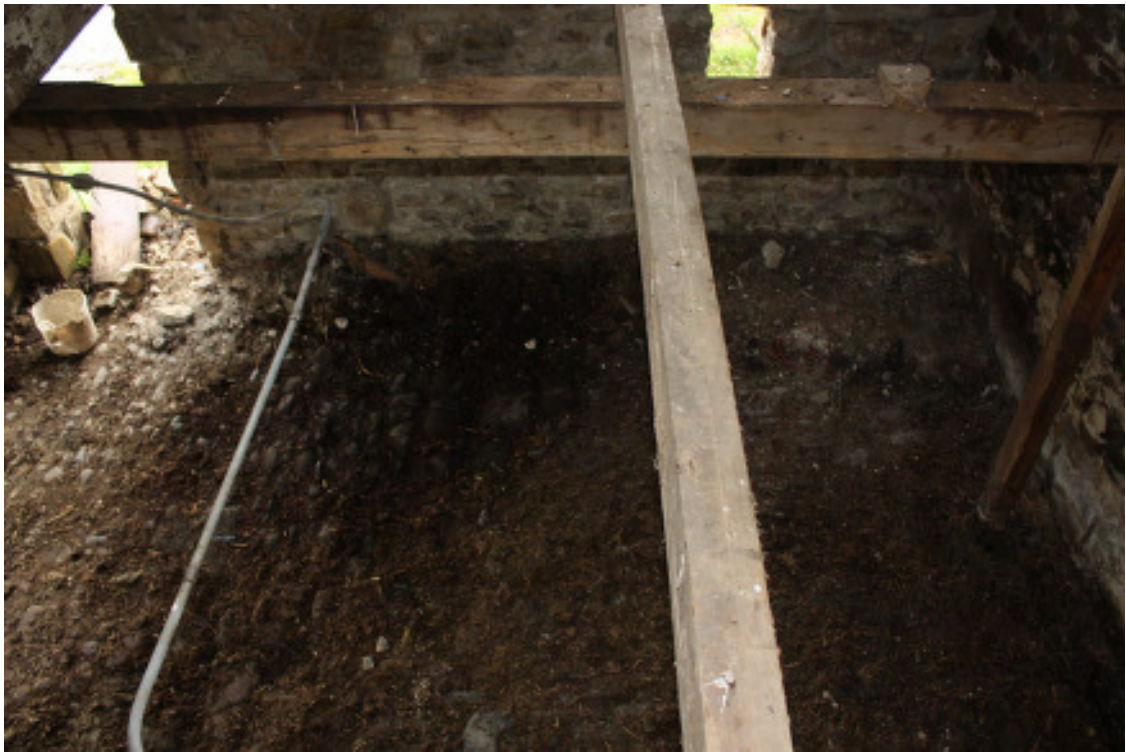
South Bay (shed) - Note stone setts to floor. South and east walls re-built late 2010. Reclaimed floor beams at first floor level

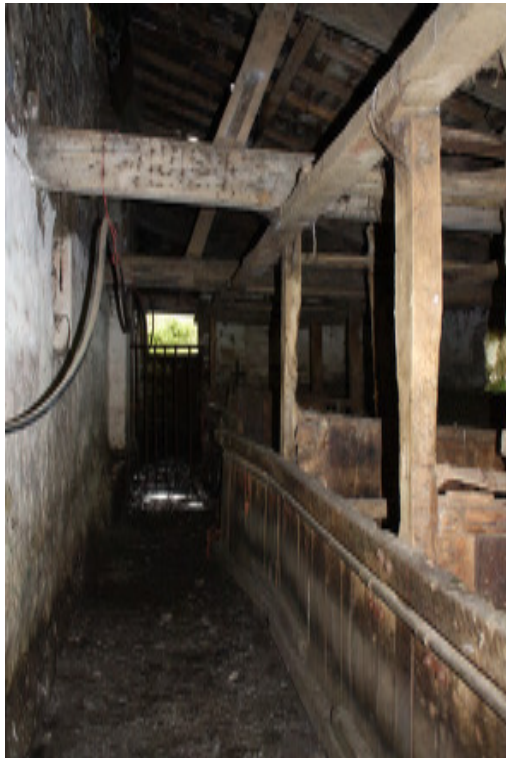
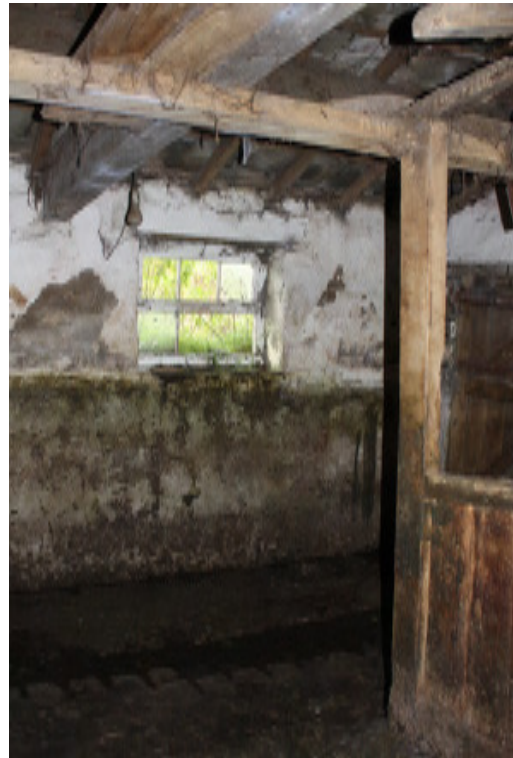
West Bay (shippon) - concrete floor. Timber windows in poor condition. Roughly plastered/painted walls in poor condition due to moisture penetration through (retaining) wall

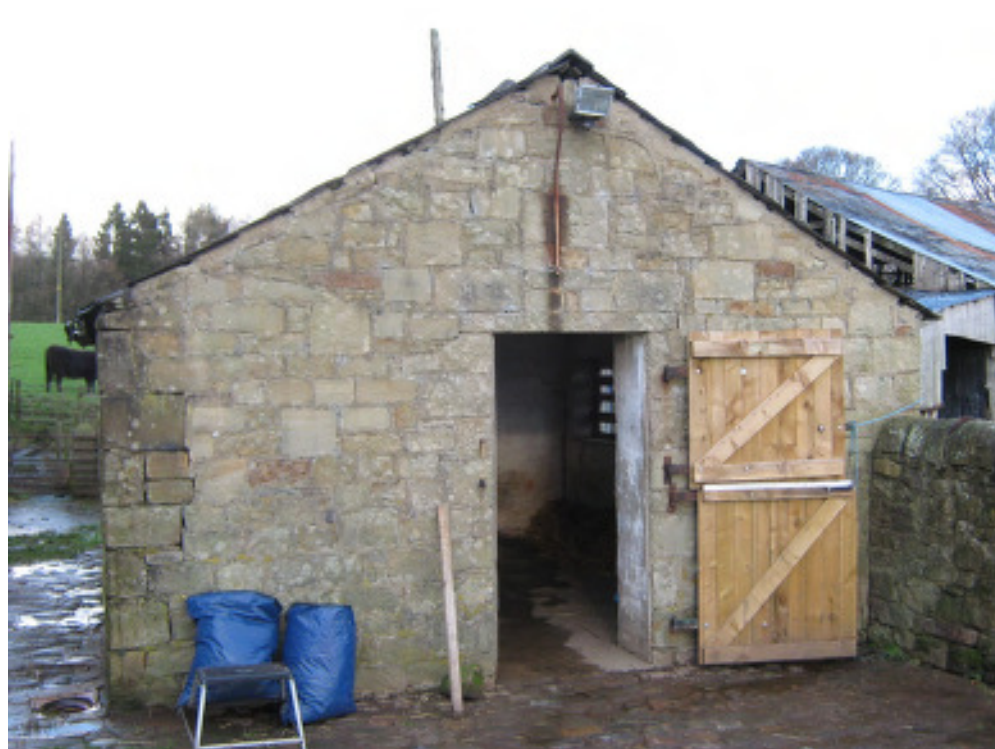
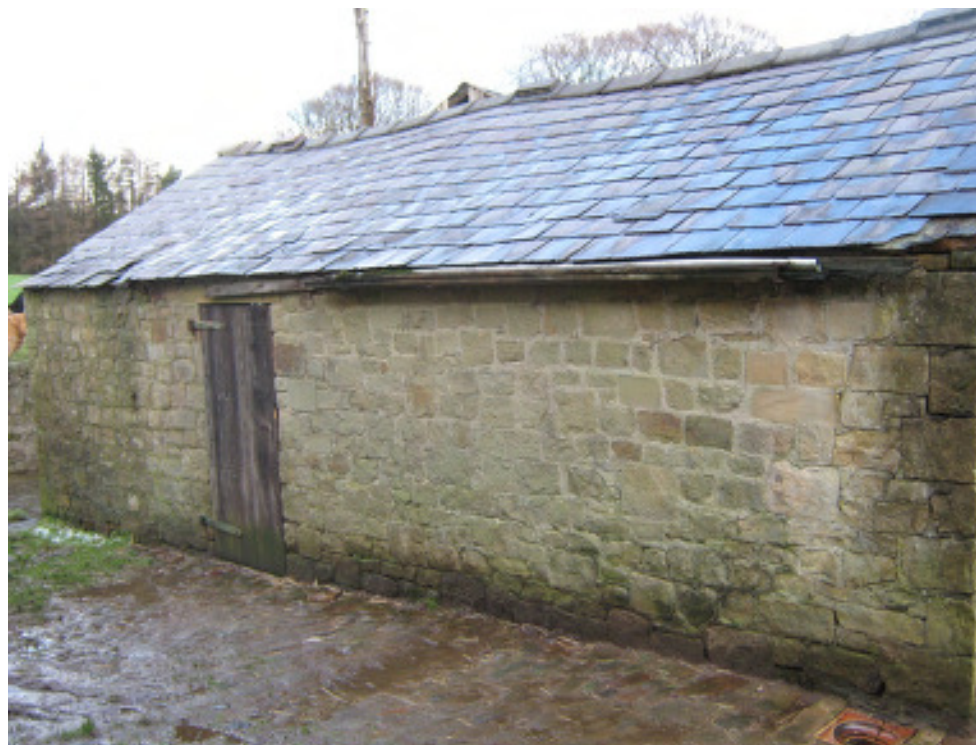
Stores - roof in poor condition with slipped slates and missing sections of gutter. Open joints to stonework
