**NORTH ELEVATION**

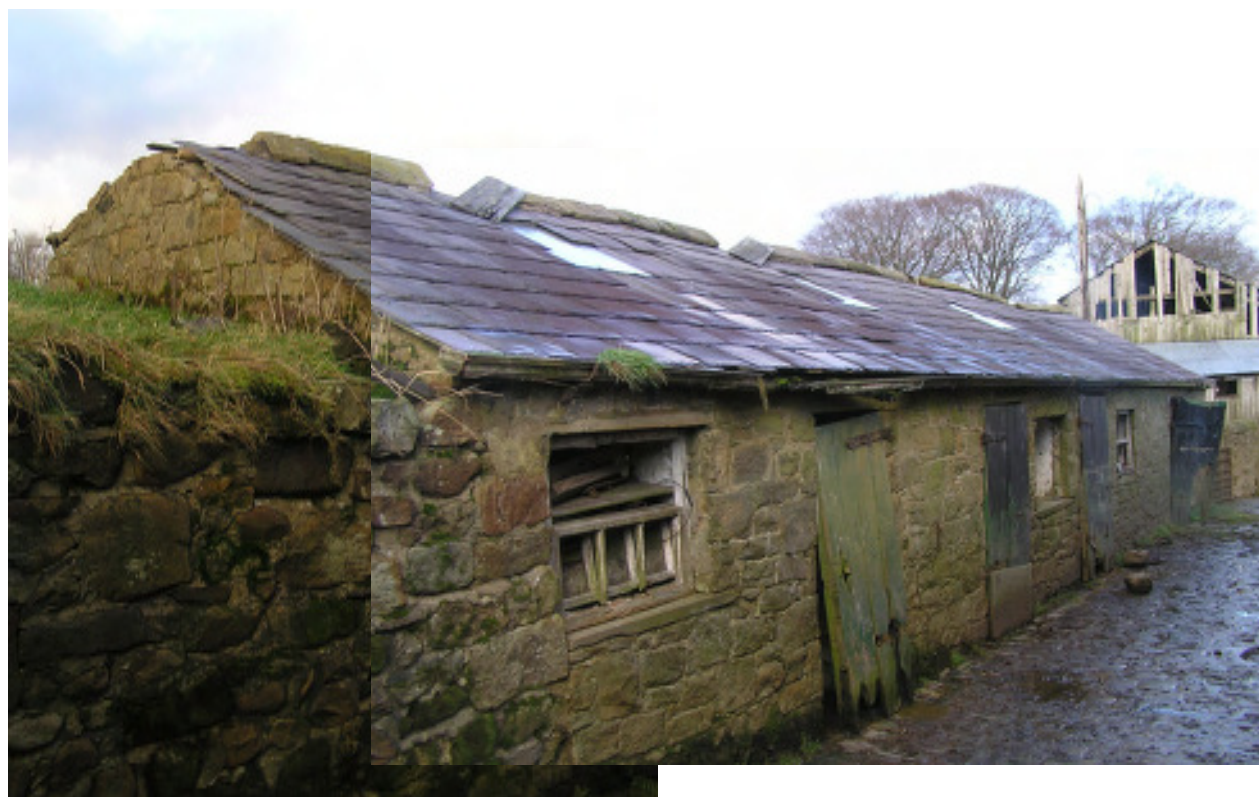
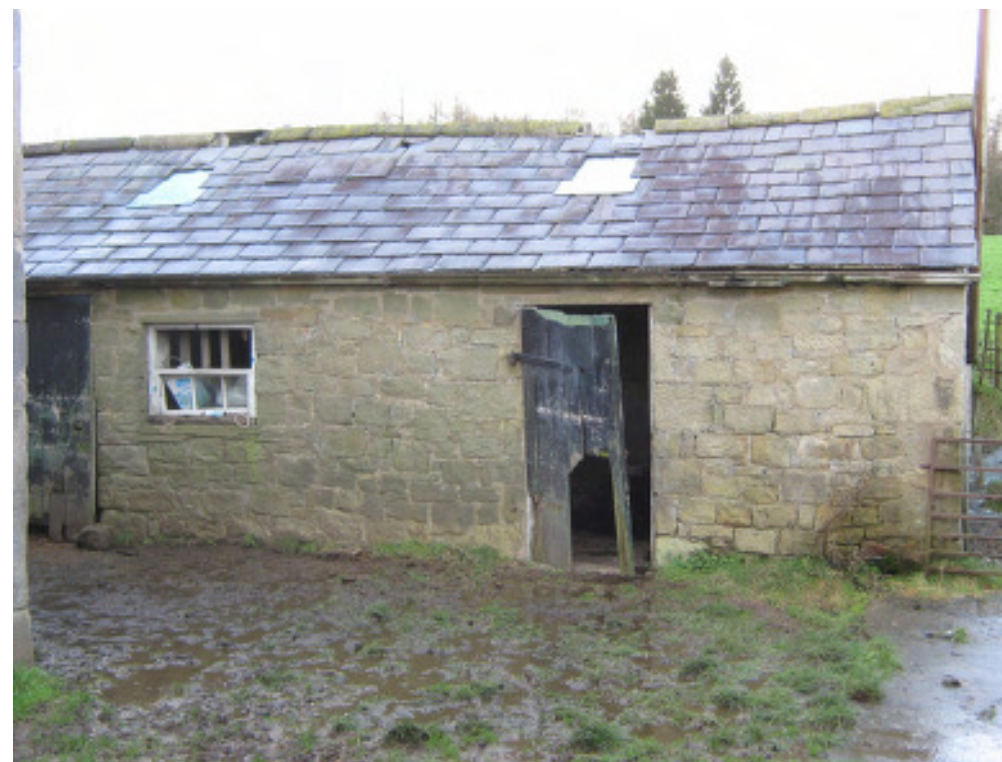
Calf house - roof in poor condition with missing ridge tiles, slate and sections of gutter. Doors and windows in poor condition with extensive areas of decay.
