**BAILEY HALL BARN,  
HURST GREEN,  
CLITHEROE  
LANCASHIRE**

## **REPORT**

on an appraisal of the structural condition of the Barn and  
surrounding outbuildings at Bailey Hall, Hurst Green on behalf of:

20<sup>th</sup> April 2012

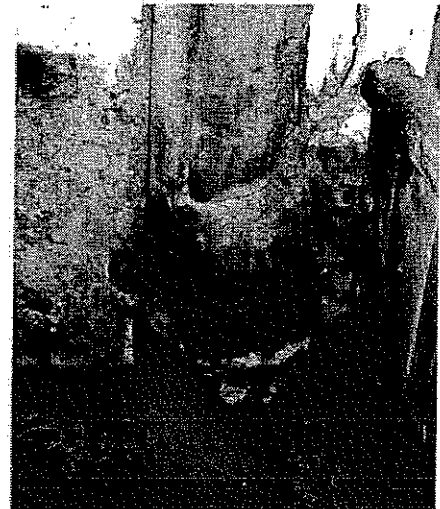
The foot of the blade on the east side of frame 2 has a marked slope down to the north. The stone plinth has been rendered with cement, or may have been replaced with concrete and there are no signs that the base has slipped sideways in the recent past. There are what appear to be two bolts in the face of the post and it is possible that it has been "bolted" back to the wall. Further investigation is required to ensure its continued stability.

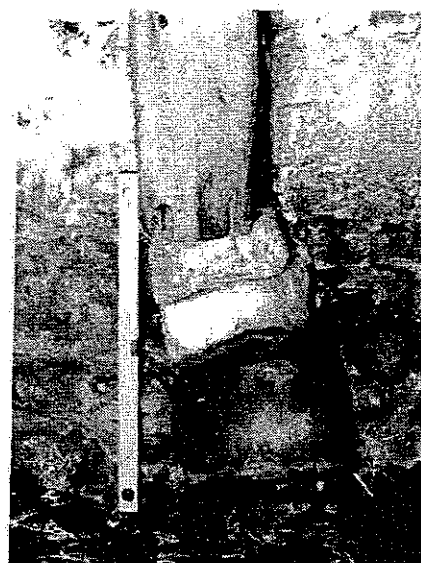
The plinth supporting the foot of the west blade of frame 4 has tilted over to the south by about 110mm, the timber projects beyond the stone by 25mm and the top stone has a slope of at least 80mm down to the south. There is a gap of 80mm between the timber and the wall to the north. The wall to the north follows the tilt of the plinth but there is a gap of 25mm between the two suggesting that there has been movement since the wall was built. There is no evidence of any recent movement but this situation is clearly not stable and strengthening works involving tying the timber / plinth back to the wall will be required.

The plinth supporting the west blade of frame 4 has tilted over to the south by about 110mm, the timber projects beyond the stone and the top stone of the plinth has a pronounced slope down to the south. There is a large gap between the timber and the wall to the north. The wall to the north follows the tilt of the plinth but a gap has developed between the two suggesting that there has been movement since the wall was built. There is no evidence of any recent movement but this situation is clearly not stable. Strengthening works involving tying the timber / plinth back to the wall with stainless steel rods resin anchored into the wall or propping the plinth / timber on the south side with timber / masonry will be required.

The other three plinths appear to be reasonably plumb and stable, though the cruck blades are not vertical (see section 2.9). In view of the condition of the others though it makes sense to treat them all similarly and ensure that they are well restrained.
