Application for Planning Permission. Town and Country Planning Act 1990

3. Description	of the Proposal	·			
Please describe the	e proposed development including any change of use:				
Conversion of barn	into two dwellings, creation of curtilages and installation of new pa	ackage treatement plan	nt.		
Has the building v	vork or change of use already started? Yes	No

Proposed Conversion of Ancillary Agricultural Building at Windy Hill Farm, Chipping Structural Appraisal Report

320120639 P WILDLIFE SURVEY FOR BATS AND OWLS

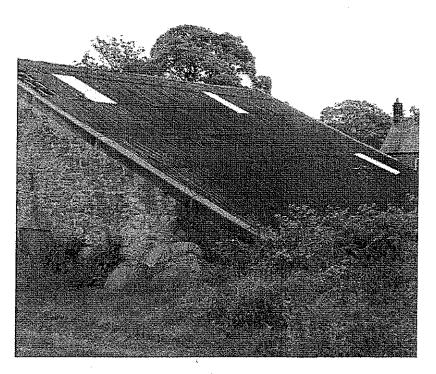
Plate 2 – Undulating roof finishes to rear pitch

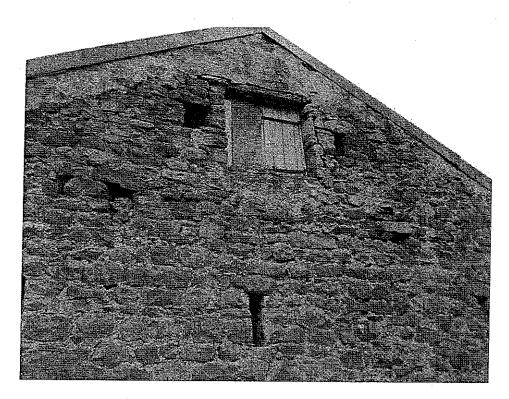
Evidence of historic weathering of the facade is clearly visible, particularly at the apex resulting in spalled mortar beds and perpends (Plate 03), and adjacent to its junction with the rear elevation, obvious water ingress and 'staining' (Plate 04)

Plate 3 – Weathered mortar to North gable apex

- 3.0.1.6 Again, not of structural significance, we would recommend that in the interests of durability, all elevations of the proposed refurbished structures are re-pointed with respect to mortar beds and perpends.

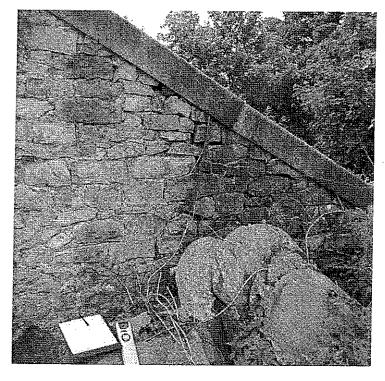
Plate 4 – Damp 'staining'

Whilst not of structural concern, we would recommend a "damp" survey be undertaken to all masonry elevations within the proposed area of refurbishment. If as expected, the level of the moisture within the wall elevations is excessive, remedial treatment solutions should be considered if necessary, particularly as proposals necessitate the 'physical connection/tie' to a blockwork lining wall

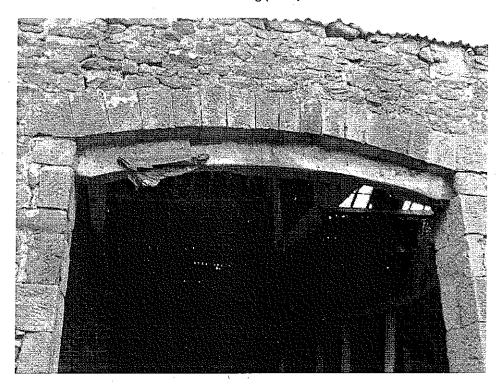
Plate 6 – Timber lintel beneath masonry arch

Additionally, we would recommend the replacement of all existing timber lintel members with suitably designed prestressed concrete replacement lintel members.

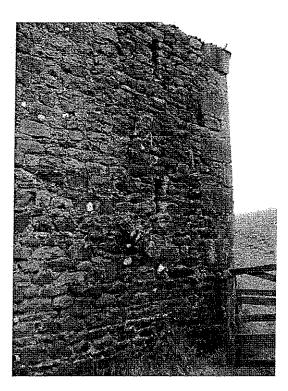
The elevation exhibits evidence of weathering, both in the appearance of mortar spalling and obvious remedial re-pointing works. Additionally, at its junction with the north gable elevation, the facade exhibits obvious water ingress staining, with vegetative growth (Plate 07).

Plate 7 – Water staining and vegetation growth

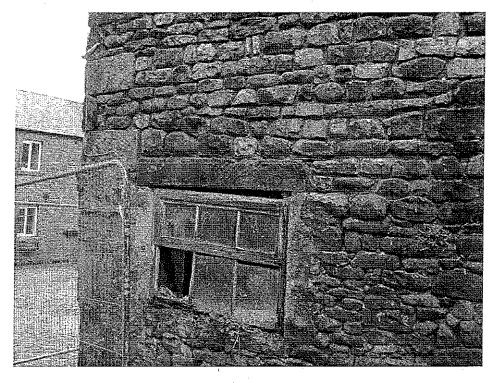
Historic movement of the elevation is noted The window opening situated adjacent to the south facing gable junction has 'dropped' at its north bearing (Plate 08). The elevation

Plate 8 – Lintel bearing movement

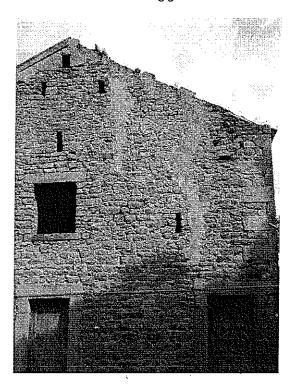
Two parallel, vertical cracks have been the subject of extensive mortar filling, emanating from eaves level of the front roof pitch to mid and ground floor door opening head height (Plate 10). Further cracking has also been subjected to a similar remedial process at the junction of the postulated 'Shippon' extension and the 'original' structure (Plate 11).

Plate 10 – 'Re-pointed' masonry cracking

Where vertical cracking is noted within the external and internal facade of the south facing gable elevation, remedial crack 'stitching' is required. The remedial works should take the form of helical reinforcement bars ('Twistfix' or approved equal) placed across the vertical crack location in accordance with the manufacturers guidance.

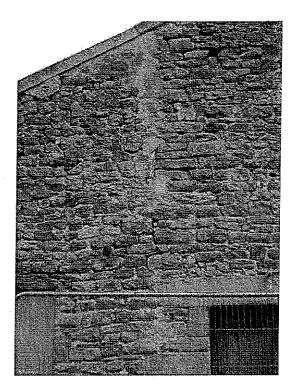
Plate 11 – 'Re-pointed' masonry cracking ('Shippon')

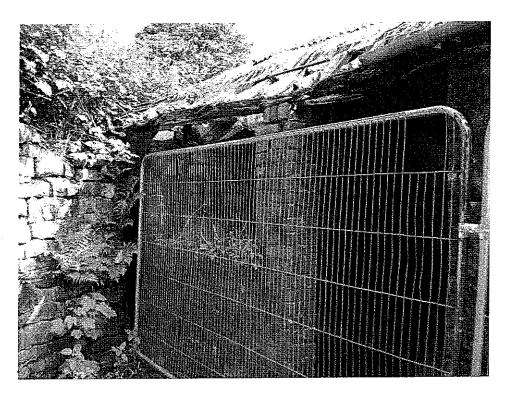
Plate 13 - Rebuilt brick facade adjacent to North Gable

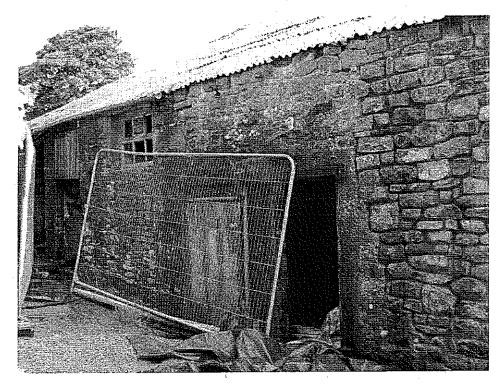
As expected of a west facing elevation, it exhibits considerable weathering, particularly within the more northerly areas (Plate 14). The elevation is laterally 'true', whilst vertical misalignment is noted within the central regions of the elevations, leaning 25mm from ground to eaves level

Plate 14 - Weathering to West (rear) Elevation

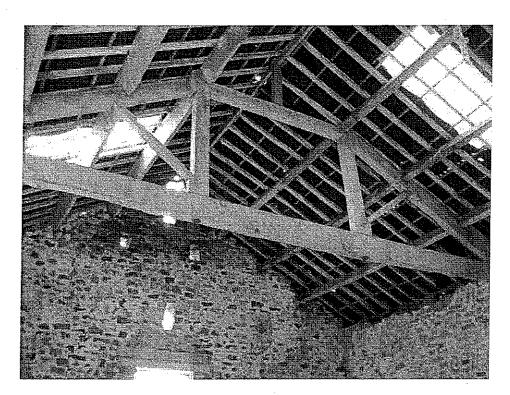
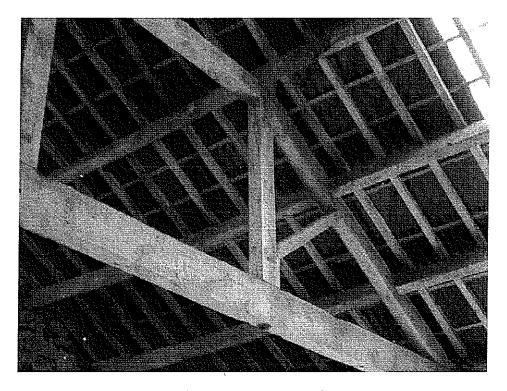
'Original' Barn Structure, Visual evidence would suggest the more formative replacement of all rafter members together with selected purlin members to both front and rear pitches. Where original purlin sections remain, these have depleted section size (Plates 15 & 16).

Plate 15 - Main Barn Roof

Plate 16 – Main Barn Roof

- 3.0 1.2 It is recommended that a "specialist" timber survey is undertaken upon the timber roof elements of the existing structures that are proposed to be retained in redevelopment, unless noted otherwise. Such a survey should identify the nature and extent of any wood boring insect infestation, dry/wet rot and fungal attack and recommend the extent of remedial works necessary to arrest such and maintain the structural member strength to continue to provide necessary support.

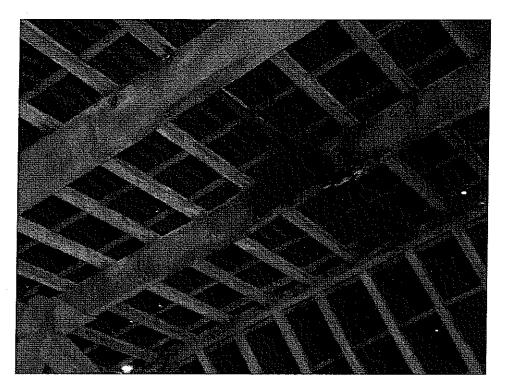
When viewed from ground level, there is evidence that all structural members have been subjected to wood boring insect infestation. Significant moisture and rot impregnation is visible within the central span of the uppermost front pitch purlin located within the central plan area of the structure (Plate 17).

Plate 17 - Damp and rot to purlin

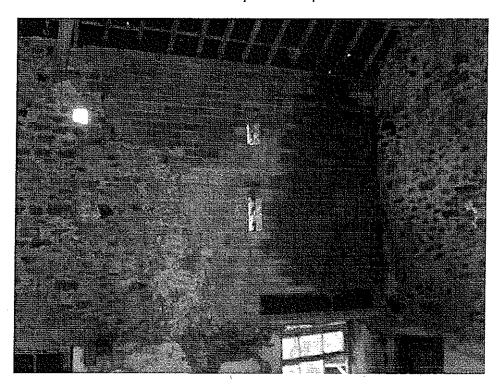
All internal walls are of solid construction and of uniform thickness. At the junction of the front and south facing elevations, the exposed internal leaf has been rebuilt in concrete block (Plate 18), however not bonded/tied. The external vertical cracking noted within the south facing gable elevation is reciprocated on the inner leaf (Plate 19). Where external cracking was noted at the rear barn/Shippon junction, visual evidence would suggest remedial rebuilding works to have been undertaken in this are previously however, the junction of the elevations remains untied/unbounded (Plate 20).

Plate 18 - Re-built inner leaf

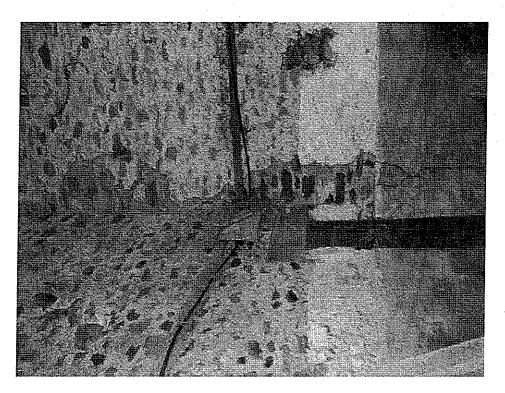
Plate 20 – South gable / Rear barn junction

3.0.3.1 Where vertical cracking is noted at the junction of the internal rear elevation and the south facing gable elevation, remedial crack 'stitching' is required. The remedial works should take the form of helical reinforcement bars ('Twistfix' or approved equal) placed across the vertical crack location in accordance with the manufacturers guidance

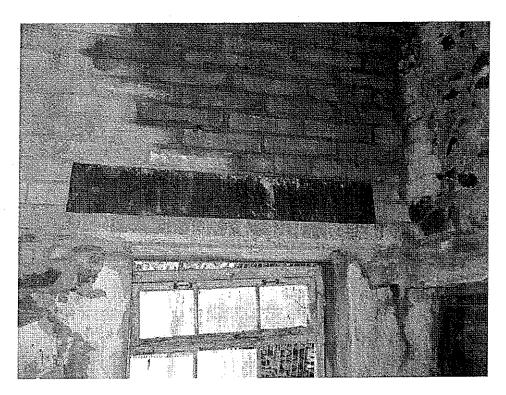
A number of internal lintel members have been replaced by prestressed concrete members (Plate 21). Where original members remain (Plate 22), these offer visual evidence of section depletion and historic wood boring insect infestation.

Plate 21 - Pre-stressed concrete lintel replacement

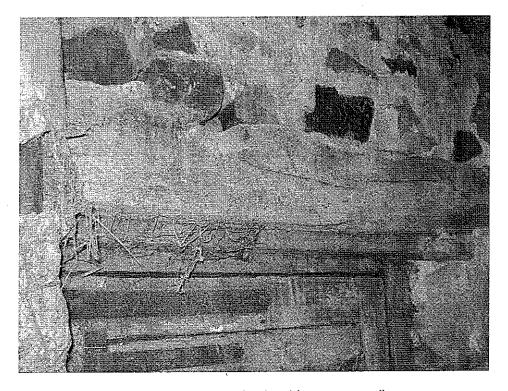
Plate 22 – Existing timber lintel (Barn – internal)

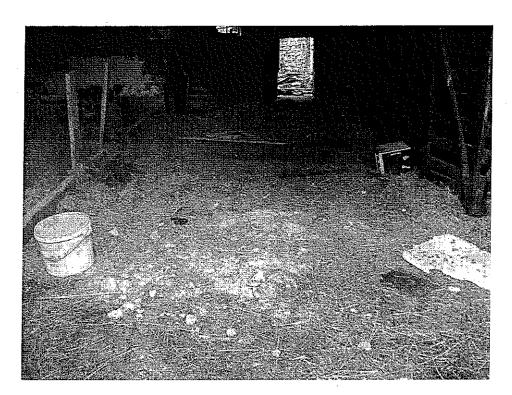
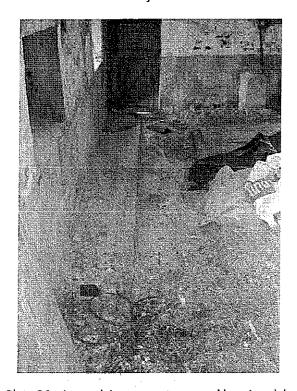
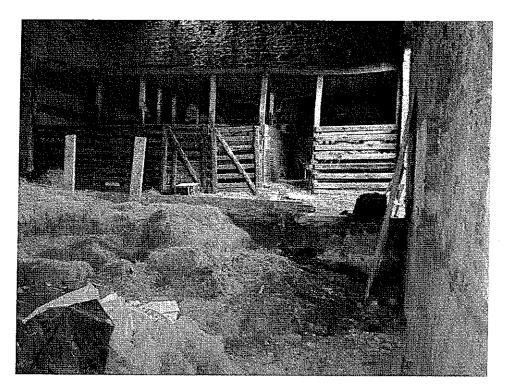
Plate's 23-25 inclusive detail the split-level ground floor construction of the main barn area. A more formatively replaced concrete ground bearing slab lies 850mm below entrance level, with adjacent ground retained by a masonry dwarf wall. The upper lying ground floor

Plate 23 – Floor adjacent to Main Door

Plate 24 – Lower lying concrete ground bearing slab

Plate 25 - Ground floor viewed from south-east corner

- Based upon redevelopment proposals raising the existing ground floor slab level, the provision for a replacement ground floor slab should comprise of a 150mm thick, ground bearing concrete slab, laid upon suitably compacted hardcore and a single layer of 1200 gauge damp proof membrane ("Visqueen" or approved equal), formed upon approved competent sub-base strata, or alternatively if competent bearing strata is proven beneath the existing slab, directly off such. Nominal mesh type reinforcement (A193) to the top of the slab should be provided with 25mm cover. Adjacent to external wall elevations, and where requirement necessitates the provision of foundation for internal load bearing wall elevations, the requirement of a thickening/downstand should be accommodated upon which formation of the proposed blockwork internal leaf can be made.

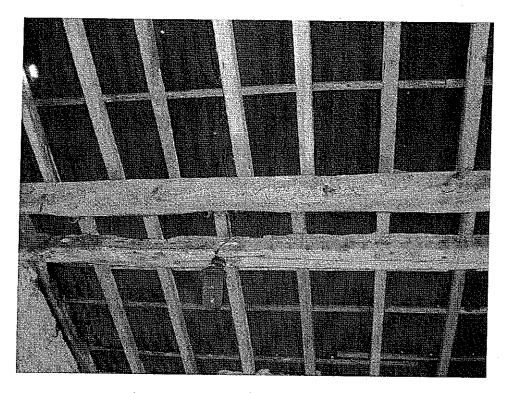
Plate 29 – Purlin section depletion (Shippon)

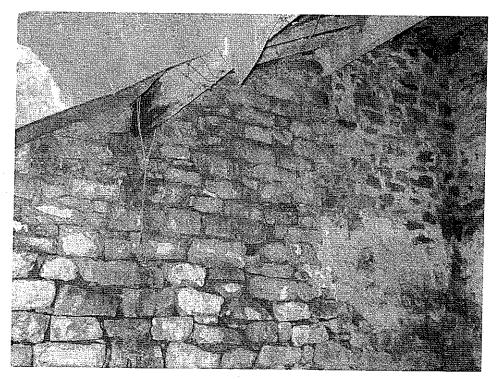
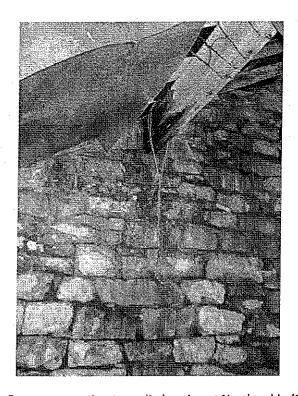
Shippon, With access gained to the first floor area/roof void via an opening formed within the rear elevation of the barn (Plate 26), visual inspection of structural timber purlin and truss roof members revealed historic wood boring insect infestation and section depletion (Plates 27-29 inclusive). Exposed roof members to the remaining northern area of the Shippon are consistent with the defects noted however, purlin end damp penetration is clearly visible at the bearing with the north facing gable (Plates 30 & 31).

Plate 30 - Damp penetration to purlin bearing and North gable (Shippon)

Plate 31 – Damp penetration to purlin bearing at North gable (Shippon)

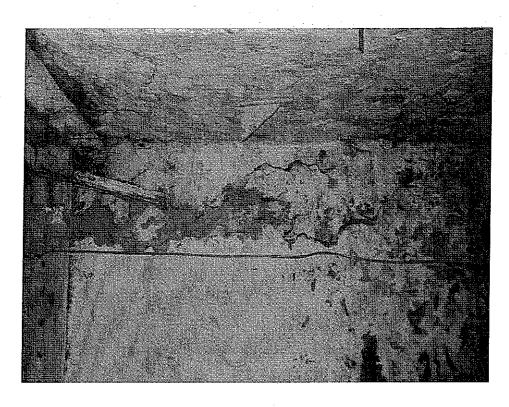
Throughout the Shippon, visual evidence clearly reinforces the assumption that this area was a more formative extension, with vertical 'butt' joints visible at the junction with the main barn masonry elements. (Plates 34 & 35) Additionally, a vertical crack is noted at the rear elevation of the Shippon with that out the south gable, corresponding to the location noted within the main barn (Plate 36).

Plate 34 – Butt joint at Shippon / Barn

Plate 35 – Butt joint at Shippon rear elevation and spine wall

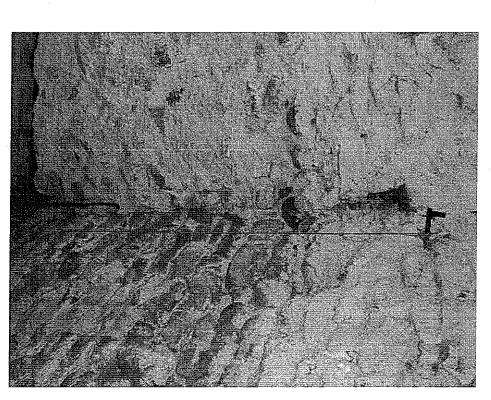
Throughout, evidence of damp ingress to all wall elevations is noted (Plate 36). At the junction of the rear external elevation and south facing Shippon gable, evidence would suggest that this area has been more formatively re-pointed/rebuilt. More obviously, directly adjacent to the north gable, the elevation has obviously been re-built utilising standard format brickwork (Plate 37).

Plate 36 — Vertical crack, damp penetration to applied Shippon wall finishes

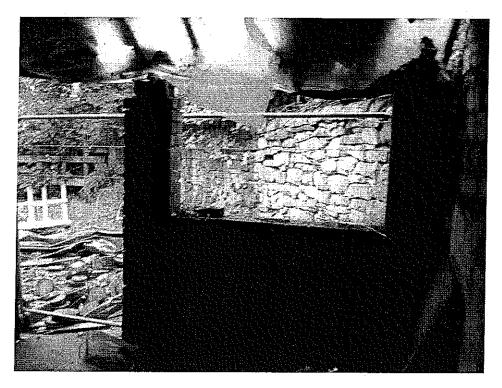
Plate 37 - Re-built brickwork elevation
