Application for listed building consent for alterations, extension or demolition of a listed building  
Planning (Listed Buildings and Conservation Areas) Act 1990

ESSENTIAL REPAIRS TO THE KITCHEN WALL, PARAPET AND ROOF, TO RECTIFY A DAMP PENETRATION PROBLEM, TO PREVENT FURTHER DAMAGE AND DETERIORATION TO THE PROPERTY.

**REPAIRS TO STANWORTH HOUSE, YORK STREET.**  
**CLITHEROE**  
**Supporting Photographic Information**

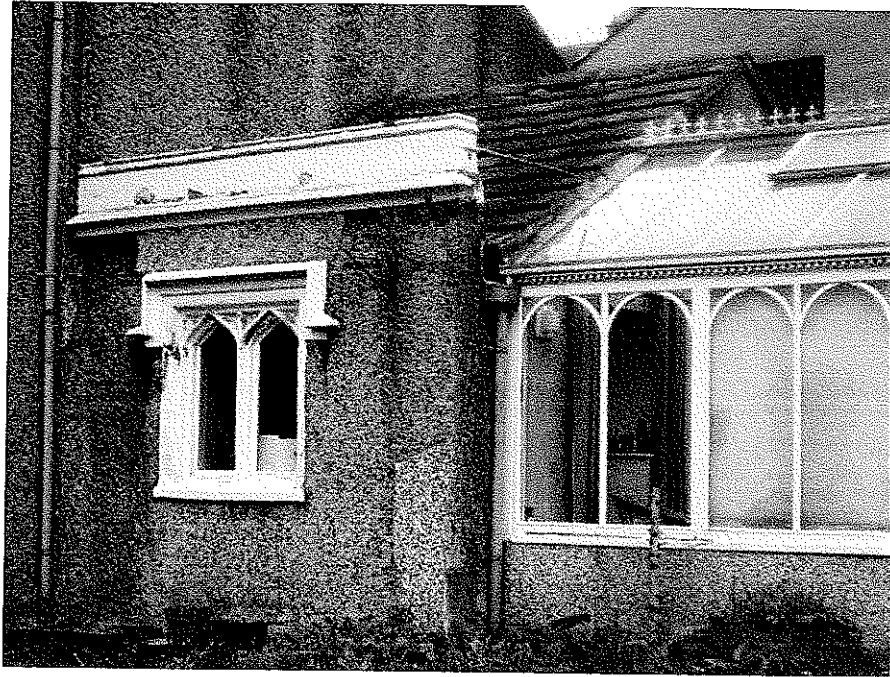
**Photo 2 – Showing Front of Kitchen Wall.**

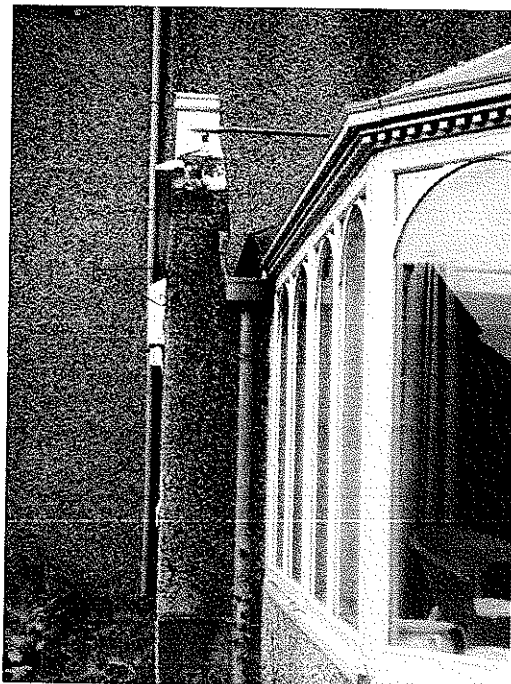
**Photo 3- Showing Side View of Kitchen Wall and Valley Gutter.**

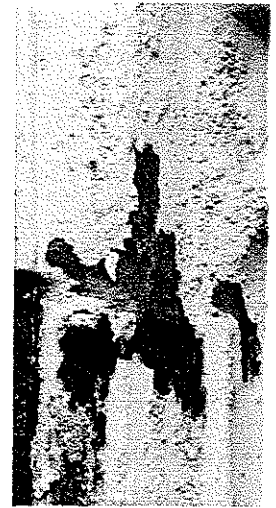
Masonry paint on the dressed sandstone surround and mullion of the window has blistered badly. However, removal of some of the paint and probing with a screwdriver showed that the stone is sound and does not require replacement, and that it is the modern resin-based masonry paint that has deteriorated because of the moisture entering the stonework behind. We only removed a small area of the badly-affected paint at the top of the surround and the mullion appears to have been repaired with cement mortar in the past.

Removal of blistered paint from the window surround exposes sound stone beneath.

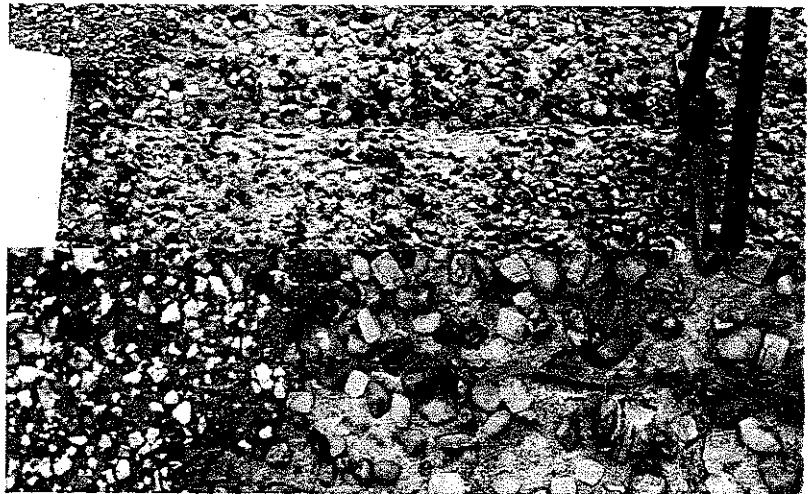
The outer face of the wall is covered by a cement pebbledash. This also has horizontal cracks, some of which have been sealed with clear silicone sealant that has now failed. Below one crack there is deposited calcium carbonate, which suggests that water that has become rich in lime by flowing through lime mortar has escaped from here in the past.

Calcium carbonate deposits are visible below a horizontal crack to the right of the window.

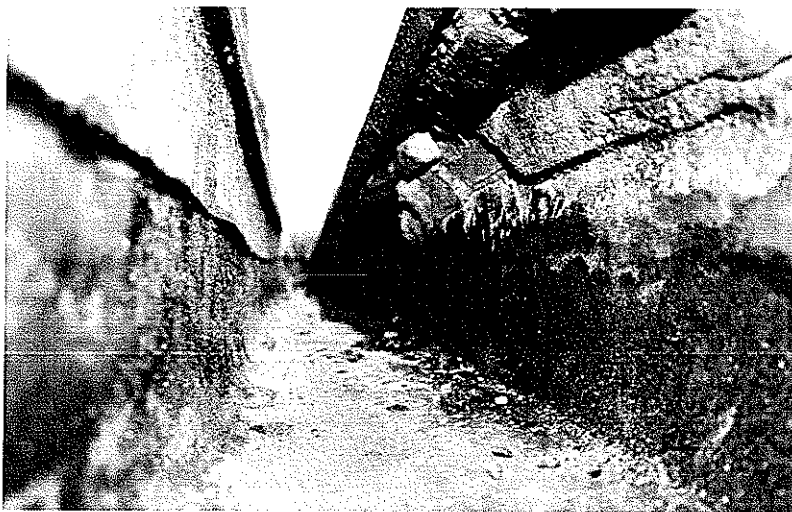
Another crack has been repaired with silicone sealant

By looking along the gutter it can be seen that the under-slates below the lower course are not continuous and that some of the infill between the top of the gutter and the undersides of the slates is missing.

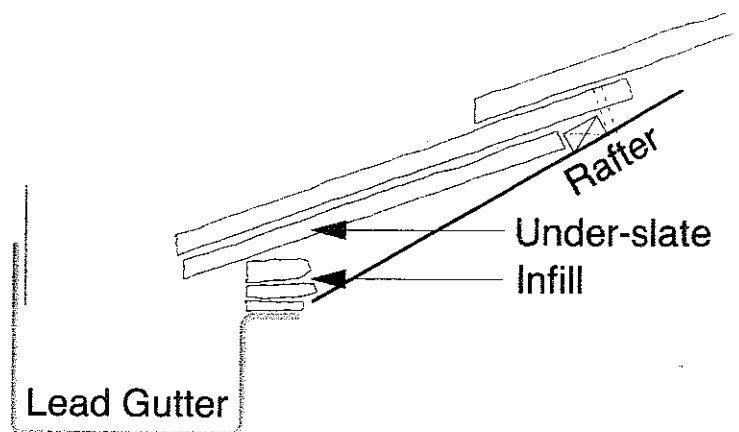
A diagram showing the relationship between the stone slates, under-slates and gutter. A damaged under-slate is the most likely cause of the damp problem

along the gutter from a ladder, to be to the left of the window. This has allowed water from the roof to run through the gap between two upper slates and behind the lead gutter.

- Confirm that the broken under-slate is the main cause of the problem and either replace it with another stone slate that is well-supported from below or insert a sheet of lead above it.

- Where the infill between the back of the lead gutter and the underside of the slates is missing renew it with small pieces of stone slate and mortar, making sure that the under-slates are well supported and that water cannot run behind the gutter.
