**Proposed Conversion to dwelling at  
'Jacksons's Barn', Sawley, Lancashire.**

**Structural Appraisal Report**

D1491 rev0

September 2011

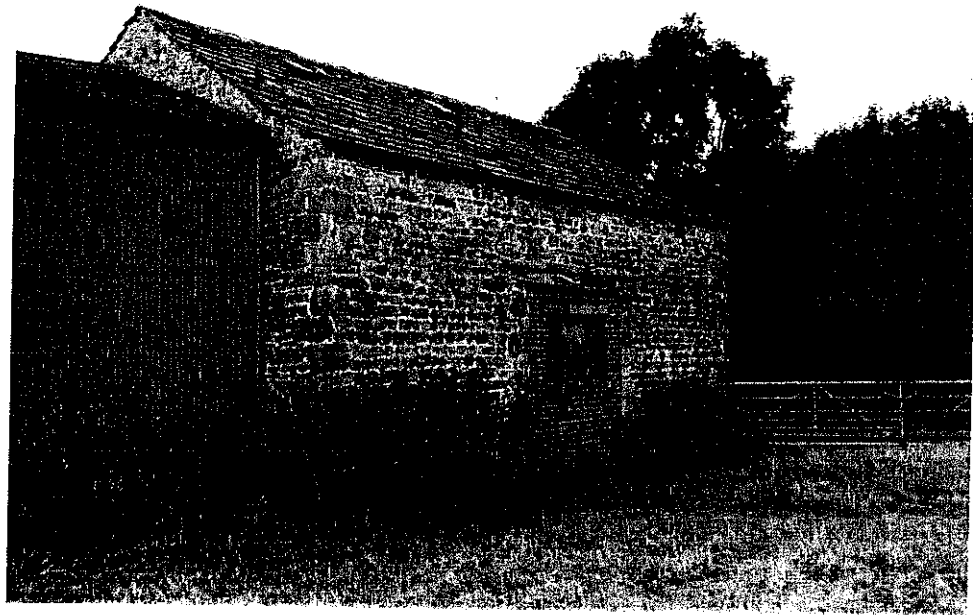
Plate 01. Front Elevation

*Front Elevation (North facing);* Plate 01 refers to the coursed stone masonry, north facing front elevation of the 'Barn' structure. The slate finishes to the front elevation roof pitch clearly exhibit evidence of previous historic deflection of underlying structural members.

It is our considered opinion that the existing timber ridge, purlin and lintel members are not structurally adequate to sustain the proposed loading, and as a result, be replaced by structurally competent support members.

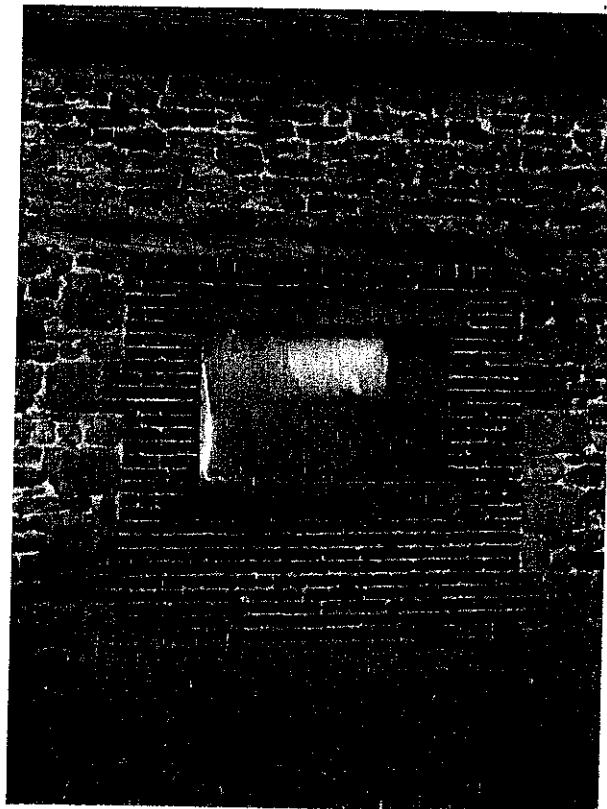
Plate 02 'Infill' door opening to Front Elevation

The elevation holds a brick infilled former main door opening, containing a Perspex glazed window opening. The original timber lintel member to the door opening remains insitu (reference Plate 02), exhibiting signs of excessive shrinkage and historic wood boring insect infestation. Emanating from the underside of the left hand lintel bearing, mortar bed and perpend cracking extends in a downward, diagonal trend. Vertical cracking emanates from eaves level adjacent to both gable returns, more prominent to the right hand side (reference Plate 03), with evidence of remedial repointing having been undertaken to the left hand side.

Original timber lintel member

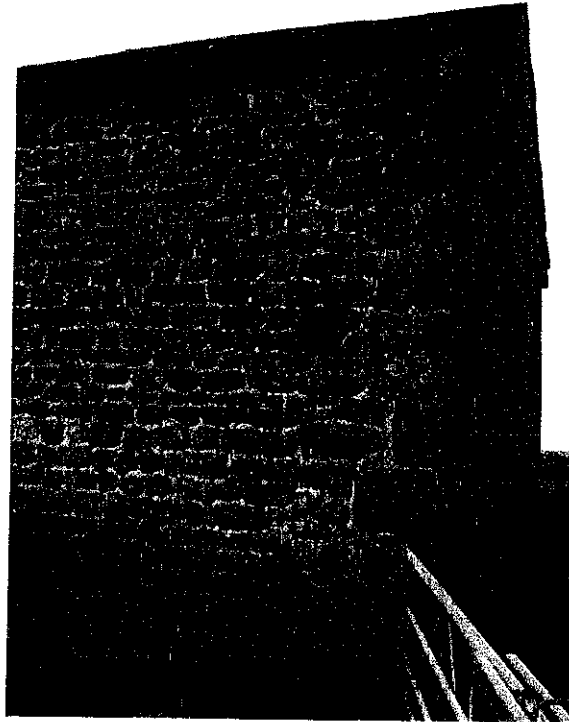
- 2.0.4 Where vertical cracking is noted externally emanating from eaves level, we are of the opinion that such is attributable to the historic 'spread' of roof members particularly based upon their proximity to return wall lengths. We would recommend the remedial 'stitching' of all external crack locations, adopting a suitably approved remedial method

Plate 03 Vertical cracking in Front Elevation adjacent to Westerly Gable

- 2.0.5 Whilst not necessarily of structural significance, we would recommend the property mortar bed and perpend joints are re-pointed, particularly where vertical cracking is noted within the external elevations, previously addressed by remedial stitching recommendations.

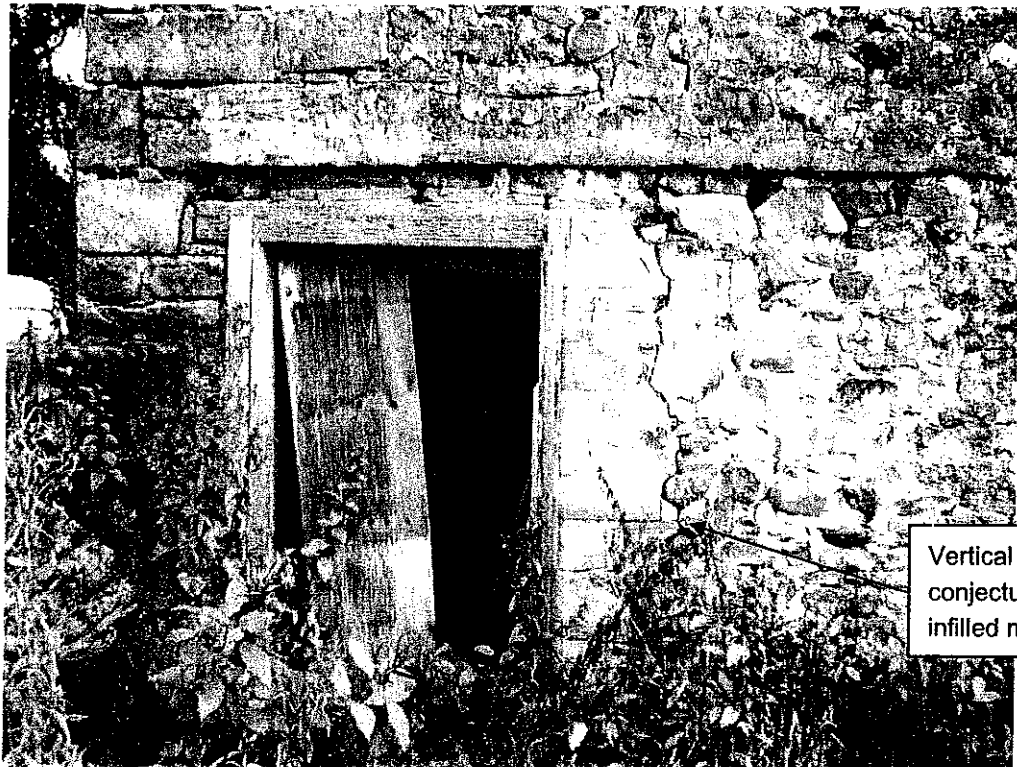
The heavily weathered, random stone masonry elevation is reasonably plumb throughout, offering signs of more formative repointing remedial works. Vertical cracking emanates from eaves adjacent to the westerly facing gable elevation, extending in a downwards trend to mid-height. Within the area of this cracking (reference Plate 09), a vertical displacement of 20mm is recorded over a 1.0m measured length. Additionally, vertical cracking is noted to the right hand side of the Barn entrance door (reference Plate 10).

Visual evidence would suggest by the colouration of the masonry directly adjacent to the crack location that such corresponds to historic infilling of an originally wider door opening.

Plate 10 Vertical cracking adjacent to entrance door in Rear Elevation

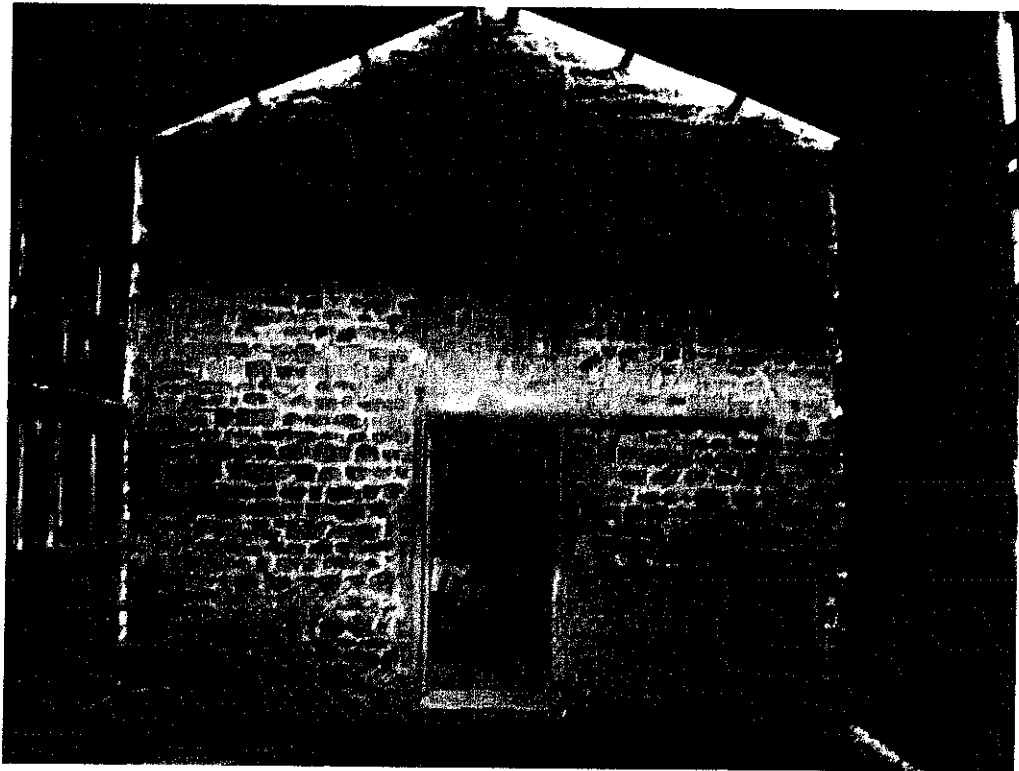
Plate 11. Easterly facing Gable Elevation

*Gable Elevation (East facing);* Plate 011 provides record of the easterly facing gable elevation general appearance. The elevation, of coursed sandstone masonry is reasonably plumb, offering no evidence of historic or progressive structural movement. It is conjectured that this elevation may be the subject of more formative rebuilding?
