**Subject:** FW: 3/2011/0247 Low Moor Clitheroe

Please find attached the Remediation Validation Report

**October 2012**

Ref: MC539/11

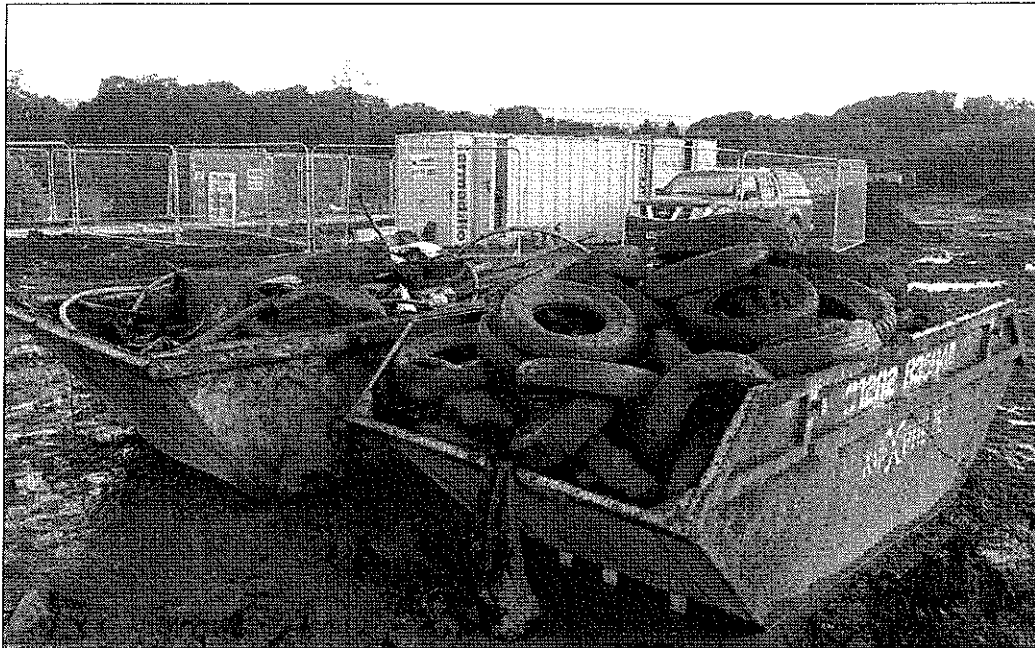
Plate 2 (below) shows the nature of salvaged materials from the tipped soil mass that was taken offsite to waste recovery facilities.

**Plate 2 Photograph showing salvaged materials from tipped waste mass**

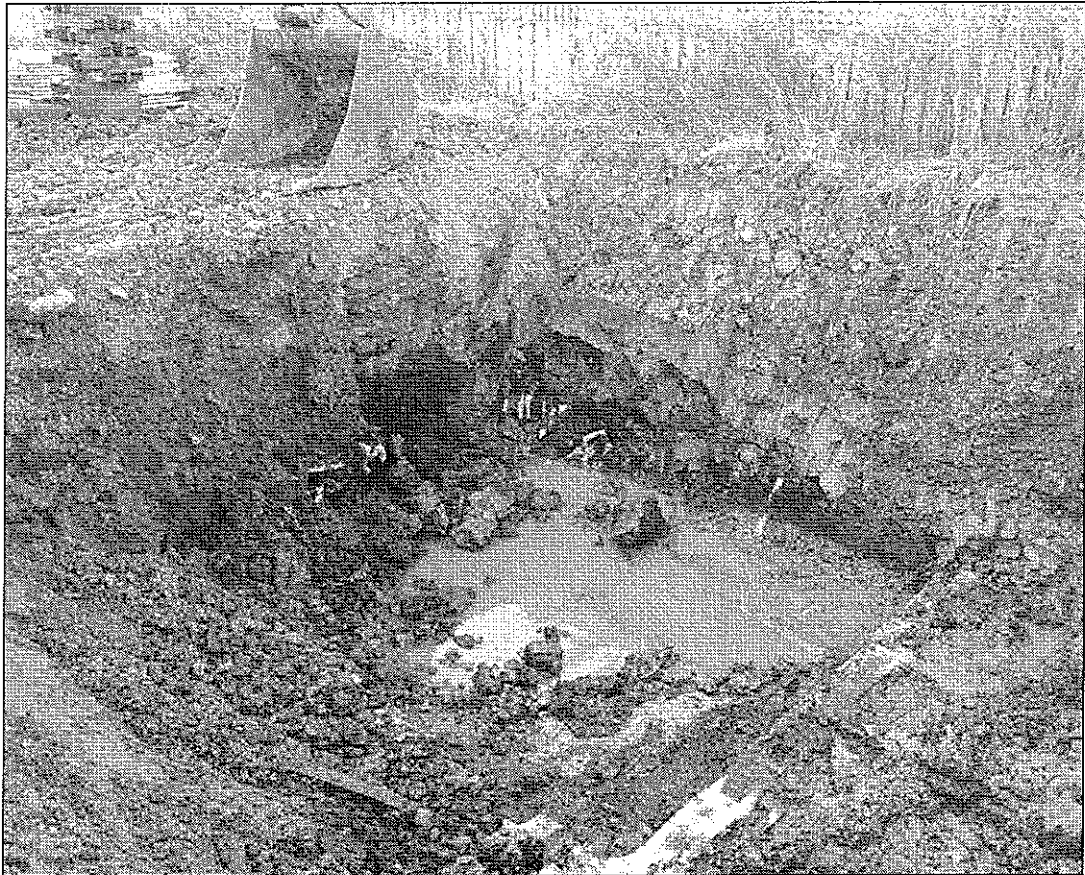
The former cess pit area located at the southern boundary of the eastern parcel was excavated with a remnant slab and wall removed. The content of the former cess pit were taken offsite together with tipped materials from the western parcel.

Plate 3 (overleaf) provides a photograph of the excavation of former cess pit, revealing an upstand on the basal concrete slab and the nature of the materials.

**Plate 3 Photograph showing area excavated cess pit**

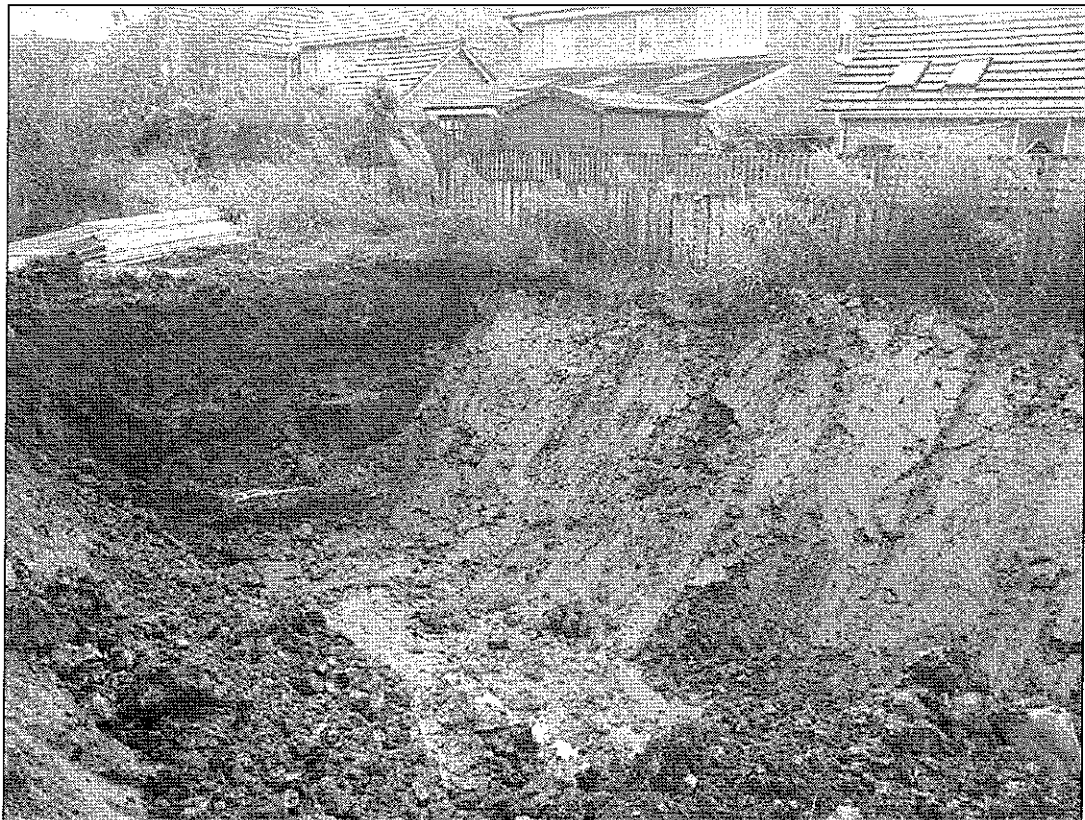
Plate 4 (overleaf) shows the cess pit being filled with site won cohesive material which was used as a physical barrier to separate the reinstated cess pit from the adjoining property. The need for a sheet piled wall was discounted primarily due to the presence of sensitive building structures adjacent to the former cess pit.

The horizontal thickness of the emplaced clay wall along the rear section of the cess pit wall was 0.5m and its construction was witnessed by McAuliffe management. The clay material was sourced from the western parcel and consisted of firm to stiff glacial Boulder Clay

**Plate 4 Photograph showing clay stank being emplaced within former cess pit**

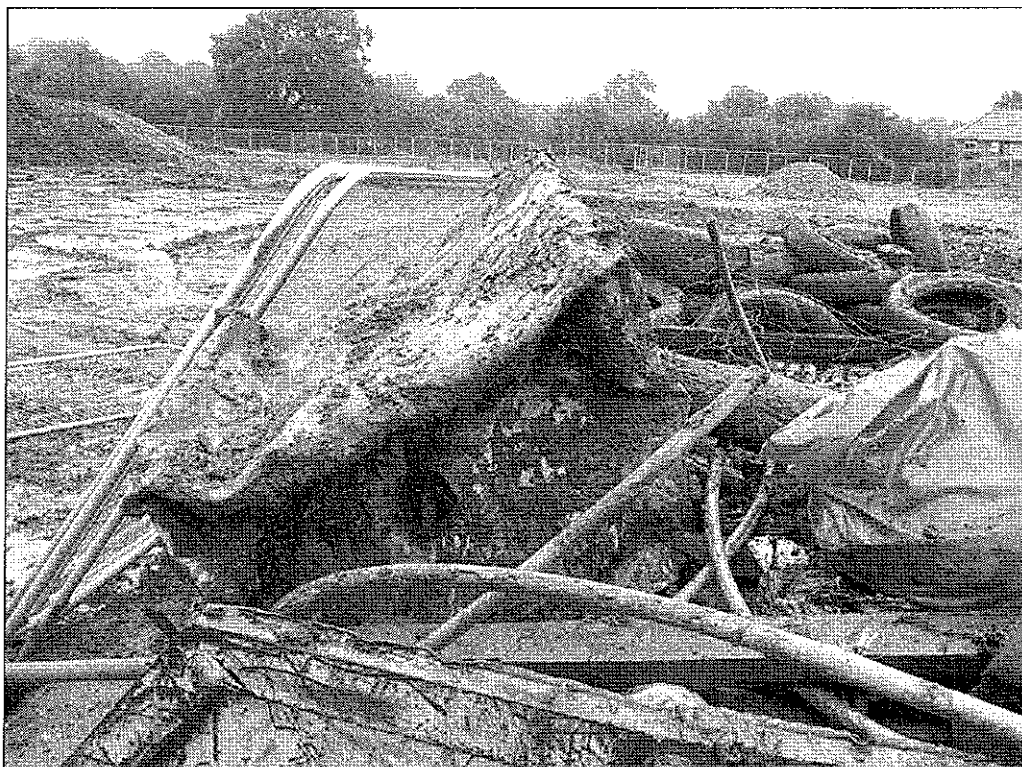
Other materials that were removed offsite included metal and tyres which were taken to a suitable recycling facility. Plate 5 (overleaf) shows the nature and volume of materials removed offsite together with the condition of the septic tank that was removed offsite.

**Plate 5 Photograph showing excavated septic tank**

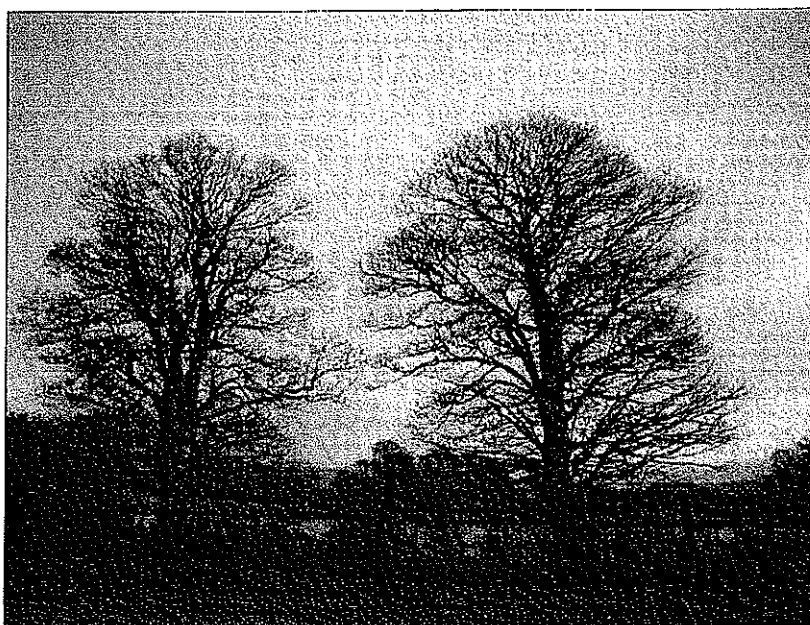
Fig 2: Sycamores T2 and T3, as seen from the eastern section of the site (the field) looking east

- 5.8 In this respect I would note that 'R' category sycamore T3 has a moderately large basal cavity with evidently extensive progressive decay within it and several *Kretzschmaria deusta* fungal fruiting bodies to its stem base, which is a very aggressive soft rot root and butt decay producing fungi that causes a brittle fracture of the wood. As such, it has a short projected remaining safe life expectancy and is considered unsuitable for retention in the context of a development and the subsequent increased land usage and associated risk that it would present to persons and/or property. However, the tree stands on or close to the site boundary and it is therefore important that its ownership is verified prior to any works being carried out
