**STRUCTURAL INSPECTION**

**THE TALBOT HOTEL AND ADJACENT BARN**

**TALBOT AT CHIPPING LTD**

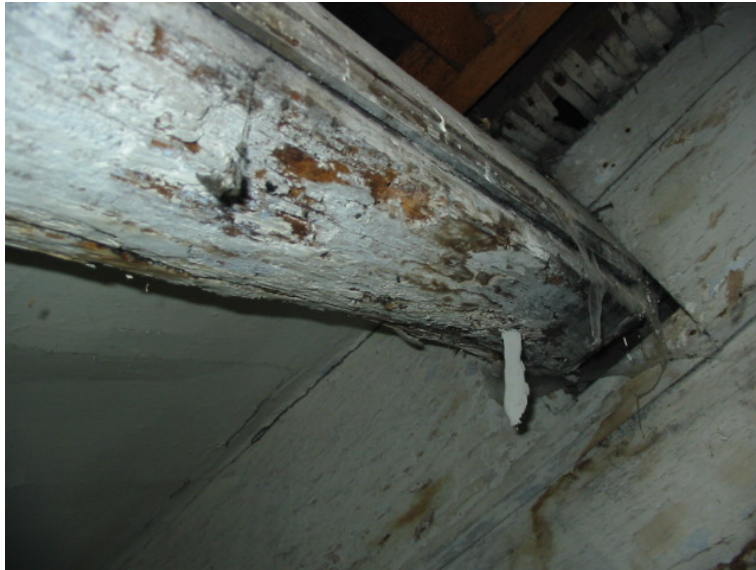
- The roof has been re-covered relatively recently, and provided with new rafters and felt.
- The original timber trusses and purlins remain in place. Signs of serious wet-rot decay were noted in the timber purlins, in particular those close to rooflights on the front slope (**photos 5,6&7**). Evidence of historic repairs to these purlins was noted. The main trusses appeared to be free of decay, but access to inspect the more vulnerable truss feet at the outer wall was restricted. Some timber purlins show a noticeable down-slope bow in

Photo 5 – Decayed Timber Purlin

The slated roof covering and timber rafters are in reasonable condition, having been replaced relatively recently, but significant decay was noted in the timber purlins, especially those on the front slope close to the rooflights. The roof trusses appeared to be reasonably sound, but with signs of insect infestation in the bottom tie beam. Other internal timbers are also affected by woodworm, and wet-rot decay was noted in several locations where water was penetrating the building fabric, at failed or missing flashings and gutters. We would recommend that a more detailed inspection is undertaken by a timber preservation specialist of the roof and floor timbers and any timber lintels built into the stone walls. Sufficient floorboards, ceilings and lath-and-plaster lining walls should be removed to provide full access to all structural members, including the feet of the main roof trusses. Following full inspection, a decision can be made on which timbers can be retained and re-used, and which need to be repaired or augmented with new timbers or steel plating. All timbers will need to be treated to eradicate wood-boring insects.

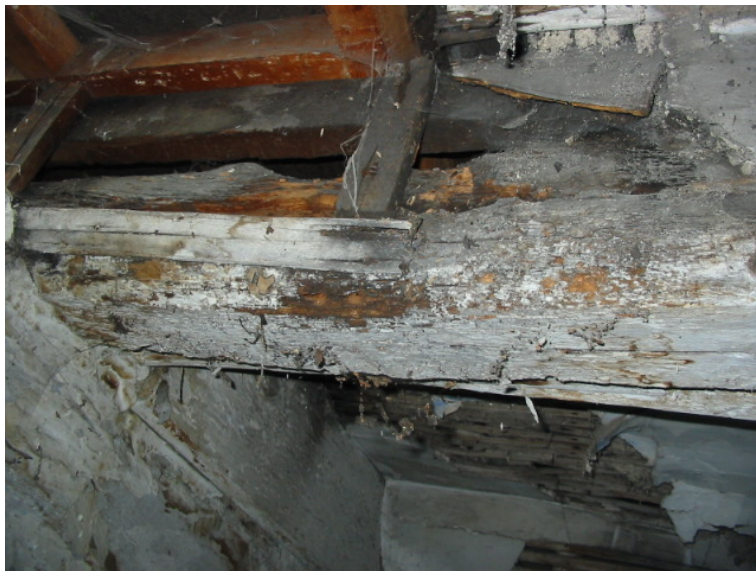
Photo 6 – Decayed Timber Purlin

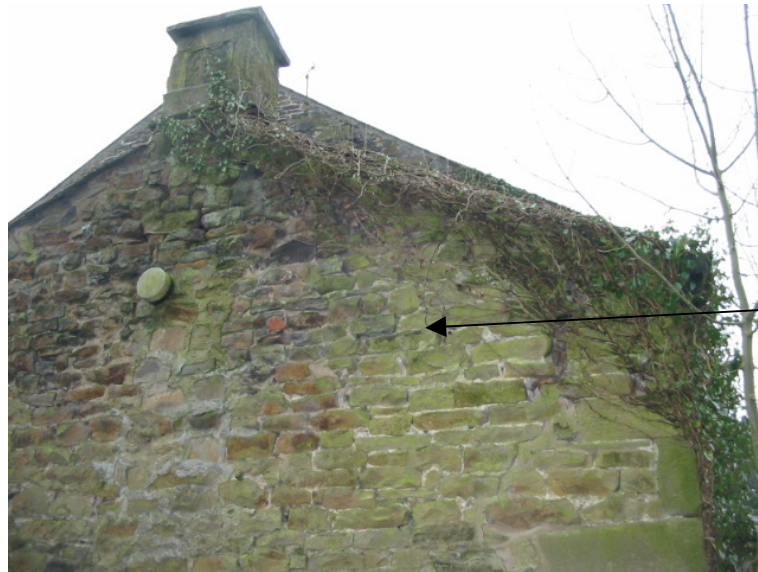
Photo 15 – Right Gable (Low Level)

- On the right-hand single-storey gable, there are some open joints in the stonework (**photo 15**).
- There is a noticeable sag in the ridge of the single-storey kitchen roof.
- At the rear left-hand corner, there is some cracking or opening of joints around the stone quoins near eaves level.
- There is a hole in the stonework and a vertical crack in the left-hand gable wall (**photos 16&17**). The stonework has been pointed with cement mortar. The face of the stone is eroded.
- There are several cracks in the render on the front wall. Above the front door, the wall shows a noticeable lean backward.

Open Joints  
in  
Stonework

The external walls are generally straight and plumb, apart from one localised area above the front door. The stonework is suffering from erosion of the mortar joints close to defective gutters or flashings. The stonework on the left-hand gable has been pointed with cement mortar, and this has resulted in water becoming entrapped in the stone and subsequent frost damage. The vertical crack in the left gable is associated with the chimney breast and may be the result of a chemical reaction between the flue gases and the cement mortar pointing. We would recommend that all the stonework is cleaned, the joints raked out and the whole re-pointed with lime mortar. Cracks in the render can be raked out and repaired during redecoration.

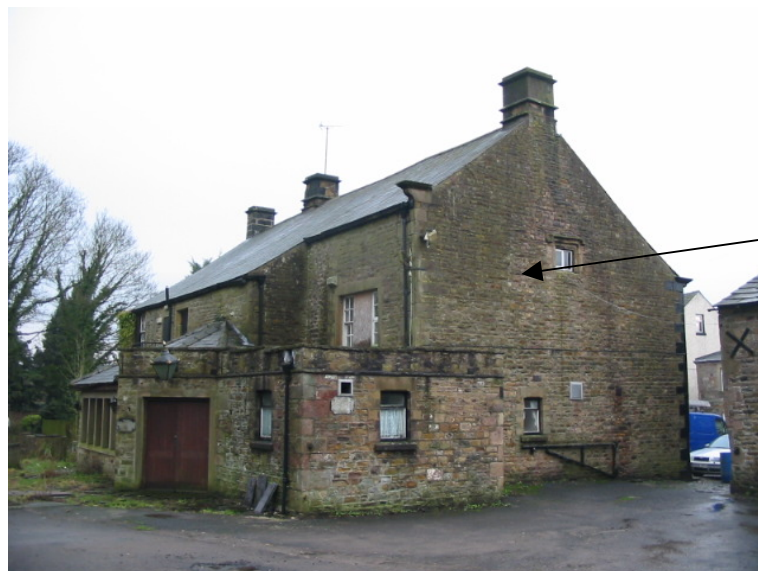
Photo 16 – View of Left Gable Wall

Location of  
Crack

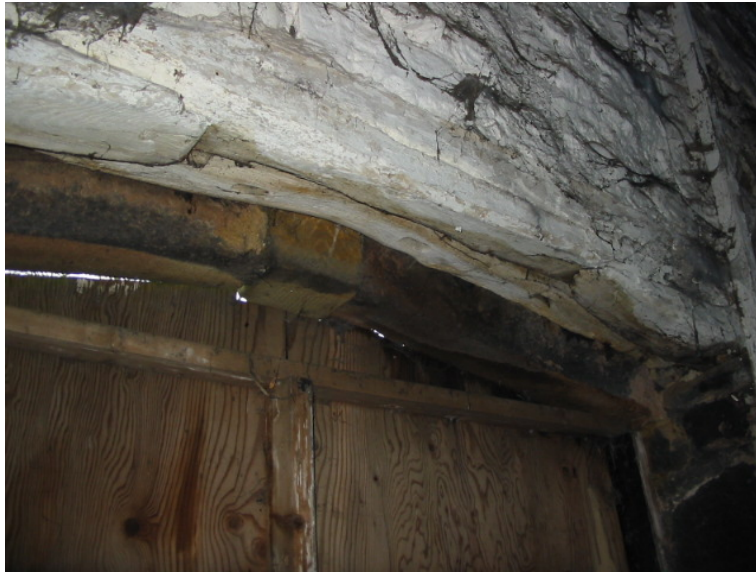
- The inside face of the front, rear and left-hand gable walls of the barn appeared to be in reasonable condition. Holes remain in the walls where the floor timbers of former upper floors were supported. Insect infestation and decay was noted in the timber inner lintel over the front and rear doors (photo 19).
- The right-hand gable wall contains an area of badly damaged and poorly consolidated masonry below a high-level doorway (**photo 20**).
- There was no access available to the rooms or spaces at the left-hand side of the main barn.

Photo 19 – Decayed Timber Lintel above Rear Door of Barn

The right-hand gable wall is significantly distorted and partially collapsed on the inside. The central portion of this wall should be re-built. Decayed timber lintels should be replaced. The stonework should be cleaned, the joints raked out and the whole of the external face of the external wall re-pointed with lime mortar. On the internal face, the re-pointing can be restricted to cracked or poorly consolidated areas.

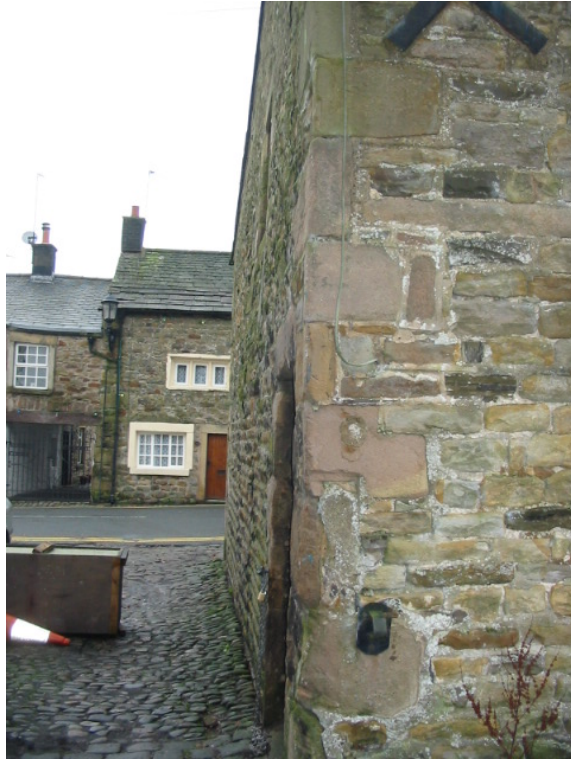
- The front wall (Talbot Street) appears to be in reasonable condition. Some open joints and erosion of the stonework were noted, especially close to leaking gutters.
- The right-hand gable wall is in poor condition and shows a significant outward bulge below the high-level door opening (**photo 21**). A metal tie bar has been installed between the front and rear walls at mid-height of the gable, presumably to prevent outward movement and separation of the gable stonework.
- The rear wall shows noticeable distortion along its length, in particular to the right (as viewed from outside) of the rear entrance door (**photo 22**). The stonework is eroded, in particular close to the rainwater downpipe closest to the right-hand gable. Stones are dislodged or missing each side of an old clay flue near the left-hand gable.
- No significant defects were noted in the left-hand gable wall.

Photo 21 - Distorted Right Gable Wall of Barn

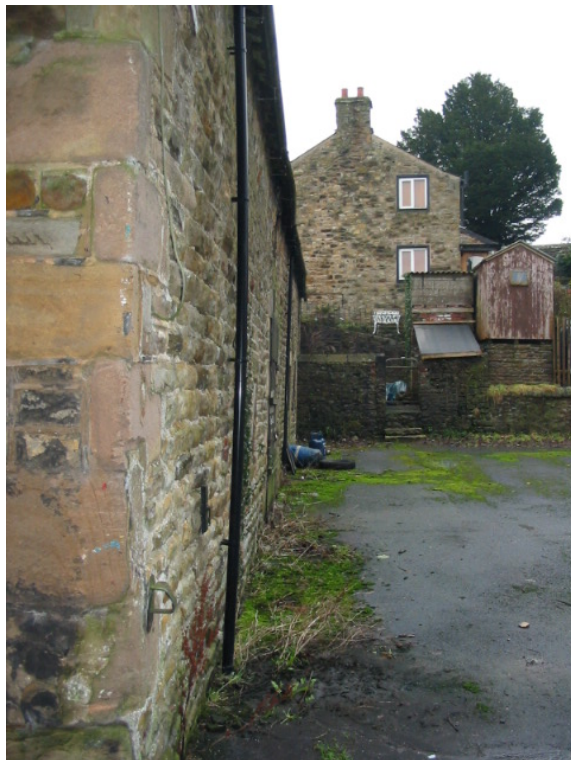
Photo 22 – Distorted Rear Wall of Barn

The conversion of the barn should include a new blockwork internal lining wall, tied to the existing stonework. This, in conjunction with a new first floor and upgraded roof, should add significantly to the overall robustness of the structure and prevent future distortion of the external walls.
