STRUCTURAL INSPECTION

THE TALBOT HOTEL AND ADJACENT BARN

TALBOT AT CHIPPING LTD

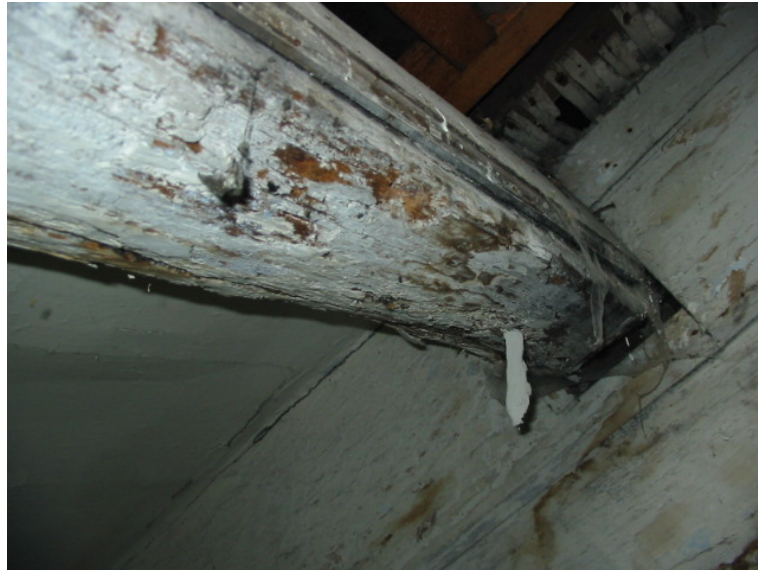
- The roof has been re-covered relatively recently, and provided with new rafters and felt.
- The original timber trusses and purlins remain in place. Signs of serious wet-rot decay were noted in the timber purlins, in particular those close to rooflights on the front slope (**photos 5,6&7**). Evidence of historic repairs to these purlins was noted. The main trusses appeared to be free of decay, but access to inspect the more vulnerable truss feet at the outer wall was restricted. Some timber purlins show a noticeable down-slope bow in

Photo 5 – Decayed Timber Purlin

The slated roof covering and timber rafters are in reasonable condition, having been replaced relatively recently, but significant decay was noted in the timber purlins, especially those on the front slope close to the rooflights. The roof trusses appeared to be reasonably sound, but with signs of insect infestation in the bottom tie beam. Other internal timbers are also affected by woodworm, and wet-rot decay was noted in several locations where water was penetrating the building fabric, at failed or missing flashings and gutters. We would recommend that a more detailed inspection is undertaken by a timber preservation specialist of the roof and floor timbers and any timber lintels built into the stone walls. Sufficient floorboards, ceilings and lath-and-plaster lining walls should be removed to provide full access to all structural members, including the feet of the main roof trusses. Following full inspection, a decision can be made on which timbers can be retained and re-used, and which need to be repaired or augmented with new timbers or steel plating. All timbers will need to be treated to eradicate wood-boring insects.

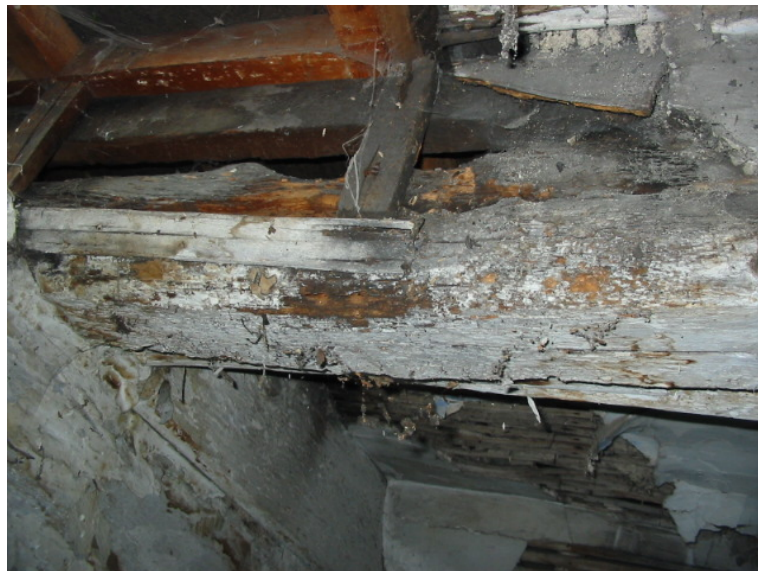
Photo 6 – Decayed Timber Purlin

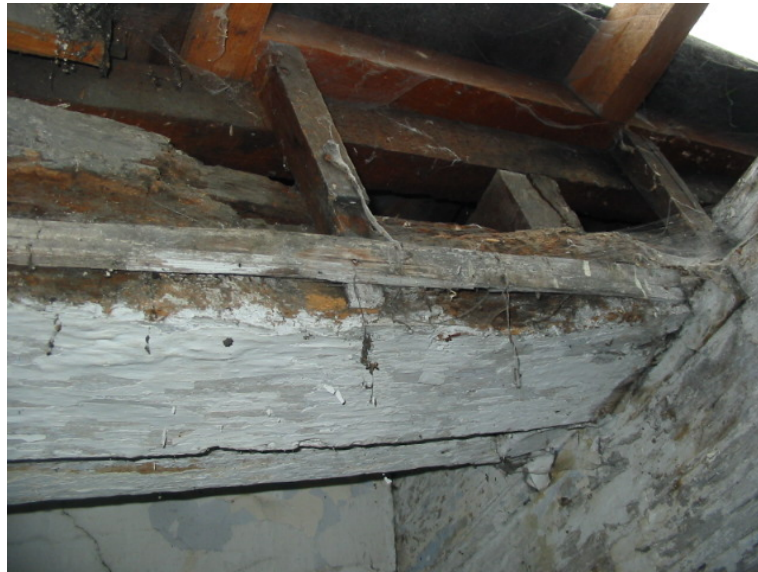
Photo 7 – Decayed Timber Purlin

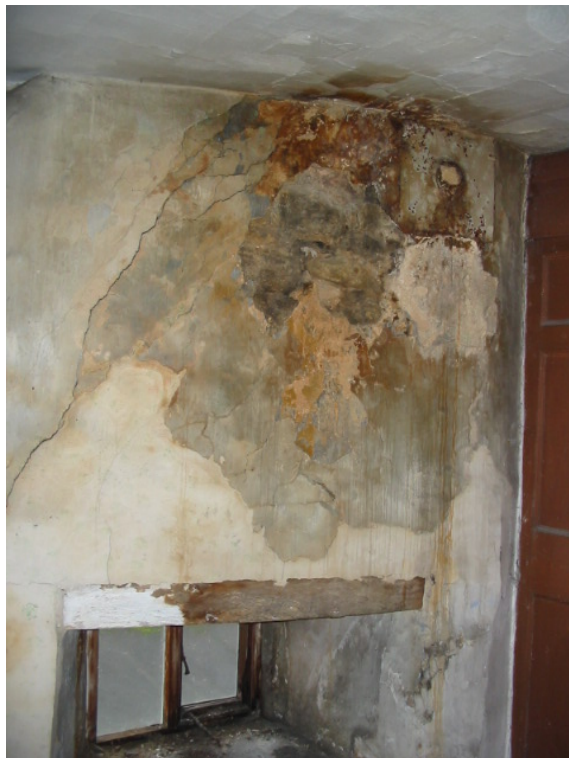
- The original ceiling joists and lath-and-plaster ceiling remain, though part has either been removed or has collapsed onto the attic floor.
- The left-hand gable wall shows signs of water ingress (**photo 8**).
- A timber lintel in the right-hand gable wall shows some signs of decay, and the masonry above and below the lintel has cracked (**photo 9**).
- The timber floor of the attic is partly supported on the bottom tie-beam of the roof trusses and is uneven and not level. The floor is covered with debris and has many missing floorboards.

Photo 8 – Damp Staining at Left Gable Wall

The external walls are generally straight and plumb, apart from one localised area above the front door. The stonework is suffering from erosion of the mortar joints close to defective gutters or flashings. The stonework on the left-hand gable has been pointed with cement mortar, and this has resulted in water becoming entrapped in the stone and subsequent frost damage. The vertical crack in the left gable is associated with the chimney breast and may be the result of a chemical reaction between the flue gases and the cement mortar pointing. We would recommend that all the stonework is cleaned, the joints raked out and the whole re-pointed with lime mortar. Cracks in the render can be raked out and repaired during redecoration.

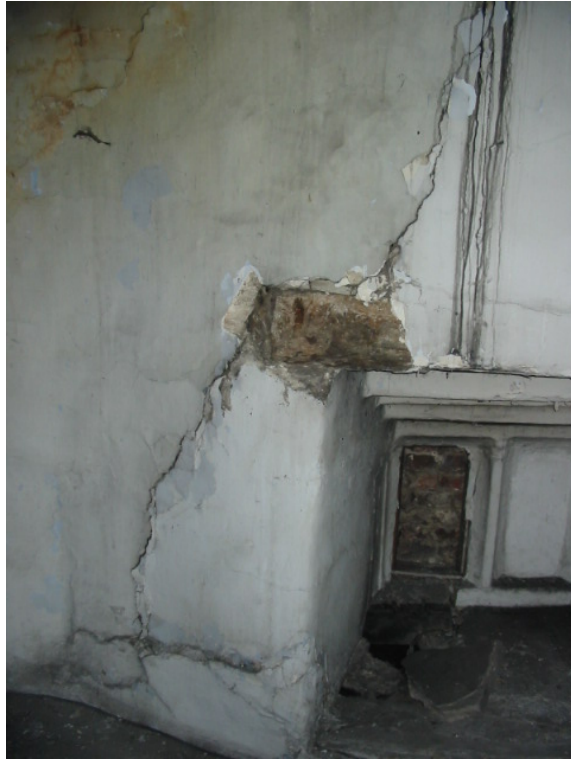
Photo 9 – Decayed Lintel and Cracking at Right Gable Wall

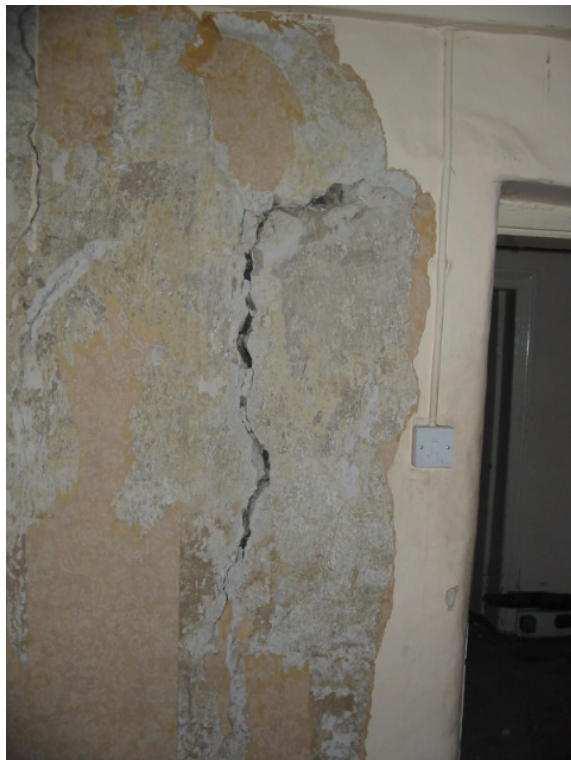
- The undersides of the main roof truss tie beams are visible behind a timber cladding. Signs of insect infestation were noted.
- There is a vertical crack of some 15mm width in the rear left-hand bedroom (**photo 10**).
- The inner wall of the room to the rear of the snooker room shows a significant lean of around 75mm over the height of a door (**photo 11**).
- Damp was noted on the left-hand wall of the snooker room (**photo 12**) and above the chimney breast in the front left-hand bedroom.
- The first floor is generally uneven and out-of-level.

Photo 10 – Crack in Internal Wall – Rear Left Bedroom, First Floor

There is cracking in the internal walls at several positions, the most significant being in the rear left-hand bedroom at first floor level. The cause of this crack is unclear without further investigation. The wall should be rebuilt locally to ensure that the stonework is fully bonded. The leaning internal wall to the room to the rear of the snooker room may be associated with this wall originally being built as an external wall. The degree of lean is not great compared to the thickness of the wall and chimney breast at this point, and re-building is not recommended.

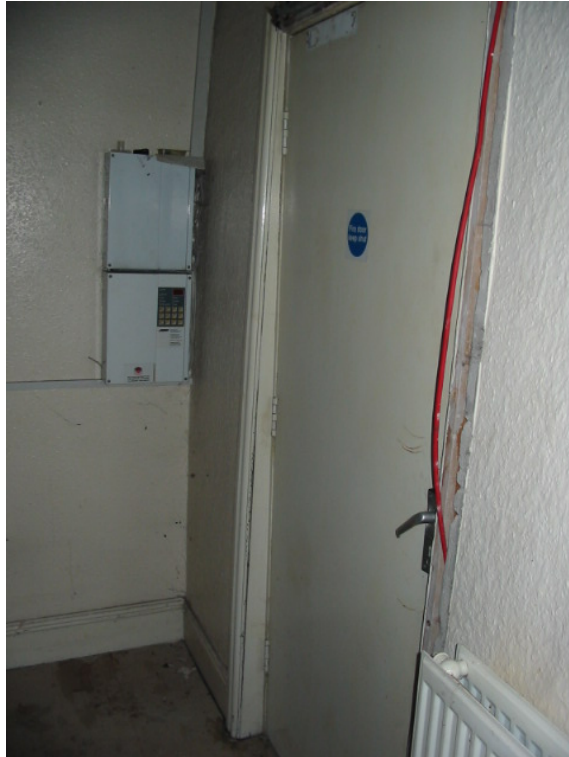
Photo 11 – Leaning Internal Wall – Rear Right Bedroom, First Floor

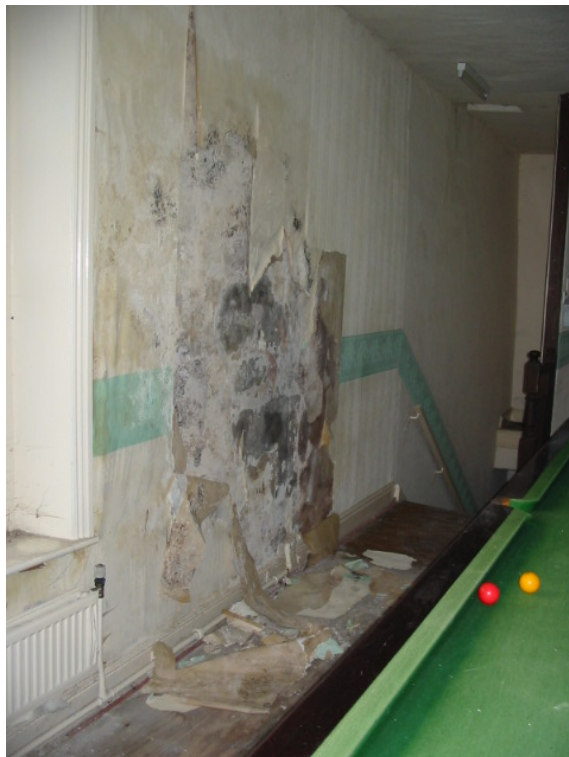
Photo 12 – Damp in Snooker Room Wall

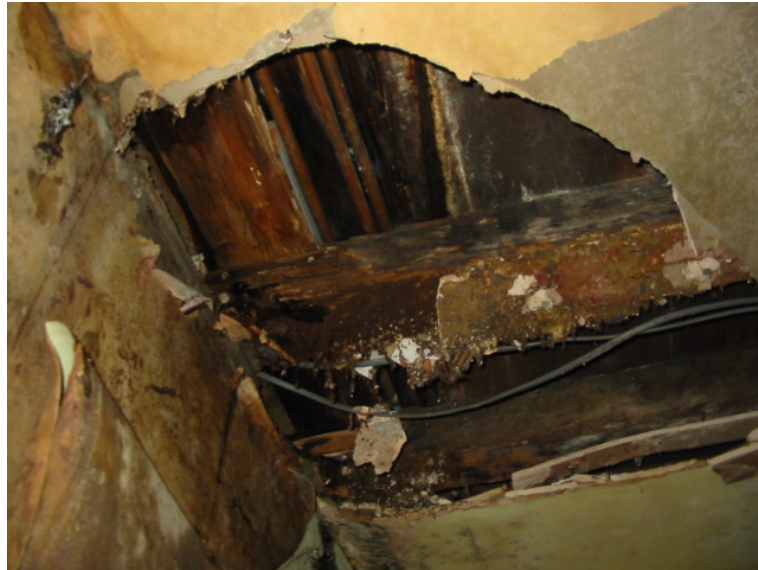
- Signs of water ingress and timber decay were noted at several locations near the rear wall (**photo 13**).
- Some signs of moisture ingress were noted in the left wall of the front right-hand lounge (**photo 14**).
- The ceiling of the kitchen appears to be sagging.
- The roof of the covered yard area appears to have failed and is propped by steel props.
- Some slates are missing from the roof of the right-hand store room.

Photo 13 – Decayed Timbers - Rear Wall, Ground Floor

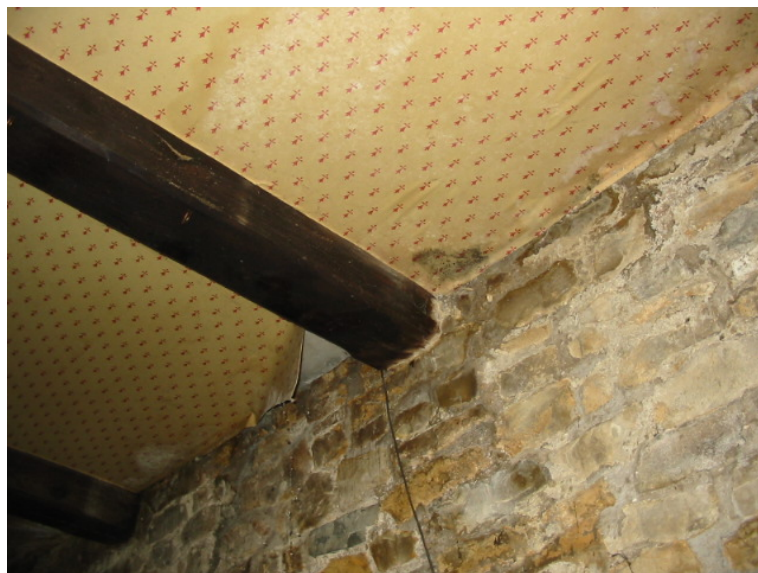
Photo 14 – Damp Staining – Left Wall, Front Lounge, Ground Floor

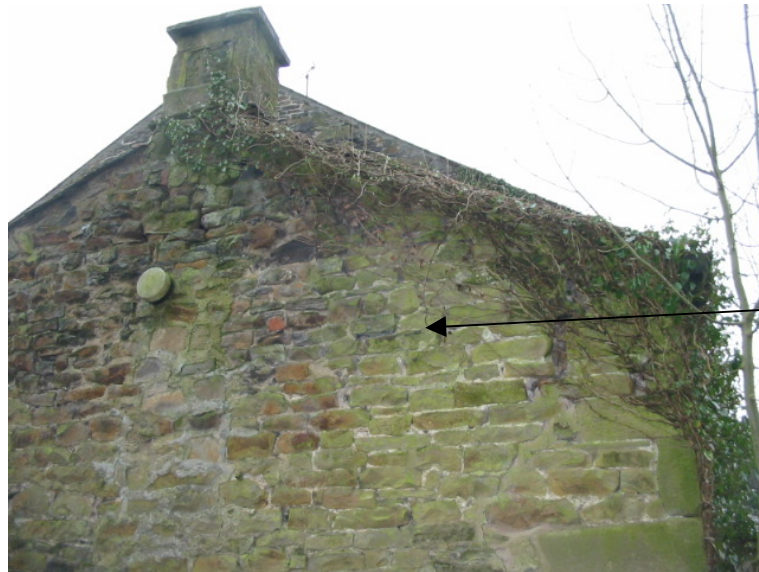
Photo 15 – Right Gable (Low Level)

- On the right-hand single-storey gable, there are some open joints in the stonework (**photo 15**).
- There is a noticeable sag in the ridge of the single-storey kitchen roof.
- At the rear left-hand corner, there is some cracking or opening of joints around the stone quoins near eaves level.
- There is a hole in the stonework and a vertical crack in the left-hand gable wall (**photos 16&17**). The stonework has been pointed with cement mortar. The face of the stone is eroded.
- There are several cracks in the render on the front wall. Above the front door, the wall shows a noticeable lean backward.

Open Joints
in
Stonework

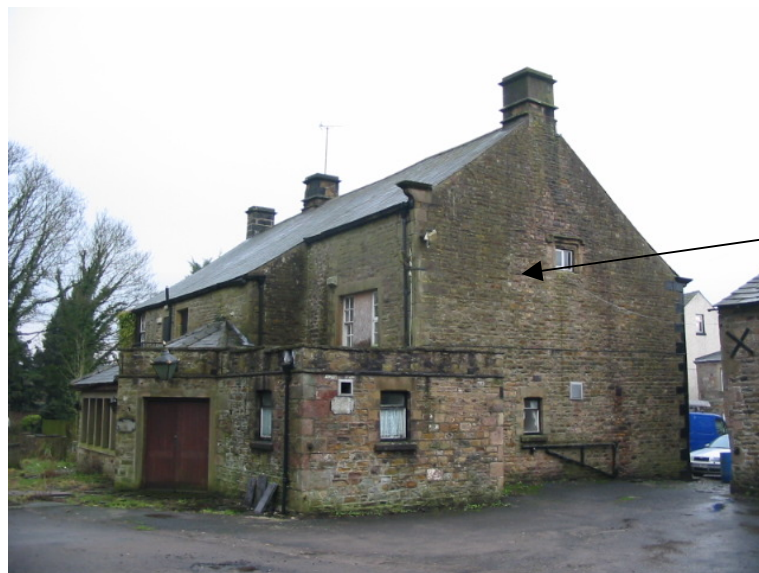
Photo 16 – View of Left Gable Wall

Location of
Crack

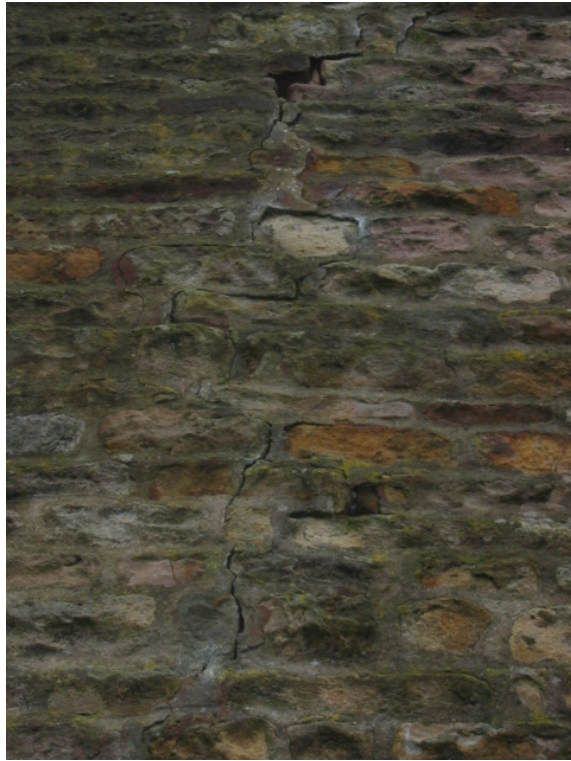
Photo 17 – Crack and Hole in Left Gable Wall

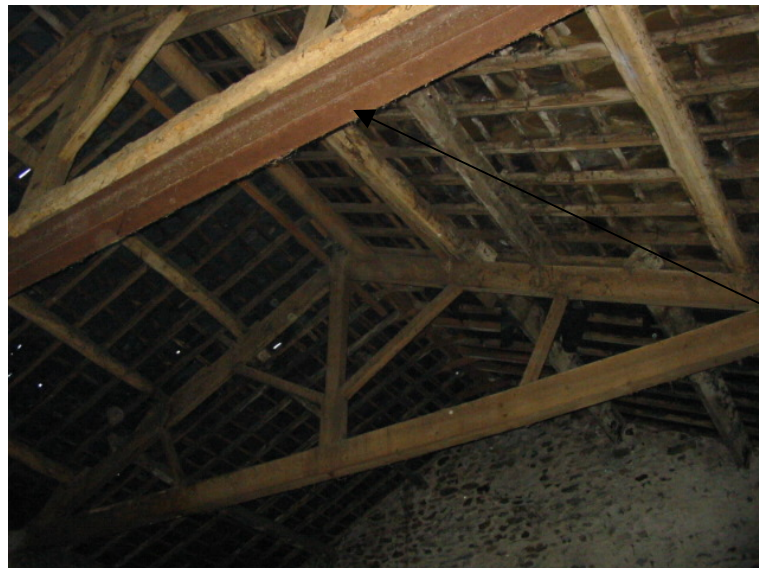
Photo 18 – Barn Roof Structure

- The barn roof has four timber trusses, all of a king post arrangement, creating five bays of timber purlins.
- Close inspection of the timber rafters and purlins could not be made from ground level. The rafters appear to be more recent replacements, not original timbers. Some purlins appear to be of original hewn timber, others are more modern sawn timber replacements. The roof covering remains largely intact and no obvious signs of decay in the timber rafters and purlins were noted.

- The first truss from the right-hand gable is of relatively modern sawn timber, and appears to be in reasonable structural condition. The second truss is similar, but appears to be propped by several timber posts rising from the floor. It is possible that these timbers may have been part of a partition wall or screen. The third truss appears to be original, but has been strengthened by the provision of a steel beam below the bottom tie, and additional timbers on both sides of the principal rafters (**photo 18**). The fourth truss is a more recent replacement, in sawn timber, and appears to be in reasonable condition.

Steel Beam

The roof should be stripped and the timbers inspected by a timber preservation specialist. It may be possible to retain and re-use the majority of the existing rafters and purlins, and the three timber trusses of more recent construction. The

strengthening work to the one original truss would need to be assessed to see if it is of a standard sufficient for inclusion in a commercial building to be used by the public.

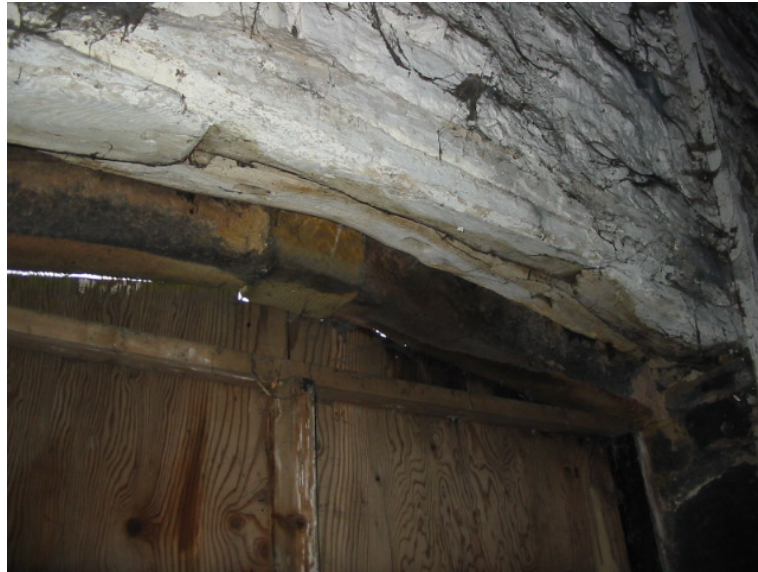
- The inside face of the front, rear and left-hand gable walls of the barn appeared to be in reasonable condition. Holes remain in the walls where the floor timbers of former upper floors were supported. Insect infestation and decay was noted in the timber inner lintel over the front and rear doors (photo 19).
- The right-hand gable wall contains an area of badly damaged and poorly consolidated masonry below a high-level doorway (**photo 20**).
- There was no access available to the rooms or spaces at the left-hand side of the main barn.

Photo 19 – Decayed Timber Lintel above Rear Door of Barn

The right-hand gable wall is significantly distorted and partially collapsed on the inside. The central portion of this wall should be re-built. Decayed timber lintels should be replaced. The stonework should be cleaned, the joints raked out and the whole of the external face of the external wall re-pointed with lime mortar. On the internal face, the re-pointing can be restricted to cracked or poorly consolidated areas.

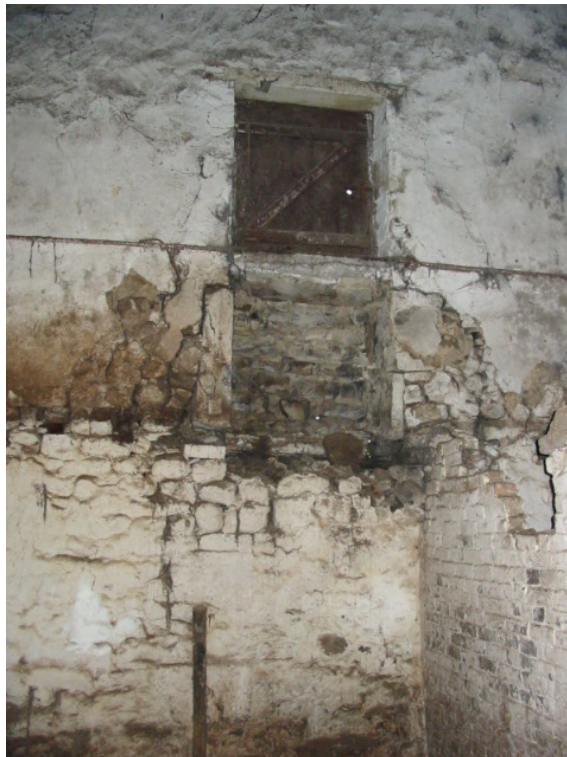
Photo 20 – Cracked and Loose Stonework on Inside of Right Gable Wall of Barn

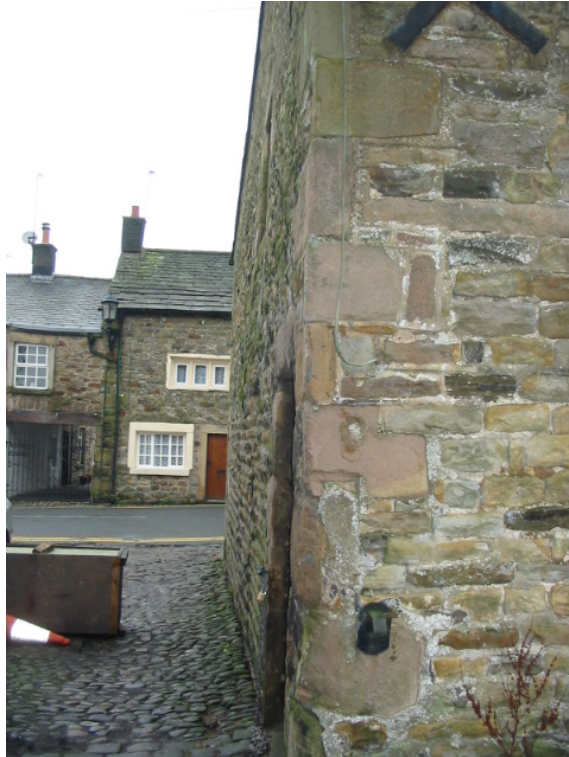
- The front wall (Talbot Street) appears to be in reasonable condition. Some open joints and erosion of the stonework were noted, especially close to leaking gutters.
- The right-hand gable wall is in poor condition and shows a significant outward bulge below the high-level door opening (**photo 21**). A metal tie bar has been installed between the front and rear walls at mid-height of the gable, presumably to prevent outward movement and separation of the gable stonework.
- The rear wall shows noticeable distortion along its length, in particular to the right (as viewed from outside) of the rear entrance door (**photo 22**). The stonework is eroded, in particular close to the rainwater downpipe closest to the right-hand gable. Stones are dislodged or missing each side of an old clay flue near the left-hand gable.
- No significant defects were noted in the left-hand gable wall.

Photo 21 - Distorted Right Gable Wall of Barn

The conversion of the barn should include a new blockwork internal lining wall, tied to the existing stonework. This, in conjunction with a new first floor and upgraded roof, should add significantly to the overall robustness of the structure and prevent future distortion of the external walls.

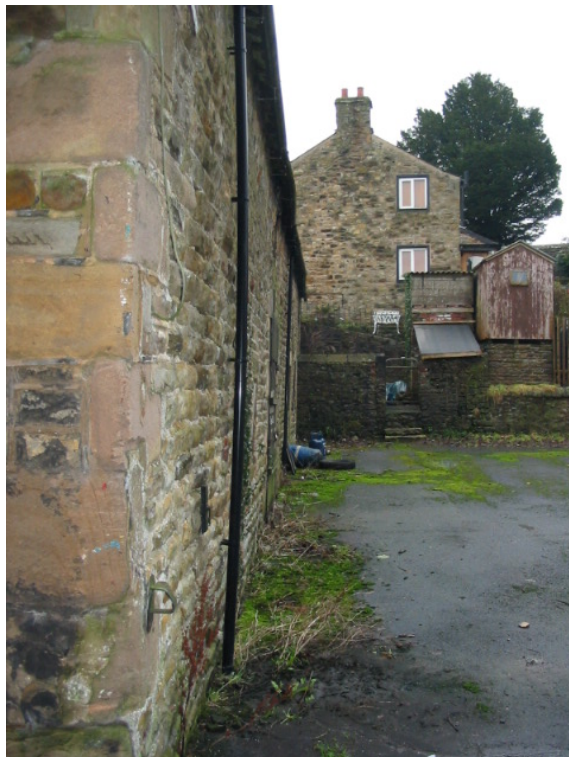
Photo 22 – Distorted Rear Wall of Barn
