| ARBORICULTURAL IMPACT ASSESSMENT | |
| Site: | The Whins, Whins Lane, Read, Lancashire, BB12 7QY |
| Report Date: | 31 October 2012 |
| Report Ref: | BTC344 |

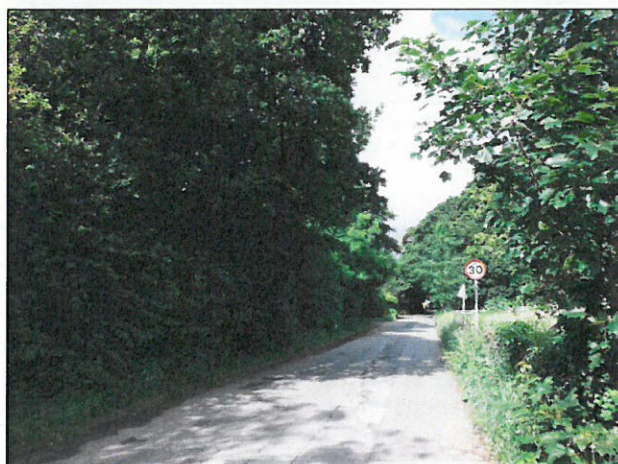
Fig. 1: Whins Lane, as seen from outside the site looking west, with the crown of Oak tree T5 visible to the left

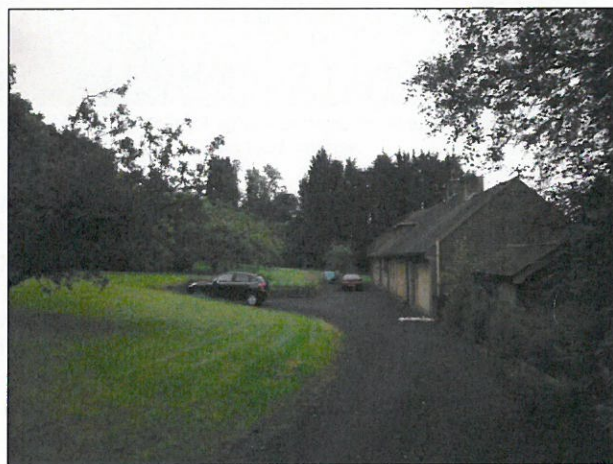
Fig. 2: The existing property, as seen from the west looking east, with group G9 in the background just right of centre

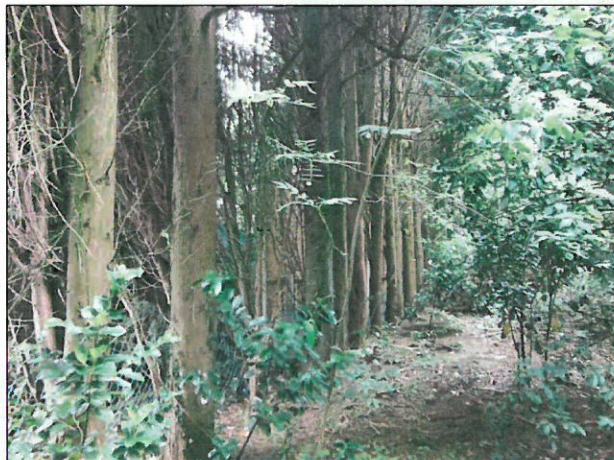
Fig. 3: Outgrown Leyland Cypress hedge forming group G11, along western boundary

| No. | Species | Height | Stem Diam. | Branch Spread | Branch & Canopy Clearances | Life Stage | PC | General Observation and Comments | Management Recommendations | ERC | Cat. Grade | RPA (m <sup>2</sup> ) | RPA Radius (m) |
|---|---|---|---|---|---|---|---|---|---|---|---|---|---|
| G11 | approx. 100no. Leyland Cypress | ≤ 19 | ≤ 450 | N ≤ 2.5<br>E ≤ 2.5<br>S ≤ 2.5<br>W ≤ 2.5 | ≥ 0<br>≥ 0 | SM-EM | G | <ul style="list-style-type: none"> <li>Very closely spaced linear group mostly along boundary.</li> <li>Approximately 70% have been reduced to a height of approximately 13m.</li> <li>All have tight forks and/or included bark unions of branches.</li> <li>Several trees have sustained upper crown failure.</li> <li>One tree has sustained rootplate failure.</li> <li>Short projected remaining safe life expectancies.</li> </ul> | <ul style="list-style-type: none"> <li>Remove due to short remaining safe life expectancies.</li> <li>Grub out stumps outside retained tree RPAs and grind out stumps within tree RPA.</li> </ul> | <10 | U | ≤ 92 | ≤ 5.4 |

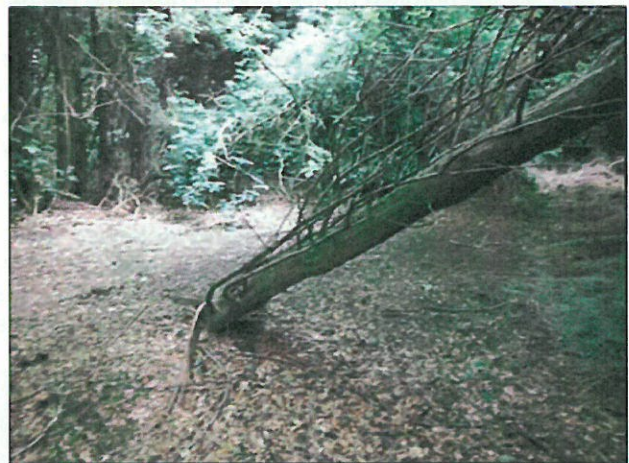
Fig. 4: Substantial sized branch failure of approximately 300mm diameter from Leyland Cypress in outgrown hedge
