**The Sanctuary, Langho  
TREE SURVEY REPORT**

**Dated: January 2013**

**Report to be read in conjunction with  
TPM Tree Survey Drawing 1680.01**

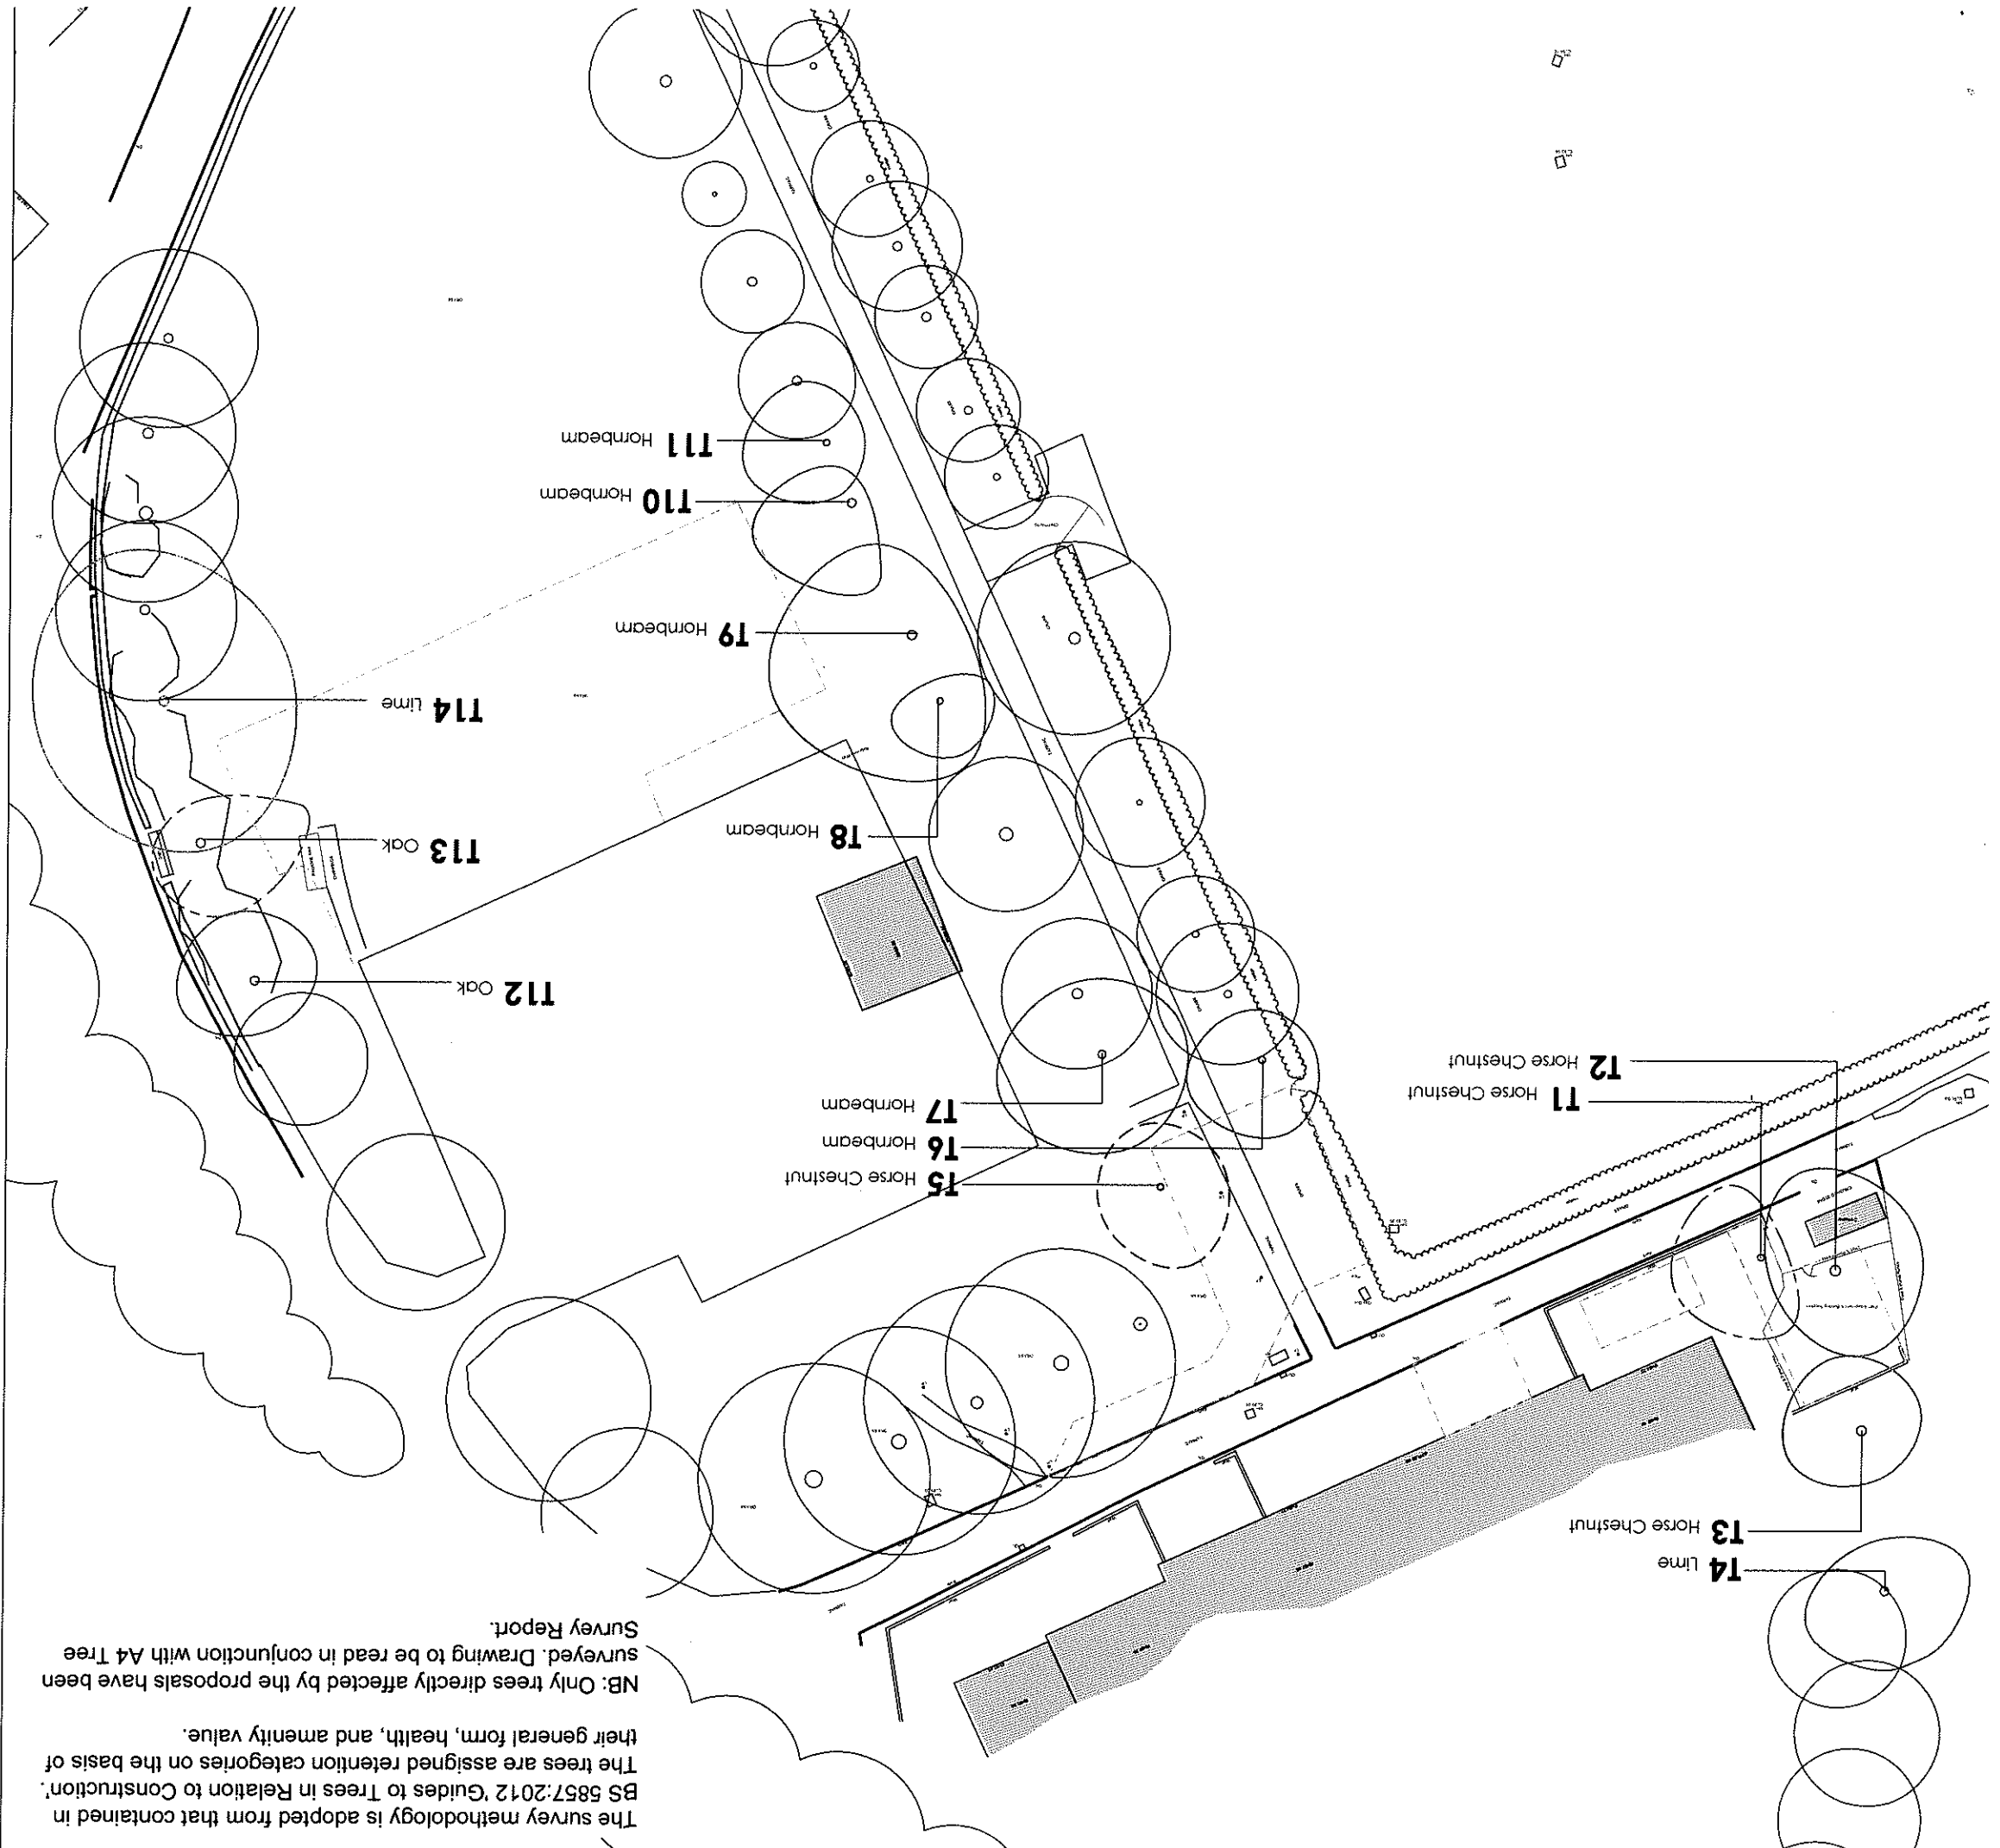
1680.01 Tree Survey Drawing

- T1-T14 are located to the west of the main building and form the end of a larger group of trees which continue north along the eastern boundary. They comprise 3 x Horse Chestnut and 1 x Lime. They have been categorised as B trees apart from one of the Horse Chestnuts which have been graded as a C category tree as it is showing signs of Canker and have a one sided canopy. **These trees form part of W3 in the TPO**

- T5 is a Horse Chestnut located at the start of the avenue of Hornbeams which run the length of the footpath. This tree is in poor condition showing signs of die back and decay and has been categorised as a grade U tree. We would recommend that this tree is felled for health and safety reasons regardless of any development proposals. **This tree form part of G4 in the TPO**

- T6-T7 are two grade B Hornbeams which are the first two trees of a long avenue which stretch along the length of the footpath. They are both mature trees in a fair condition. **These trees form part of G4 in the TPO**

- T8-T11 are all Hornbeams and a continuation of the avenue of trees along the footpath. They are the same as T6-T7 and are mature trees in a fair condition, categorised as grade B. **These trees form part of G5 in the TPO**

- Trees T12-T14 are located to the east of the proposed car park extension and include 2 x Oaks and 1 x Lime.
- T12 is a large mature Oak which has a good shape and form and been categorised as a grade A tree.

- T13 is an Oak but has a more squat form and showing signs of significant die back therefore only categorised as a grade C tree, it is recommend that the deadwood is removed and this tee monitored for further signs of failure.

- T14 is a mature Lime tree which has a reasonable shape and form. It is in good condition and categorised as a grade B tree.

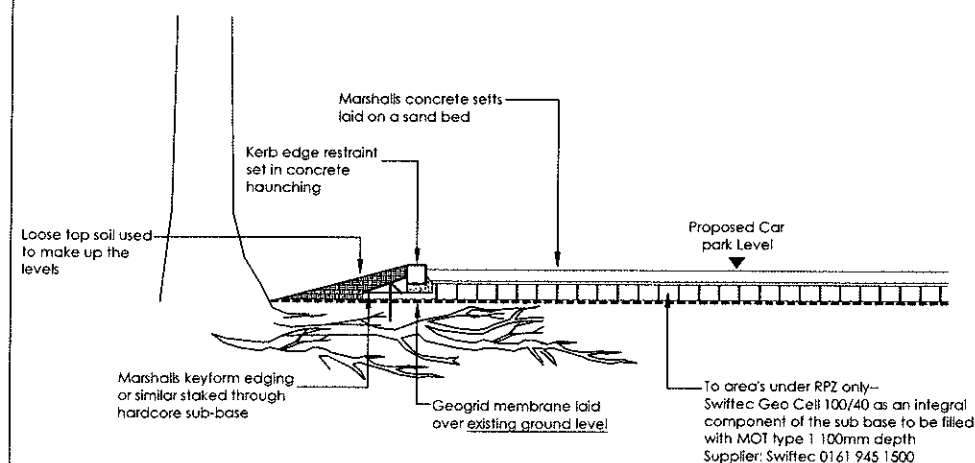
Figure 2

Permeable Block Pave NO DIG construction detail
