**STRUCTURAL CONDITION SURVEY**

**PROPOSED RENOVATION OF  
THE REDUNDANT COTTAGES**

**AT TOP ROW**

**Date:** 12<sup>th</sup> December 2012  
**Author:** L.F Gill B.Sc. (Hons.)

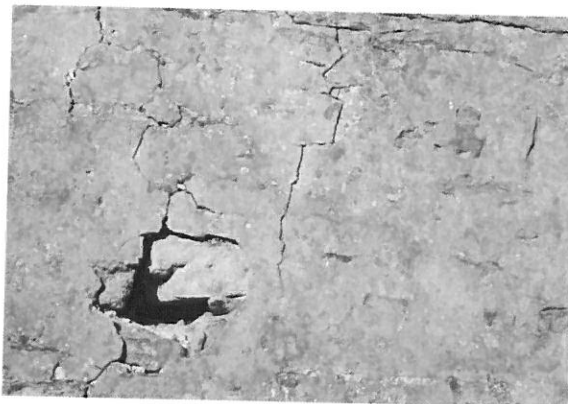
The wall to the south elevation is constructed in random rubble; this random rubble has a sand/cement render finish. The render finish is in poor condition with numerous hairline cracks.

Photograph (1) – Hairline cracks in the render to the south elevation.

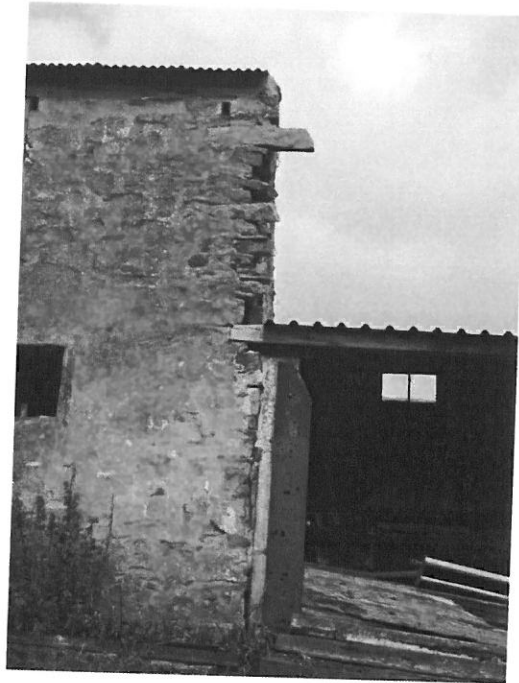
The cottages do not have any stone quoins at any of the corners, this is due to the fact that the cottages remaining today were in the middle of the row originally, so would have been adjoining neighbouring cottages and so consequently were not built with stone quoins. This has resulted in some of the corners having cantilevering stones that are visible; this is where the now demolished adjoining cottages were originally constructed.

Photograph (2) – The cantilevering stones at the South West corner where previously this cottage would have been joined onto adjacent cottages.

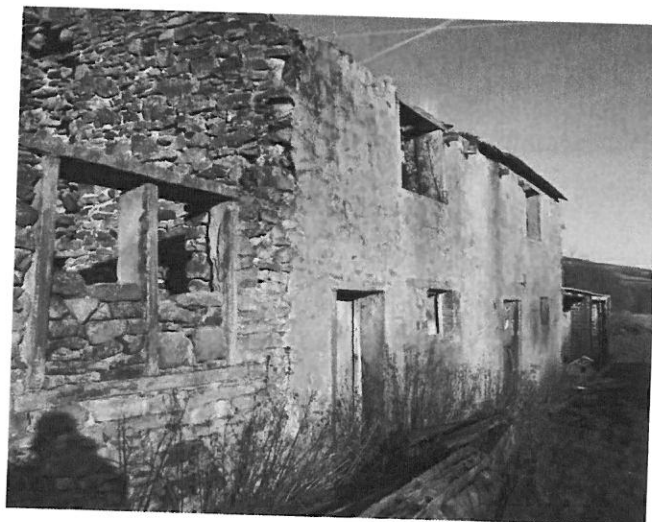
Photograph (3) - Showing the South elevation wall.

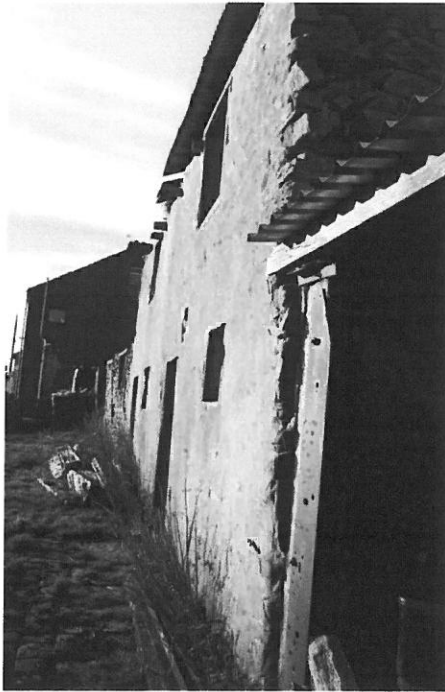
Photograph (4) - Showing the South elevation wall.

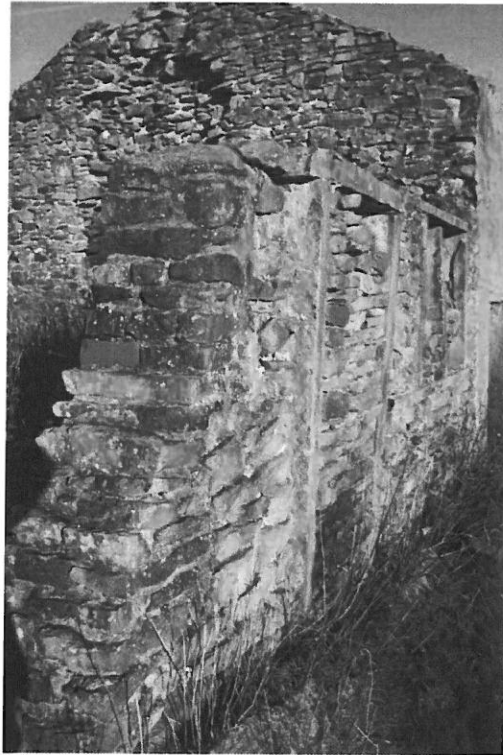
Photograph (5) below shows the western door opening to the south elevation that is no longer plumb. The stoned up door opening is gradually falling over, this is due to the fact there is no wall above the door surround to hold the surround in place. The pointing is also missing around the door surround, as a result the surround is no longer tied into the structure and as a result it is slowly falling over. It is recommended that this section of wall is taken down and rebuilt.

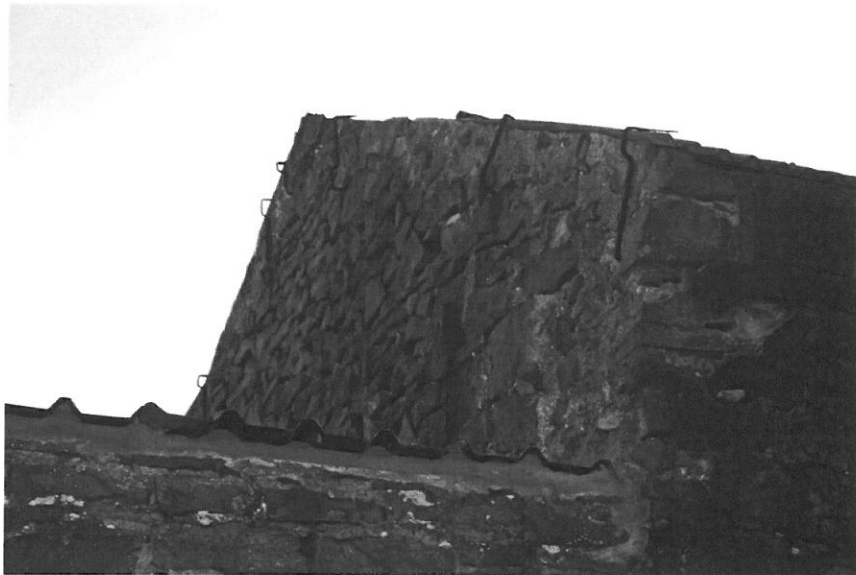
The gable wall to the east elevation is built from random rubble stone; the wall has a single storey outbuilding abutting it but the proposal involves the demolition of this building. The stonework is in good condition but does need re-pointing. The wall is straight and plumb. Metal ties are visible on the East elevation; these have been used to hold in place the corrugated roof sheeting that has been used to re-roof the eastern cottage in the past.

Photograph (6) – East Elevation showing the good condition of the stonework and the metal ties holding the corrugated roof sheeting in place.

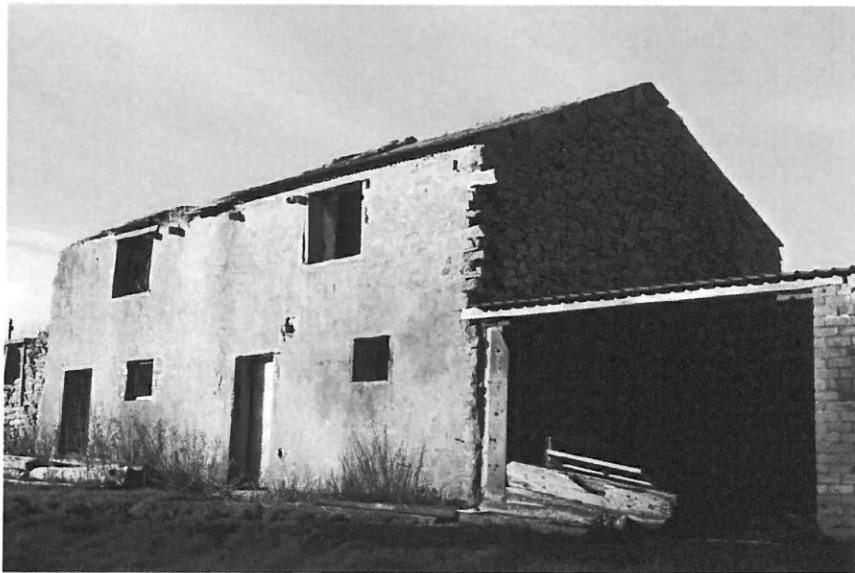
Photograph (7) – East Elevation showing the cantilevering stones at the south east corner as identified previously and the adjoining single storey outbuilding that is to be demolished.

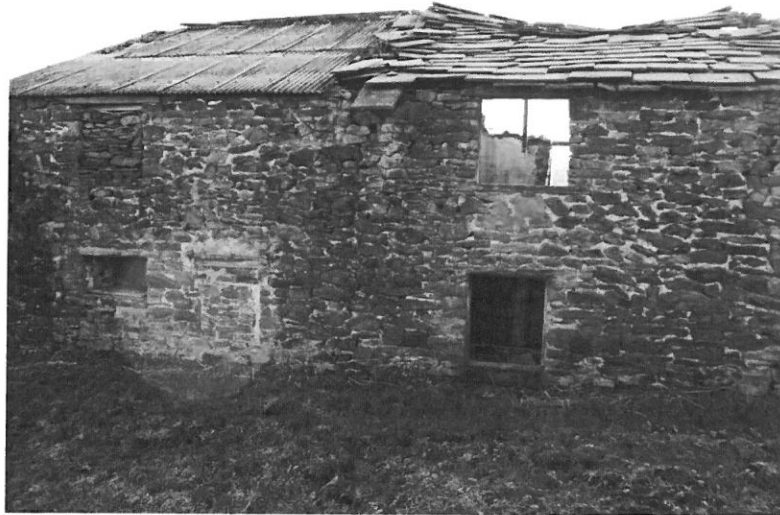
Photograph (8) – North Elevation showing main section of stonework in reasonable condition.

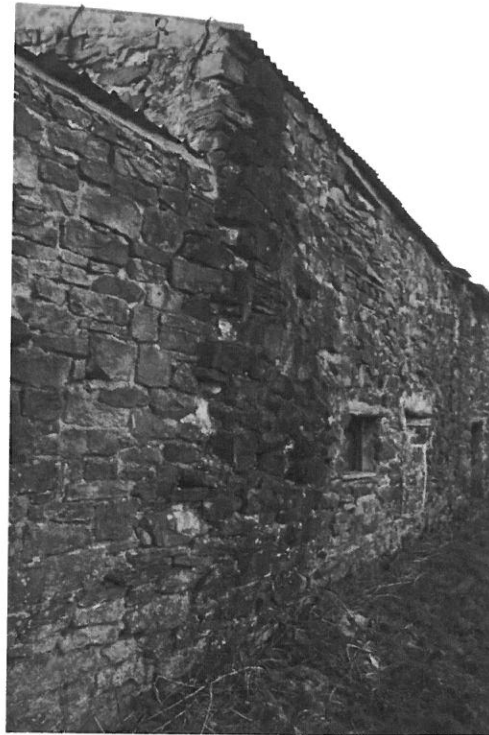
Photograph (9) – North east corner showing slight bow in wall.

The wall is likely to be bowing in these sections due to the fact that when the adjoining cottages were demolished, the corners have not been properly tied together. This historical movement can be rectified by rebuilding the north/east corner and using stone quoins to tie the walls together.

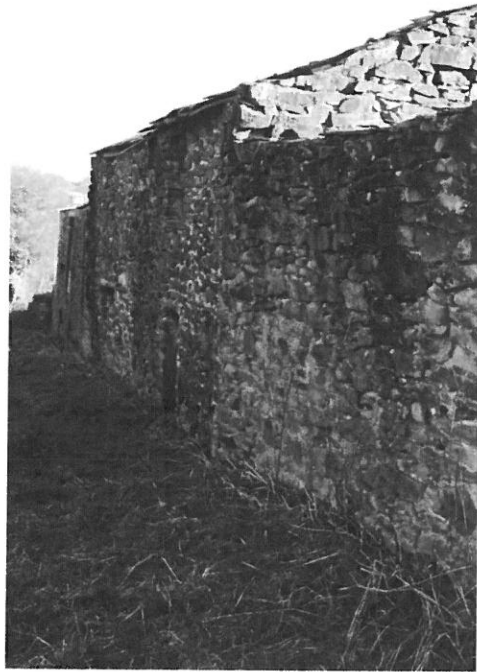
Photograph (10) – North west corner showing slight bow in wall.

The proposal involves the existing north west corner being joined by a new section of wall, this will provide stability to the north west corner and prevent further movement. The section of wall identified in Appendix A will still need rebuilding where it is bowing out however.

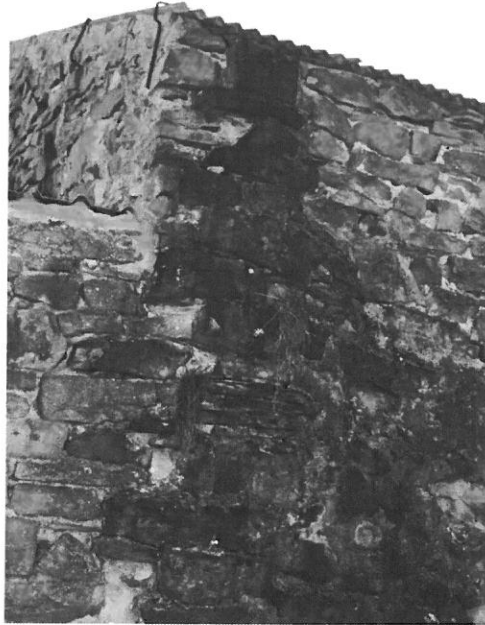
The slight bow at the north/east corner has been further exasperated by the presence of plants growing within the mortar joints in this section of wall, this has been caused due to that fact at some stage the wall has become damp, enabling the plants to take root. The rebuilding of this section of wall as mentioned earlier will rectify this problem.

Photograph (11) – North east corner with plants growing in wall.

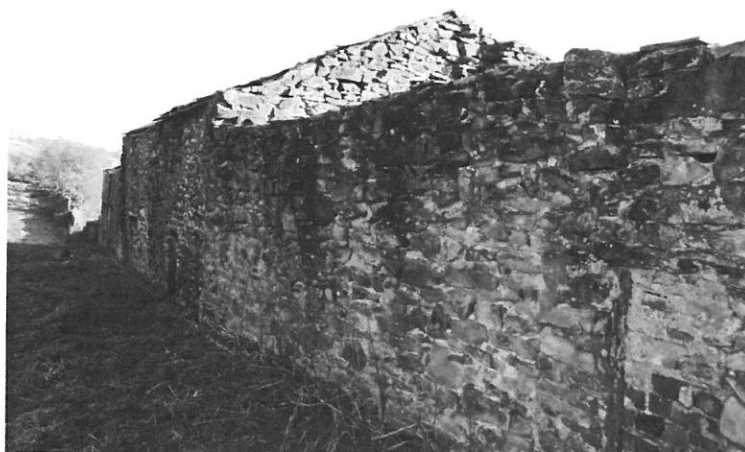
The top half of the wall to the north elevation, which forms one of the remaining walls to the fallen down cottages to the west is in poor condition; it is bowing out at the top. This is due to the fact that the roof would have originally provided lateral restraint to the walls of the cottages, when this collapsed/was removed the walls would no longer have had the restraint required to hold them in place, resulting in the bowing at the top of the wall.

Photograph (12) – Wall forming part of the remains of the fallen down cottage showing the bowing at the top.

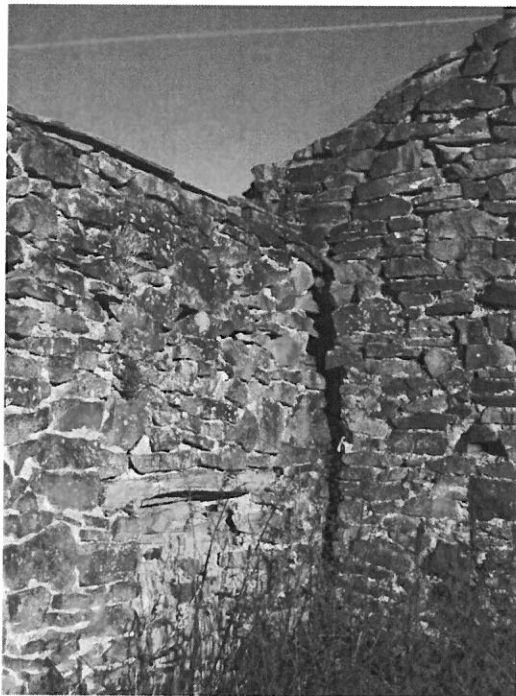
It can also be seen in photograph (13) below that a crack has formed at the north/west corner, this indicates that the wall which will form the proposed Utility and Garage is moving away from the gable wall of the western cottage. This movement would have begun when the roof was removed from the adjacent cottage and maybe on going.

Photograph (13) – Showing the crack at the north west corner.

The proposals involve building part of this section of wall higher than it is currently (as it would have been originally). Although the bottom section of the wall is in reasonable condition, it is recommended that this section of wall which will form the proposed Utility and Garage be rebuilt. This is because even though the movement of the wall away from the gable wall of the western cottage can be stopped, the wall would also need to be reduced in height until the stonework is in reasonable condition to build up off, which may in turn lead to stability issues.

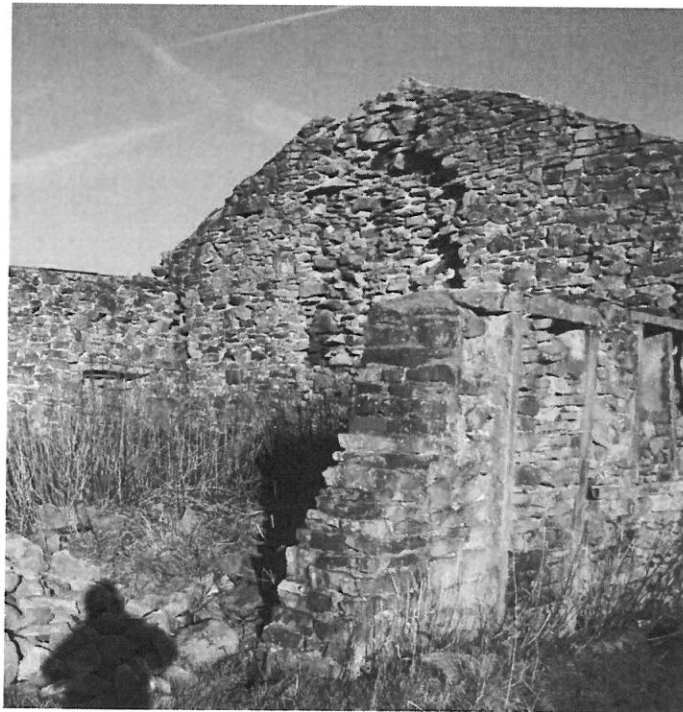
Random rubble stone such as this was built traditionally in two skins of stone with the gap inbetween filled in with all the angular/small sections of stone. In photograph (14) below part of the external "skin" of the random rubble wall has fallen away, a hole has not formed because the internal "skin" of the random rubble wall is still intact. This section of wall may have collapsed along with the roof to the adjacent cottage that is no longer standing.

Photograph (14) – Showing the remaining internal skin of the random stone wall.

Other than this section of missing stonework that will be rebuilt during the conversion works, the wall is plumb.

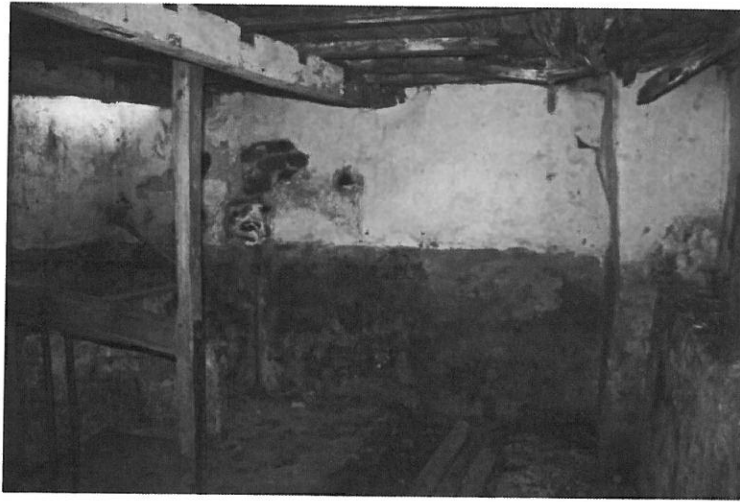
The floor structure to the western cottage is in poor/unsafe condition due to years of water ingress. This water ingress has rotted the timber floor boards and joists and led to partial collapse in some areas, which would have been the result of both water ingress and the collapse of the roof structure.

Photograph (15) – Showing the partially collapsing floor to the western cottage.

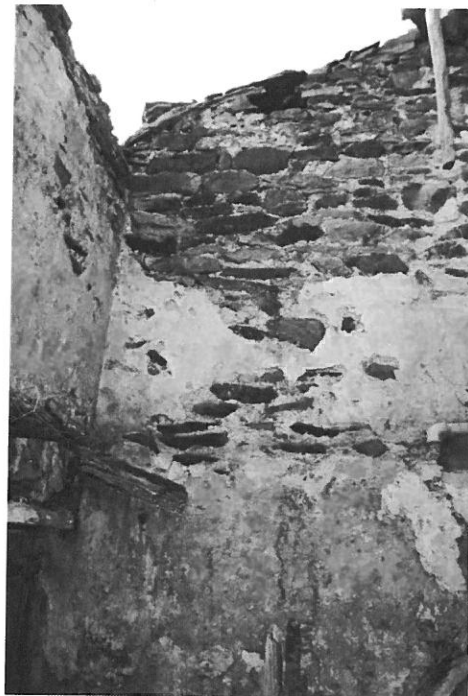
Photograph (16) – Showing some of the collapsed floor to the western cottage and missing plaster.

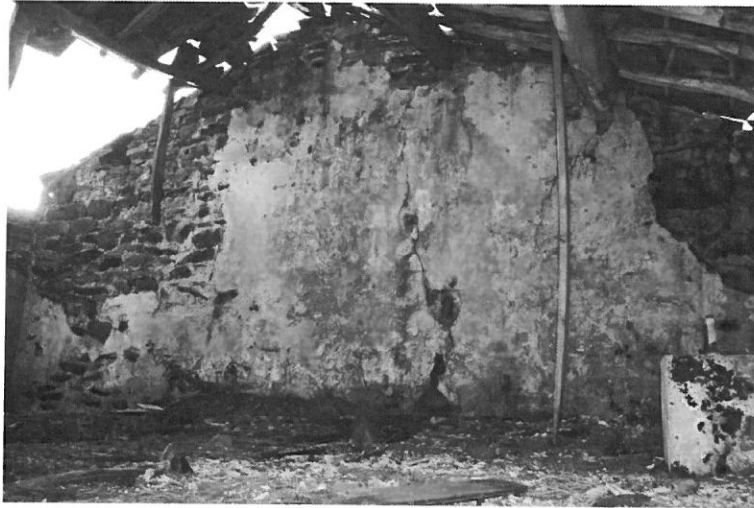
This water ingress has also led to large sections of the original plaster coming off the walls as can be seen below, cracks within the plaster are visible where the remaining plaster is becoming loose. The internal walls are plumb and straight.

Photograph (17) – Showing plaster missing in the western cottage.

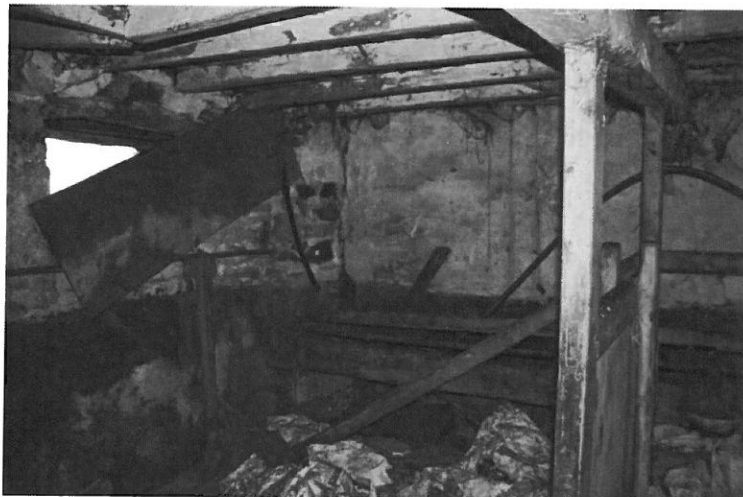
The floor structure to the eastern cottage is in good condition and has been used as a hayloft recently. The internal walls in the eastern cottage are in good condition, although small areas of plaster are missing in places.

Photograph (18) – Showing the good condition of the walls and floor to the eastern cottage.

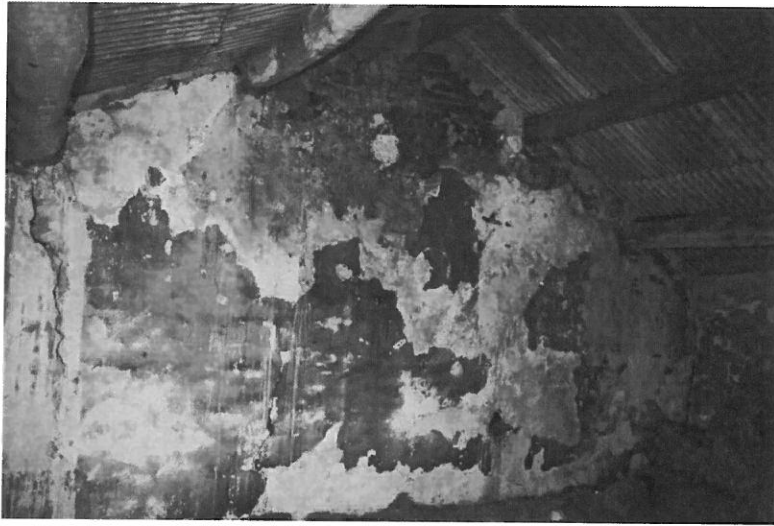
Photograph (19) – Showing the condition of the walls at first floor in the eastern cottage.

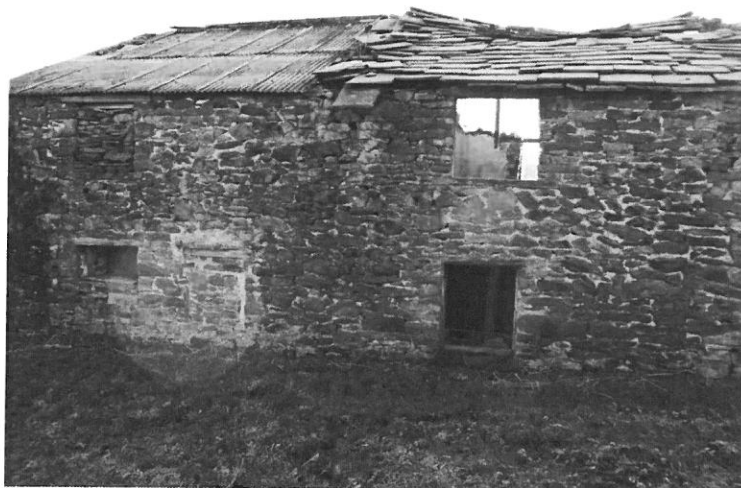
Originally, both of the remaining cottages, along with the ruined cottages to the west would have had a grey slate roof, as is traditional of buildings of this age in the area. The cottage to the west still has the remains of a grey slate roof, the majority of this can be seen from the north elevation, see photograph (20). However, the eastern cottage has been re-roofed at some stage and the roof is now covered in corrugated sheeting.

Photograph (20) – Showing the grey slate roof to the western cottage and the corrugated sheeted roof to the eastern cottage.

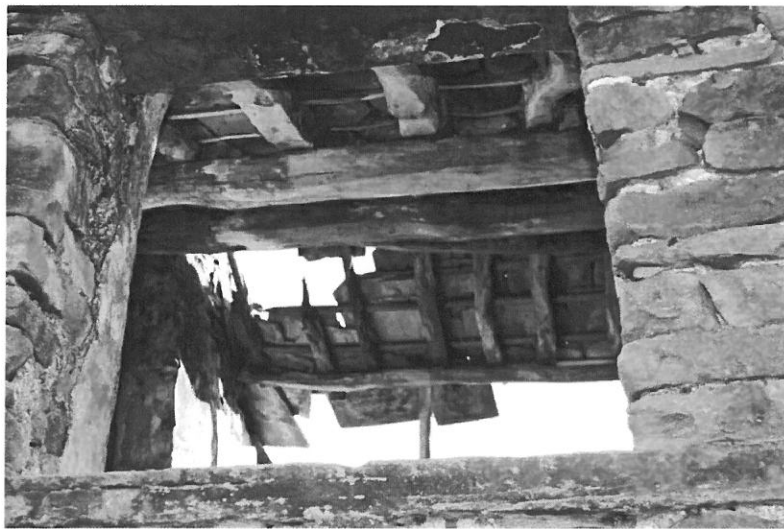
A large part of the western cottages roof to the north elevation is in tact; however, the majority of the roof to the southern elevation has collapsed. The most likely cause of this is water ingress that will have been allowed to continue unchecked. Over a number of years this will have lead to the timber members in the roof rotting and eventually failing. Consequently, the majority of the roof timbers to the western cottage will need to be replaced; it maybe possible to retain some of the purlins and rafters to the north elevation but these members may need to be repaired if they are to be retained.

Photograph (21) – Showing part of the roof to the western cottage.

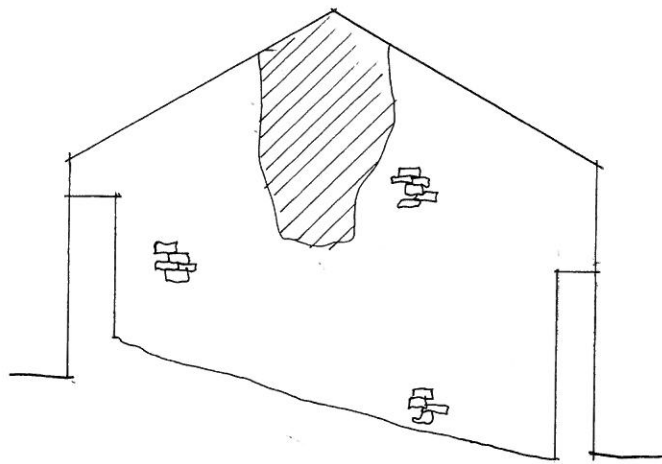
West Elevation

External skin of random rubble to be rebuilt.

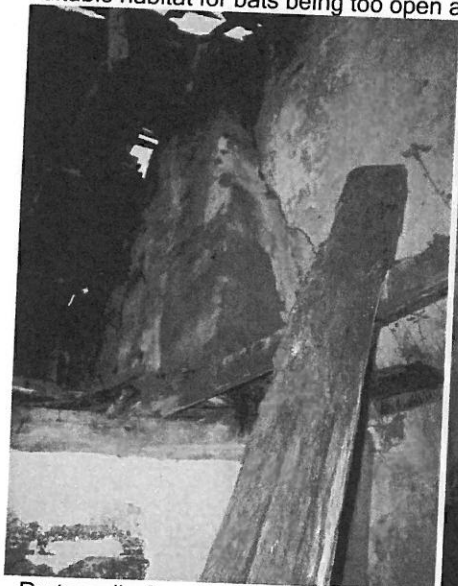
Party wall of cottages.

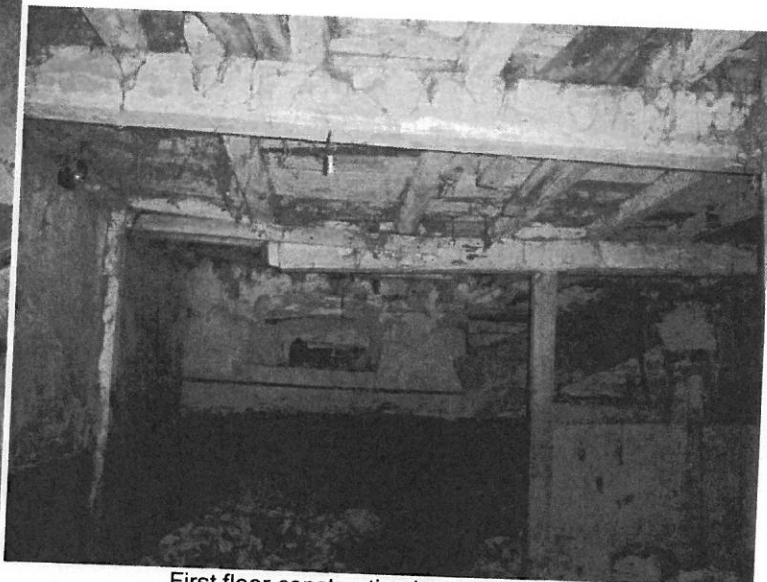
First floor construction in one cottage.
