**RE. THE RANN, SACCARY LANE, MELLOR, BLACKBURN BB1 9DL**

**STRUCTURAL APPRAISAL OF FORMER COTTAGE AND DOMESTIC STORES**

**STRUCTURAL APPRAISAL OF OUT BUILDINGS/DOMESTIC STORE**

Survey in Relation to Bats & Breeding Birds

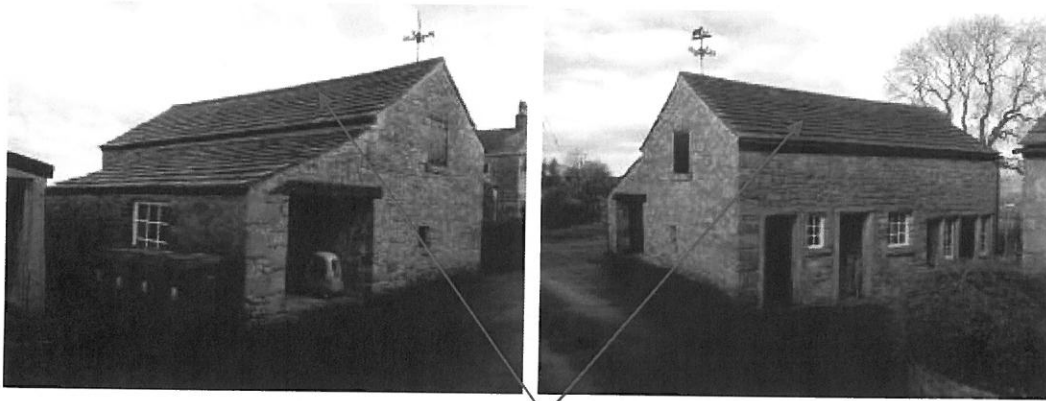
- 7.5 During the interior inspection it was noted that underfelt is present beneath the stone roof tiles, which will significantly increase potential in this area for crevice dwelling bats, such as the Pipistrelle bat, whereby they often roost between the two materials, provided that external access is available. The breeding roosts of Pipistrelle bats are proportionally higher in occupied residential dwellings where the warm, dry conditions favour the requirements of a maternity colony but other structures are also used, especially for hibernation or by male bats outside of that time as they do not need the same conditions as a maternity colony.

**Building 1 proposed for conversion – gaps present between roof tiles**

- 10.1 For the reasons outlined in the survey results it is recommended that in order to establish if bats are using the buildings dusk/dawn emergence/re - entry surveys should be undertaken prior to any work being undertaken at both buildings. The surveys will need to be undertaken during the active season of bats i.e. between May – August therefore there will be some time implications in relation to the work schedule. The table below is taken from the Bat Conservation Good Practice Survey Guidelines, which gives guidance in relation to the level of survey effort and concurs with then recommendations of the bat ecologist.

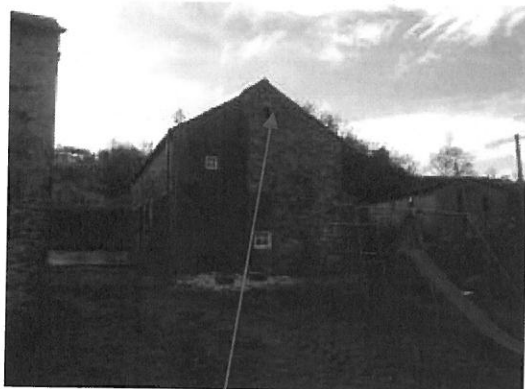
**North elevation of building 1 – gap at gable providing access into structure**

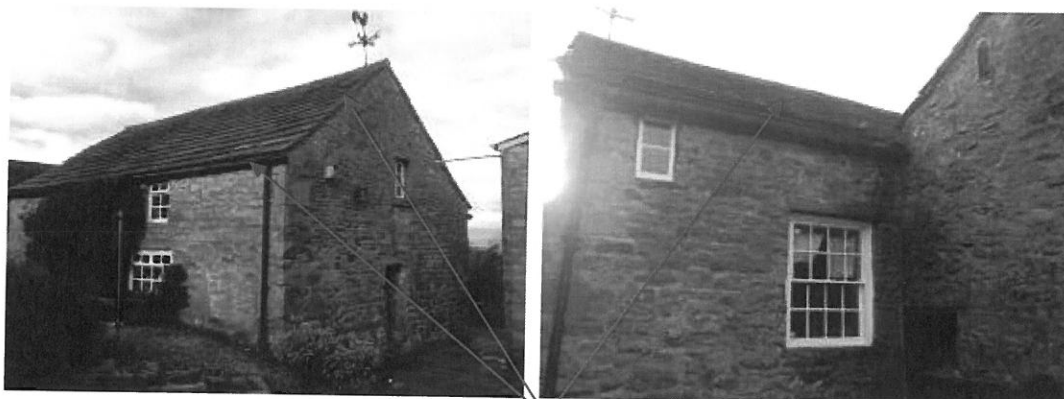
- 7.7 During the external inspection typical places favoured by crevice dwelling bats such as soffit and barge boards are absent, however, timber fascia boards were noted and opportunities exist between the boards and exterior stonework, which could provide access for crevice dwelling species. Additionally, gaps are present between the roof tiles and at the roof verges which offer potential ingress that could be used at any time of the year.

**Building 2 – planned to be sold for future development, potential identified between roof tiles, roof verge and fascia board**

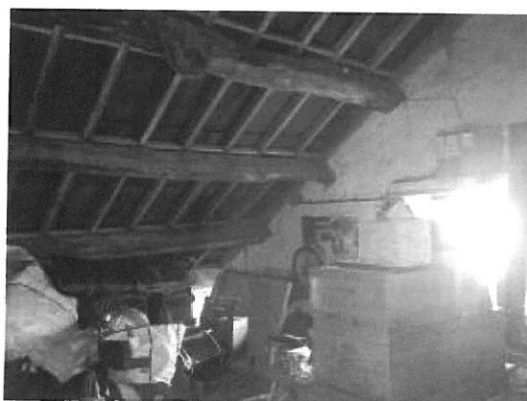
**Light filled & restrictive nature of upper floor within building 2**
