DACW/2871

20th November 2012

Bailey Hall Barn, Hurst Green
TRIAL PITS & CRUCK RESTRAINTS

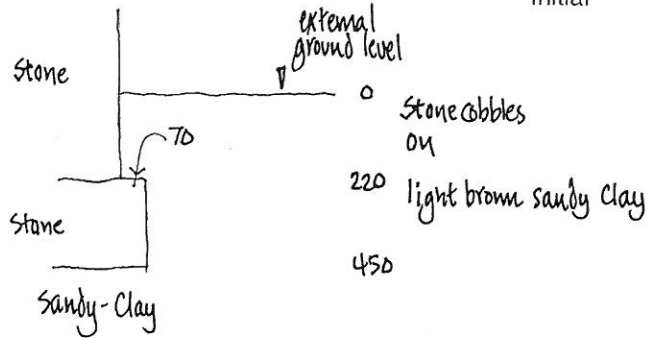
TRIAL PIT 1

The north and east walls are founded between 400 and 450mm below ground level (TPs 1,2 & 3). Providing the finished floor level is at present ground level or better still slightly above, then underpinning can probably be avoided.

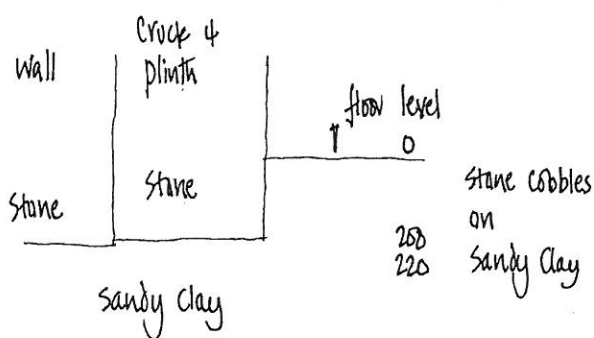
TRIAL PIT 5

The footings found in TPs 5-8 & 13 are founded between 200 and 360mm below ground level. This is too shallow and the walls will be undermined by the excavation for the new ground floor. Underpinning will therefore be required along both the east and west walls and probably the south wall of Unit 1.

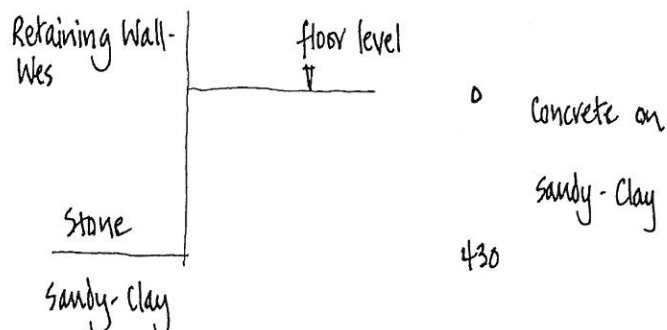
TRIAL PIT 9

Trial pits 9 & 10 show the walls founded 430 and 300mm below the ground floor level. The floor next to TP10 is lower than by TP9 so if the final ground floor level is kept as high as possible, underpinning may not be necessary. Underpinning of retaining walls is always tricky so this will be beneficial.

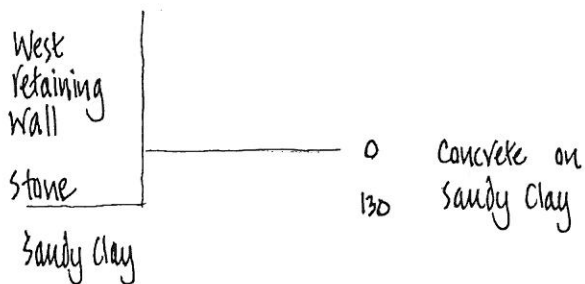
TRIAL PIT 12

The west wall is founded only 130mm below ground floor level (TP12) whilst the north wall is 450mm below ground level. In bedroom 3 at the west wall will have to be underpinned, but it may be possible to avoid underpinning the north wall. Bedrooms 1 & 2 are three steps up and underpinning of the remainder of the west wall and the south wall can probably be avoided.
