Report 434

**BAILEY HALL BARN,  
HURST GREEN,  
CLITHEROE  
LANCASHIRE**

**REPORT**

20<sup>th</sup> April 2012

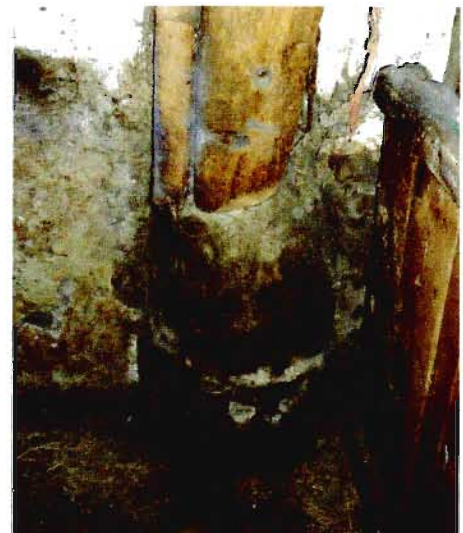
The foot of the blade on the east side of frame 2 has a marked slope down to the north. The stone plinth has been rendered with cement, or may have been replaced with concrete and there are no signs that the base has slipped sideways in the recent past. There are what appear to be two bolts in the face of the post and it is possible that it has been “bolted” back to the wall. Further investigation is required to ensure its continued stability.

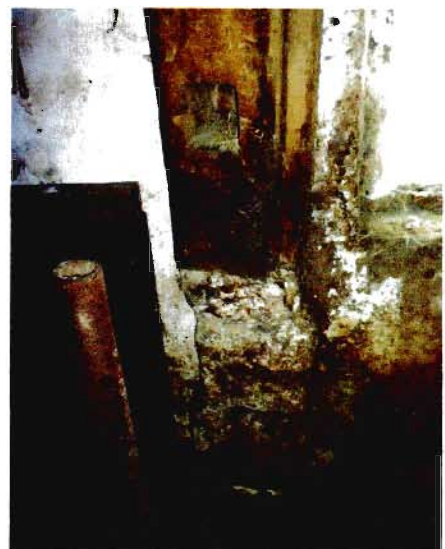
The foot of the blade on the east side of frame 3 is twisted to the north and sits on the edge of the plinth, with the top stone displaced to the north as well. Again it appears to be stable and there is no sign of recent movement but it should be checked for its long-term stability.

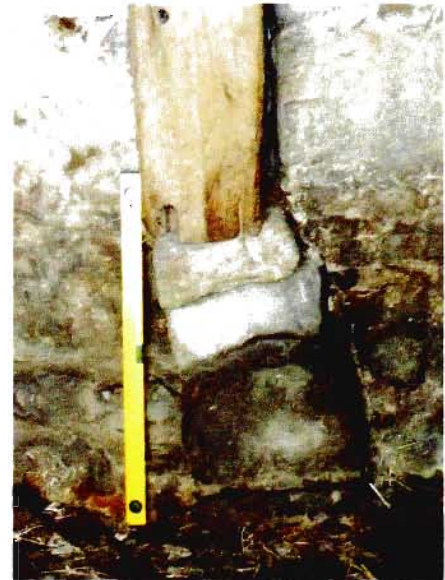
The plinth supporting the foot of the west blade of frame 4 has tilted over to the south by about 110mm, the timber projects beyond the stone by 25mm and the top stone has a slope of at least 80mm down to the south. There is a gap of 80mm between the timber and the wall to the north. The wall to the north follows the tilt of the plinth but there is a gap of 25mm between the two suggesting that there has been movement since the wall was built. There is no evidence of any recent movement but this situation is clearly not stable and strengthening works involving tying the timber / plinth back to the wall will be required.

The plinth supporting the west blade of frame 4 has tilted over to the south by about 110mm, the timber projects beyond the stone and the top stone of the plinth has a pronounced slope down to the south. There is a large gap between the timber and the wall to the north. The wall to the north follows the tilt of the plinth but a gap has developed between the two suggesting that there has been movement since the wall was built. There is no evidence of any recent movement but this situation is clearly not stable. Strengthening works involving tying the timber / plinth back to the wall with stainless steel rods resin anchored into the wall or propping the plinth / timber on the south side with timber / masonry will be required.
