# ABBOTT & LOMAX LTD

Re:- Parkhouse Farm, Clitheroe

Further to your instructions we have visited the above property in order to carry out a visual inspection and prepare a written report on the structural condition of the property.

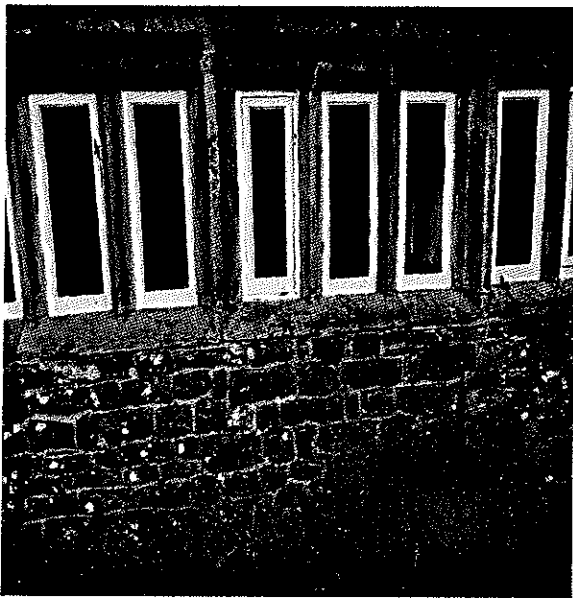
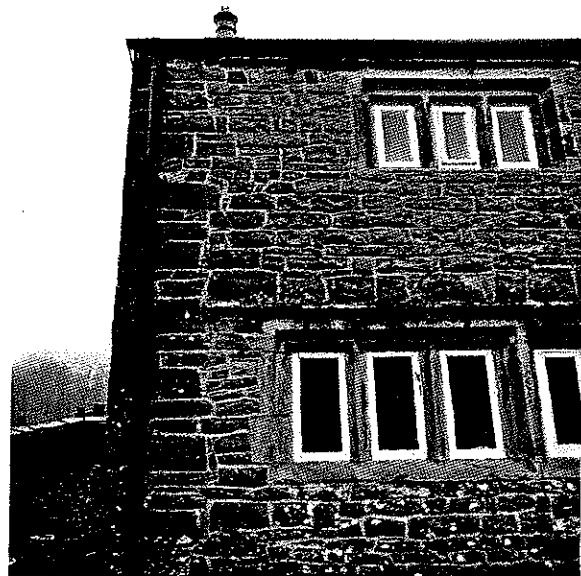
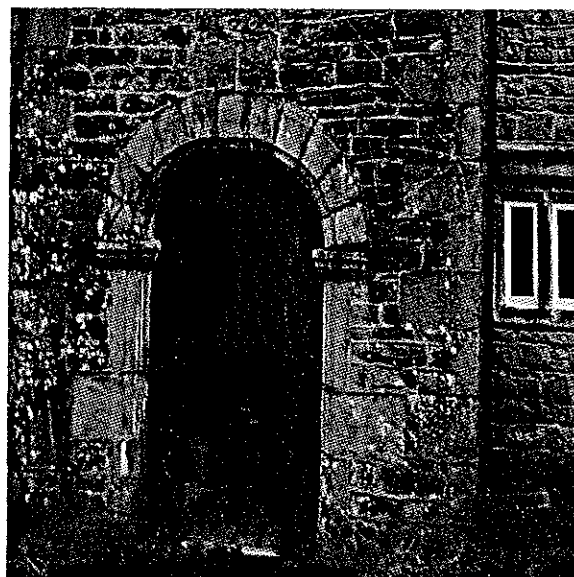
All the external walls were checked for vertical alignment using a 1.2metre long builder's spirit level and, whilst minor local undulations were noted in some areas, the overall alignments were found to be acceptably plumb. The horizontal alignment was similarly checked along the window cills and found to be acceptably level overall. Localised cracking was noted to the dressed stone window surrounds to the left hand side of the entrance porch at both ground and 1<sup>st</sup> floor levels together with some erosion evident to the stone window mullions. In addition the keystone to the stone arch to the entrance porch door has dropped.

- 1) The cracked stone lintel to the side entrance door should be repaired/replaced.
- 2) The vertical crack noted on the rear elevation gable corner should be repaired using a "Helifix" system of reinforced bars or similar approved.
- 3) The movement noted to the keystone to the front porch arch would appear to be of a long-standing nature with no evidence of any recent movement. We do not consider that a repair is necessary at this moment in time, nevertheless we would recommend that this area is inspected at regular intervals to ensure no further movement is taking place.
- 4) We would offer similar comments with regard to the opening up of the joint in the bowstring truss at 1<sup>st</sup> floor level.

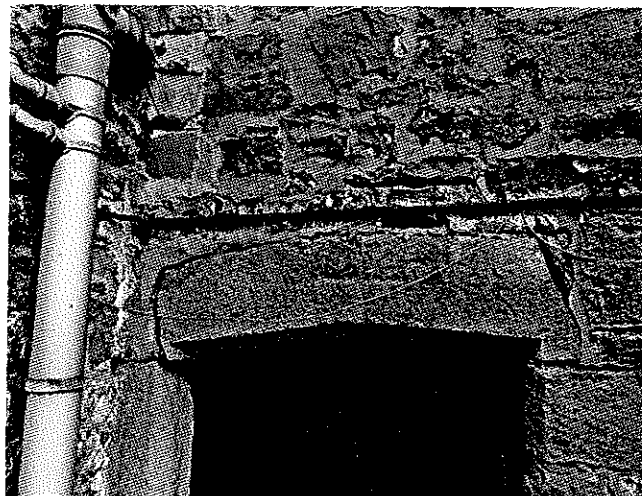
The stone lintel over the side entrance door was found to be cracked vertically at the left hand bearing with the wall.

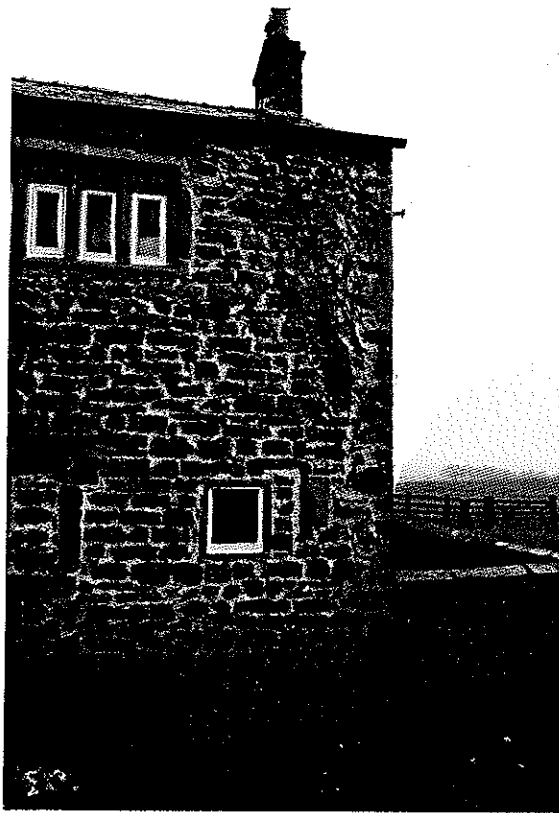
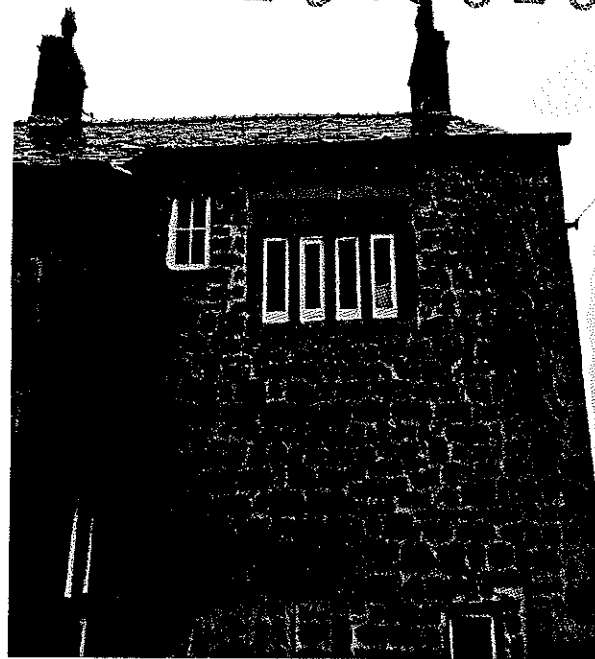
More significantly, similar lateral movement was noted at the right hand corner of this elevation with an accompanying large vertical crack adjacent to this corner generally following the junction of the quoins with the random stone wall.

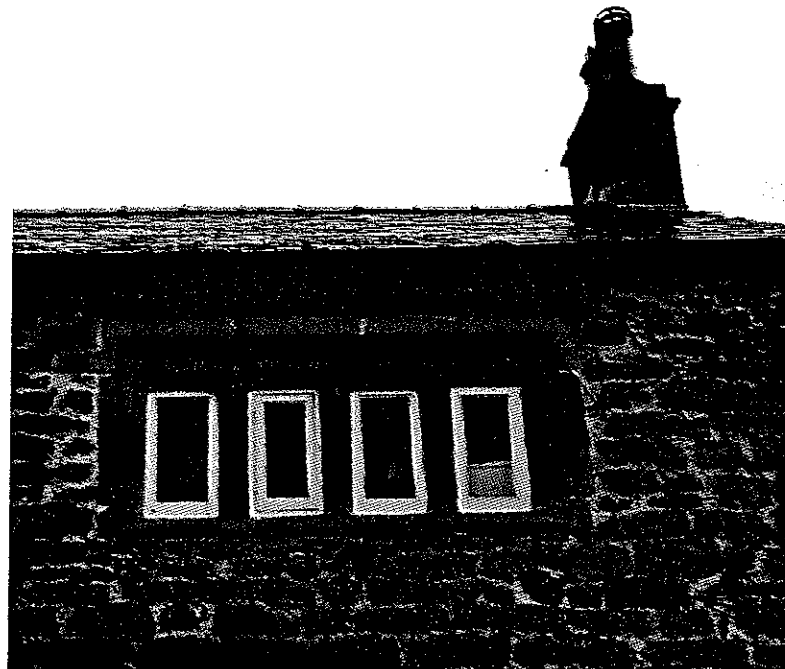
There was also evidence of joint cracking and erosion to the stone window surrounds at 1<sup>st</sup> floor level.

The joint cracking and erosion noted to the stone window surrounds on the external elevations are not strictly speaking a structural problem, nevertheless this deterioration in their condition will leave the external elevations prone to water ingress/damp penetration and will have to be dealt with eventually.

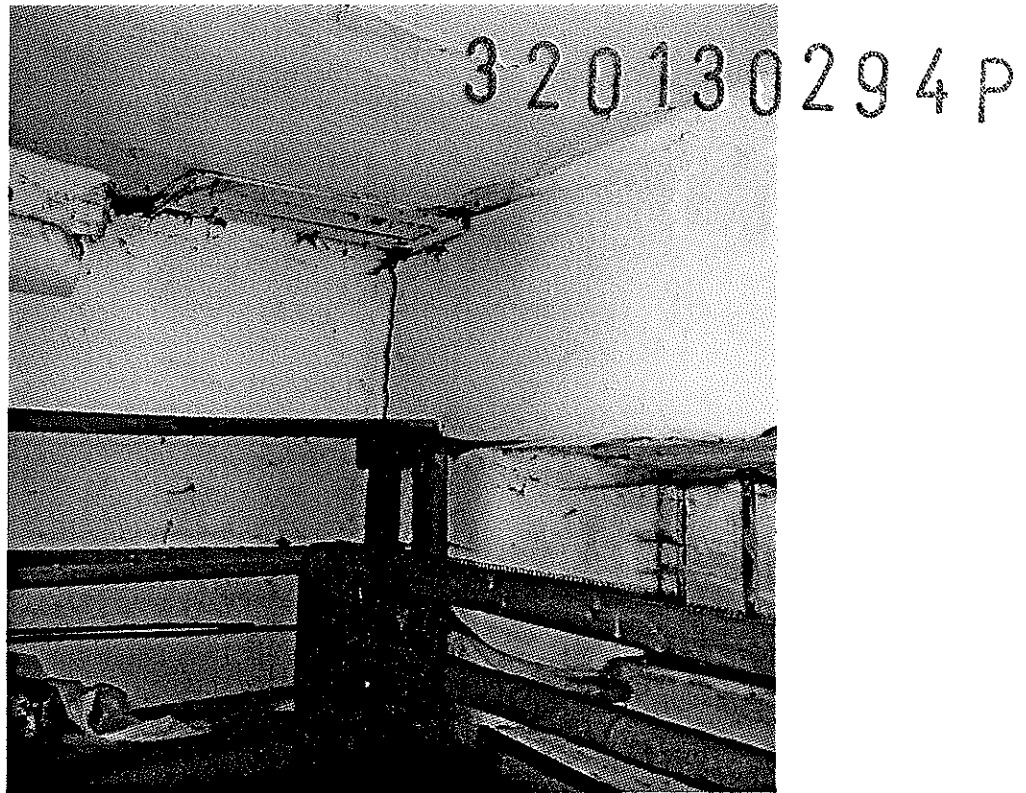
An examination of the ground floor larder confirmed the vertical cracking observed externally on photograph 9 is repeated at the internal junction of the rear and rear gable walls.

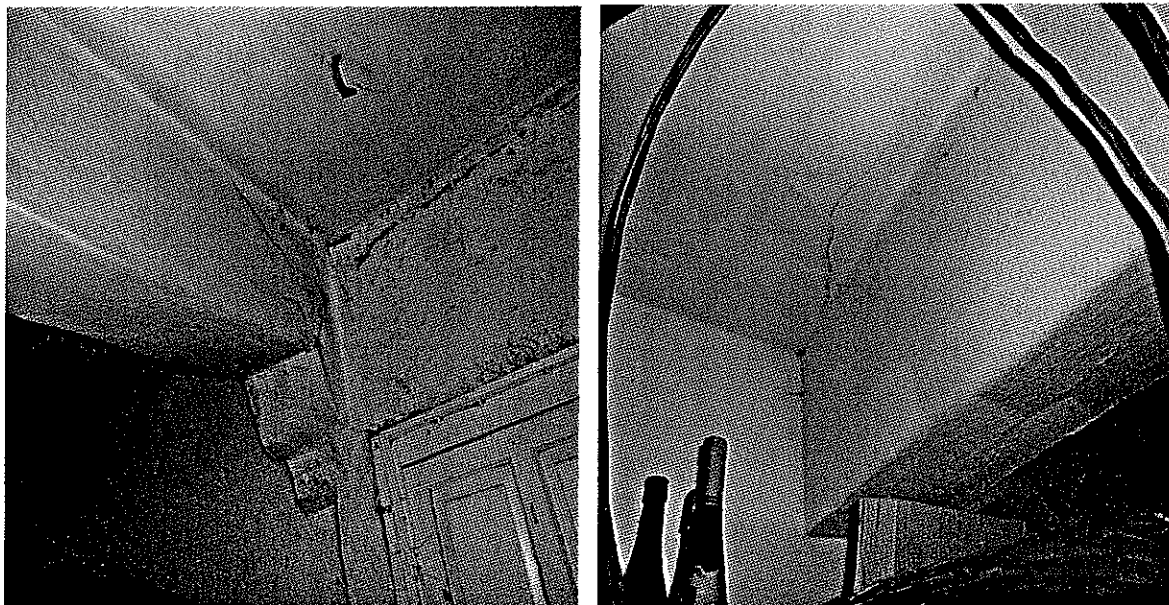
There was also minor cracking evident around the bearings of timber beam in the same room.
