**BAT SURVEY**

**AT  
INTACK FARM  
DUTTON  
LONGRIDGE**

**DATE AND TIME OF VISIT**  
21<sup>st</sup> May 2013 8.30 - 10.00pm

**REFERENCE NO. 4368**

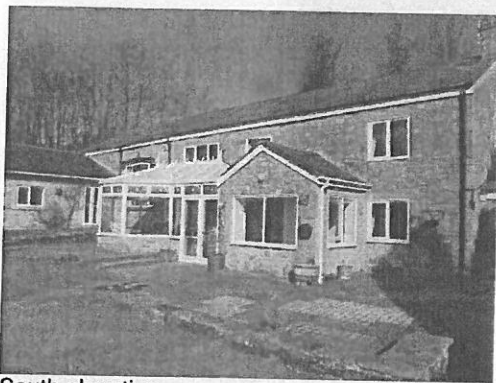
South elevation

COMMENTS: The property is a barn and existing farmhouse conversion probably carried out around 1980's. To the south elevation there is a single storey outrigger which is a more recent addition.

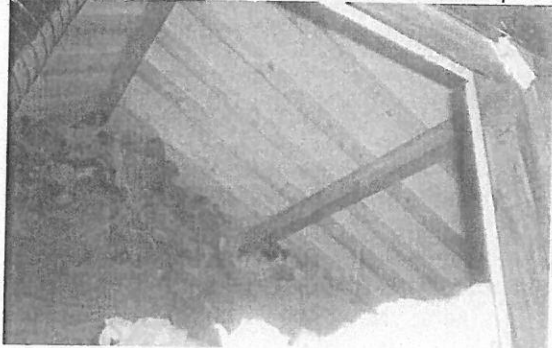
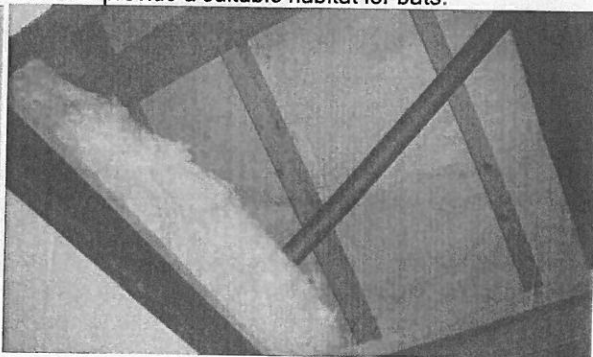
COMMENTS: The roof timbers and felt are new in perfect condition with no cracks or crevices in the timbers. The Roof space is insulated at ceiling level with insulation quilt between the joists. The bedroom to the Eastern end has no ceiling and the rafters are lined out to the underside. It is not possible to access the porch roof void. No evidence of bat usage was found. The roof space does not provide a suitable habitat for bats.
