## **STRUCTURAL APPRAISAL REPORT**

**Cocklick End Farm, Slaidburn**

**United Utilities Property Services**

**March 2012**

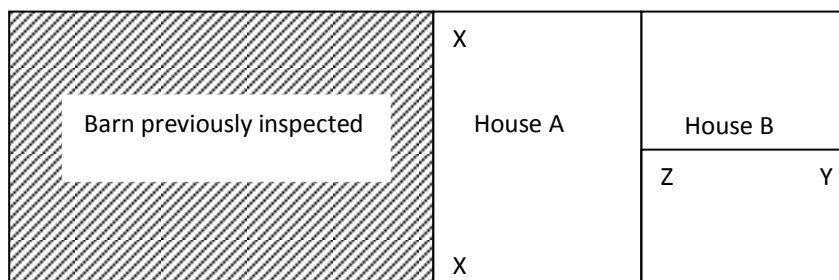
Figure 1

- Vertical cracks throughout full height of wall between house A and the barn to each corner indicating lack of bonding between walls (X in Fig. 1)

- This house was divided into two rooms at ground and 1<sup>st</sup> floor levels by a masonry wall
- Vertical crack throughout full height of wall between houses A and B to each corner indicating lack of bonding between walls (Y in Fig. 1)

- Vertical crack throughout full height of wall between internal masonry wall and the gable wall indicating lack of bonding between walls (Z in Fig. 1)

- 3 Replacement of all timber lintels with stone or precast concrete to the external walls. The internal wall lintels may be replaced in timber.
- 4 Tying of the vertical joints between the houses using stainless steel bed joint reinforcement.

- 5 Tying of the vertical joints between house A and the barn using stainless steel bed joint reinforcement.
- 6 Tying of the vertical joints between internal partition wall of house B and the gable wall using stainless steel bed joint reinforcement.

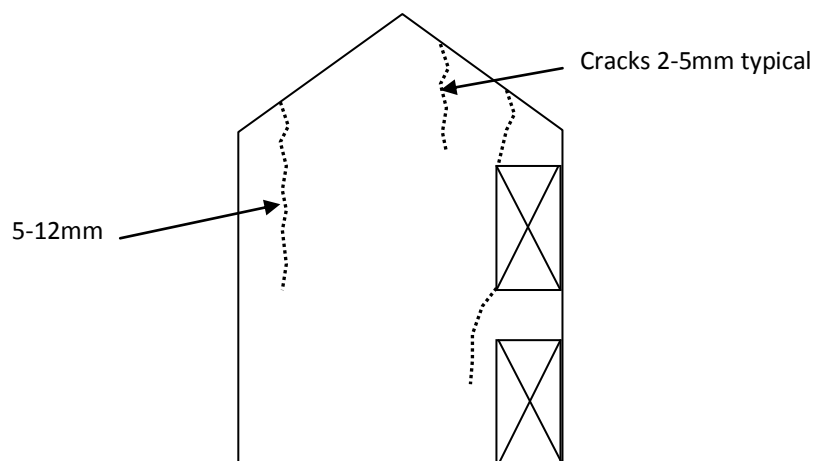
Figure 2

- This area of the building was open over two storeys with the first floor timber structure having been removed deliberately some years ago.
- Window to east façade at 1<sup>st</sup> floor stone infill.
- Timber roof intact but significant timber decay in the bottom tie of the roof truss and in a number of rafters.
- A number of slipped or missing roof slates. The roof was without felt and the slates had mortar backing to the joints
- Timber lintel over window heavy woodworm damage.
- Vertical cracks noted throughout the wall between houses A and B. Generally the cracks emanated from the purlin positions (see Fig 2)

- 2 Repairs to all cracks including the installation of proprietary stainless steel reinforcement ties across the cracks at 400mm centres vertically, ie. Helifix reinforcement or similar

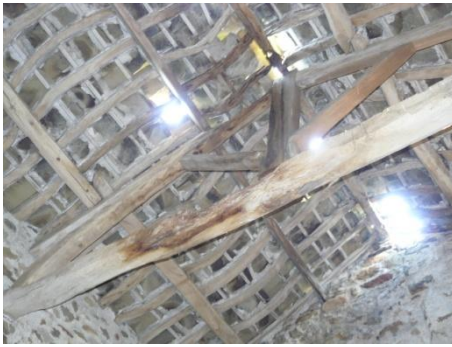
- East roof - stone flag roof to extended house has completely collapsed with failure of timber purlins. Chimney to south gable appeared in reasonable condition.

The roof of the later house extension has partially failed with collapse of the eastern slope and partial collapse of the west.

Collapsed roof of later extension to house

1. Reconstruction of the roof of the extension house including all timber elements, ie. purlins and rafters.
2. Whilst access was not available it should be assumed that 1<sup>st</sup> floor of the extension house will require reconstruction including all timber elements, ie. beams and joists.

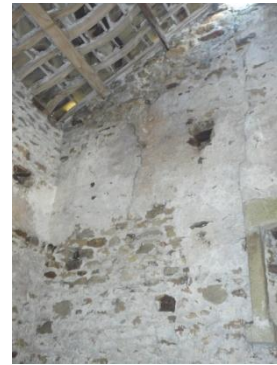
Cracks in wall between houses A and B  
emanating from the purlin support positions

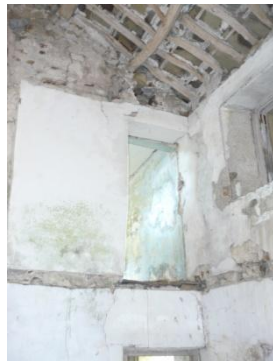
Cracks in wall between houses A and B  
emanating from the purlin support positions

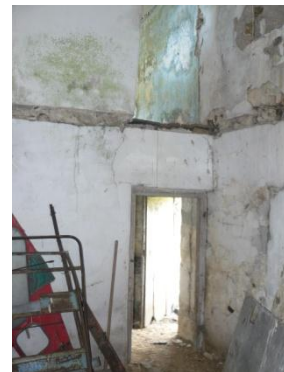
Cracks in wall between houses A and B  
emanating from the purlin support positions

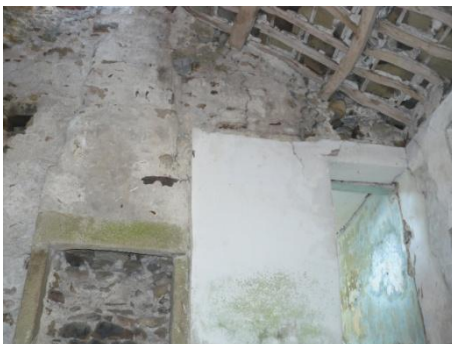
Cracks in wall between houses A and B  
emanating from the purlin support positions

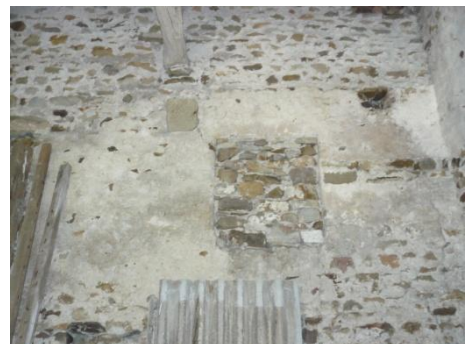
Infilled window to east elevation

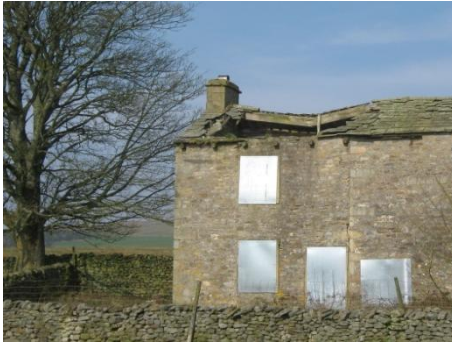
Collapsed roof of later extension to house

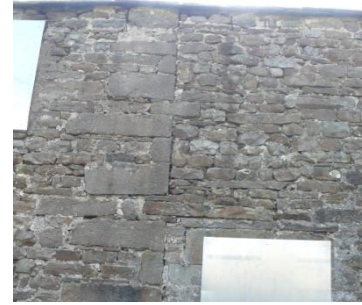
- East elevation vertical joint between original and extended house. Joint is unbonded and has opened by approx. 8mm throughout its height. The original construction was unbonded externally.

Vertical joint between original house and later extension – noted limited bonding

7. Replacement of all internal timber lintels with stone or precast concrete
8. Tying of the vertical joints between the original house and the later extension using stainless steel bed joint reinforcement.

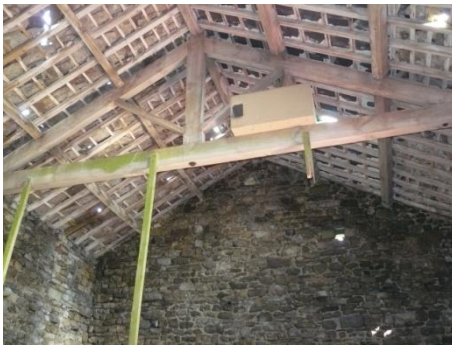
- Internally – main barn. The roof consisted of timber rafters on timber purlins supported off primary timber trusses. The primary trusses and purlins were observed to be in generally very good condition however the end supports built into the external stonework should be checked for decay. The rafters were generally in sound condition except in areas local to missing slates in which some decay and rafter failure has occurred. The roof has no felt and some areas of back pointing with lime mortar were noted.

Barn roof - note truss in sound condition

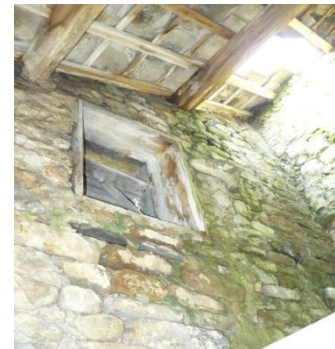
- Internal - room to left of barn door. The 1<sup>st</sup> floor within this space has been removed. The roof has numerous holes with signs of long term water penetration. This has resulted in considerable weathering of the stone walls and some areas of decay in the timber rafters. The floor is constructed as stone cobbles. The windows were noted to have no lintels internally and the surrounding stonework was generally supported by the window framing.

Internal stonework deterioration in barn room to left of main door - note no lintels

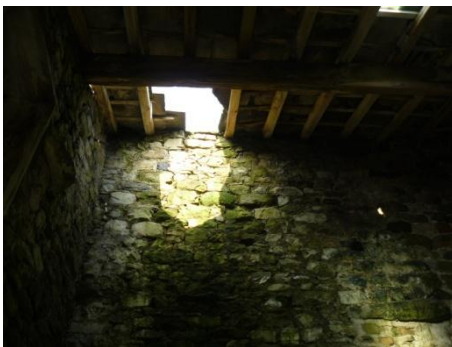
Internal stonework deterioration in barn room to left of main door

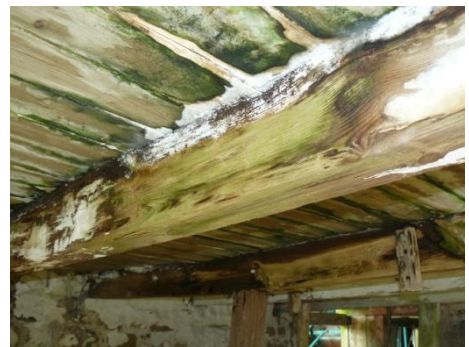
- Internal - mistal. Constructed in timber at ground floor with timber 1<sup>st</sup> floor over. Timber structure generally in poor condition with timber rot and wood worm damage. 1<sup>st</sup> floor joists built into gable wall - possible decay within bearing. Floor boards very poor condition. Floor is raised concrete slab within the cow stalls and the remaining area was buried under manure.

Timber decay in mistal 1<sup>st</sup> floor

Within the barn the building is effectively single storey and all remaining 1<sup>st</sup> floor timber structures will require replacement.

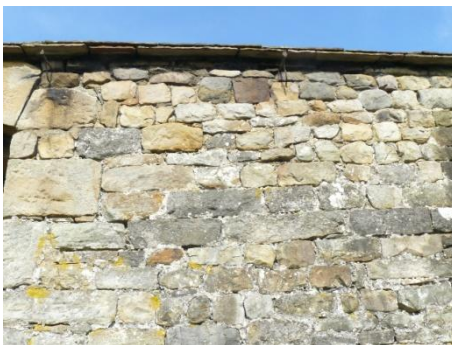
Externally the stonework generally suffers from significant weathering with the resulting loss of mortar. This is particularly prevalent in the upper reaches due to water run-off from the roof (there are no gutters) and at the lower level due to rising damp.

Typical weathering at high level

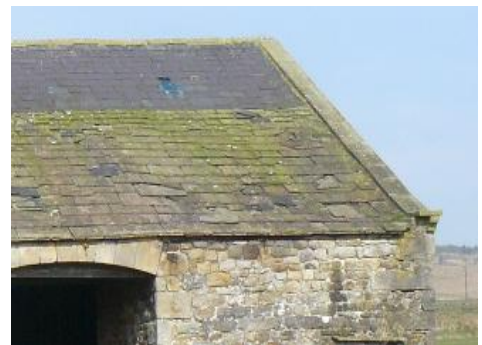
- East roof - slate roof of barn has been replaced with Welsh slate in the upper reaches. The lower, original area of the barn roof has extensive slate damage including missing slates, cracked and broken slates, slipped slates and localized patch repairs using Welsh slate.

General condition of barn roof - east slope

3. Re-slating of the entire roof area in York stone slates with new battens and roofing felt. This will include partial replacement of rafters where decay is present and replacement of an estimated 75% percent of the slates.
