Hansons Garden Centre

Hanson Garden Centres Ltd

Phase 1 Environmental Desk Study

March 2013

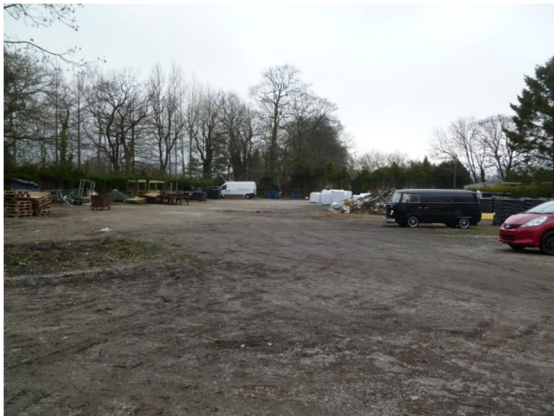
1. There are two piles of demolition material in the rear storage area. These comprise masonry rubble, concrete roof tiles, timber, plasterboard and metal. There are also at least two old refrigerators in the area.

Photograph 1 Rear storage area

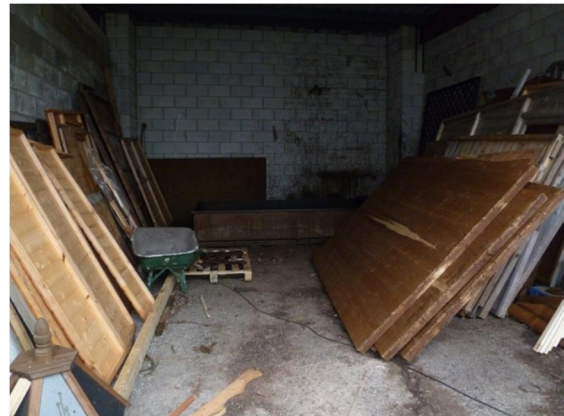
2. In the rear portal frame building is a preservative bath for dipping timber wall panels. The building has a concrete floor slab and there did not appear to be contamination arising from the dipping bath.

Photograph 4. Timber preservative bath

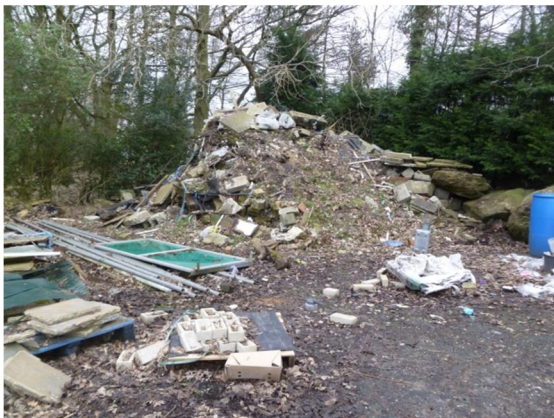
The potential sources of on-site contamination identified are from any contaminants which may be present in the two piles of demolition material, although from brief a visual inspection it appears that the material is inert. The refrigerators and portable gas cylinders are not considered as sources of contamination as these are readily identifiable and removable. Although there was no evidence seen of fuel oil spillages, historical spillages cannot be ruled out.

Photograph 2. Tipped demolition material

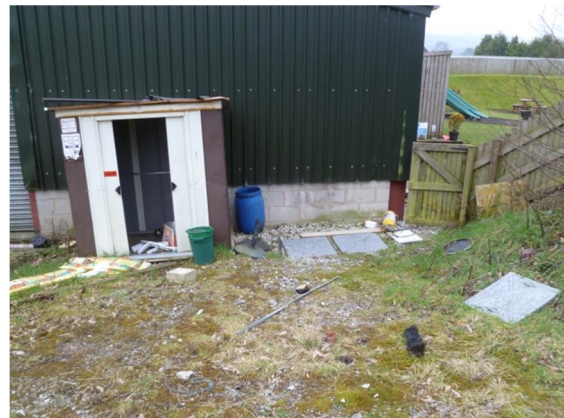
Photograph 5. Kitchen grease trap covers

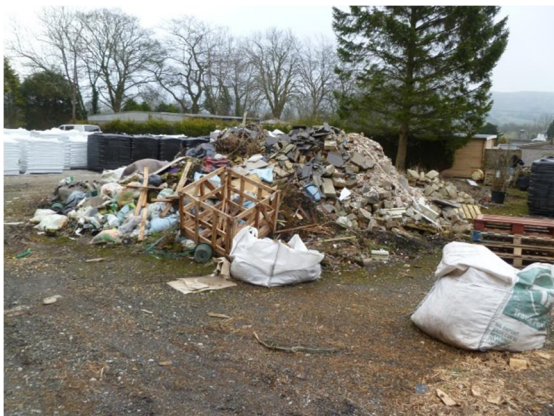
Photograph 3. Tipped demolition material

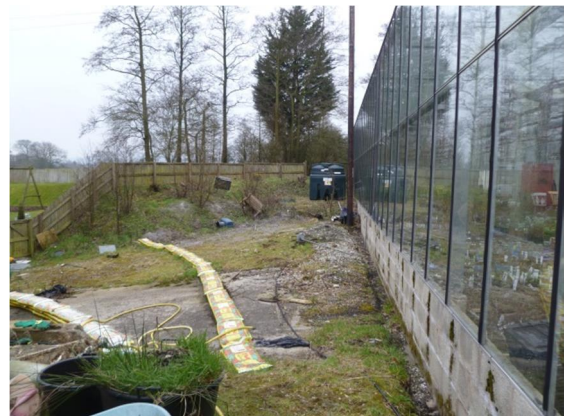
3. There are 3 fuel oil storage tanks on site. One by the rear glasshouse is a twin wall plastic tank; there are steel tanks inside masonry bunds adjacent to the main shop building and the front lightweight building.

Photograph 6. Twinwall plastic heating fuel tank

As part of the geotechnical investigations which will be required to determine the engineering properties of the underlying ground, it will be prudent to carry out screening tests for common contaminants. Close visual, olfactory monitoring and spot testing should be carried out in the areas of the fuel oil tanks to check for the presence of any fuel oil spillages.

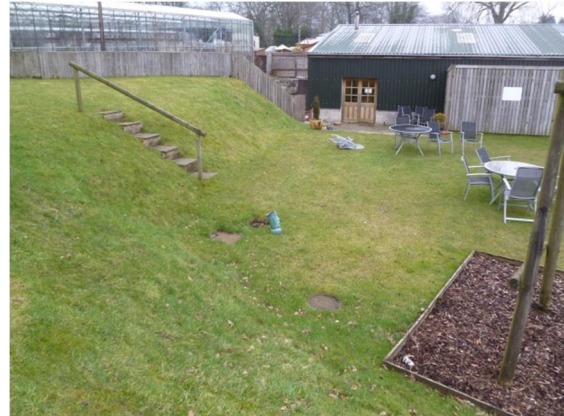
4. There is a vented septic tank under the children's play area. There is a plastic drain outlet into the boundary ditch adjacent to the septic tank. It is not clear if the outlet is from the septic tank or the roof drainage from the adjacent buildings.

Photograph 10. Septic tank covers in foreground

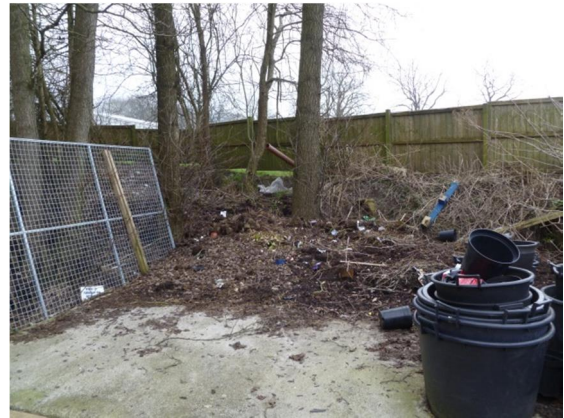
Photograph 11. Septic tank vent between trees

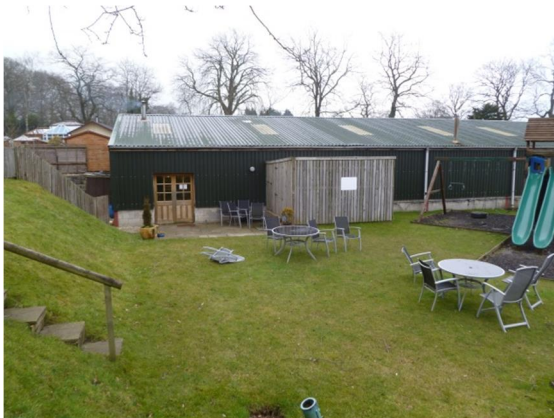
Photograph 9. Steel heating fuel tank in bund behind timber enclosure by building

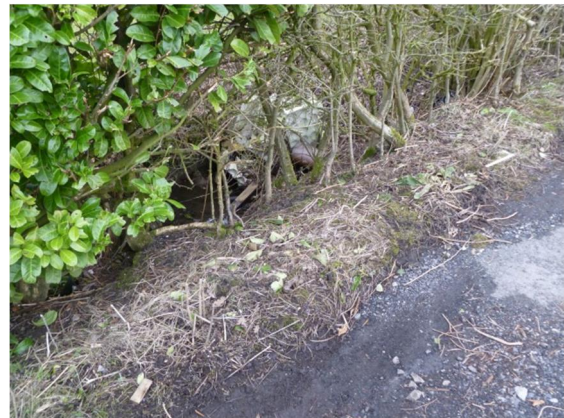
Photograph 12. Outfall pipe into ditch

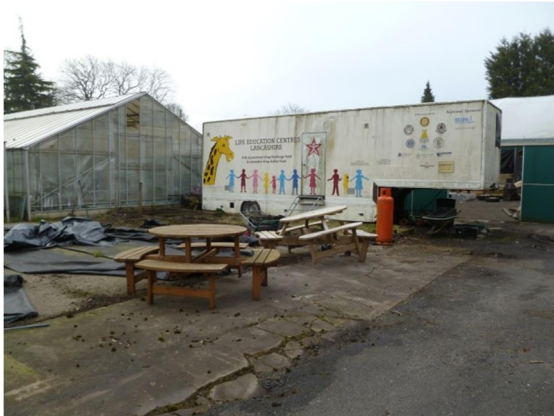
5. There is an old articulated lorry trailer in the side storage area.
6. There are a number of portable gas cylinders around the site.

Photograph 13. Side storage area
