**Sawley Hall
Sawley, Clitheroe**

Arboricultural Report

Report for Mr & Mrs Bannister

September 2013

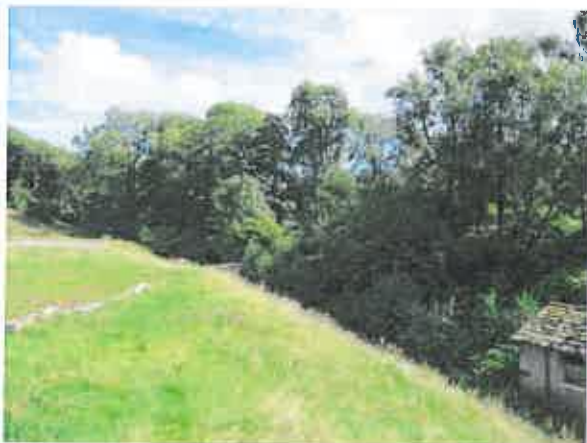
Photo. 1 - Ash and alder trees on the bank above Skinners Sike stream, viewed from the south-west.

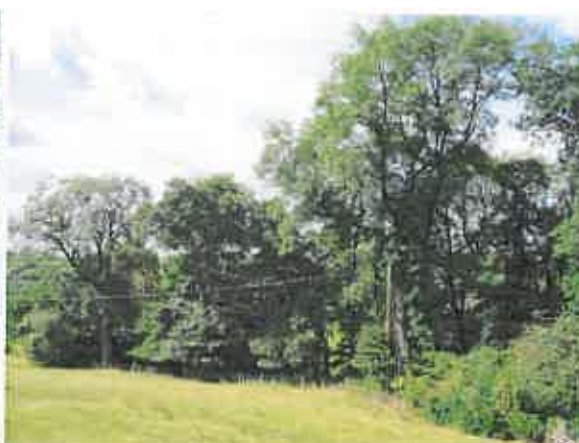
Photo. 2 - Ash and alder trees on the bank above Skinners Sike stream, viewed from the east.

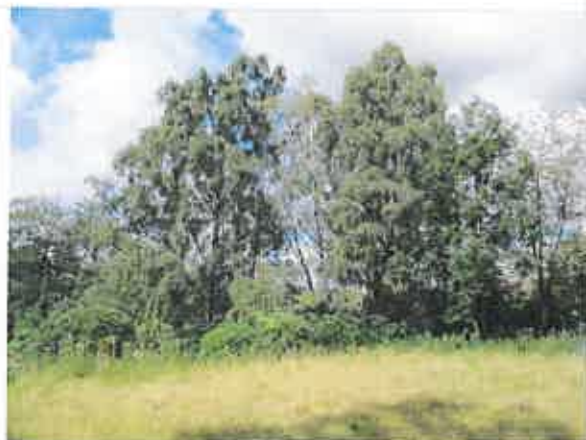
Photo. 3 - Silver birch and ash trees nos. 68-70, viewed from the tennis court to the east.

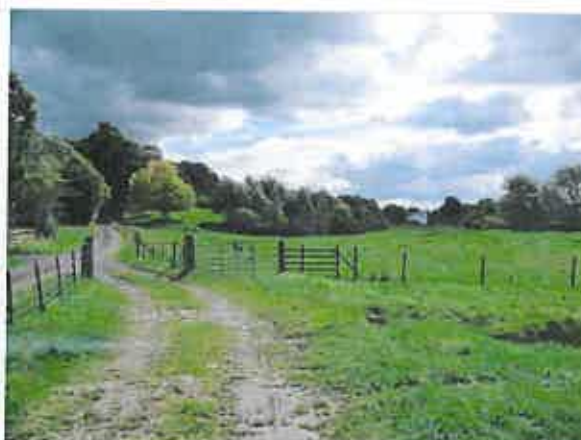
Photo. 4 - Distant view of the horse chestnut tree no. 97 and group of mixed planting no. G7, viewed from the north-west

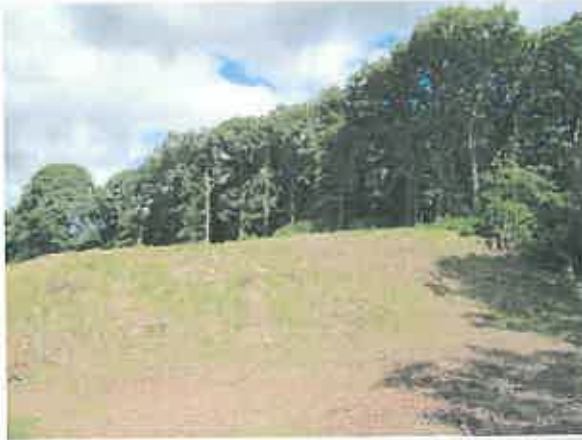
Photo. 5 – Brownthwaites Wood with felled area and retained trees, viewed from the south.

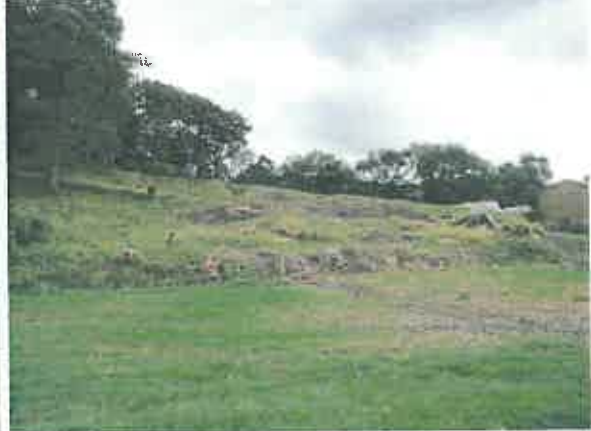
Photo. 6 – Brownthwaites Wood with felled area and retained trees, viewed from the west.

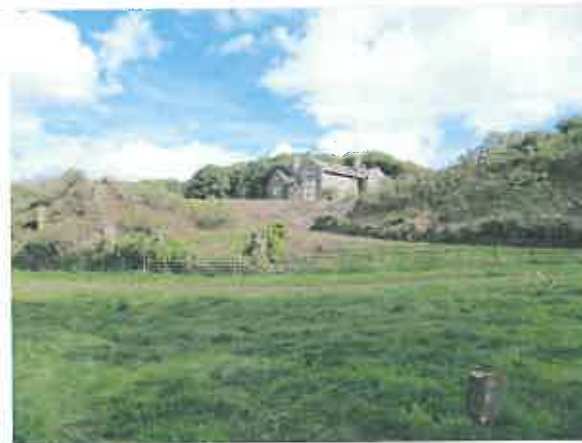
Photo. 7 - Sawley Lodge with felled trees on the bank to the south-west, viewed from the south-west.

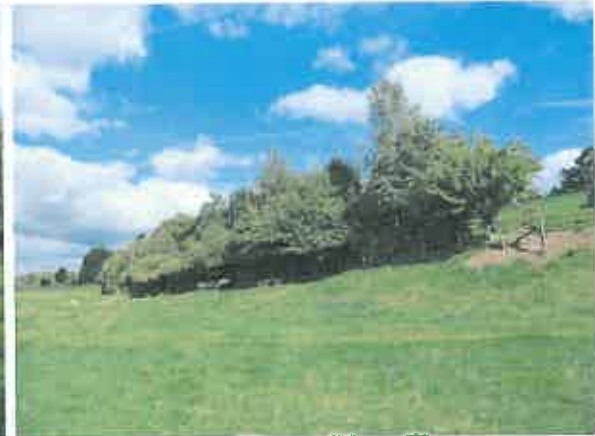
Photo. 8 – Group of mixed planting no. G7, viewed from the south-west.
