BAT SURVEY
AT
SPRINGFIELD
WHITEACRE LANE
BARROW

DATE AND TIME OF VISIT
25th Nov 2013 2.00pm external inspection.
27th Nov 2013 11.00am Internal inspection

REFERENCE NO. 4291

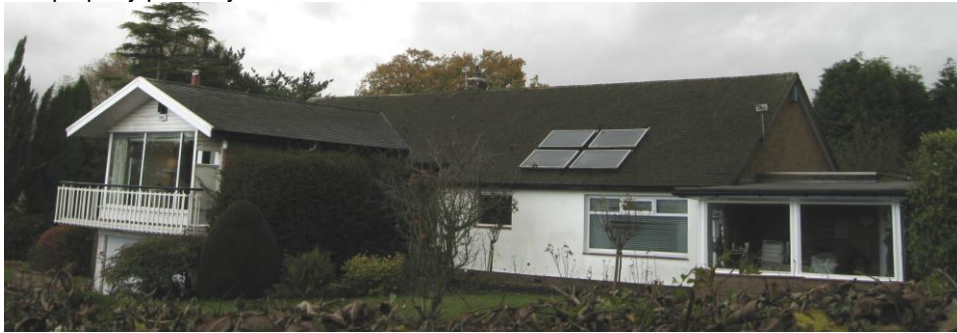
COMMENTS: The house is a currently uninhabited detached bungalow with a garage at a lower level to the east. The property probably dates from the 1970's.

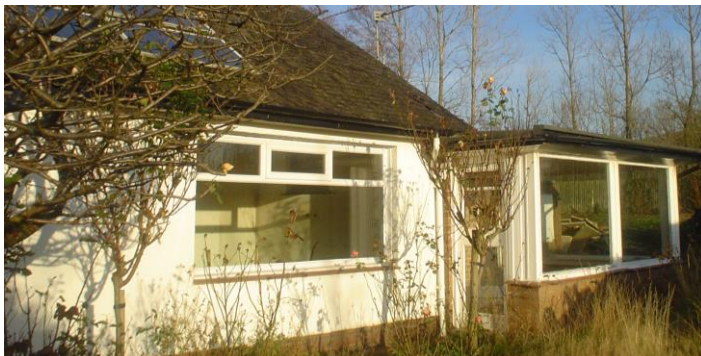
COMMENTS: The walls are a combination of white painted render with a brick plinth. The side walls are brick.

COMMENTS: The render is in good condition with no access points. The pointing is generally in good condition however there are some very small sections of brickwork pointing missing at eye level near the rear north east corner. After close inspection they proved not to be a suitable roost for bats.

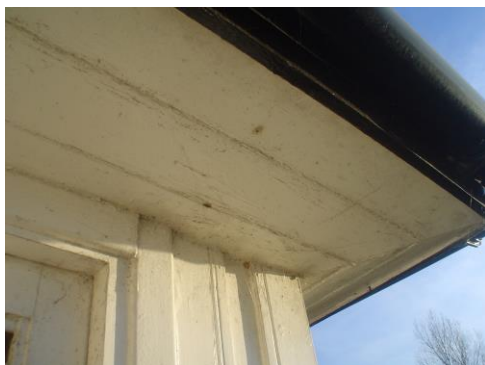
Soffit

COMMENTS: The pitched roofs are slate with overhanging eaves with soffits which are boarded to the underside.
The porches both have felt flat roofs.

The boarded soffits as can be seen in the photograph above are in good condition, all are tight fitting.

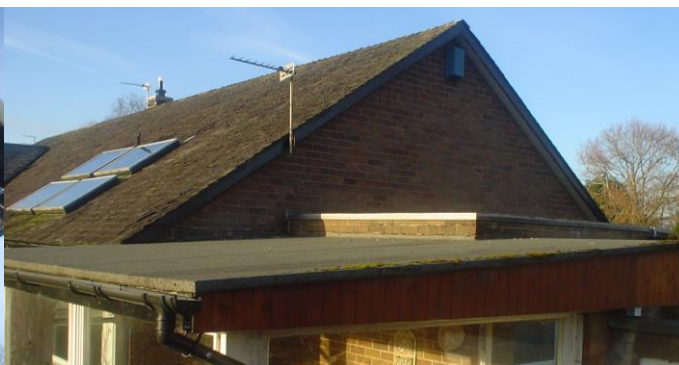
Felt flat roof

COMMENTS: The condition is generally reasonable with just a couple of slates missing near to the eaves adjacent to the flat roofed porch. It was possible to inspect quite closely the missing slates, there was no evidence of bats using the crevice.

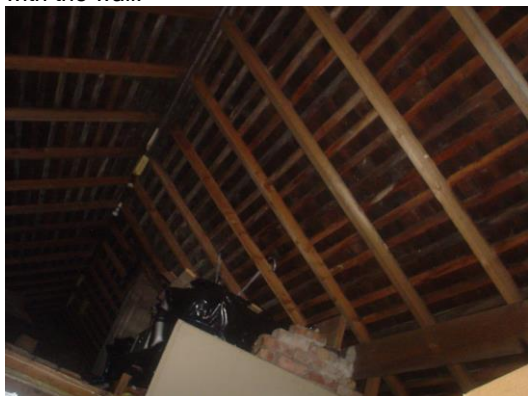
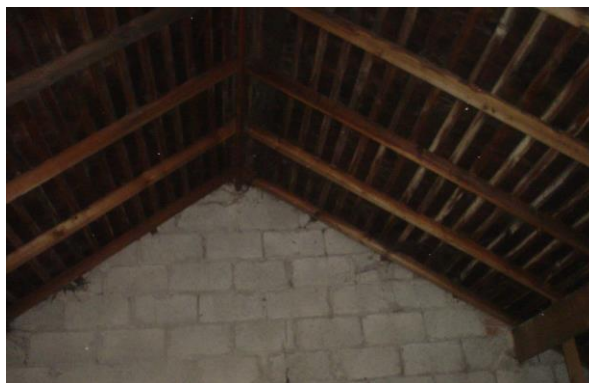
COMMENTS: The roof void was draughty with no felt or insulation, the timbers were in reasonable condition with no cracks or crevices which may harbour a bat. There was significant cob webbing at abutment of the roof with the wall.

COMMENTS: The roof void was inspected for any evidence of hibernating bats and any feeding or roosting signs. No bats were found nor were there any signs droppings or insect feeding, nothing to indicate that bats have ever used the space.
