Drawing No. C-981-01

Drawing title Technical Appendix 2 Survey of existing trees

Project Land off Chatburn Road, Clitheroe

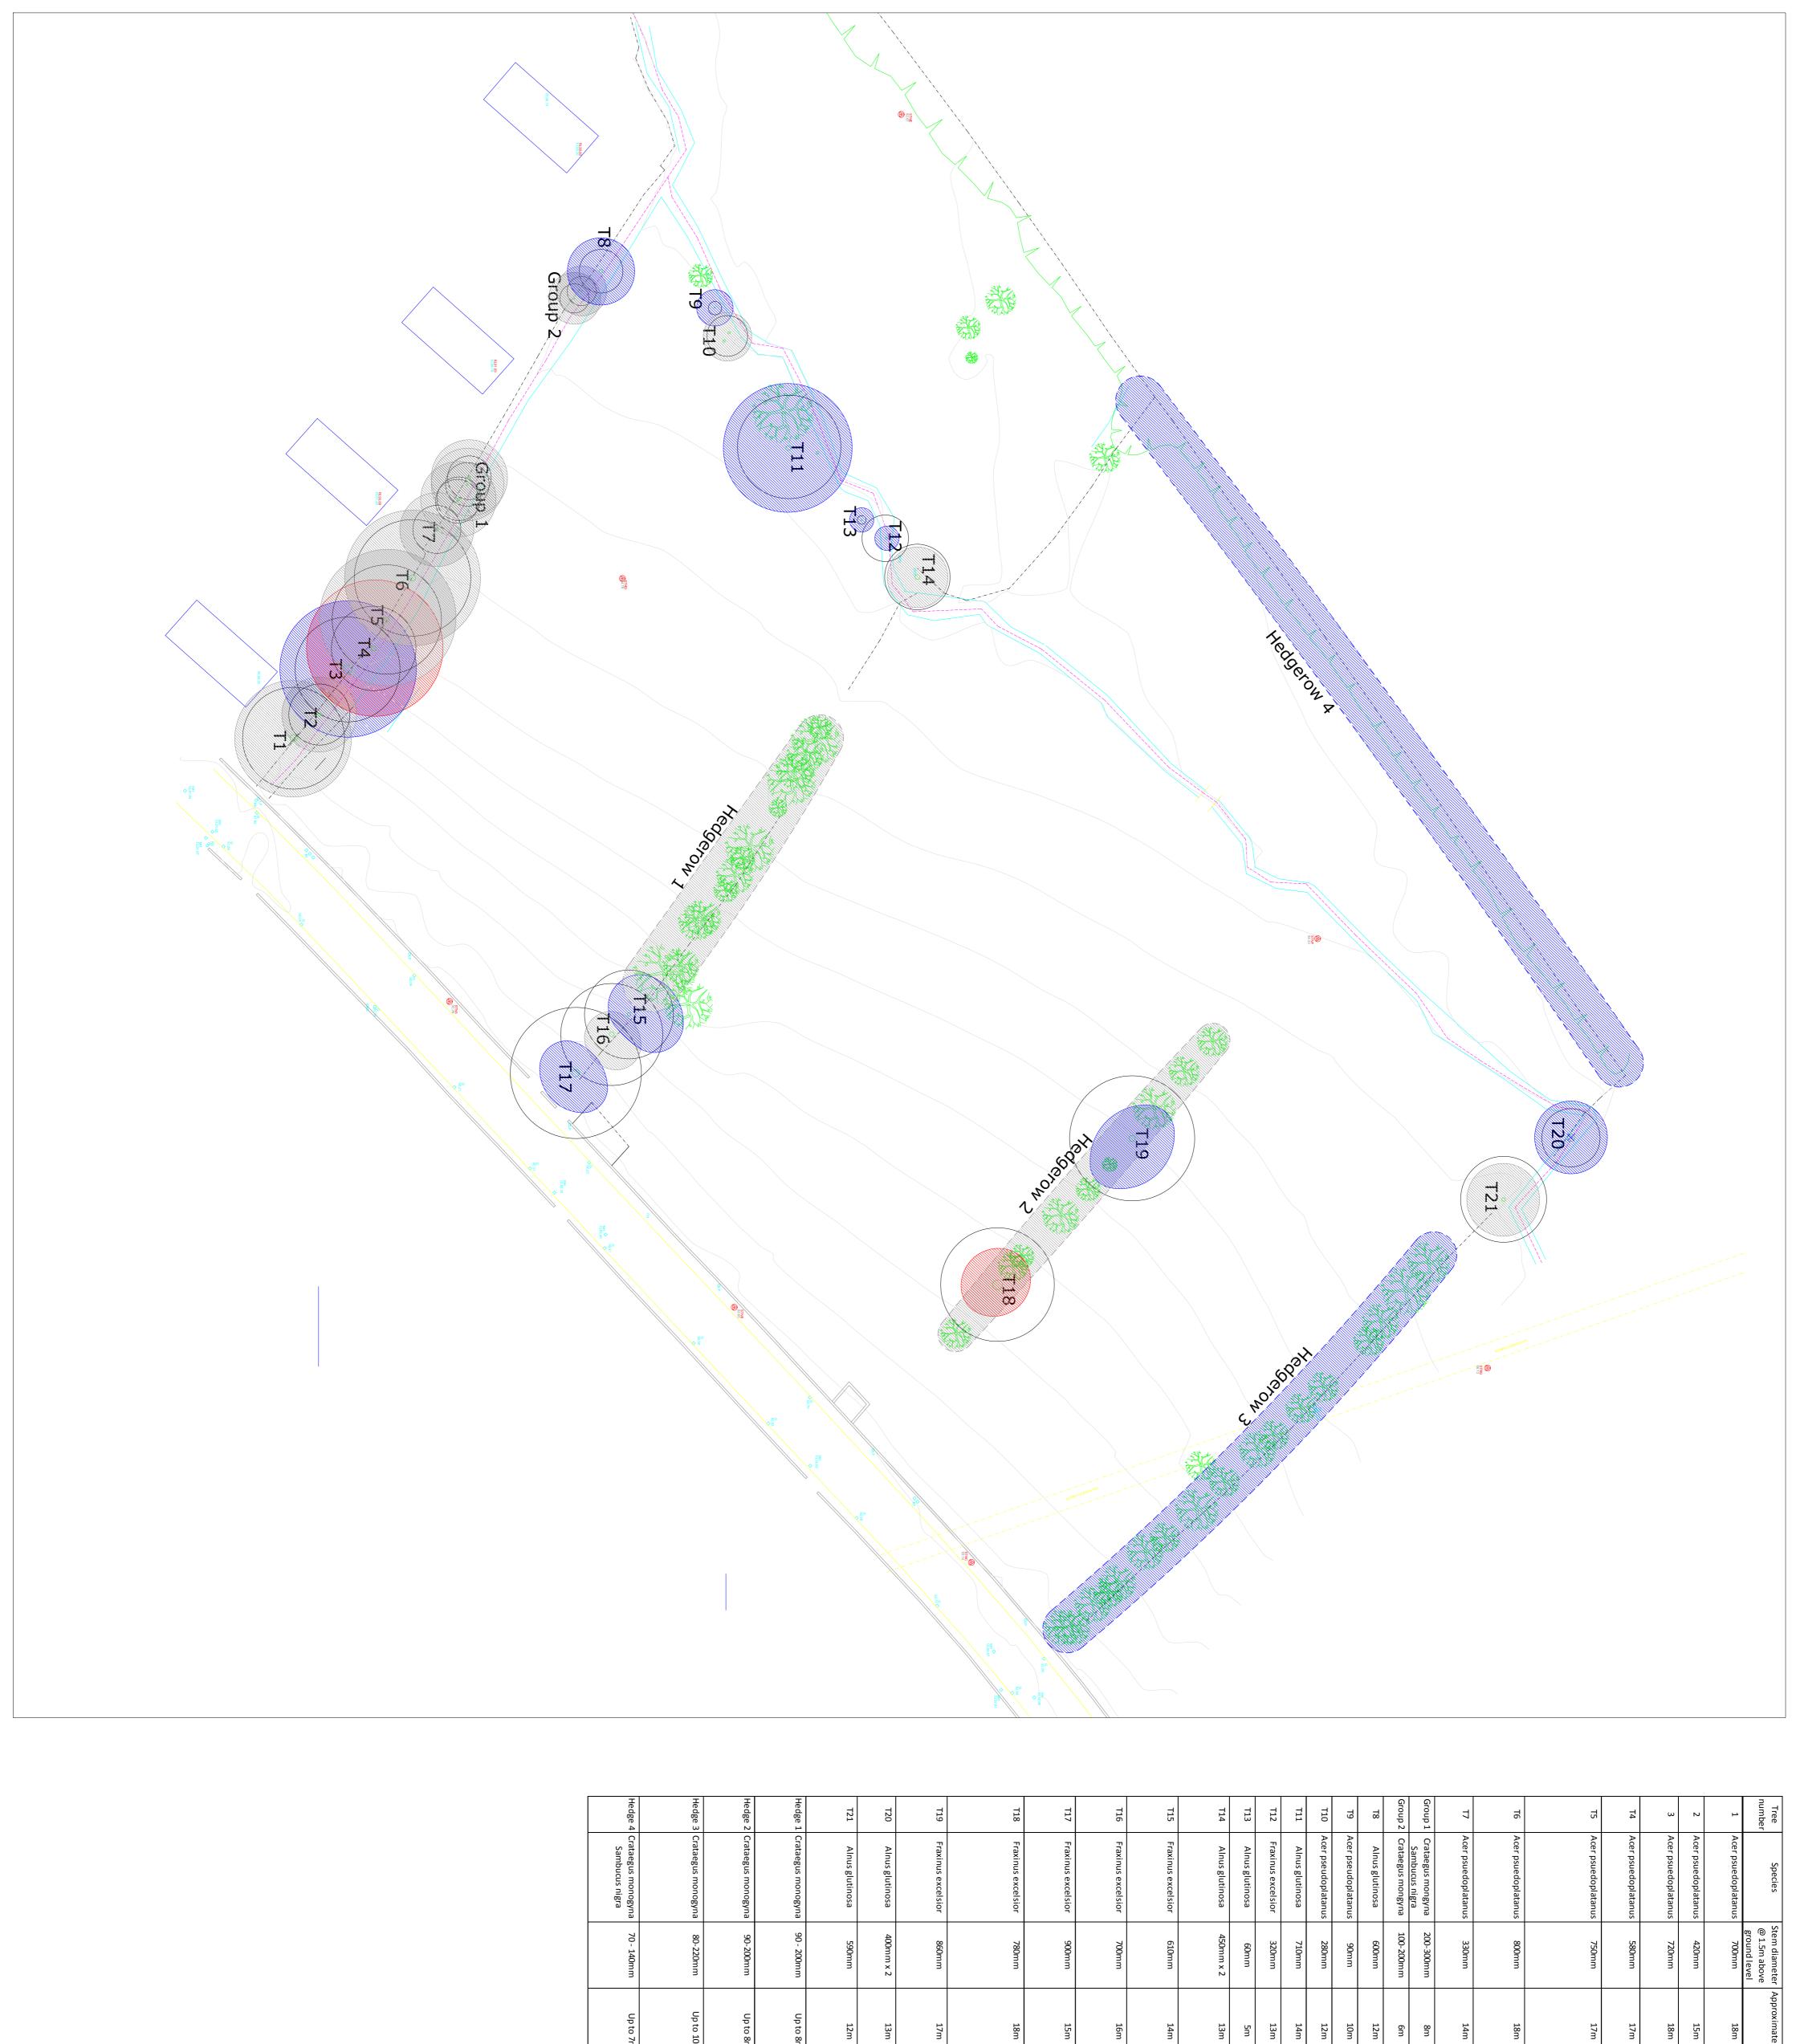
edge 3	edge 2	Н Н		T20	T19	Т18	Т17	T16	T15	T14	T13	Т12	T11	T10	T9	78 8T	roup 2	roup 1	7	Т6	15	T4	ω	2	1	Tree umber
Sambucus nigra	Crataegus monogyna Crataegus monogyna	Crataegus monogyna		Alnus glutinosa	Alnus glutinosa	Fraxinus excelsior	Fraxinus excelsior	Fraxinus excelsior	Fraxinus excelsior	Fraxinus excelsior	Alnus glutinosa	Alnus glutinosa	Fraxinus excelsior	Alnus glutinosa	Acer pseudoplatanus	Acer pseudoplatanus	Alnus glutinosa	Crataegus mongyna	Crataegus mongyna	Acer psuedoplatanus	Acer psuedoplatanus	Acer psuedoplatanus	Acer psuedoplatanus	Acer psuedoplatanus	Acer psuedoplatanus	Acer psuedoplatanus	Species
	80-220mm 70 - 140mm	90-200mm	90 - 200mm	590mm	400mm x 2	860mm	780mm	900mm	700mm	610mm	450mm x 2	60mm	320mm	710mm	280mm	90mm	600mm	100-200mm	200-300mm	330mm	800mm	750mm	580mm	720mm	420mm	700mm	Stem diameter @ 1.5m above ground level
	Up to 10m Up to 7m	Up to 8m	ਰ	12m	13m	17m	18m	15m	16m	14m	13m	5m	13m	14m	12m	10m	12m	6m	8m	14m	18m	17m	17m	18m	15m	18m	Approximate height

Approximately 2m Approximately 1m	Approximately 2m	Approximately 2m	Encroaches 6m into site.	Encroaches 6m into site.	N 7m S 9m E 7m W 5m	N 6m S 6m E 6m W 5m	N 4m S 6m E 7m W 6m	N 4m S 4m E 6m W 4m	N 8m S 3m E 9m W 5m	N 5m S 6m E 4m W 3m	Encroaches 2m into site.	Encroaches 2m into site.	Encroaches 3m into site.	Encroaches 4m into site.	Encroaches 3m into site.	Encroaches 5m into	Encroaches 3m into	Encroaches 4m into	Encroaches 3m into site.	Encroaches 5m into site.	Encroaches 7m into site.	Encroaches 7m into site.	Encroaches 7m into site.	Encroaches 3m into site.	Encroaches 6m into site.	Crown spread
level	Ground level	Ground level	Ground level	1m	2m	3m	3m	4m	5m	2m	2m	1m	2m	1m	2m	2m	1m	1m	1m	4m	5m	2m	2m	2m	8m	5m	Crown
	Mature	Mature	Mature	Mature	Mature	Mature	Mature	Mature	Mature	Mature	Mature	Young		Mature	Middle- aged	Young	Mature	Mature	Mature	Mature	Mature	Mature	Mature	Mature	Mature	Mature	Age Class

many gaps, but good, vigorous plants, ready to form significant boundary.	Mature hedgerow, with gaps, and constituent plants in fair condition, forming pleasing boundary to field. Young hedgerow, with	Former hedgerow in poor condition with major damage to constituent plants.	IO = 0 '	Attractive tree but with evidence of decay within main leader.	Twisted form, but highly attractive and in fair condition.	Good shape to canopy with moderate amounts of recent loss.	Considerable dead and damaged wood within canopy. Large cracks within main stem and cavities. Major wound on eastern side.	very large, imposing tree with dead wood within canopy.	Considerable canopy damage, some very recent.	ner hedgerow 1e recent limb	Wound in main bough, but does not appear progressive.	Self-sown, young Alder.	Squat but good shape. Ivy clad.	Twin-stemmed tree with some dead wood.	Fair condition. Coppiced hazel embeded beneath.	Young and vigorous. Self-sown.	Appears sound.	Group of former hedgerow	Sparse former hedgerow	Much smaller than adjacent trees with sparse canopy.	One-sided due to previous removal of adjacent tree. lvy clad. Considerable previous surgery works.	Recent surgery works within canopy, which appear to be healing. Fruiting bodies on base suggests Ustulina deusta fungal infection.	No sign of recent damage or loss from crown. Some basal growth.	t damage o Some	asal growth and oss from canopy.	n the	Notes

ω σ	0	0	0	С	8	zi.	В	n	В	n	В	8	В	С	В	В	С	С	С	О	ಸ	В	В	С	С	Category grading

reinforcing if considered desirable.	No work required other than reinforcing if considered desirable. No work required other than	Low useful life expectancy of remaining plants, but not considered dangerous.	Retention and enhancement possible. No work required.	Small tree so retention possible is not in a position to be dangerous. Requires further assessment.	No work required.	Tidy any broken limbs in canopy and remove dead wood.	Fell and remove due to safety concerns.	Remove dead-wood.	Tidy canopy and remove dead or damaged wood. During work, assess for further damage.	Clean limb damage to flush with tree and remove deadwood.	Monitor for any decline, otherwise no work required.	No work required.	No work required.	Remove dead wood.	No work required.	No work required.	No work required.	No work required.	No work required.	No work required.	No work required.	The tree will require removal if infection is confirmed.	Remove basal growth.	Remove basal growth.	Remove basal growth and dead wood.	Suggested inspection of canopy and removal of dead or damaged wood.	Recommendations
