As Proposed
Repair and Alterations

BAILEY HALL BARN, HURST GREEN
MR HOLT

WOODHALL
PLANNING AND CONSERVATION

Woodhall Lane
Calverley
Leeds
LS28 5NY
Telephone:
0113 - 255 4660
Facsimile:
0113 - 256 9688
e-mail:
planning@woodhall.co.uk
Scale: 1 - 100 @ A1
Date: 17-05-12
Drawn: HJW
Dwg no: 2647-01-200B

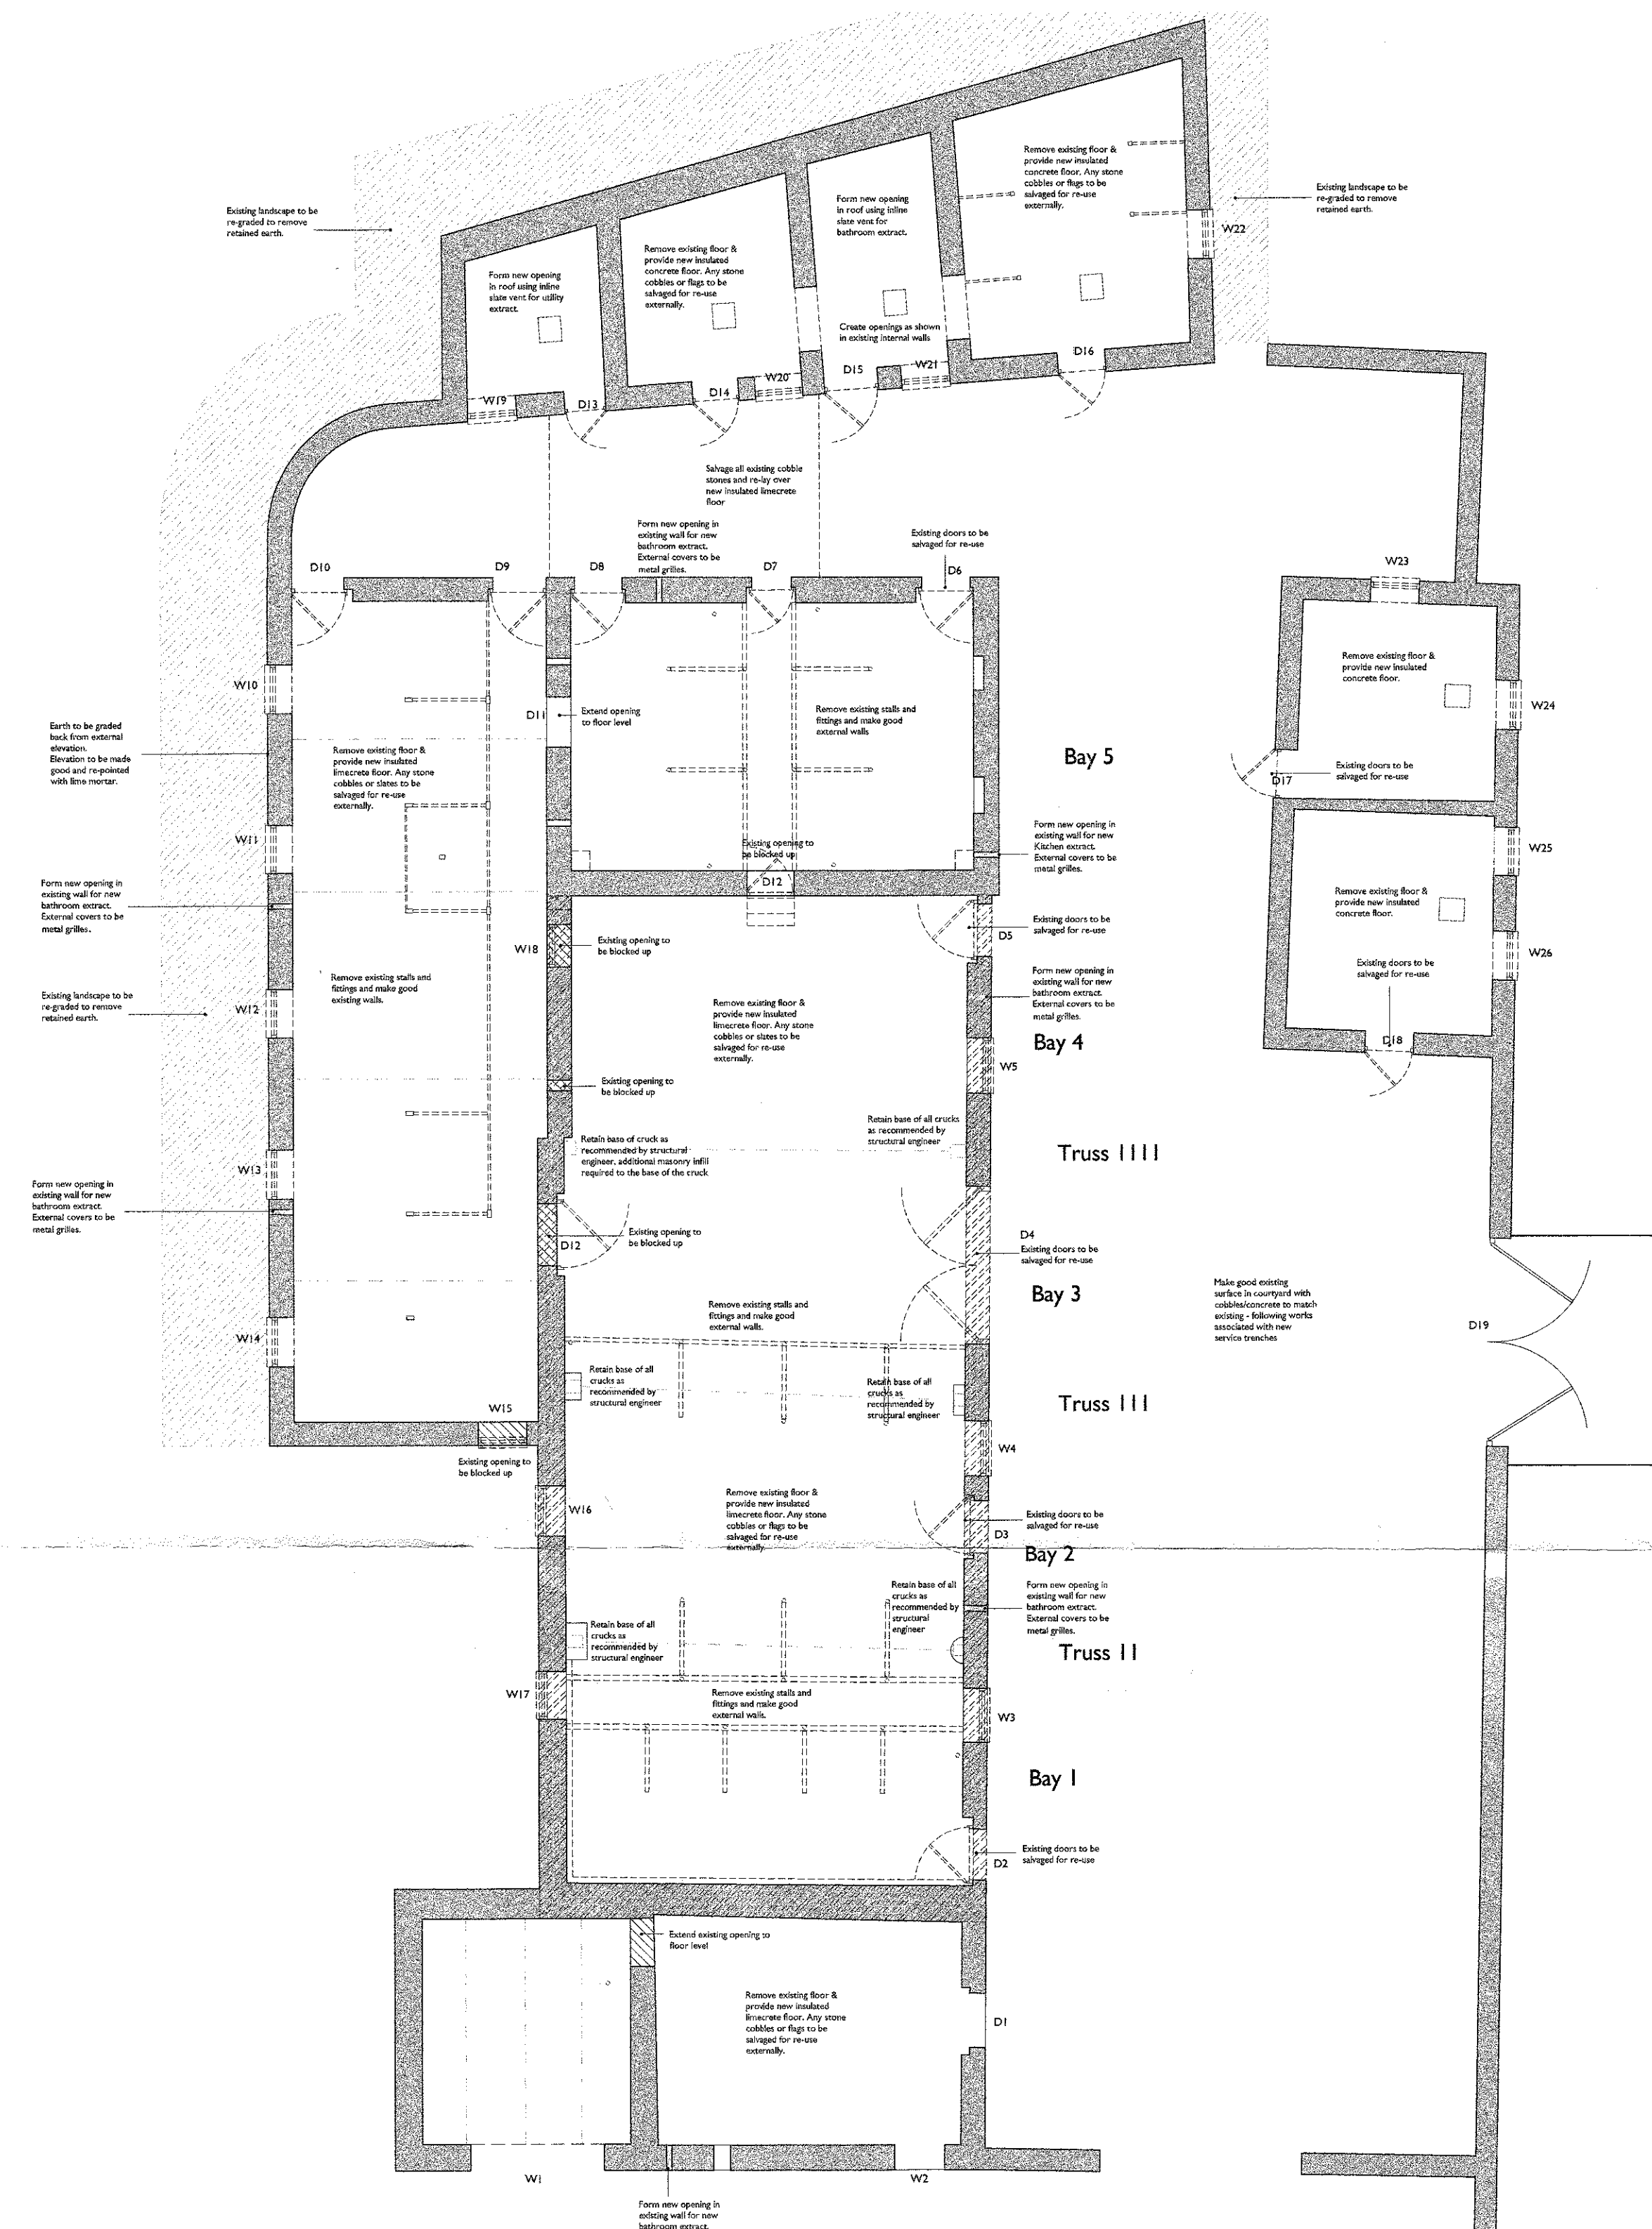
Roof Structure

- Bay 1**
- rafters approx 60mmx90mm at 375mm centres.
 - decay evident in top of ridge beam at south end. Allow for inspection of beam following removal of slates and battens.
 - Check all wedges between rafters and provide new wedges as necessary.
- East side**
- timber wallplate 170mm deep x 140/160mm wide.
 - Provide new oak tenon to upper wind brace
 - section of rafter 1 below lower purlin decayed. Provide new oak rafter along side existing rafter.
 - Provide new oak lintol to inner leaf - over window W6.

- West side**
- upper wind brace missing - provide new oak brace.
 - re-fix loose lower wind brace.
 - no wall plate - rafters packed off wall head with stone slips. Allow for provision of new oak wallplate and minor alterations to rafter feet to accommodate wallplate.

- East side**
- timber wallplate 170mm deep x 140/160mm wide. Rafters to lower section approx 75mm x 60mm at 400 mm centres. upper rafters approx 95mm x 55/50mm
 - decay evident to rafter feet of 2, 5, 7 & 10. Allow for provision of new oak rafters below lower purlin.
 - decay evident to rafters 4 & 11. Allow for provision of 2no. new oak rafters between upper and lower purlins.
 - Upper ends of the rafters are cut over the ridge - which has significantly reduced the size/strength of the rafters. Allow for doubling up 50% of the rafters with the provision of new oak rafters along side.

- West side**
- rafters generally approx 95mm x 55mm but 2no. only 75mm x 50mm
 - rafter 2 has failed and the ends of other decayed and displaced. Provide new oak wallplate and new oak rafters below lower purlin.
 - lower wind braces missing - provide 2no. new oak braces.
 - Decay evident to rafters 5, 6, 7 & 8 between upper and lower purlins. Allow for provision of 4no. new oak rafters between upper and lower purlins.
 - lower ends of 5no. rafters above the upper purlin are displaced. Re-align and fix rafter ends to purlin.

- East side**
- timber wallplate propped off timber lintol. Infill between wallplate and timber lintol with stone/line mortar
 - Allow for provision of new oak rafter alongside rafter 12.

- West side**
- rafters generally modern SW approx 60mm x 70mm
 - Provide new oak wallplate
 - Rafter no. 4 at eaves level decayed. Allow for new oak rafter
 - Rafter no. 5 between upper purlin and ridge decayed. Allow for new oak rafter

- East side**
- Timber wallplate
 - Extensive decay at junction between wall post and tie beam below Truss V. Carefully cut out decayed timber and allow for joinery repairs.
 - Rafter no. 8 at eaves level decayed. Allow for provision of new oak rafter
 - Rafter no. 13 at between ridge and upper purlin decayed. Allow for provision of new oak rafter

- West side**
- rafters generally modern SW approx 60mm x 70mm
 - Provide new oak wallplate
 - Rafter no. 7 at eaves level decayed. Allow for provision of new oak rafter

- East side**
- Provide new oak wallplate
 - Rafter nos. 4, 5, 6 & 11 at eaves level decayed. Allow for provision of new oak rafters
 - Rafter no. 6 at between lower and upper purlins decayed. Allow for provision of new oak rafter

- West side**
- Provide new oak wallplate
 - Rafter nos. 8, 9 & 14 at eaves level decayed. Allow for provision of new oak rafters
 - Allow for 1m long splice repair to north end of upper purlin

- Bay 2**
- Check all wedges between rafters and purlins and provide new wedges as necessary.

- Bay 3**
- Check all wedges between rafters and purlins and provide new wedges as necessary.

- Bay 4**
- Check all wedges between rafters and purlins and provide new wedges as necessary.

- Bay 5**
- Check all wedges between rafters and purlins and provide new wedges as necessary.
