STRUCTURAL REPORT
BARRACKS FARM BARN
CHIPPING ROAD
CHAIGLEY
CLITHEROE
BB7 3LX

Our Ref: DJL/DB/6321

Date: 31st March, 2014

STRUCTURAL REPORT BARRACKS FARM BARN CHIPPING ROAD CHAIGLEY

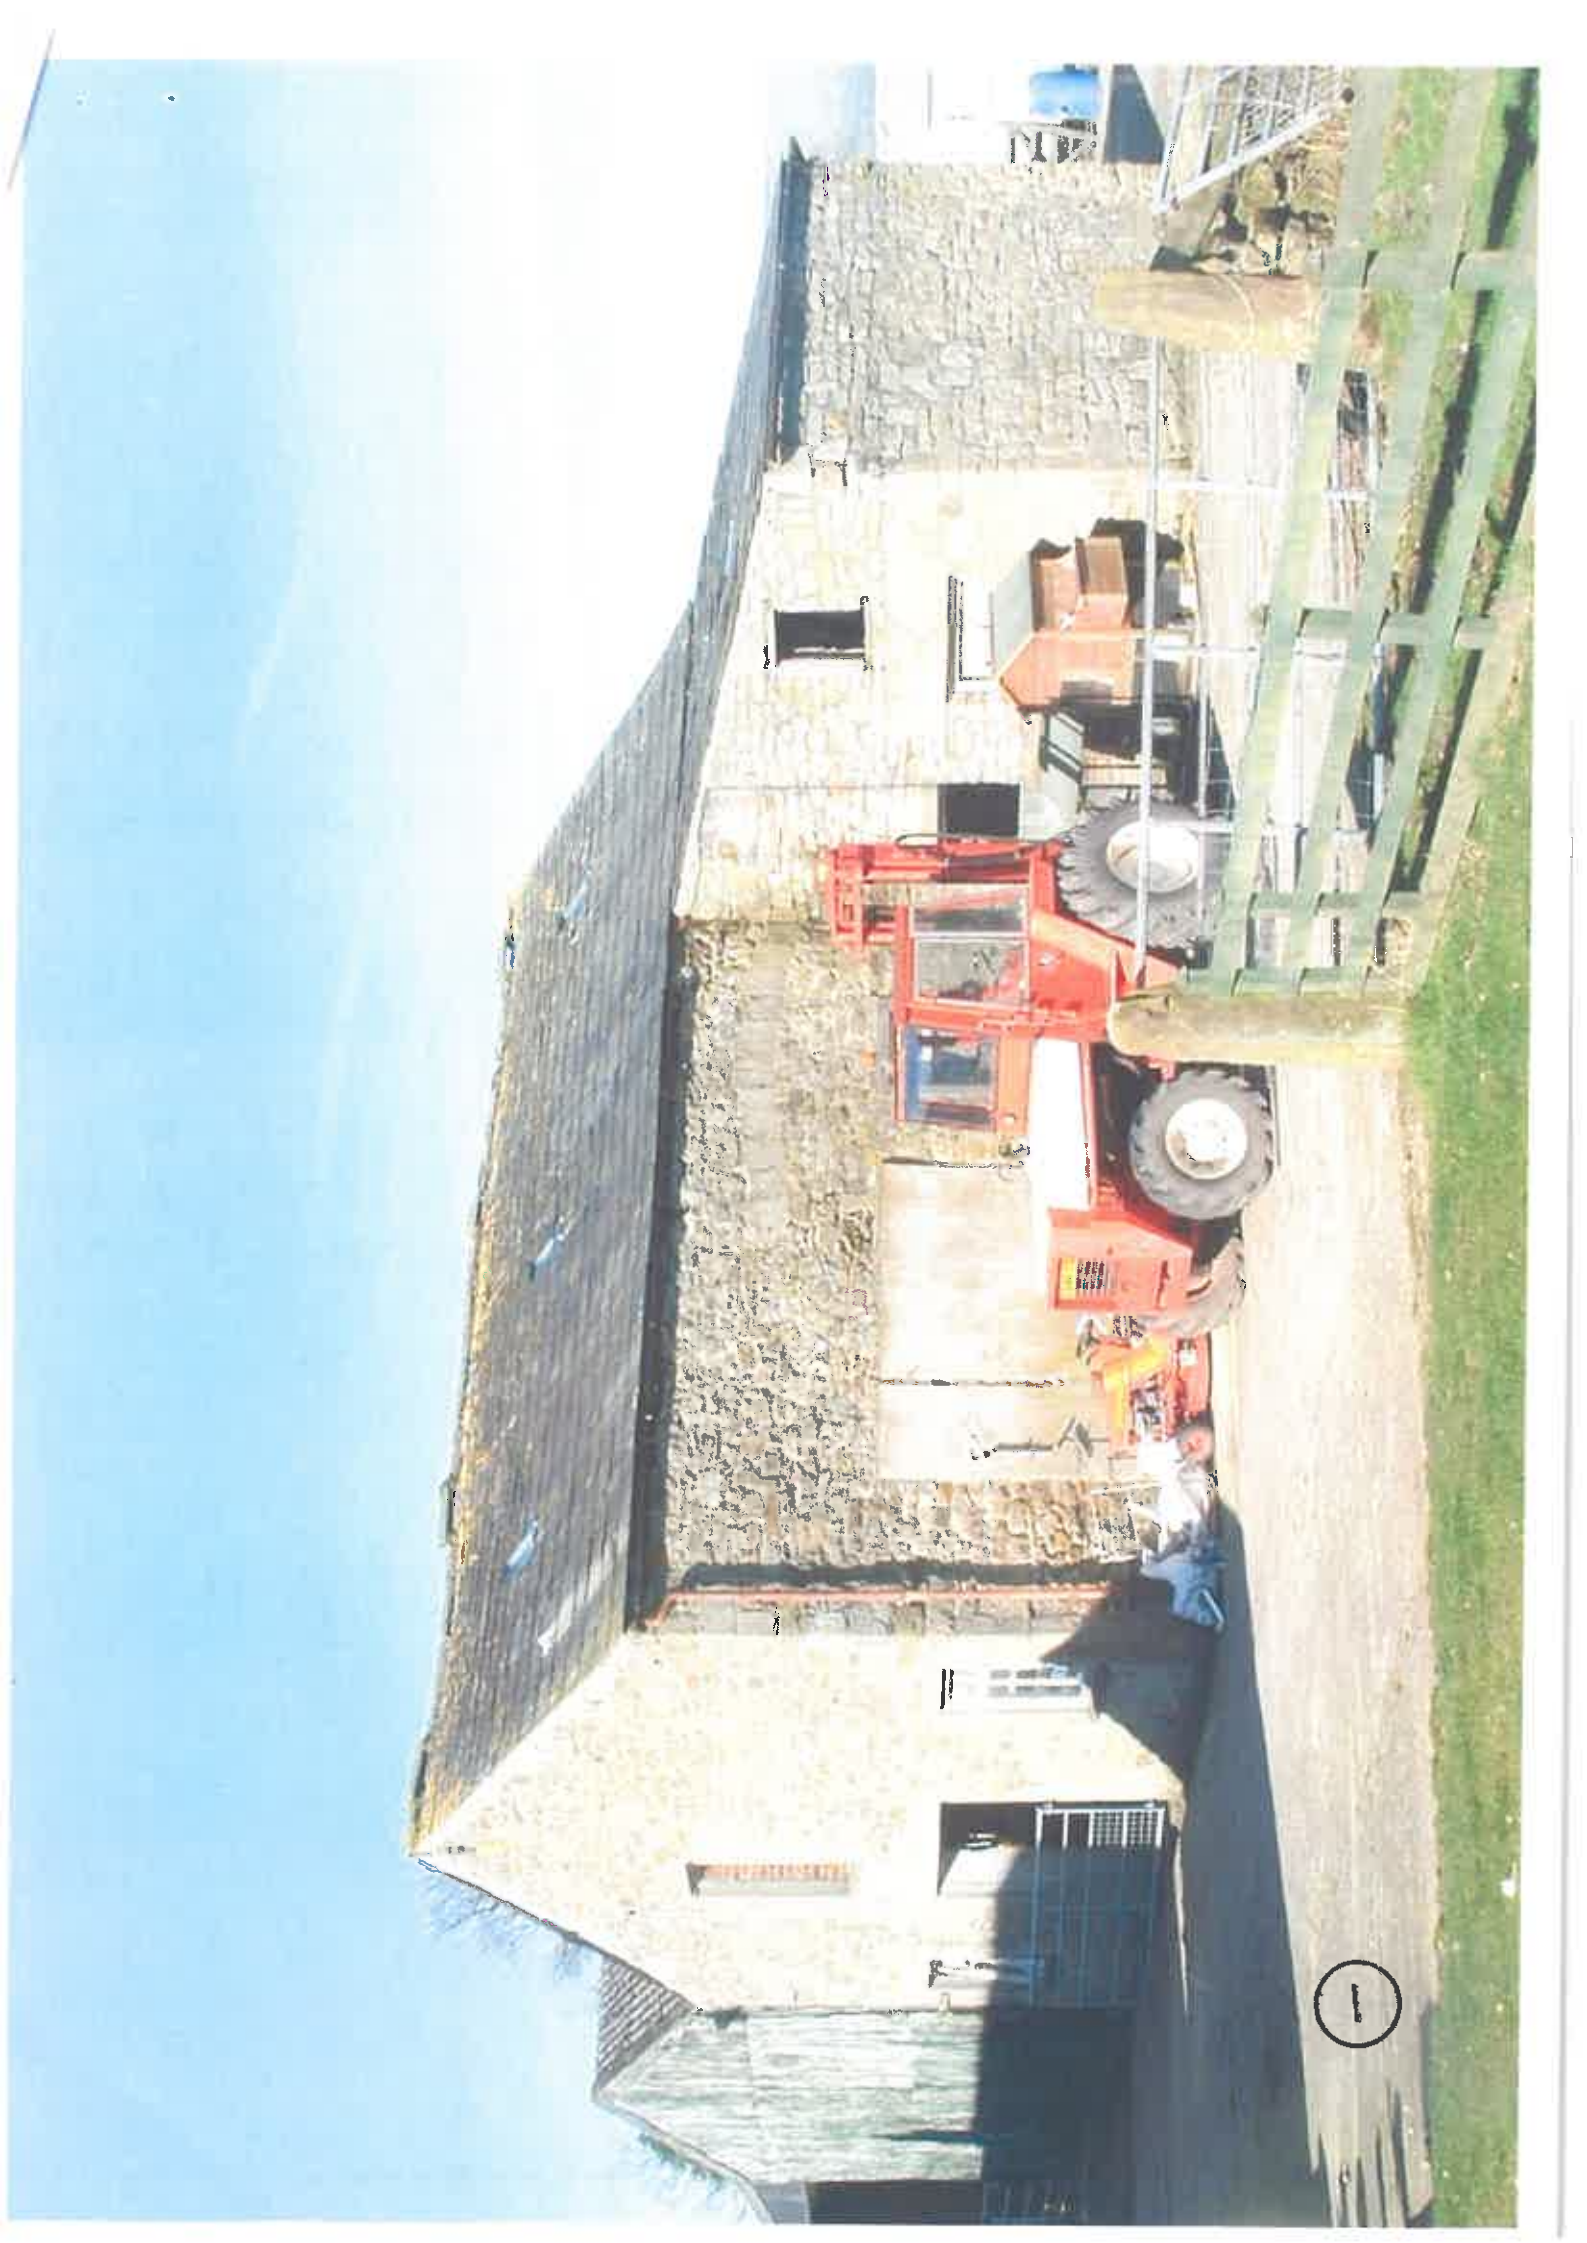
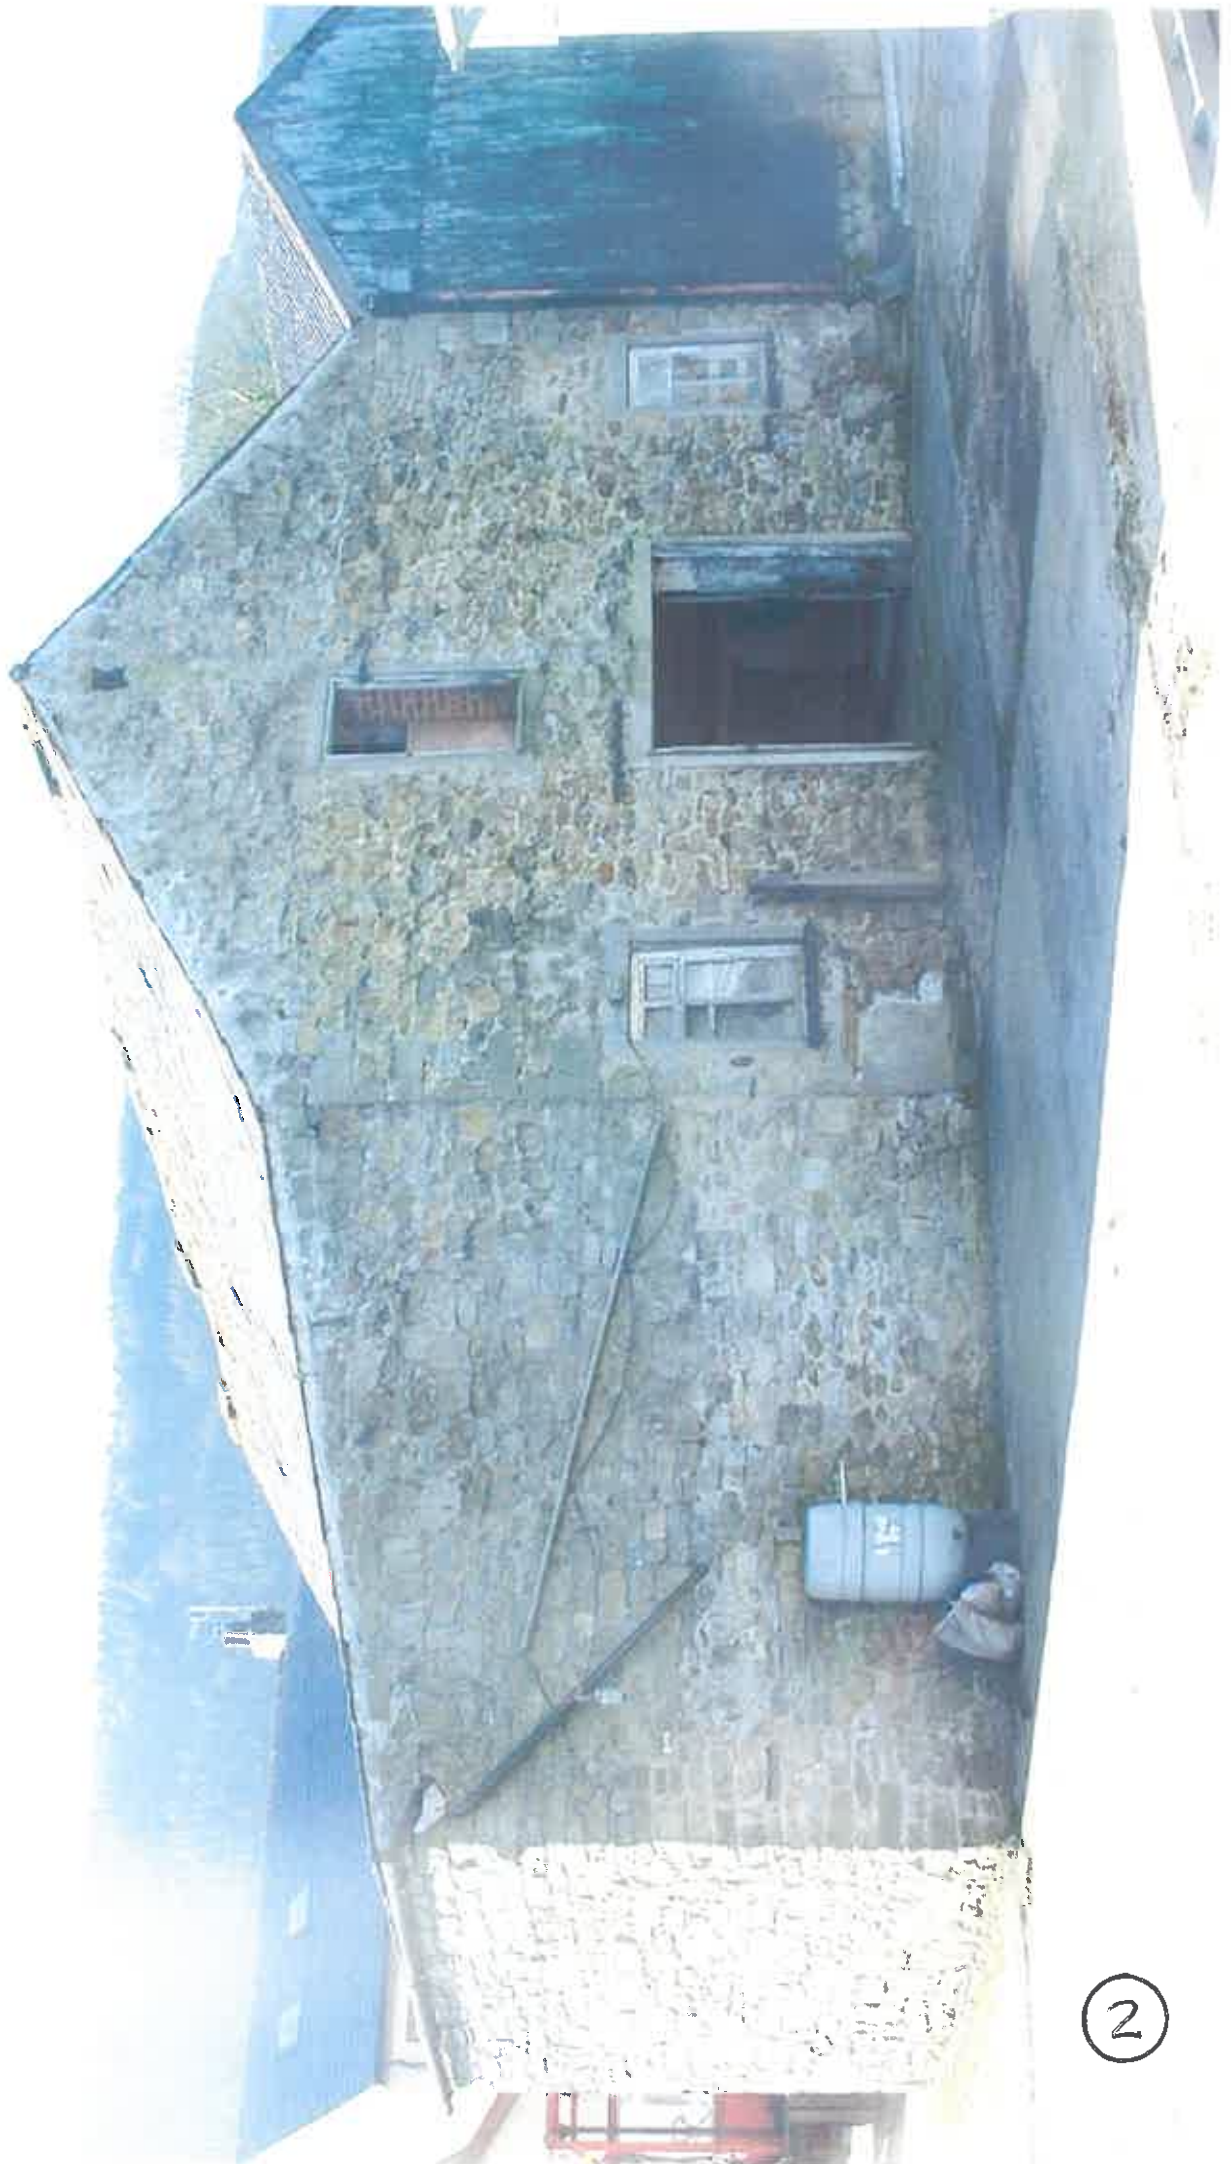
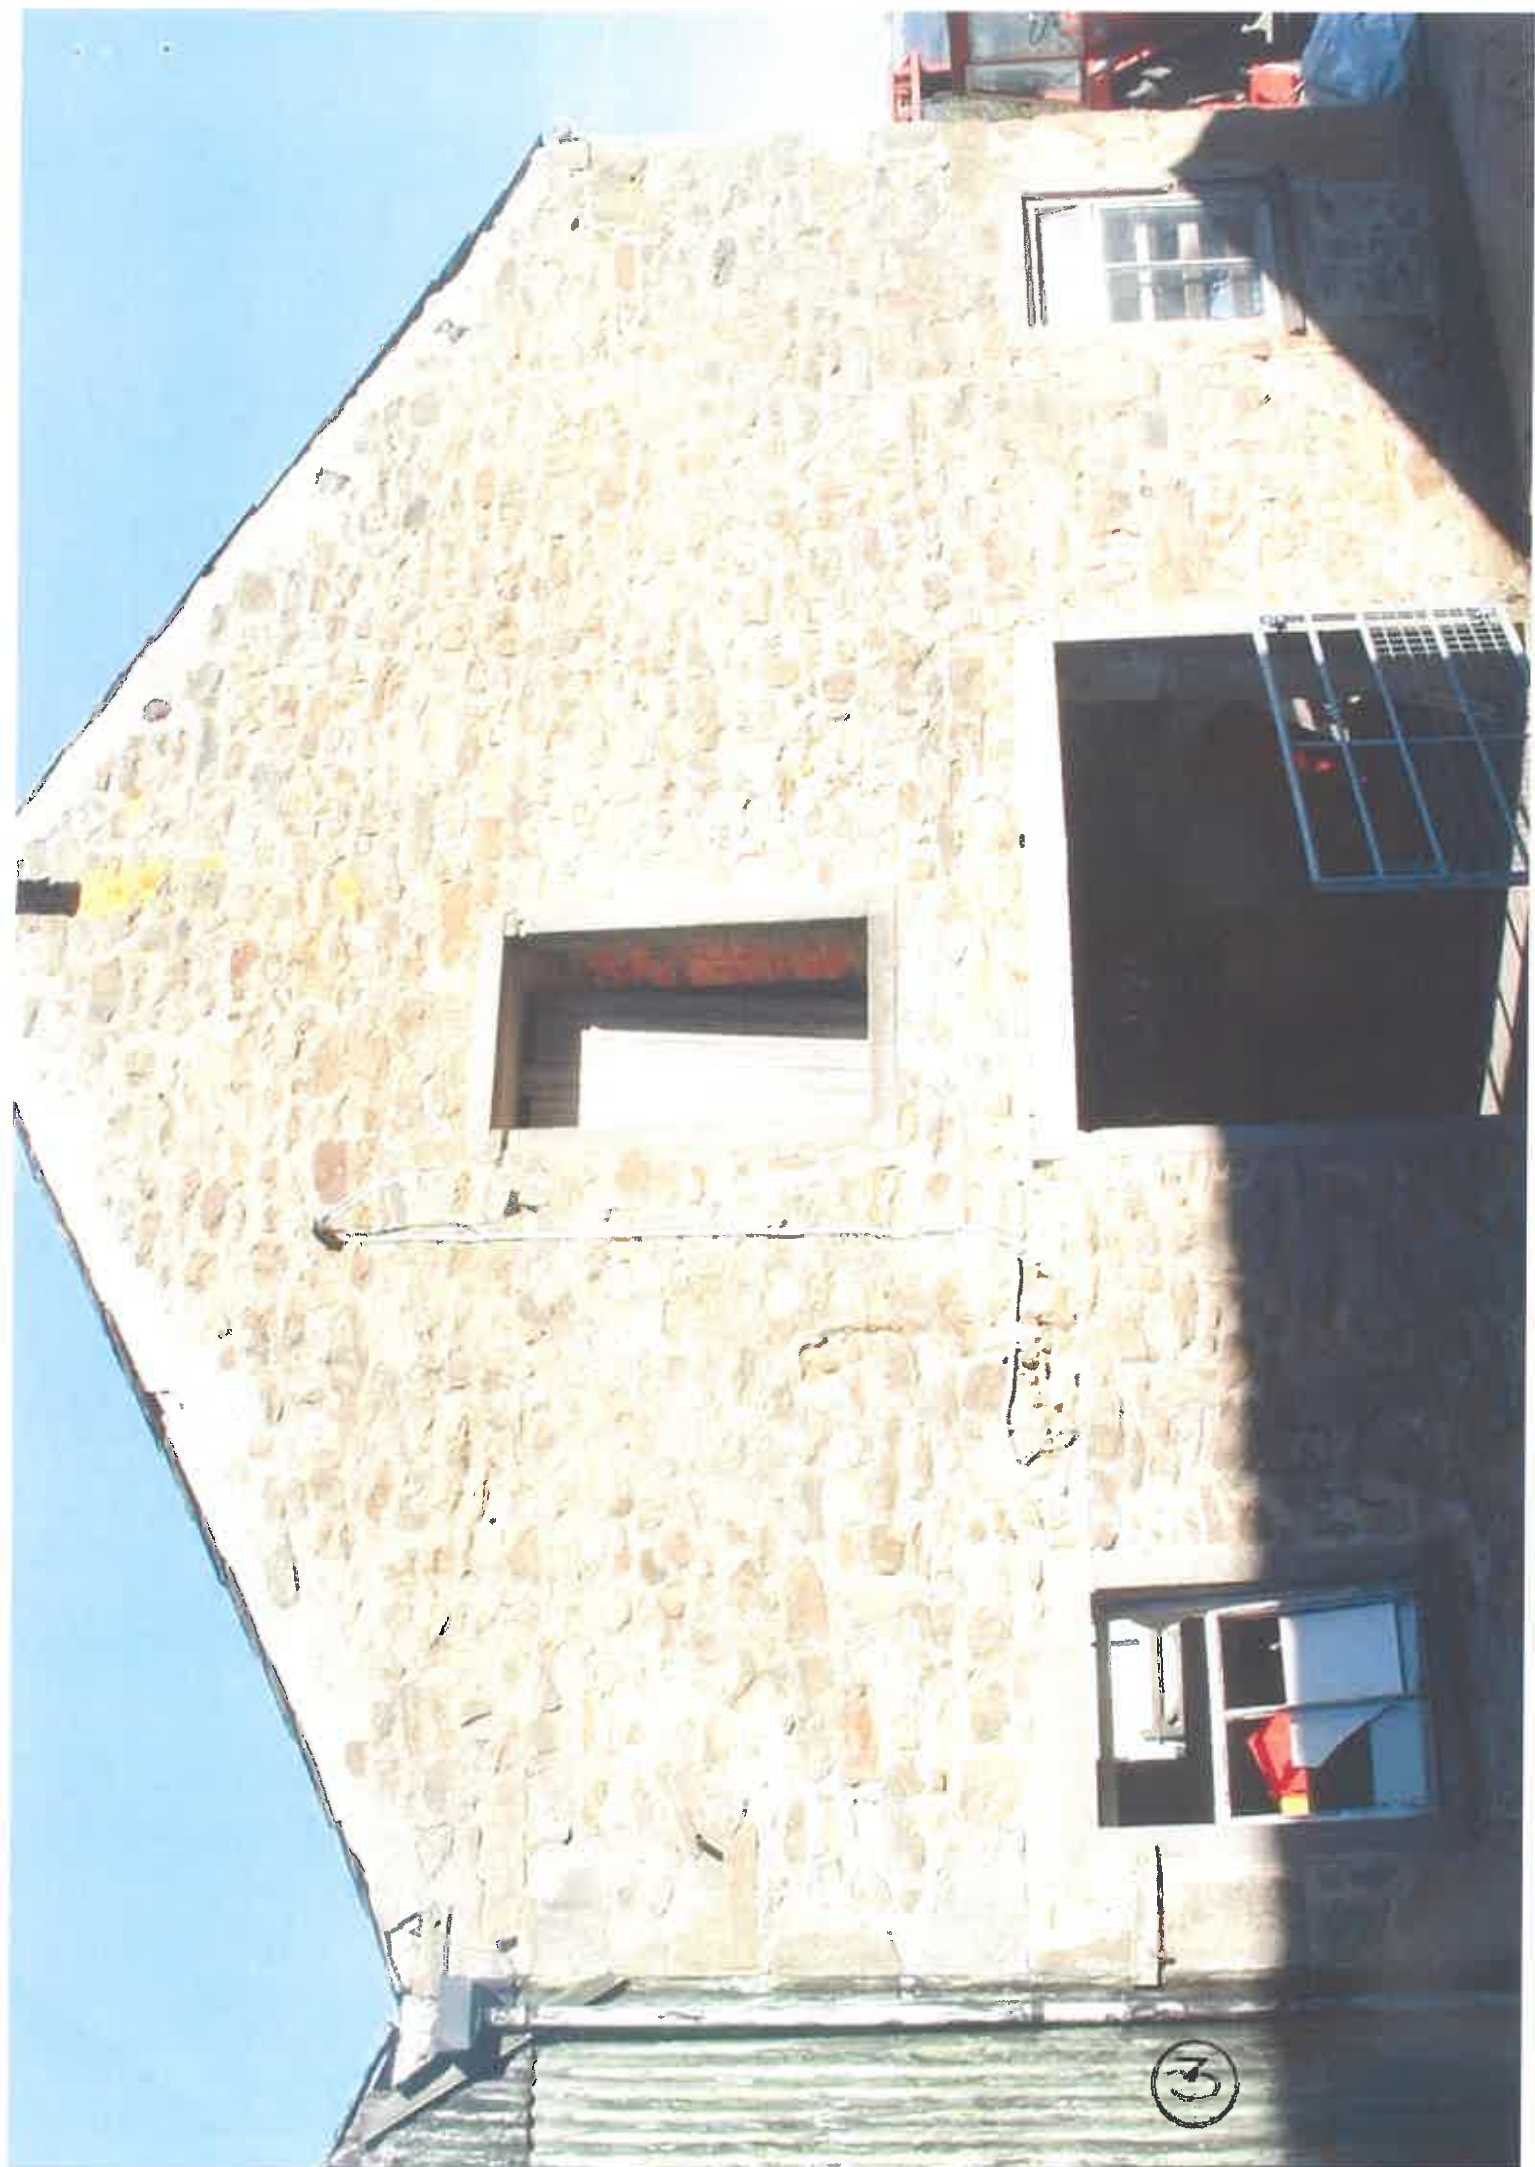
Plates 1 - 3 show general views of the barn structure.

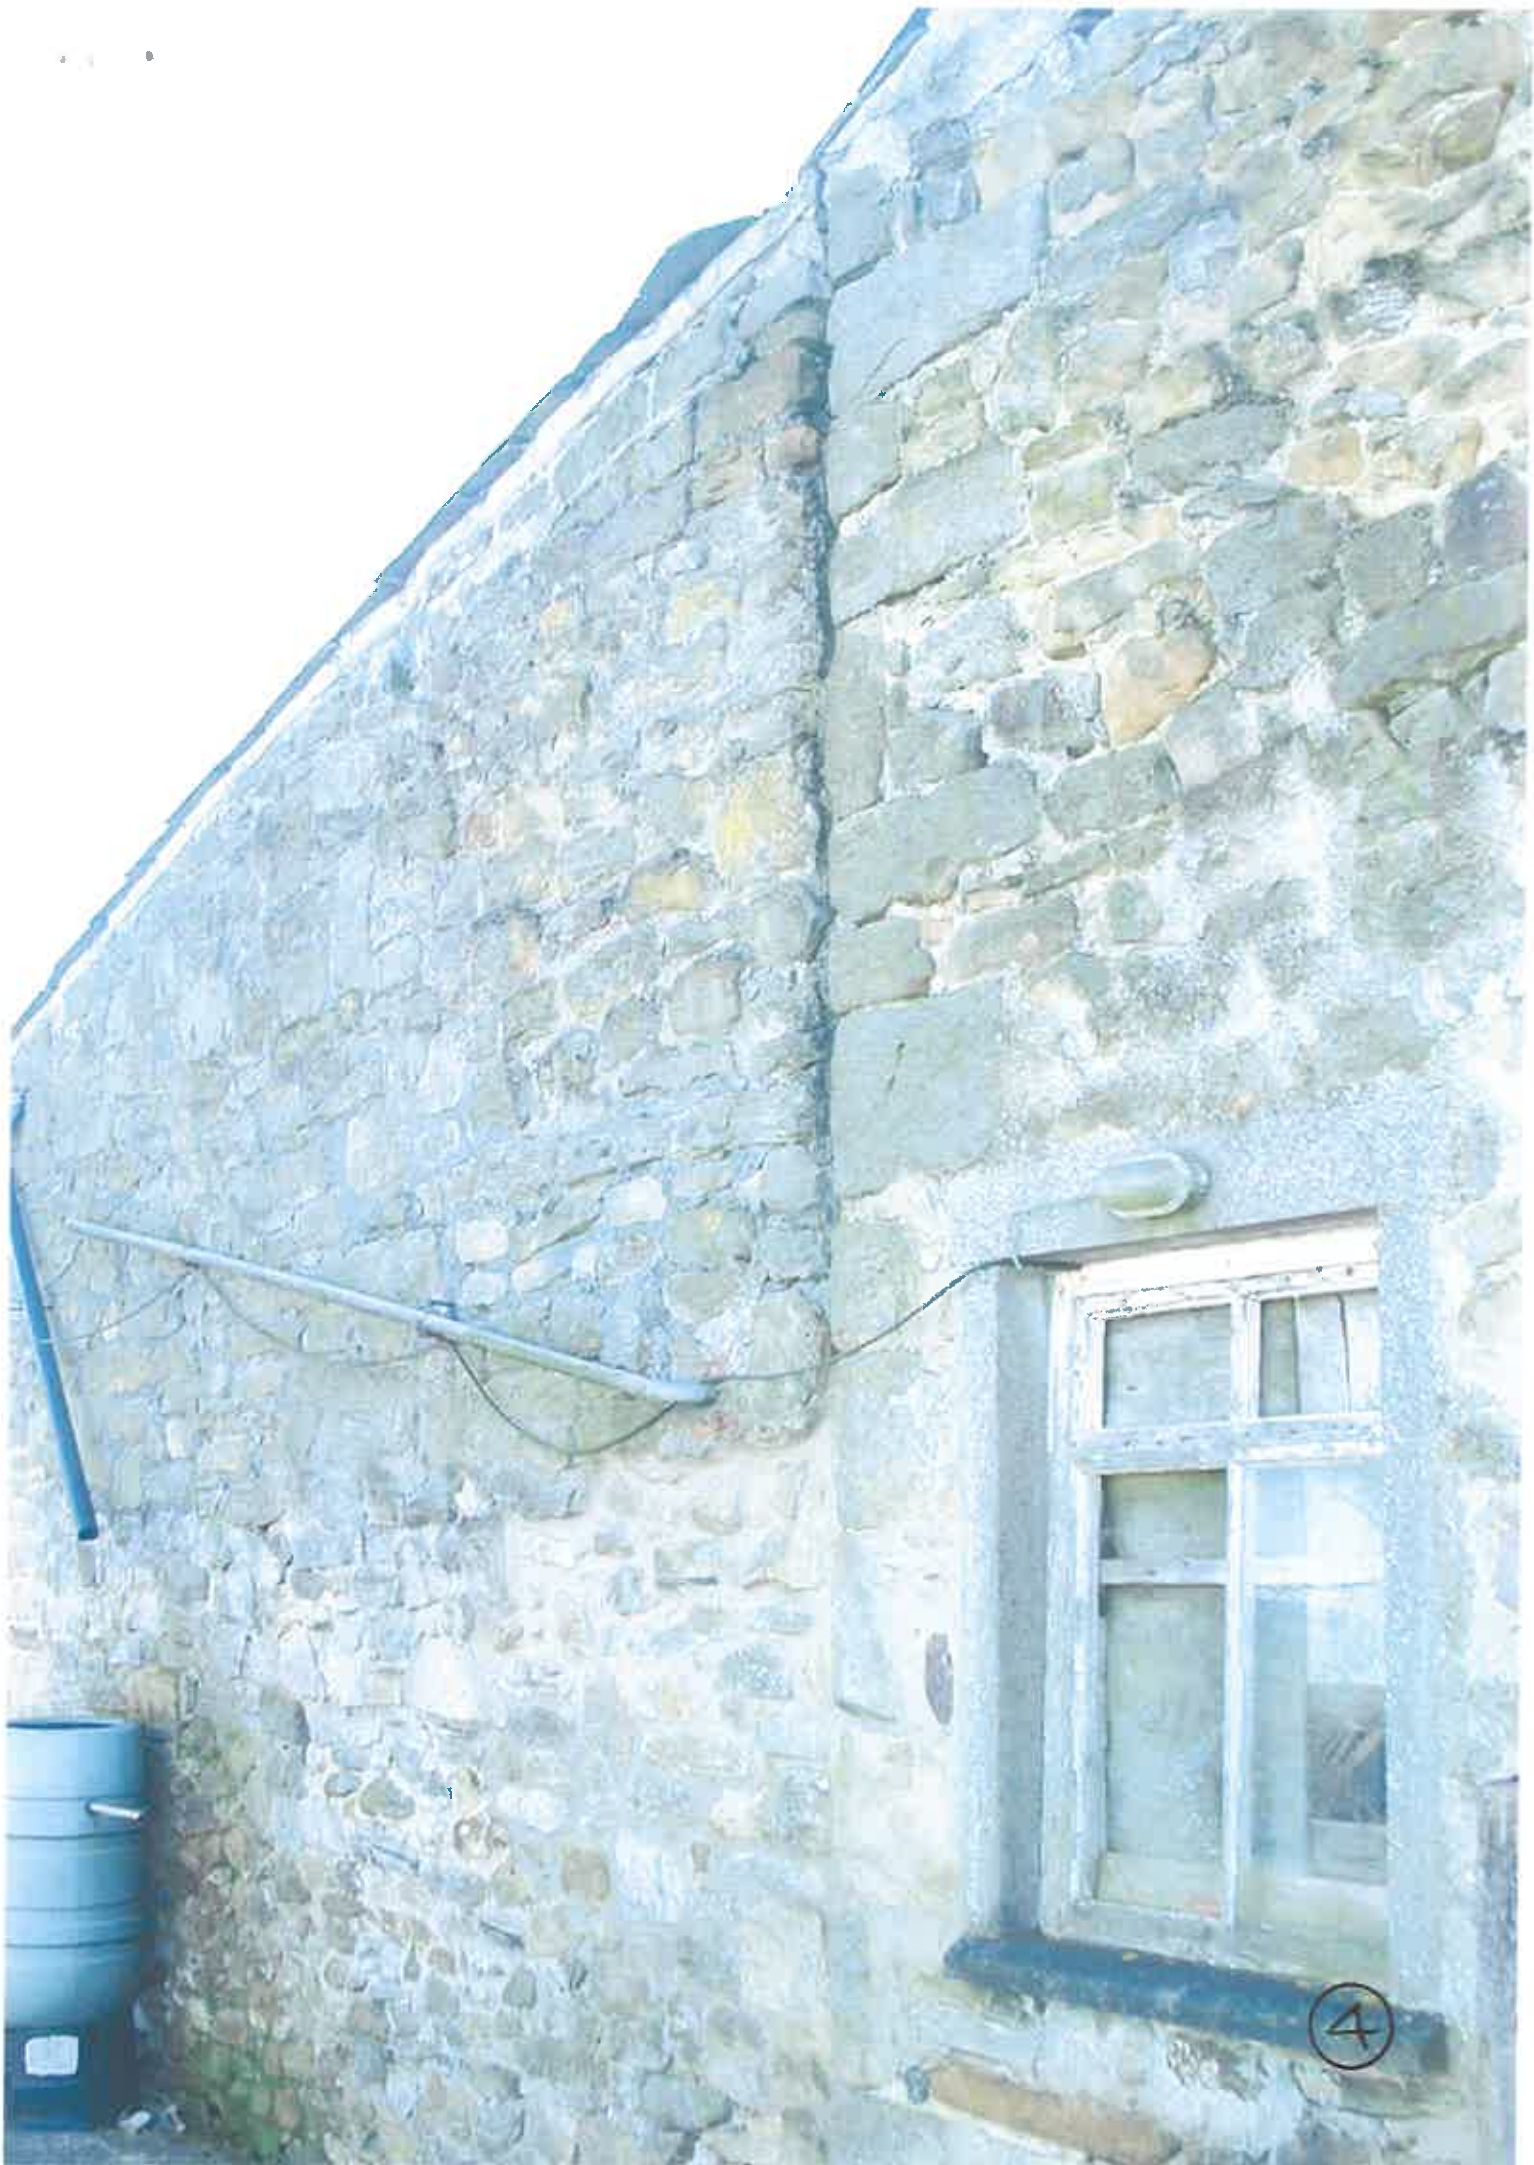
Walls generally were reasonably plumb with only slight bulging and irregularities being evident, except the upper half of the northerly side of the lean-to outrigger which displayed some bulging (Plate 4) with significant vertical gap at its juncture with the main barn.

The barn is in reasonable condition, excepting the upper half of the northerly wall of the outrigger which has suffered some displacement with consequential cracking. Some lintels and jambs to openings are also defective.

1. Replace defective lintels and jambs.
2. Rebuild upper half of the northerly side wall of the outrigger.
3. Re-roof, as necessary.
